HANLON EXP.

MINISTRY OF TRANSPORTATION AND COMMUNICATIONS-ONTARIO
DESIGN SERVICES BRANCH - FOUNDATIONS OFFICE

BORE HOLE LOCATIONS & SOIL STRATA

*Soils Investigation to Determine Causes
of the Settlements and Slope Deteriorations
on the Approach Fills of the Speed River Bridge
Hanlon Expressway, W.O. 72-11108, Cont. #71-01*

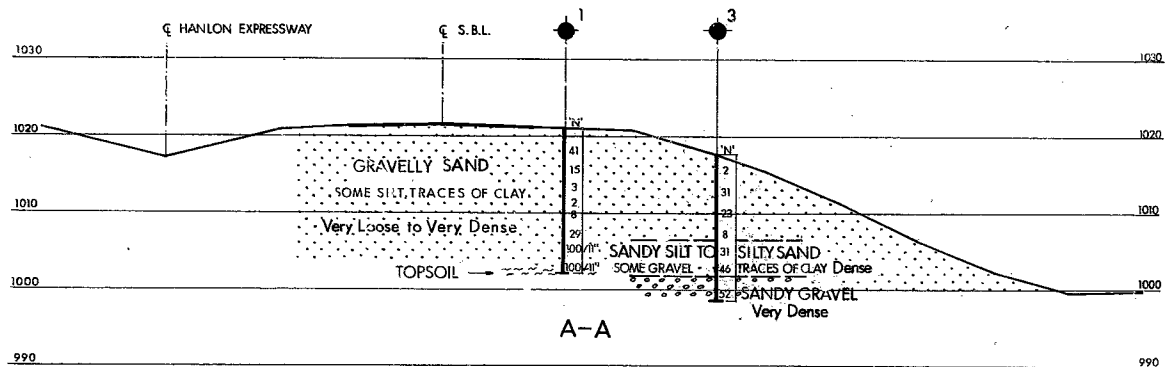
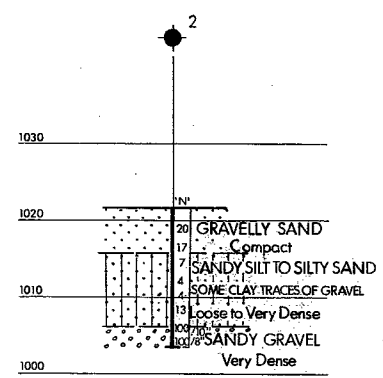
NOTE
The boundaries between soil strata have been established only at Bore Hole locations. Between Bore Holes the boundaries are assumed from geological evidence.

Standard penetration tests performed in the boreholes proved that under the actual road bed the soils have loose to compact relative density and soft to stiff consistency. Penetration N values were recorded to vary between 2 blows per foot and say 20 blows per foot. Higher N values within these strata were caused by larger size gravels rather than by better compaction. The vertical extent of this poorly compacted material was found to be approximately 10 ft. under the north approach fill and some 14-15 ft. under the south approach of the northbound structure.
