63-F-89
HWY. # 535
PROP. D.H.O.
PATROL YARD,
APPLEBY TWP.

FOUNDATION INVESTIGATION REPORT

Proposed D.H.O. Patrol Yard, Hwy. 535,
Lot 1, Conc. III, Twp. of Appleby,
District of North Bay, Dist. No. 13.
W.J. 63-F-89 -- W.P. (Nil)

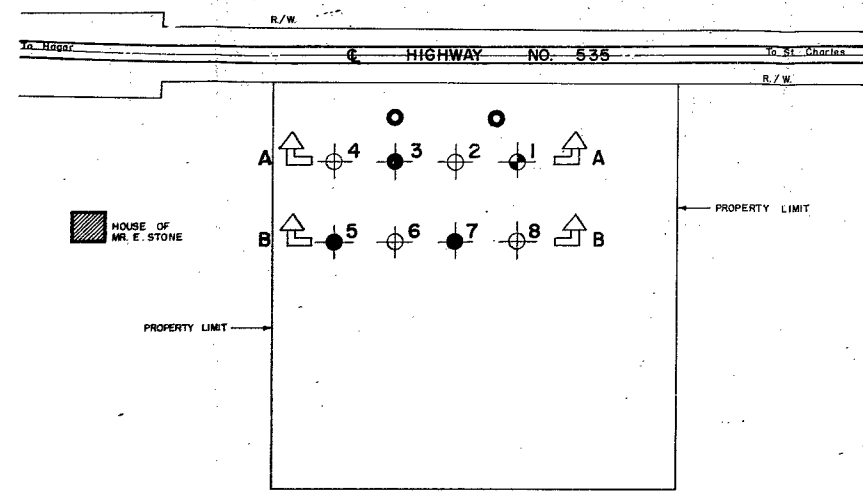
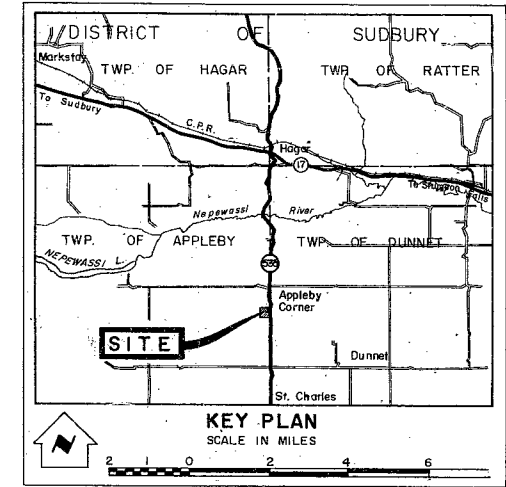
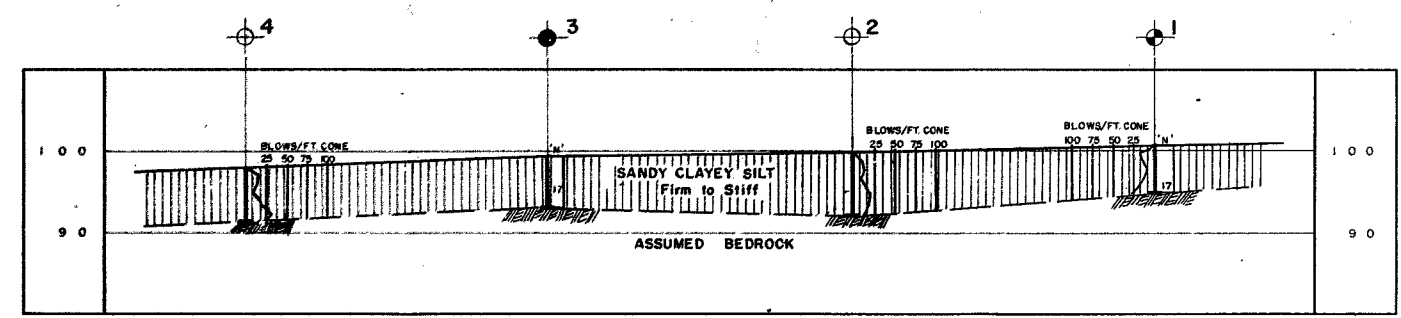
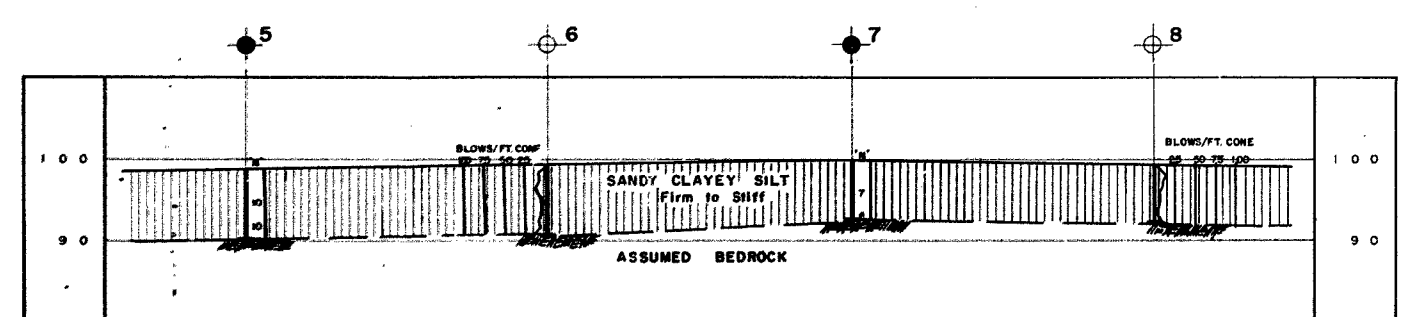
DEPARTMENT OF HIGHWAYS - ONTARIO		
MATERIALS & RESEARCH SECTION		
ST. CHARLES PATROL YARD		
ORIGINATED W. KULMATICAS	DISTRICT NO. 13	DATE 23 AUG. 1963
DRAWN D. MUMFORD	W.P. NO.	JOB NO. 53-F-89
CHECKED <i>[Signature]</i>	SCALE	DRAWING NO.
APPROVED <i>[Signature]</i>	AS SHOWN	63-F-89 A

NOTE
THE BOUNDARIES BETWEEN SOIL STRATA HAVE BEEN ESTABLISHED ONLY AT BORE HOLE LOCATIONS. BETWEEN BORE HOLES THE BOUNDARIES ARE ASSUMED FROM GEOLOGICAL EVIDENCE AND MAY BE SUBJECT TO CONSIDERABLE ERROR.

The elevations, as well as the locations of the boreholes, are shown on Dwg. No. 63-F-89A, attached to this report.

The stratigraphy of the soil, throughout the site, was found to be quite uniform. The upper 12" consists of black organic topsoil, followed by a layer approx. 6 to 9 feet thick of firm to stiff sandy clayey silt, which in turn, is underlain by bedrock.
