63-F-8
HWY # 541
GARSON
PATROL YARD

D.H.C. FOUNDATION INVESTIGATION REPORT -
Proposed Garson Patrol Yard, Hwy. #541,
Dist. #12, Sudbury - W.J. 63-F-8 - W.P. (Nil)

It is proposed to construct a D.H.O. Patrol Yard on Highway #541, approximately 4 miles north of the Town of Garson. For design purposes, a foundation investigation of the site was requested by the Special Services Section in a memo dated January 7, 1963.

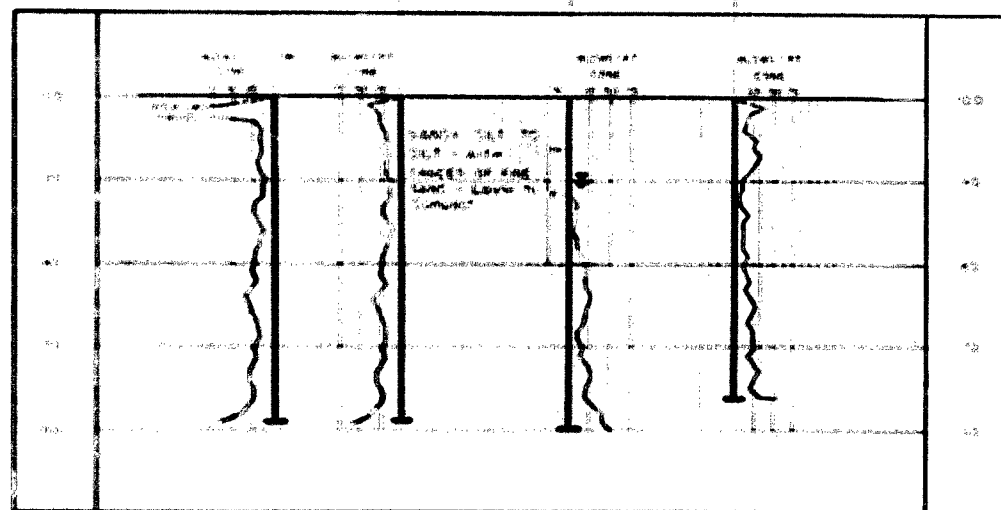
A - A

The boundaries between soil strata have been established only at the hole locations. Between hole locations the boundaries are assumed from geological evidence and may be subject to considerable error.

The subsoil at the site consists of silt with traces of fine sand. The relative density of the silt is loose to compact and there is no marked increase in density with depth for the first 35 feet, or so.

The water table was found to be 10 feet below the ground surface.

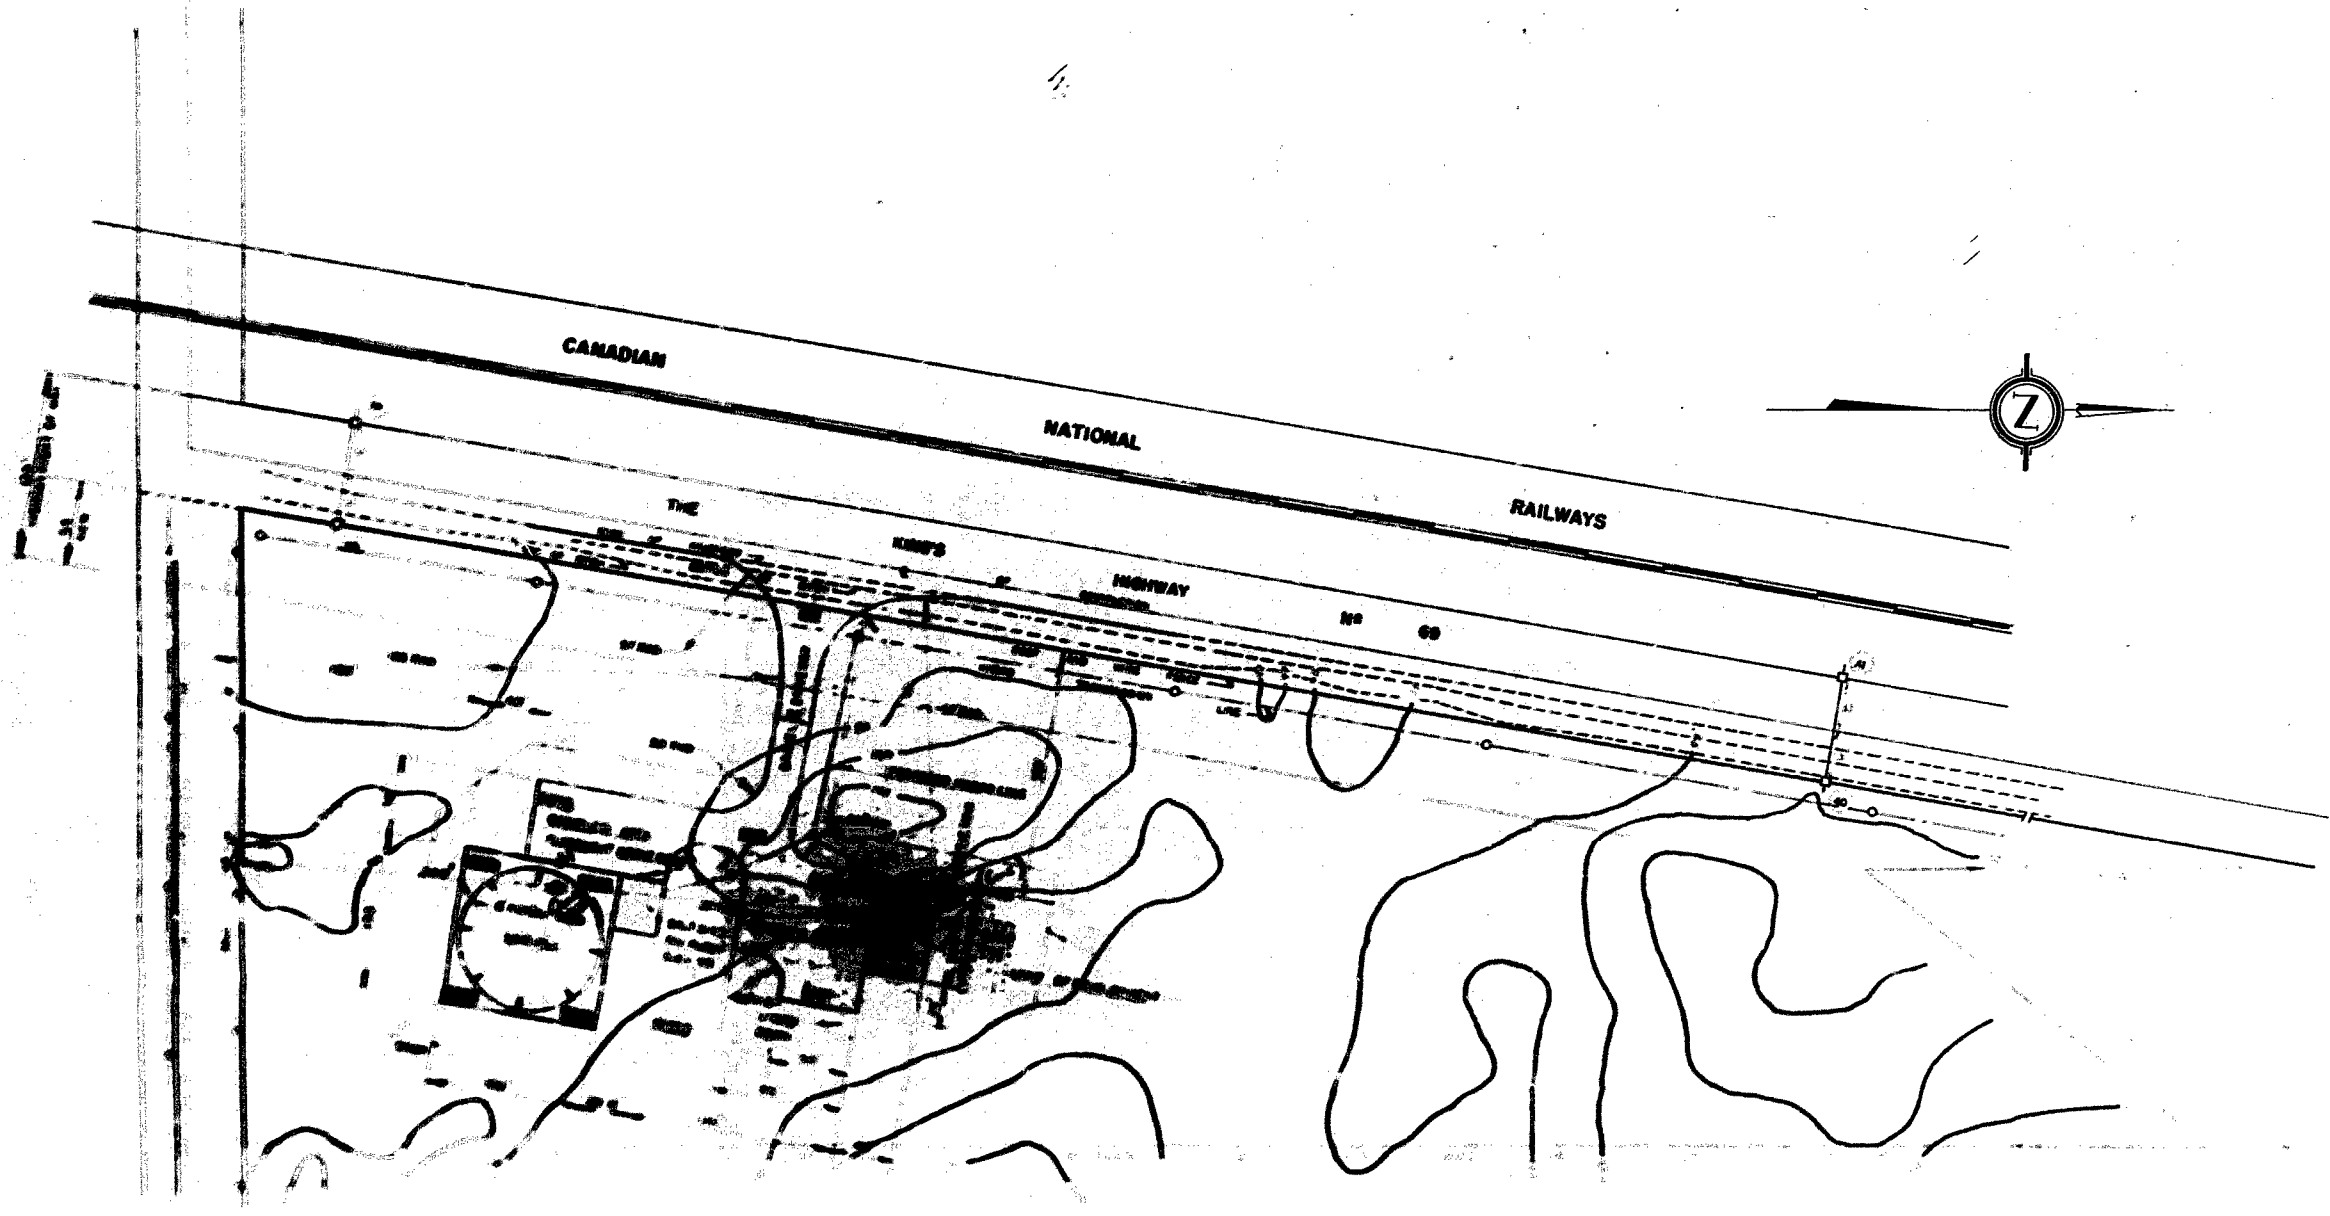
PROPERTY OF THE GOVERNMENT OF CANADA		
SITE PLAN		
HANMER SLOBBURY DISTRICT		DEC-26-1962
		1" = 50'-0"
		5-174

LOT 10, 63-A9 CONCESSION 4
HANMER PATROL YARD
