GEOCRES No. 41J-116

DIST. 17	CONT No	SHEET
WP	No 129-76-02	
LITTLE PANACHE NARROWS BRIDGE 80MI. SOUTH OF HWY. 7 GENERAL LAYOUT

FOUNDATION INVESTIGATION REPORT

Foundation Investigation Report
for
Proposed New Structure at the Crossing of
Sec. Rpa, 549 and Little Panache Lake Narrows
District of Sudbury, District #17
Site 46-173, W.P. 129-76-02

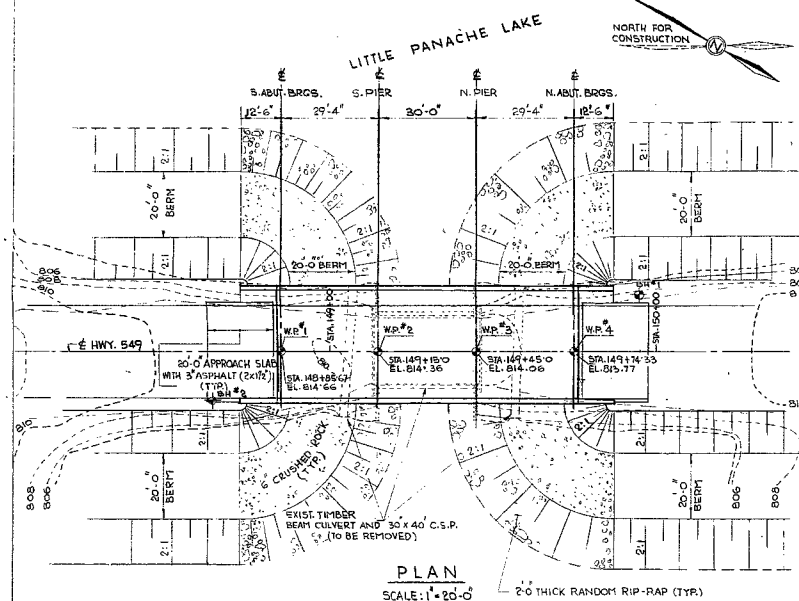
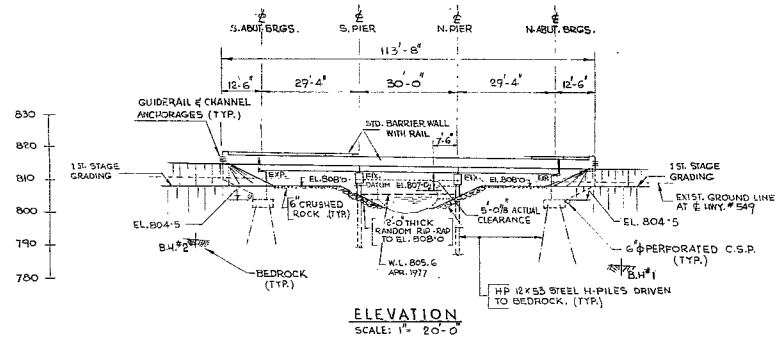
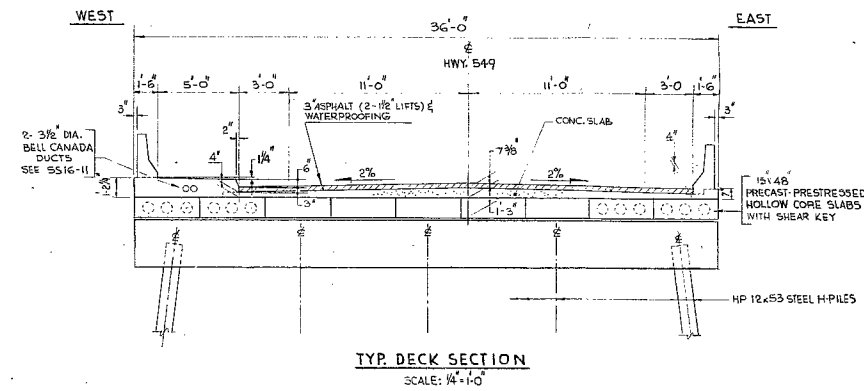
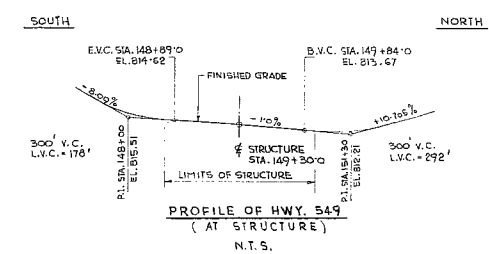
- PILES TO BE DRIVEN TO BEDROCK.
- TEMPORARY BRACING FOR PIER BENTS TO BE PROVIDED DURING CONSTRUCTION.

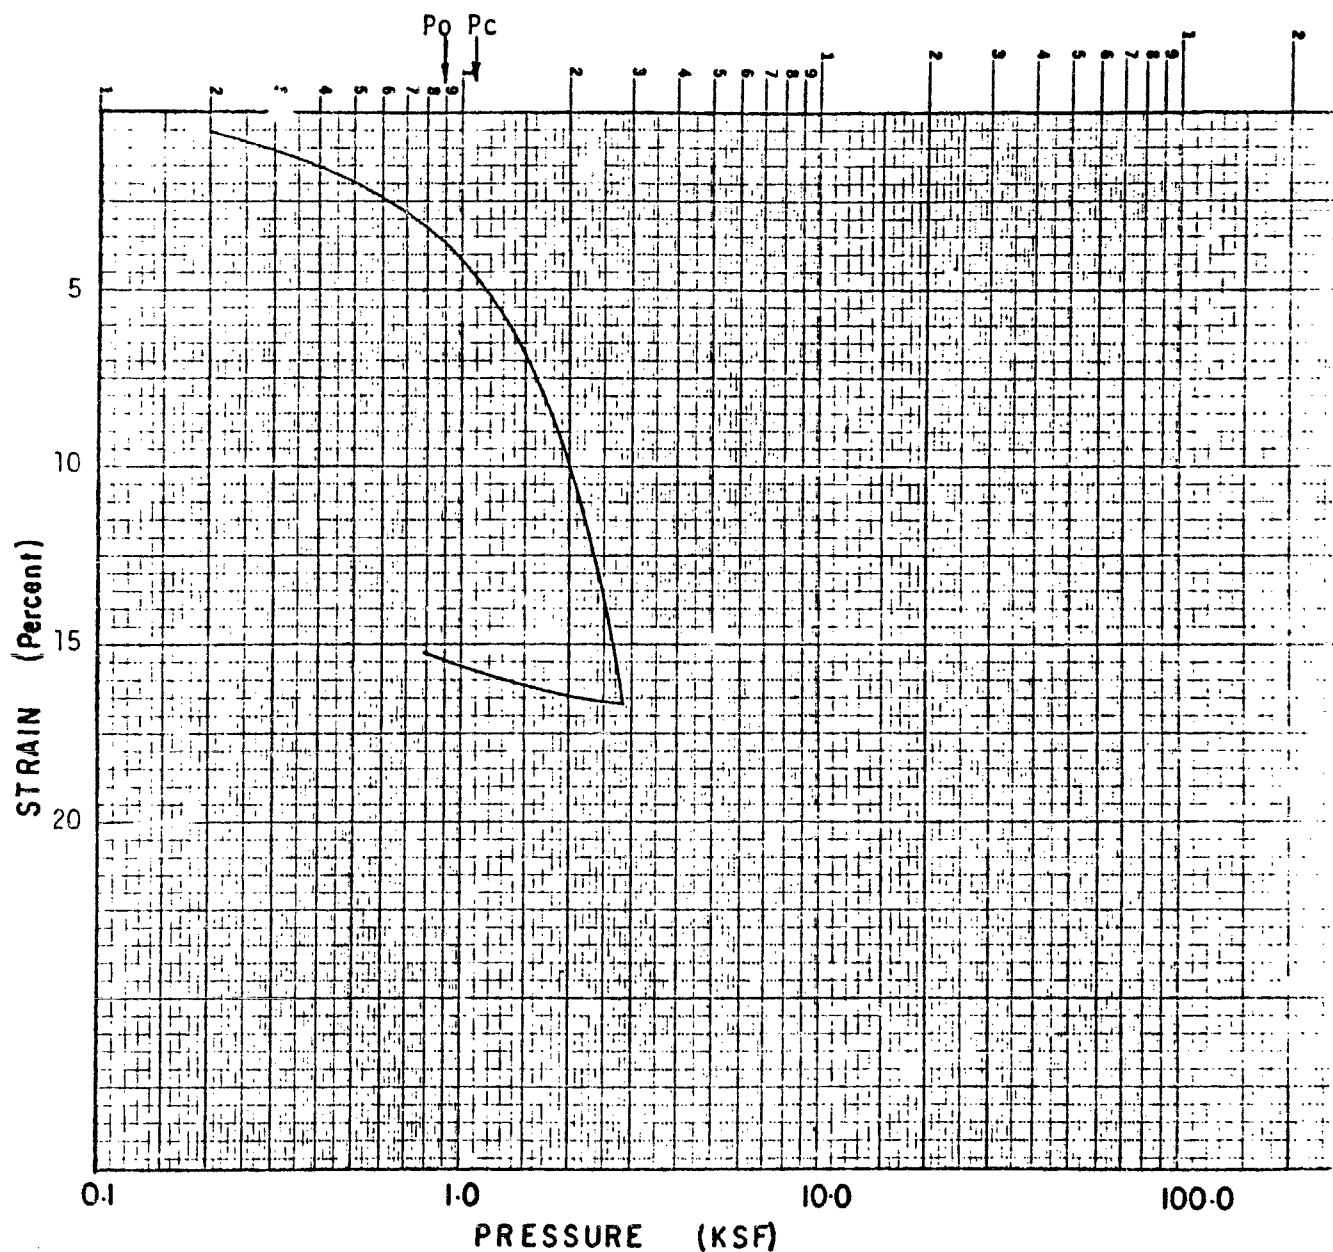
Borehole No 1
 Depth 15 - 16.5 ft.
 Moisture Content 62 %

Sample Description: Soft Silty Cla
