memorandum

Re: Preliminary Foundation Recommendations
Proposed Grade Raise, Northwest Bay Crossing
W.P. 89-86-01, Str. Site 43-57
Highway No. 64, District 54, Sudbury

WP 89-86-01
Highway 64, Causeway Realignment and
Structure Rehabilitation at Lavigne
Site 43-57
District 54, Sudbury

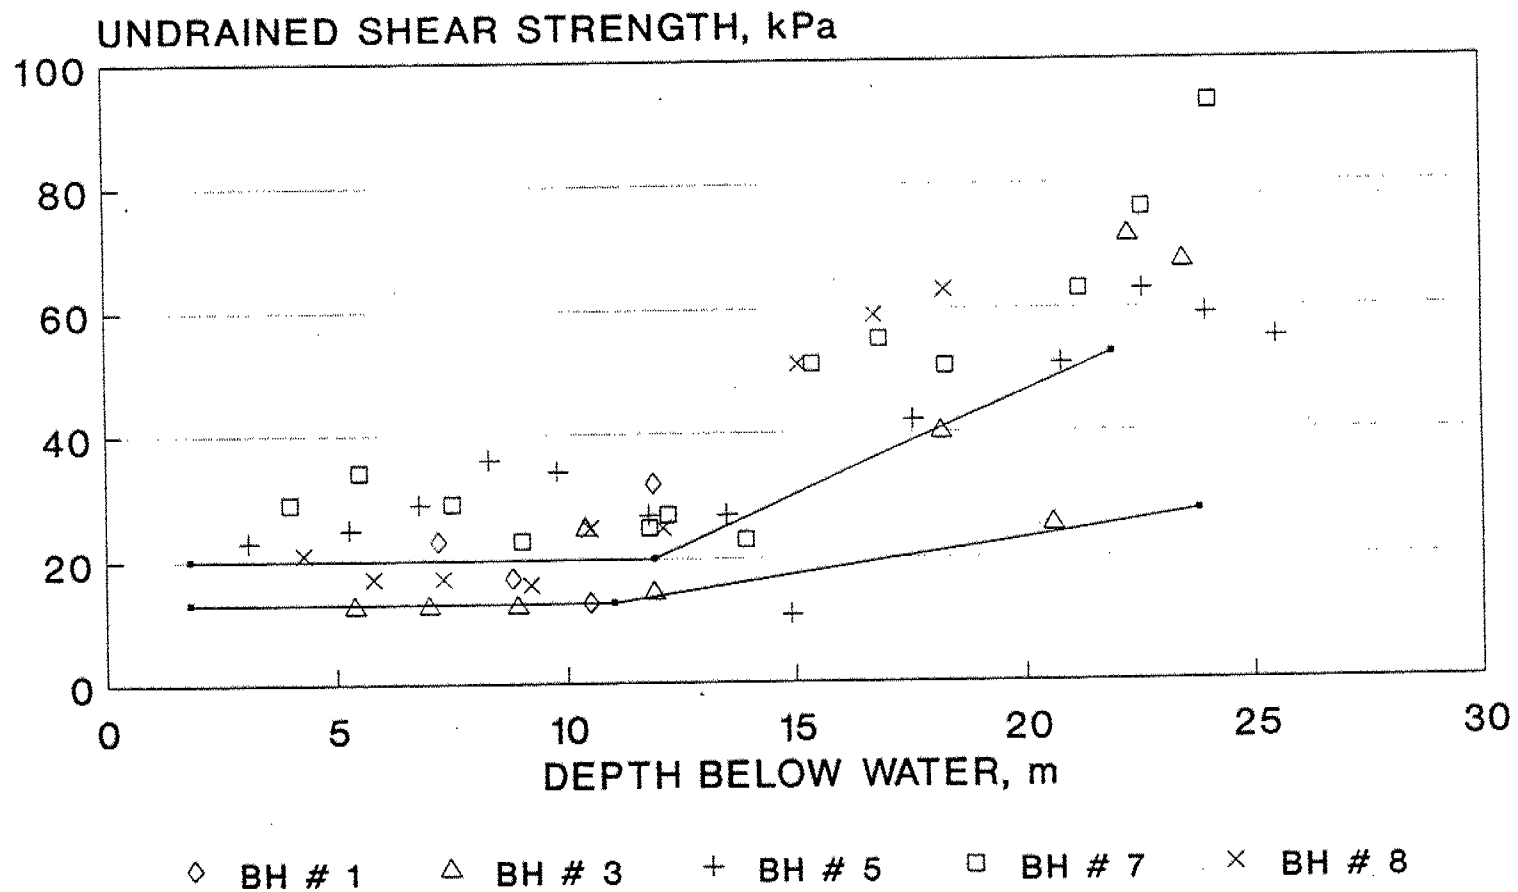
FIG -1
WP 89-86-01

UNDRAINED SHEAR STRENGTH vs ELEVATION

The variation of undrained shear strength versus elevation (plotted as depth below water level) is shown on Figure 1. The vane shear strength values obtained during the recent investigation are shown on this figure. Also included in the figure is the range of shear strength values obtained from the previous investigation included in the Geocon Report. No well defined trend could be seen in the change in shear strength over the last 30 years or so. Some increase in shear strength appears to have occurred in the area of boreholes 5 and 7, whereas in boreholes 1, 3 and 8, the average shear strength at shallow depths remained practically the same.

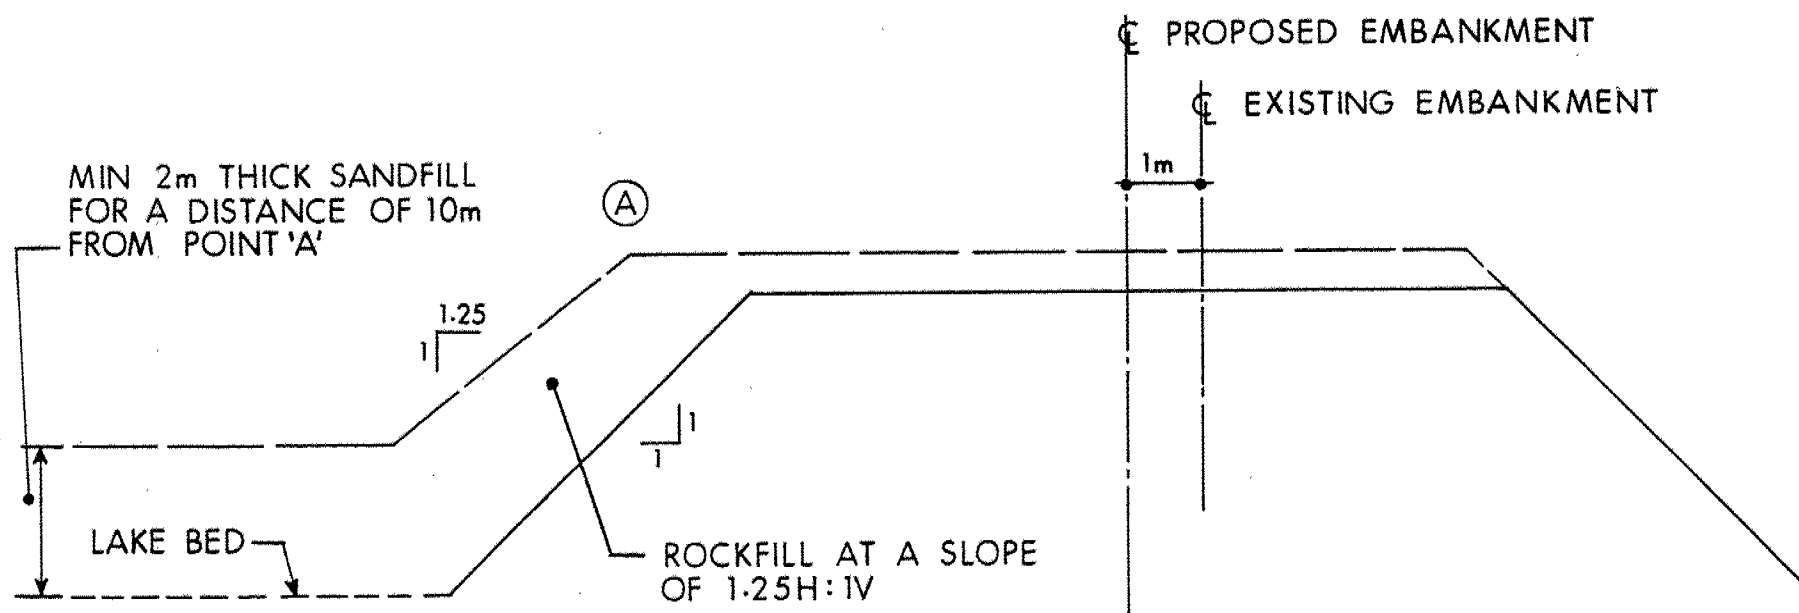
PROPOSED EMBANKMENT WIDENING
TYPICAL DETAIL
