LOCATION HWY 17B & THESSALON
RIVER.

Re: Soils Investigation for Proposed New Bridge on Huron Street
Over the Thessalon River.

This report contains comments and recommendations concerning the foundation for a proposed New Highway Bridge on Huron Street over the Thessalon River at Thessalon, Ontario. These recommendations are based on the results of soil borings made at the site during July 24th to July 30th, 1963.

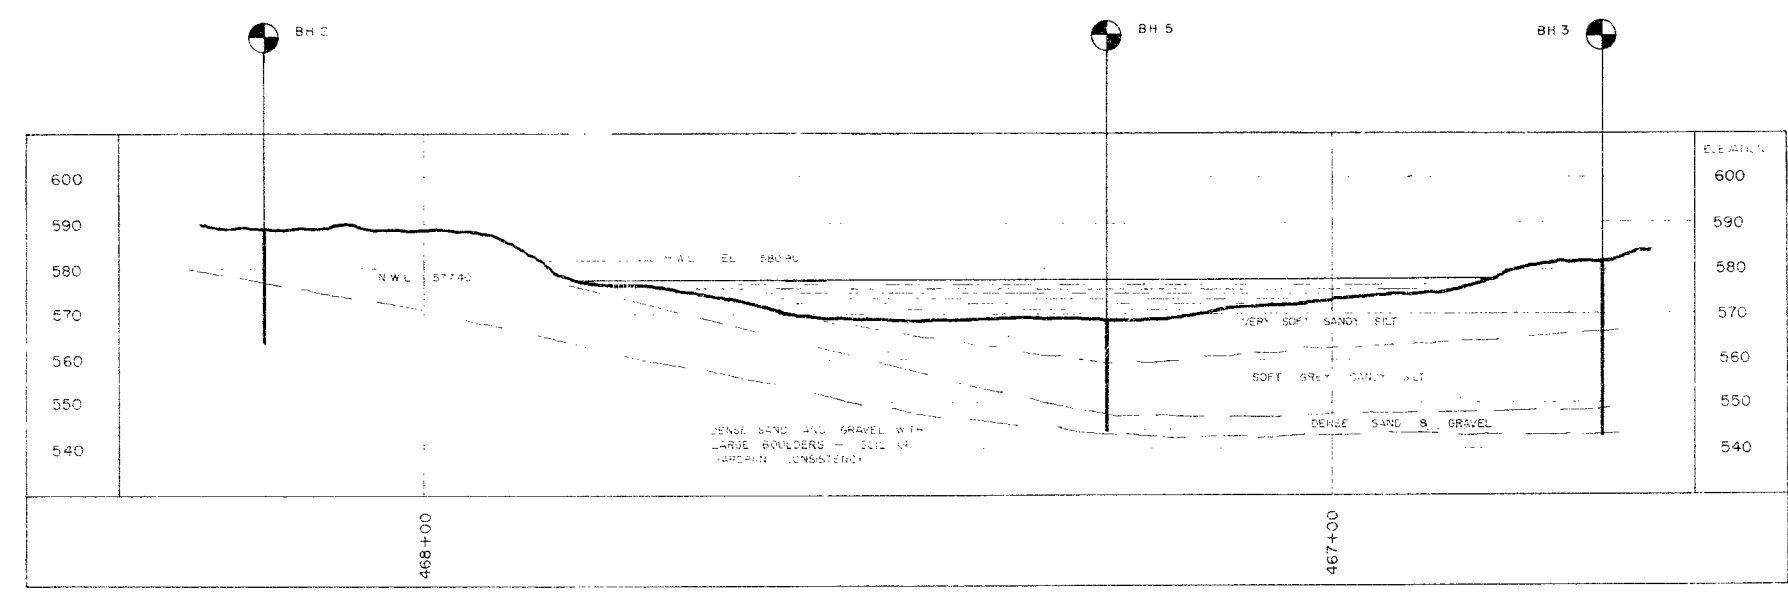
SECTION A - A PROFILE

NOTE
The soil samples between the bridge and the highway 17 bypass are of the same type and consistency. The soil samples between the bridge and the highway 17 bypass are of the same type and consistency.
