Memo to Mr. A. M. Toye, **Date** August 13, 1959.
Bridge Engineer. **Subject** Re: Harmony Creek Crossing,
From Materials & Research Section. Hwy. 17 (TCH) W.P. 919-59,
District #18.

FOUNDATION INVESTIGATION
HARMONY RIVER CROSSING
HWY. NO. 17 T.C.H.AT
HARMONY BEACH
WP 919-59 BW 270

A foundation investigation was requested by the Materials and Research Section of D.H.O. for the Harmony River and Highway No. 17 crossing at Harmony Beach. Four boreholes were requested to determine the foundation conditions for a proposed new bridge on Line "E" about 75 ft due west of the existing roadway.

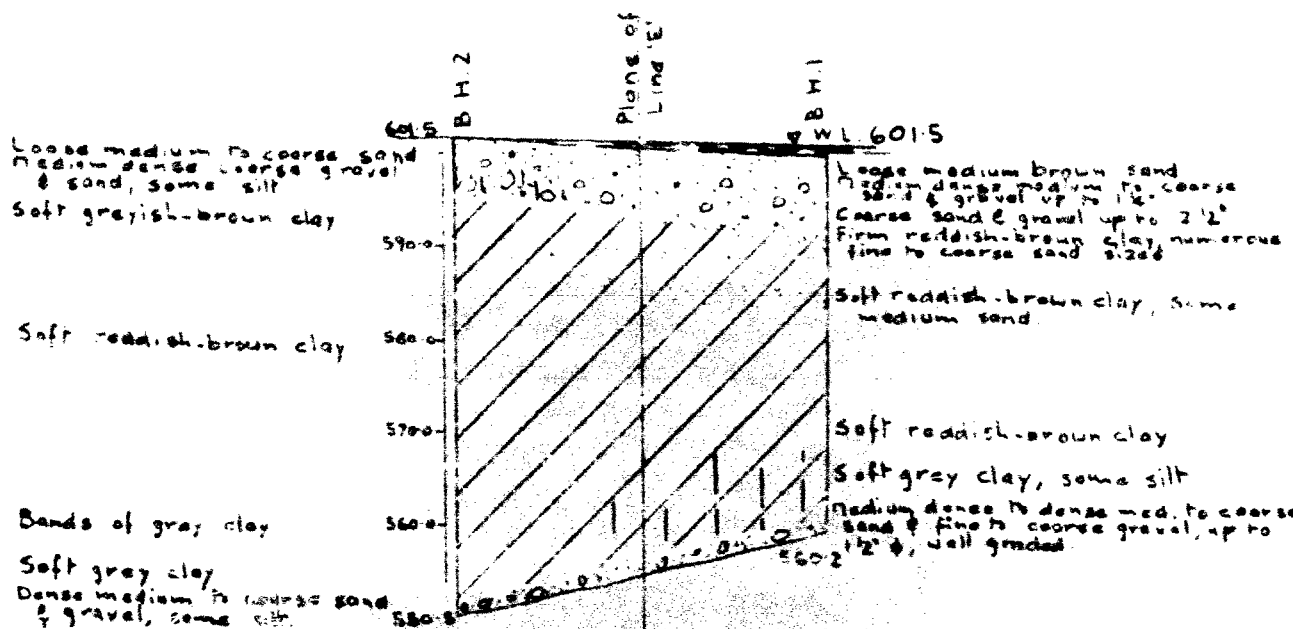
SUBSURFACE SECTION NORTHWARD

Scale: 1" = 20'

From the ground surface to a depth of about 3 ft, the soil is a loose to medium dense sand with some gravel. This is followed by a medium dense coarse gravel, sand and silt to the clay stratum. In borehole 1 the granular soil extended to elev. 592.6 and to elev. 596.0 at borehole 2. On the south bank clay was reached at elev. 599.5.

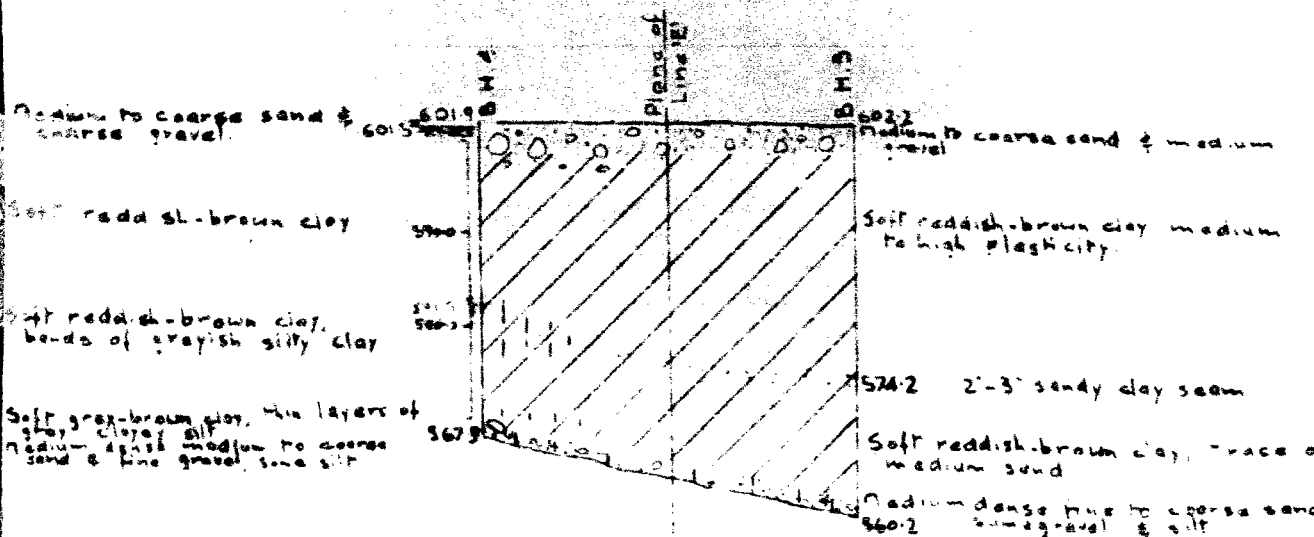
SUBSURFACE SECTION SOUTHWARD

Scale: 1" = 20'

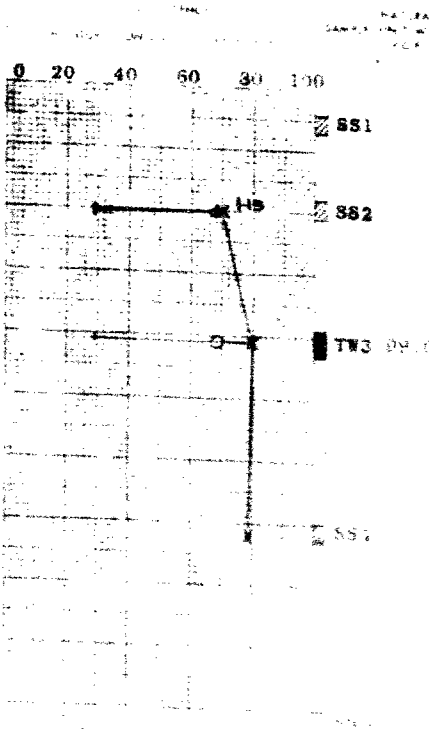
Enclosure No. 4

Project: Harmony River Bridge
 Location: Hwy. 17 T.C. d. SW 270
 Hole location: Sta. 1574+36, 20' left
 Hole Elevation and Datum: 602.0
 Field Supervisor: A.K. Prep. G.R.
 Driller: C.S. Checked:
