Hwy. #17

ROOT RIVER

e.m. peto & associates ltd.	
SOIL SITE INVESTIGATION AT HWY-17 ROOT RIVER BRIDGE #1 FOR DEPARTMENT OF HIGHWAYS OF ONTARIO	
OUR JOB No. 5867	DATE June 24-58
CLIENTS PLAN No.	PER. G.T.

**Soil Site Investigation
Proposed Highway 17 - Root River # 1 Crossing
W. P. 308 - 58**

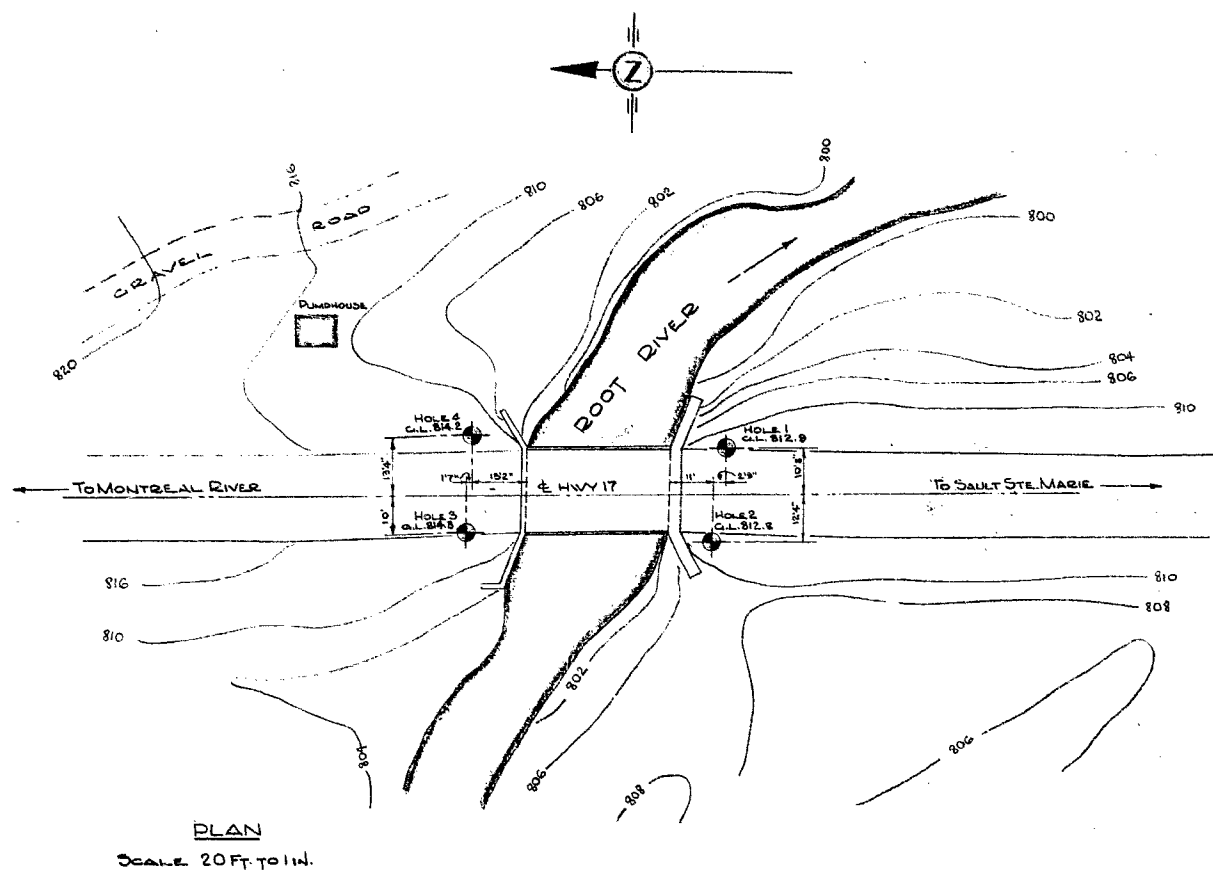
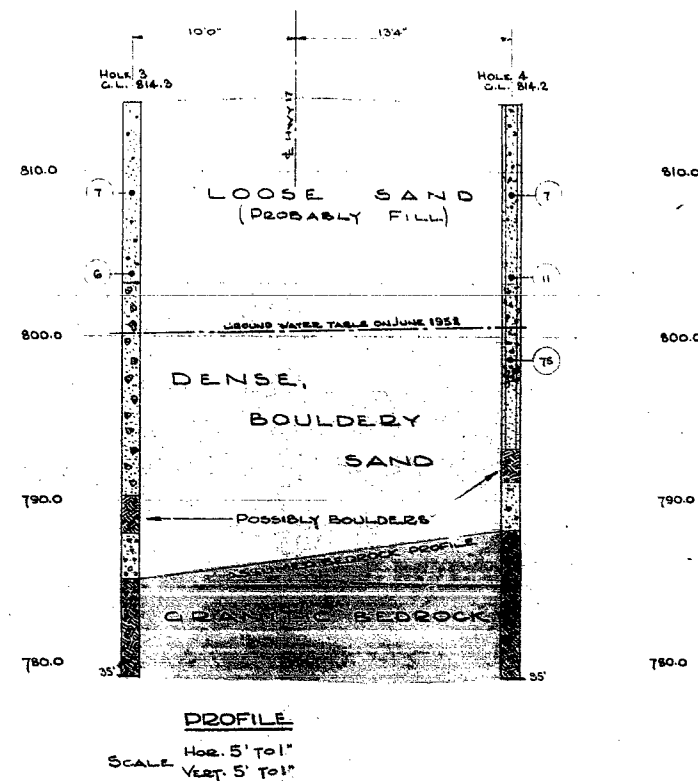
- LEGEND**
- TEST HOLE
 - ⊖ BLOWS/FOOT

NOTE:
THE SOIL BOUNDARIES HAVE BEEN ESTABLISHED AT THE BOREHOLE LOCATIONS ONLY. BETWEEN BOREHOLES THE SOIL STRATIGRAPHY HAS BEEN INFERRED.

Soil conditions on this site are fairly uniform. Three main classes of material were encountered on this site, viz. loose sand and silty sand fill, dense bouldery till, and granitic bedrock.

The observed free water levels in all four test holes corresponded closely, and in addition were approximately equal to the river water level. Due to the rainy weather during the performance of our field work, fluctuations of up to a foot in the river level occurred and this was reflected by a similar change in the ground water level. This indicates the high permeability of the sandy boulder till soil.
