GEOCRES No. 41K-39

LOCATION Proposed Culvert North
of Rydall MILL Rd. and
HWY. 17.

BORE HOLE LOCATIONS & SOIL STRATA

FOUNDATION INVESTIGATION REPORT

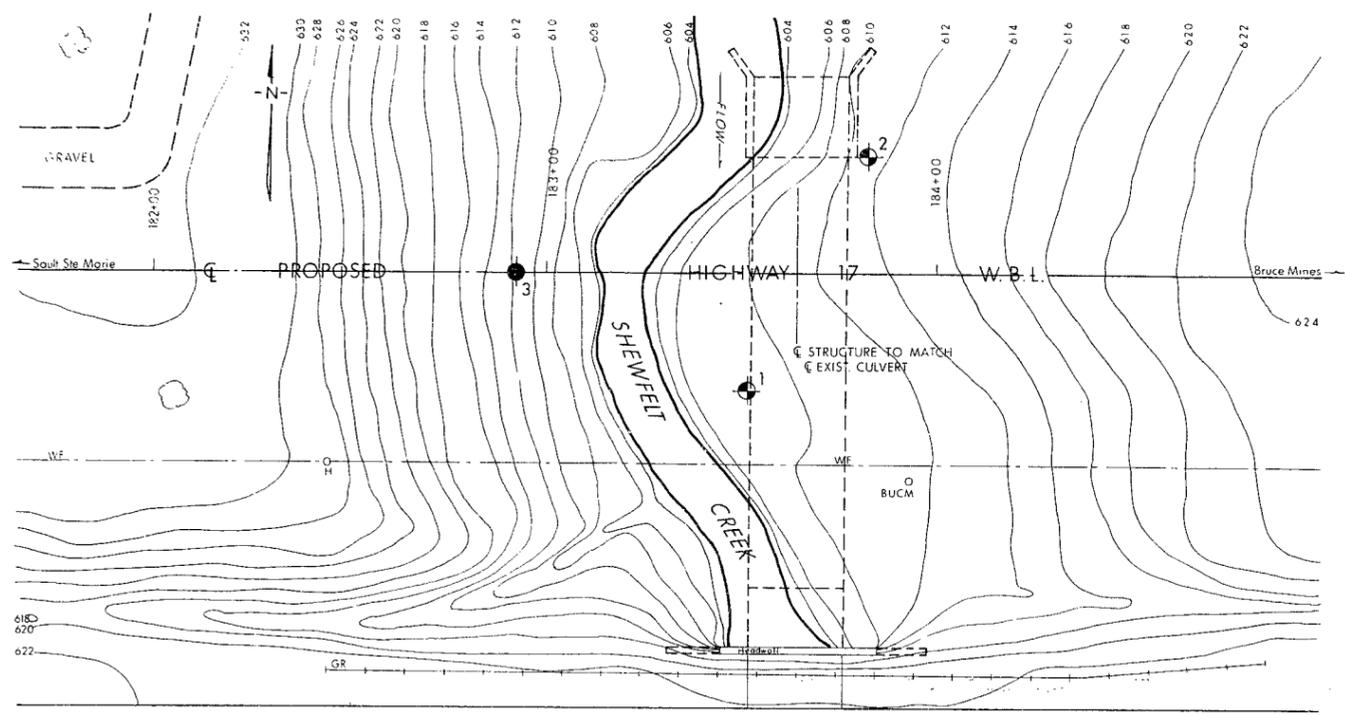
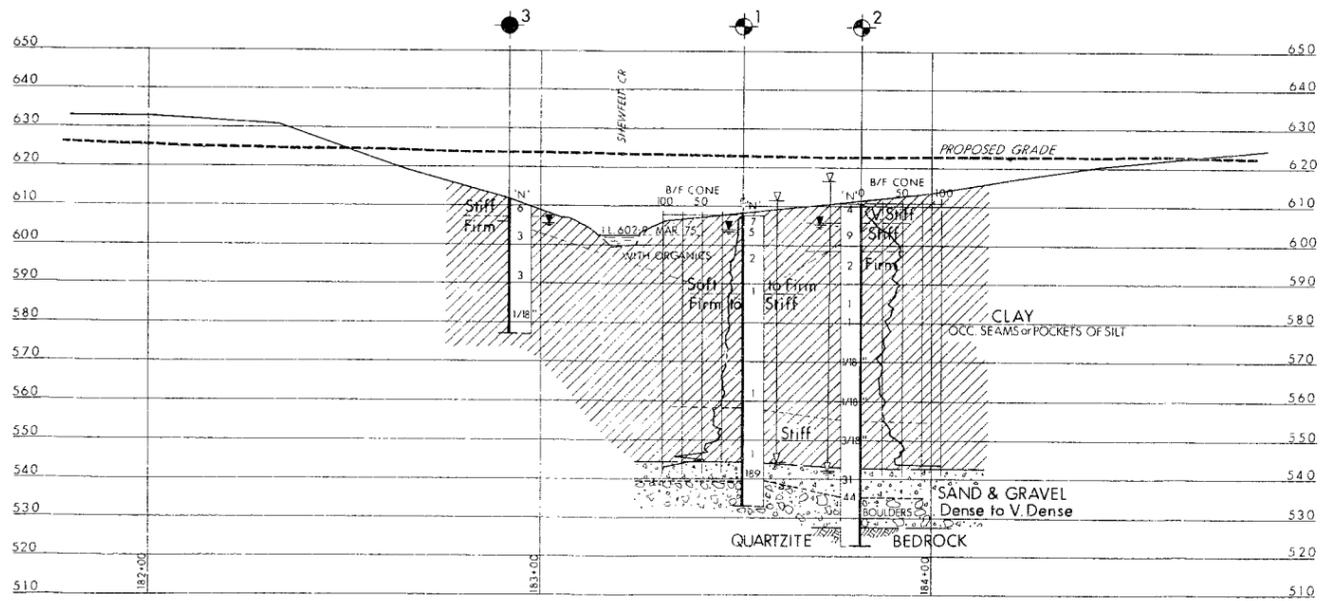
EXISTING HIGHWAY 17
PLAN
 SCALE 20 10 0 20 40 FT

Q PROFILE
 SCALE 20 10 0 20 40 FT

NOTE
 The boundaries between soil strata have been established only at Bore Hole locations. Between Bore Holes the boundaries are assumed from geological evidence.

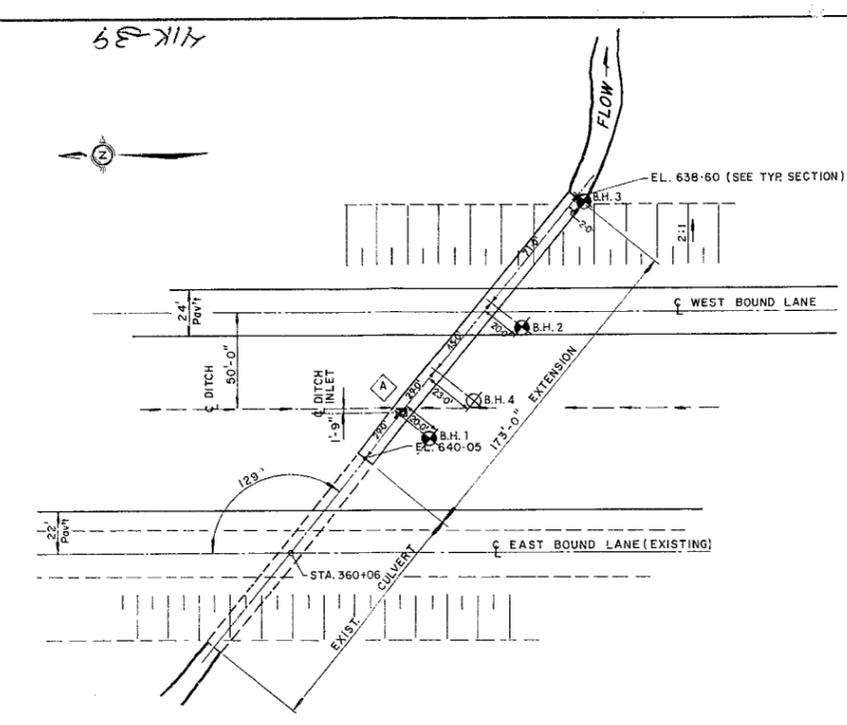
PLAN

1. The soil data shown on this plan view is for the soil in the culvert. It is not to be used for any other purpose.

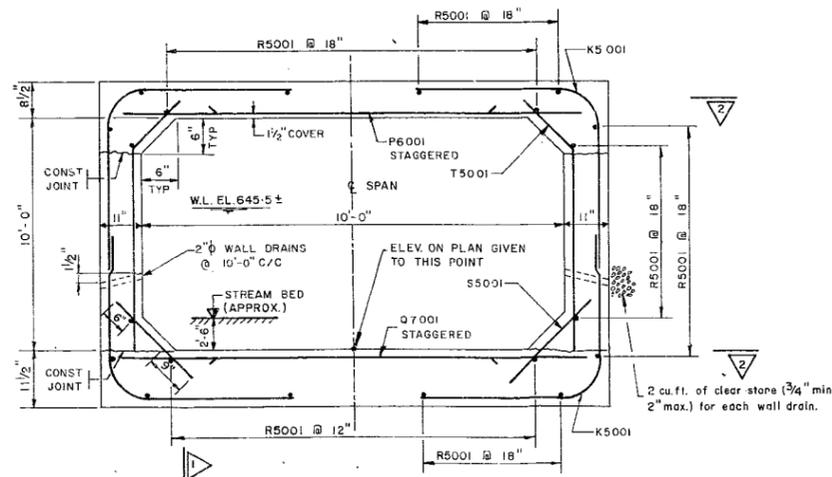
TYPICAL CULVERT SECTION
SYMMETRICAL ABOUT & SPAN

- CLASS OF CONCRETE 3000 PSI
- CLEAR COVER TO REINFORCING STEEL 3" EXCEPT AS NOTED
- ALL EXPOSED CORNERS TO BE CHAMFERED 3/4"
- NO CONCRETE SHALL BE PLACED IN BOTTOM SLAB UNTIL THE DEPTH OF THE EXCAVATION AND CHARACTER OF THE FOUNDATION MATERIAL HAVE BEEN APPROVED BY THE ENGINEER
- FILL SHALL BE PLACED AT BOTH SIDES OF CULVERT SIMULTANEOUSLY
- CULVERT AND RETAINING WALLS (WHERE APPLICABLE) SHALL BE BUILT IN ACCORDANCE WITH MTC FORM 9
- REINFORCING STEEL SHALL BE HARD GRADE
- STEEL FOR EACH CULVERT (INCLUDING RETAINING WALL WHERE APPLICABLE) SHALL BE BUNDLED SEPARATELY AND MARKED WITH STATION NUMBER
- WALL DRAIN OPENINGS TO BE FORMED USING NON-METALLIC MATERIAL
- VERTICAL LOCATION OF WALL DRAINS SHALL BE DETERMINED IN FIELD BY THE ENGINEER
- IF DENOTES INSIDE FACE
- OF DENOTES OUTSIDE FACE
- E.F. DENOTES EACH FACE

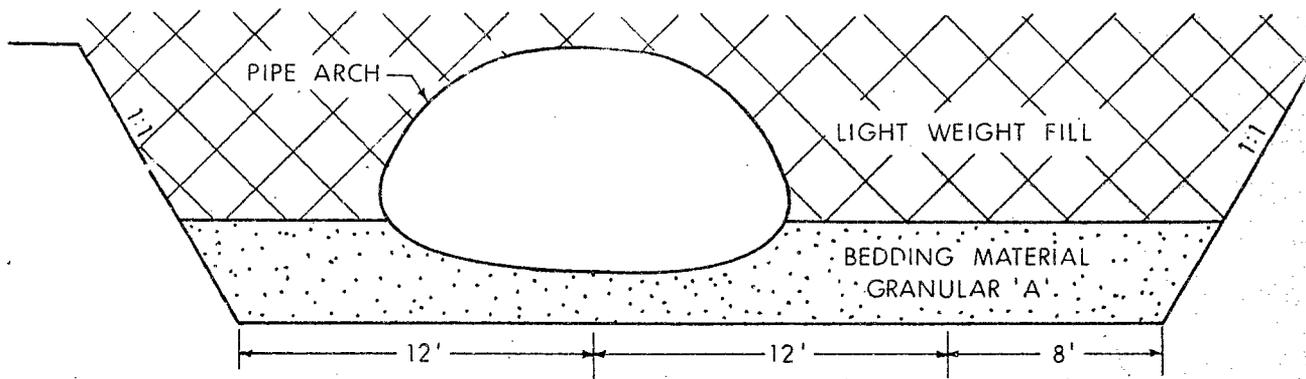
The bedding requirements for the proposed culvert should be according to MTC Standard No. DD 808-B, Type 5 with subexcavation as shown on the following page.

The structural steel plate pipe arch should be placed on a mat of granular material in order to distribute the critical corner bearing pressure so that the stress increase induced in the cohesive foundation subsoil will not exceed the allowable bearing capacity of this deposit.

During construction, should pockets of organic material be encountered below the limit of excavation such material should be excavated to its full depth and replaced with well-compacted granular material. The compaction of the material in the vicinity of the haunches is critical. The limits of subexcavation are indicated on the aforementioned figure, where slopes of 1:1 should be brought up to the frost line which is approximately 6 ft. below the ground surface. Lightweight backfill of Algoma Steel slag as shown above should be used to reduce the load on the foundation soil to minimize post-construction settlement.

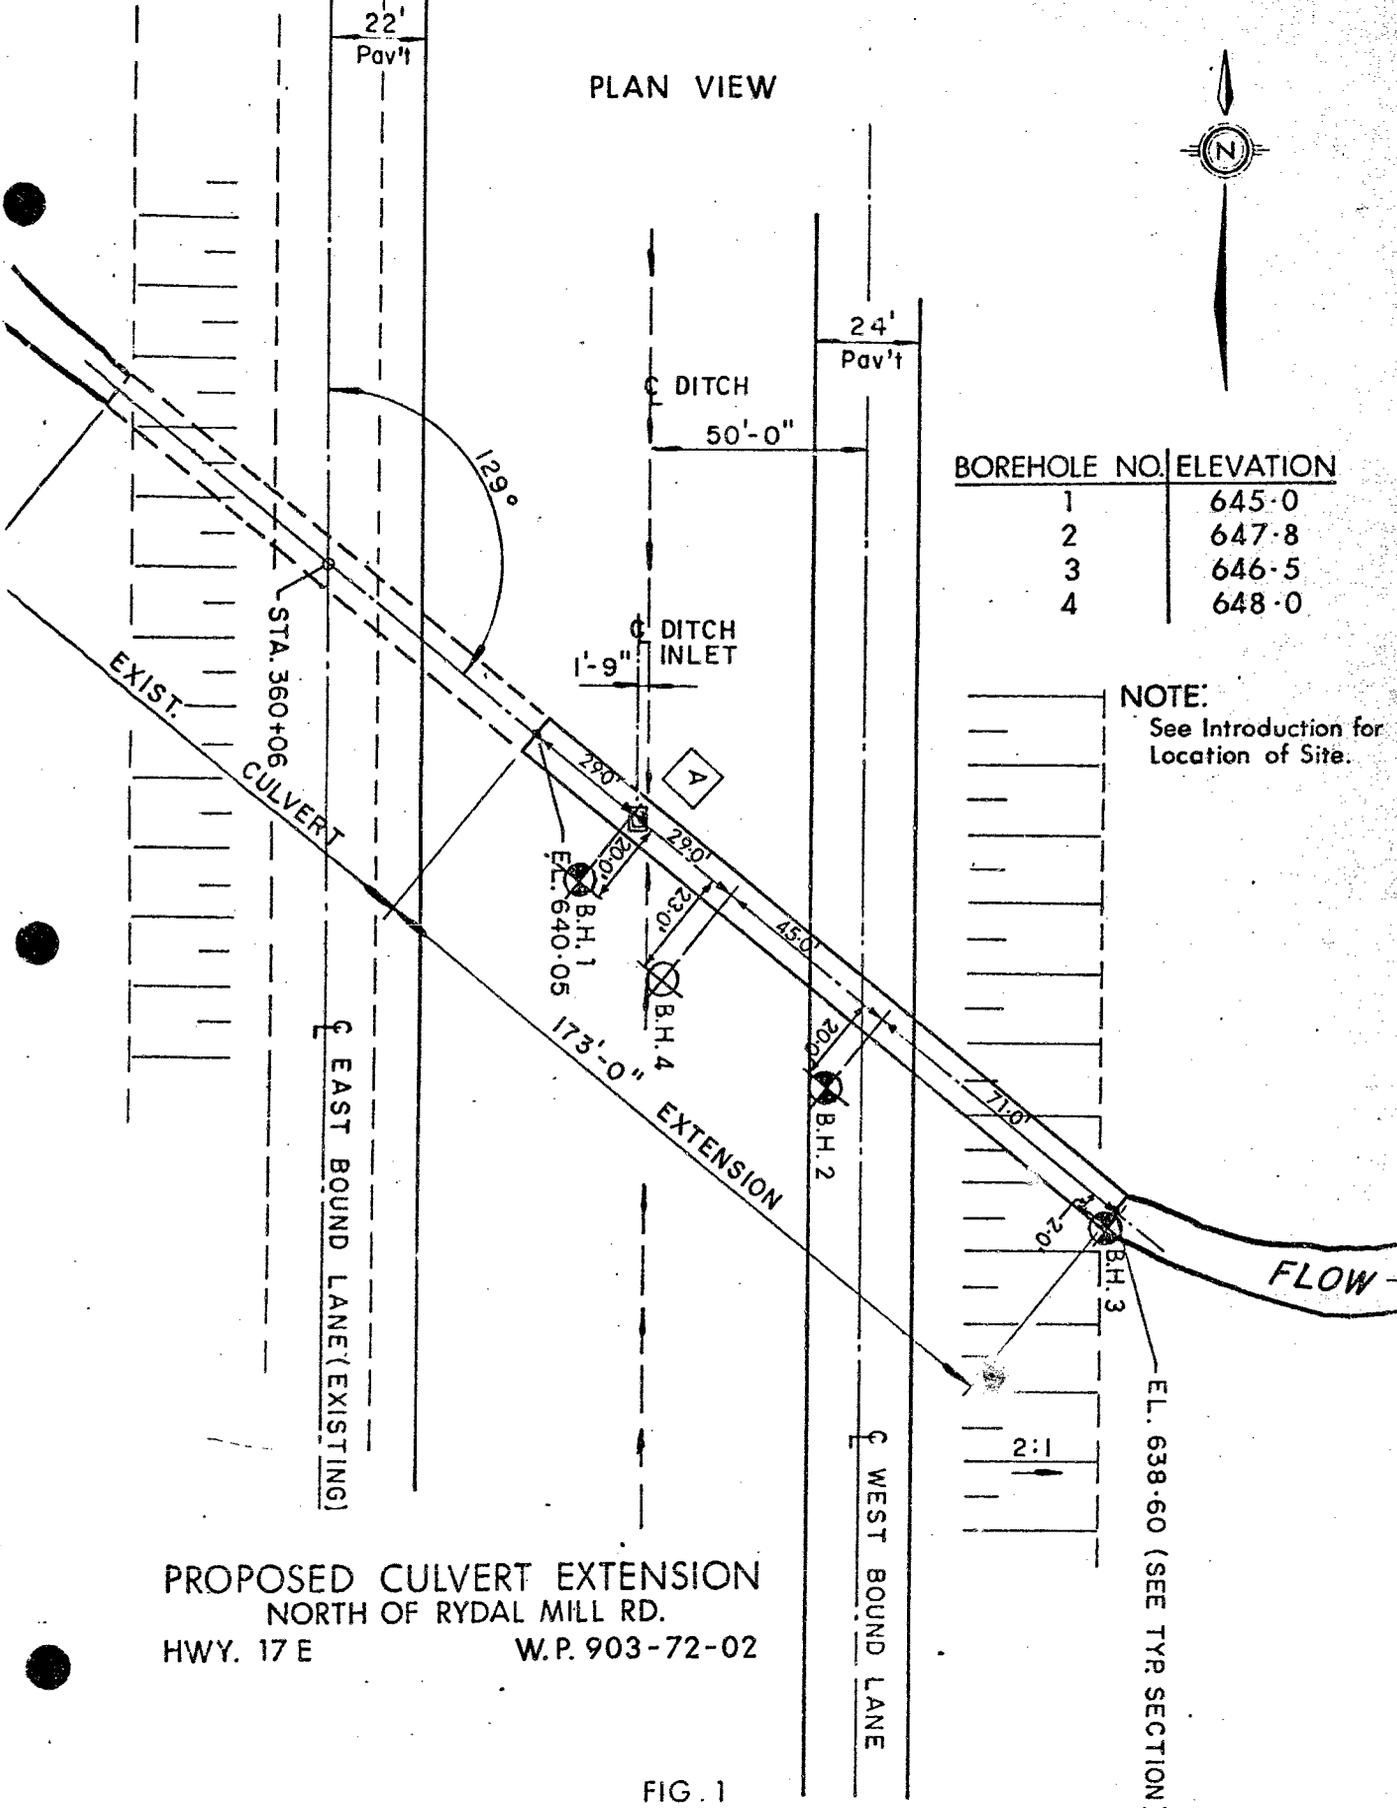
FIG. 1

PROPOSED CULVERT EXTENSION
NORTH OF RYDAL MILL RD.
HWY. 17 E W.P. 903-72-02

Surveying of the borehole locations was carried out by personnel from the Sault Ste. Marie District Office. (See Fig. 1).
