MATERIALS LABORATORY-DEPARTMENT OF HIGHWAYS - OILTATION  
OFFICE REPORT ON SOIL EXPLORATION

## STRUCTURE 542 HWY 11 AT ANGELINA CREEK LOCATION OF BOREHOLES

REPORT OF FOUNDATION INVESTIGATION  
BRIDGE AT ANGELINA CREEK  
ON HIGHWAY NO. 11, 25 MILES WEST OF HEARST  
(Structure 542 District of Cochrane)

A subsoil investigation at the bridge site on Hwy. # 11 at Angelina Creek (District Structure # 542) 25 miles West of Hearst has been completed.

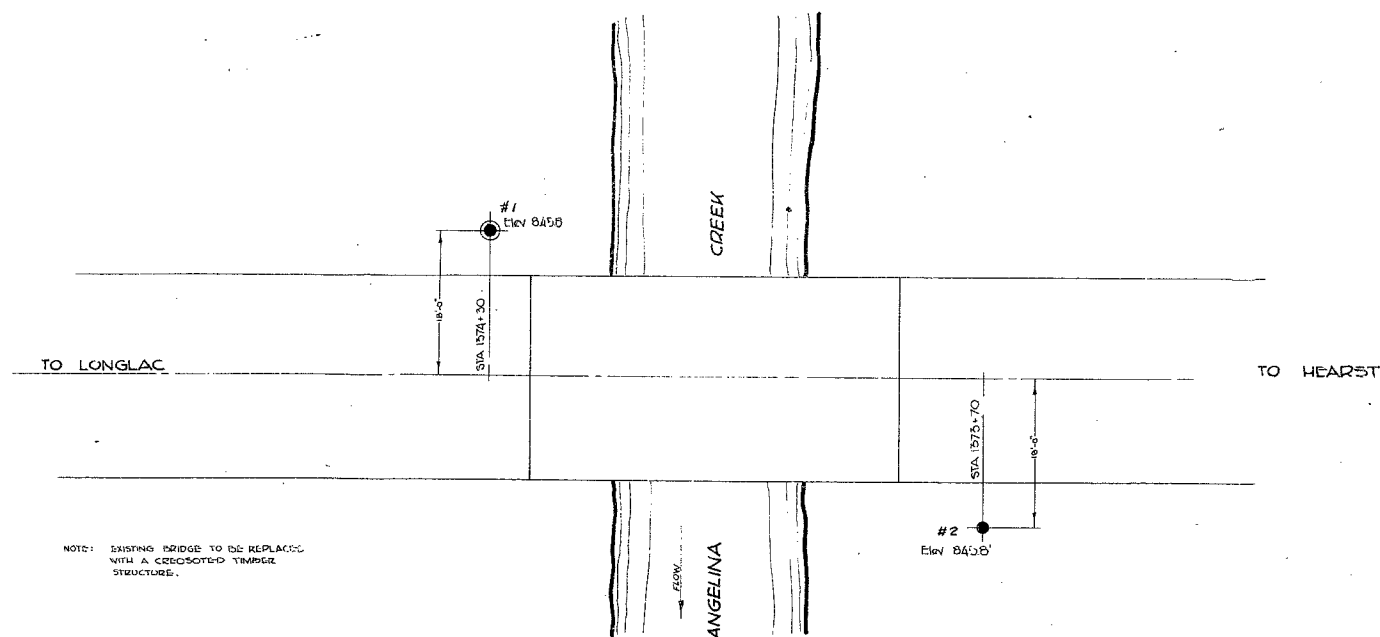
# PLAN

Scale 1 inch = 10 feet.

- PENETRATION TEST HOLE
- ⊙ PENETRATION AND BORE HOLE

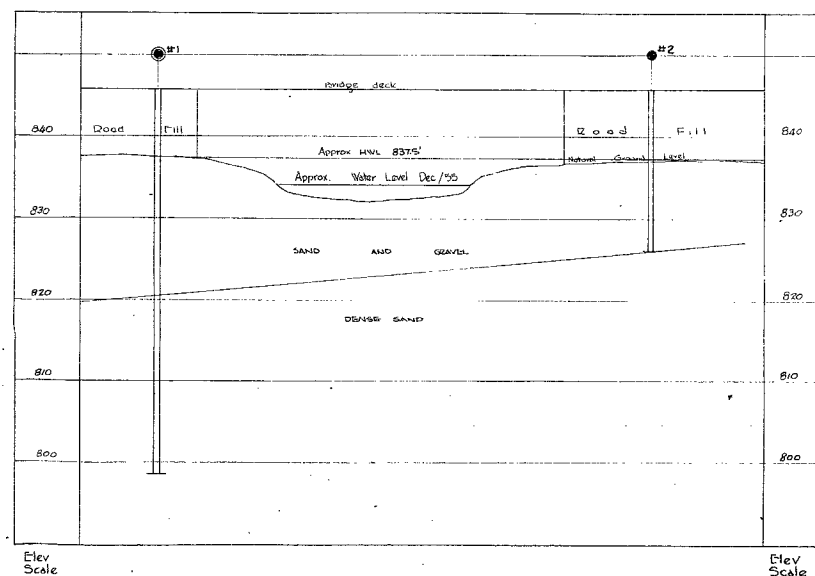
# PROFILE

Scale Horizontal / Vertical 1 inch = 10 feet

The piles should be driven until they reach hard resistance in the dense compacted sand which is found at elevations varying from 820.0 on the West bank to 826.0 on the East bank of the creek.

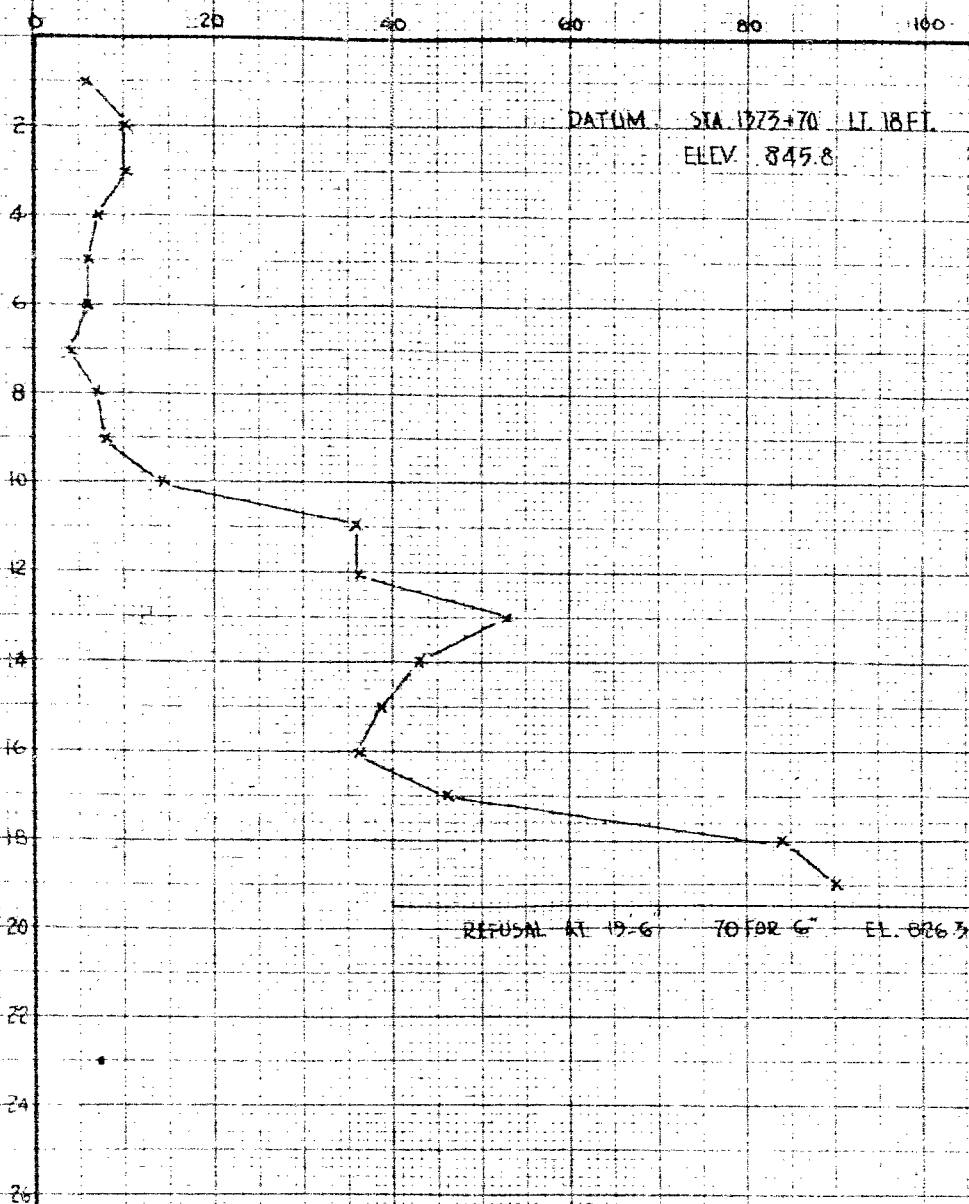
DATUM STA. 1273+70 LL 18 FT.  
ELEV. 845.8

DEPTH IN FEET

REFUSAL AT 19.6 70 FOR 6" EL. 826.3

The logs of the holes are found in Appendix I.
