Foundation Investigation Report

CPR at Hwy 17 Overpass Replacement at Martin, Kenora

Final Report

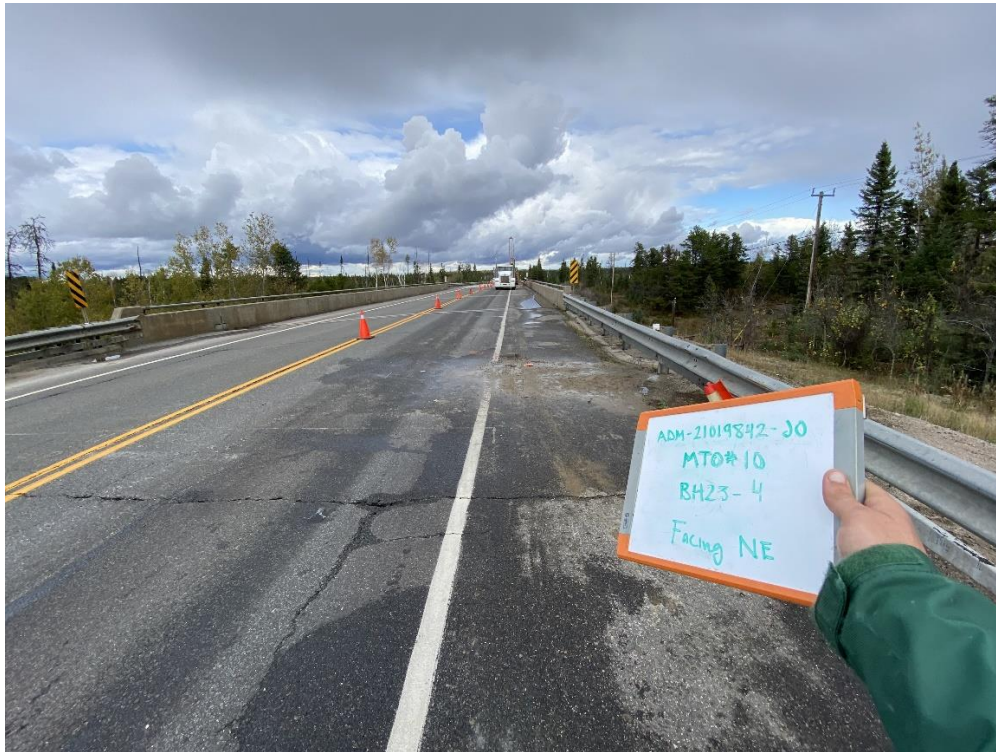
Photograph A1. Bridge deck surface conditions, looking Northeast (October 2023)

Photographs 1 to 6 taken by EXP in October 2023 and presented in Appendix A show the site and structure. Photographs 1, 2 and 3 show the surface conditions of the existing bridge along the bridge deck, north approach embankment, and south approach embankment. The existing surface has been repaved at some point, however longitudinal and transversal cracking is present throughout the roadway. Extensive rutting along the highway can be seen as well. Photograph 4 shows a profile view of the existing substructure from the point of view of the NW corner. Photograph 5 shows the substructure at the south abutment and the southern pier. Bedrock outcrops can be seen under the pier/near the bottom of the forward slope. Power lines run perpendicular to the bridge structure closely adjacent to the south abutment. Photograph 6 shows the north abutment, northern pier, and the gabion retaining wall running along the bottom of the forward slope.

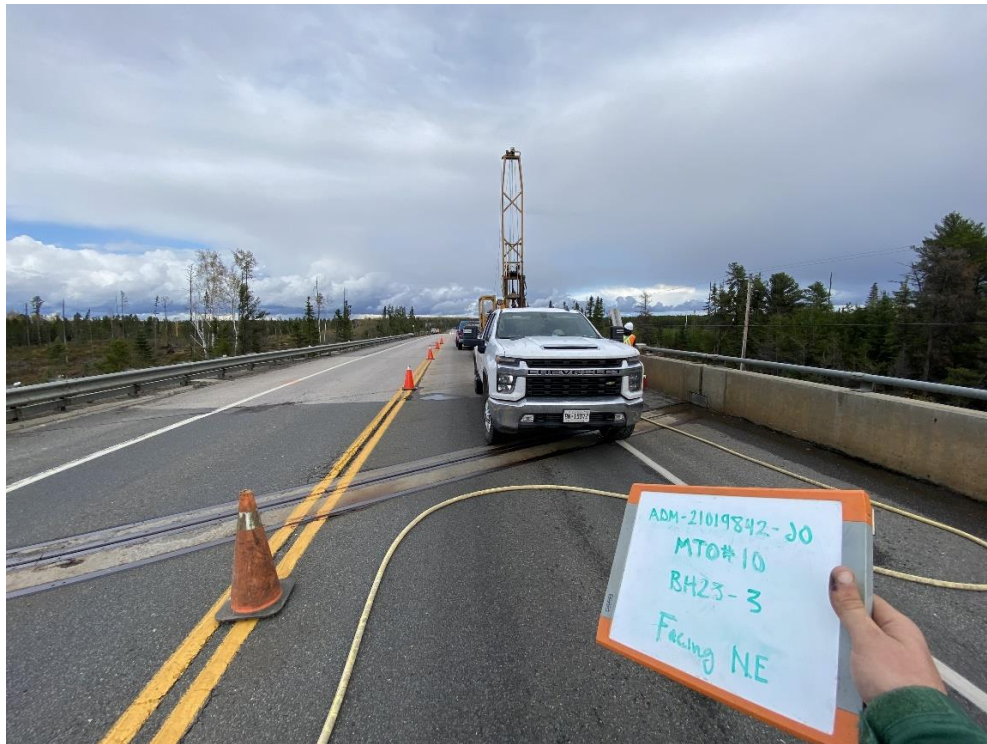
Photograph A2. Surface conditions at top of north approach embankment, looking Northeast (October 2023)

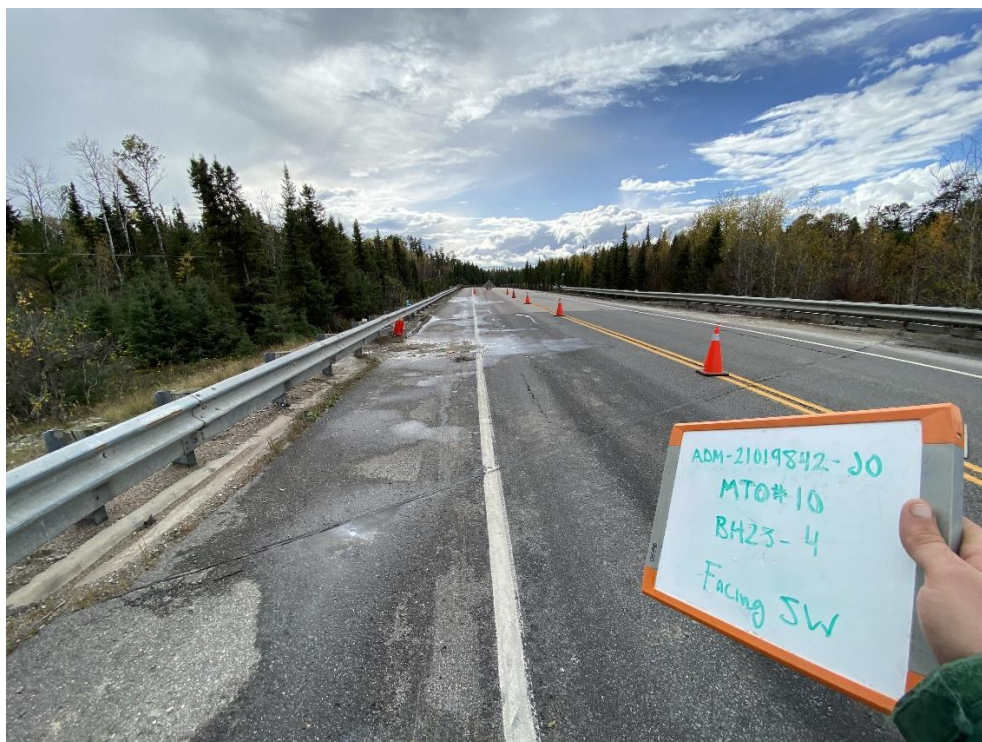
Photograph A3. Surface conditions at top of south approach embankment, looking Southwest (October 2023)

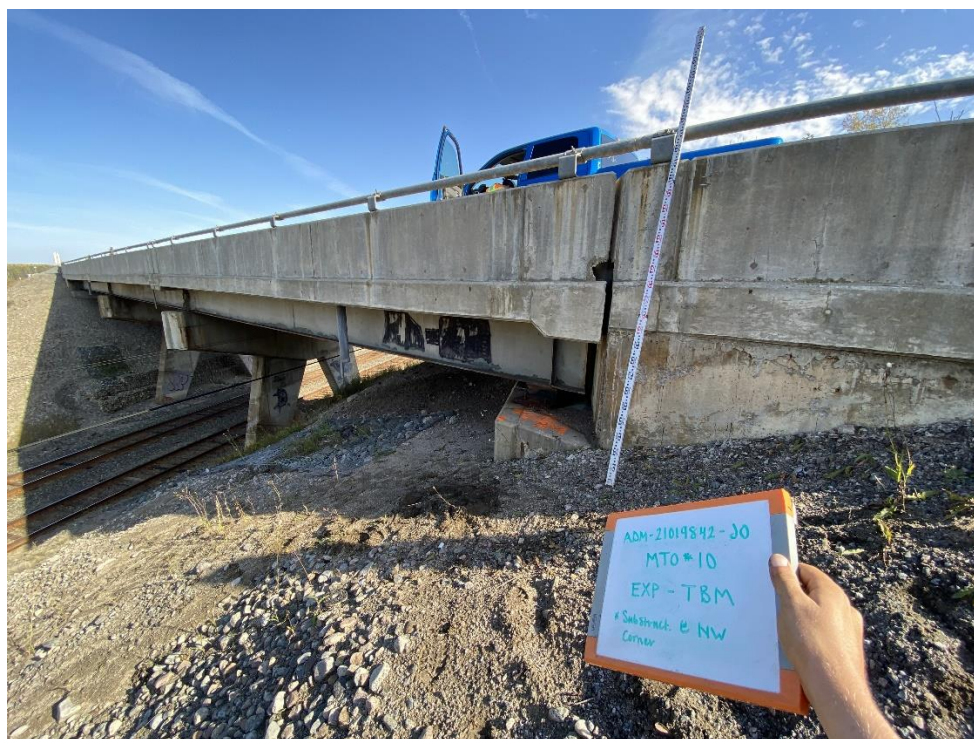
Photograph A4. Bridge substructure at northwest corner (October 2023)

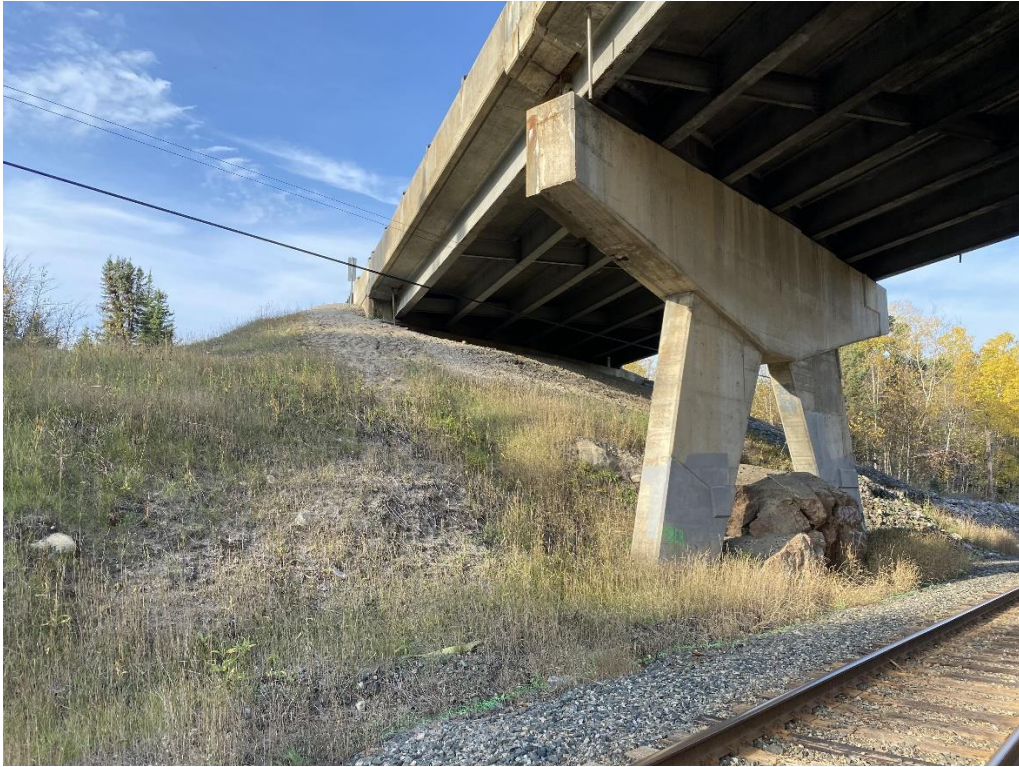
Photograph A5. Bridge substructure at south abutment, facing Southwest (October 2023)

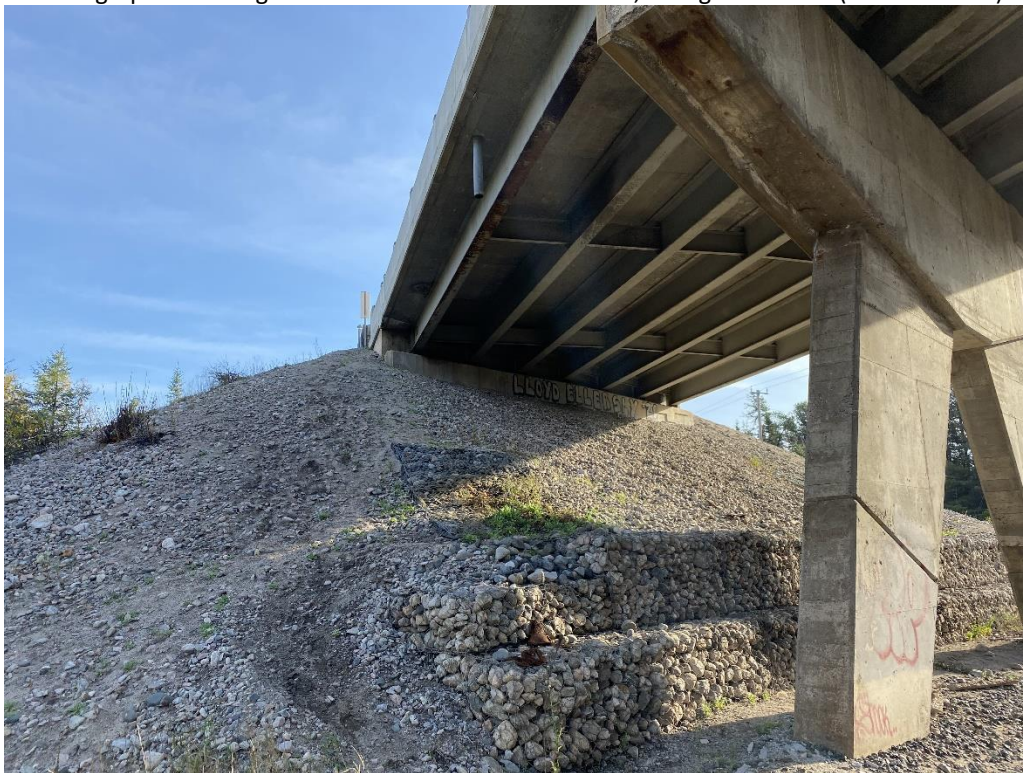
Photograph A6. Bridge substructure at north abutment, facing Northeast (October 2023)

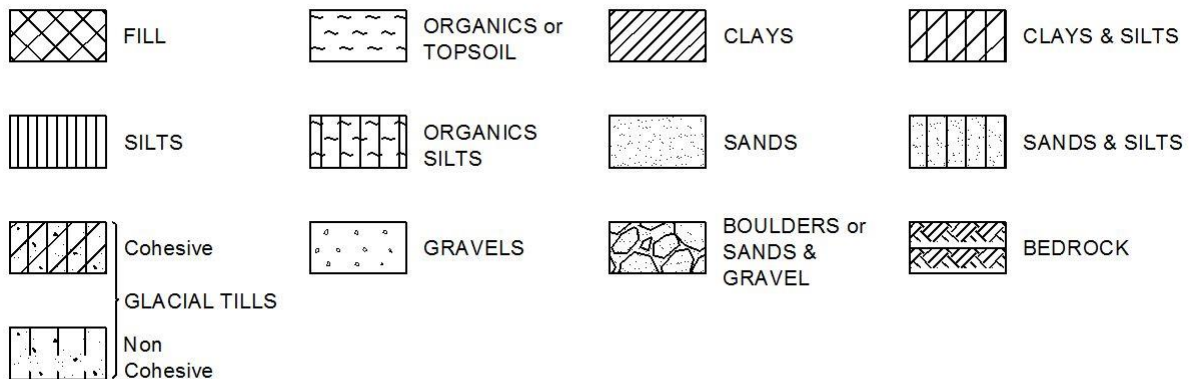
STRATA PLOT

Strata plots symbolize the soil or bedrock description. They are combinations of the following basic symbols:

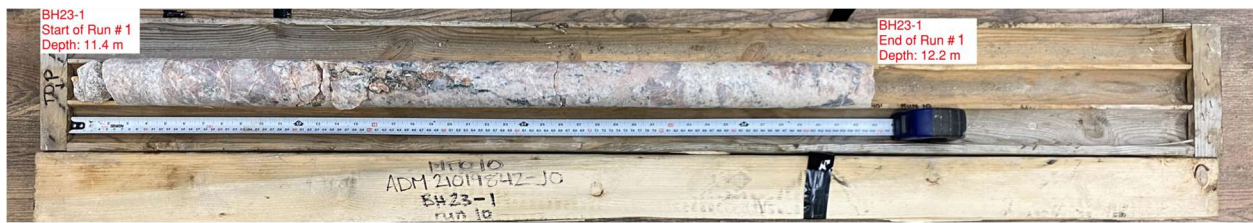
Photograph D1. Rock cores from BH23-1, Run 1 – 11. 4 m to 12.2 m (October 2023)

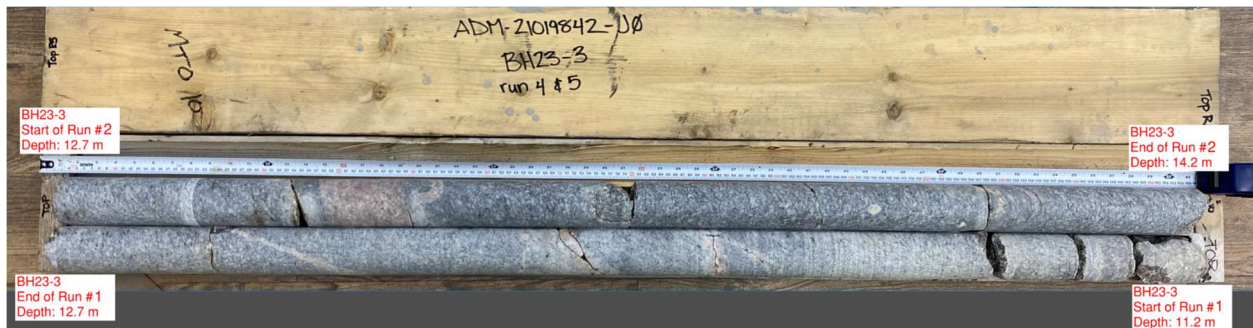
Photograph D2. Rock cores from BH23-3, Run 1 and Run 2 – 11. 2 m to 14.2 m (October 2023)

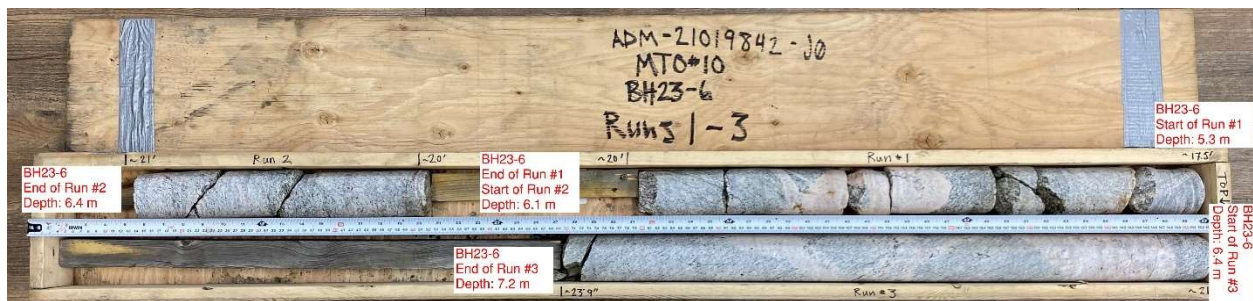
Photograph D5. Rock cores from BH23-6, Run 1 to Run 3 – 5.3 m to 7.2 m (October 2023)

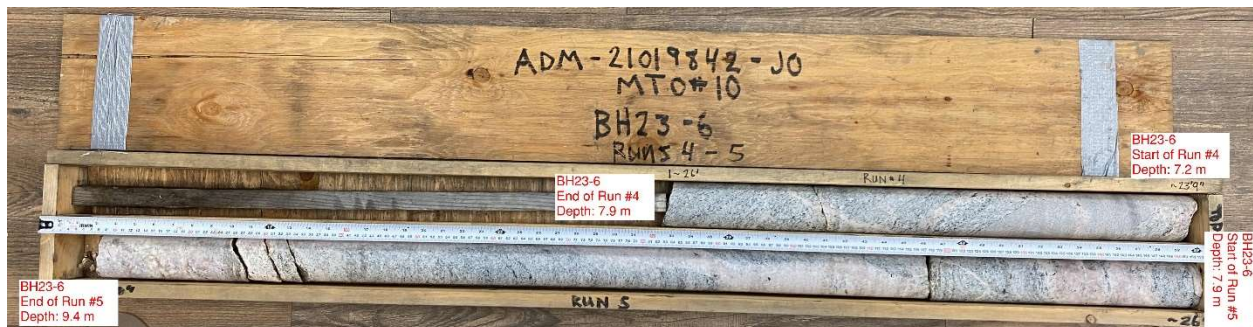
Photograph D6. Rock cores from BH23-6, Run 4 and Run 5 – 7.2 m to 9.4 m (October 2023)

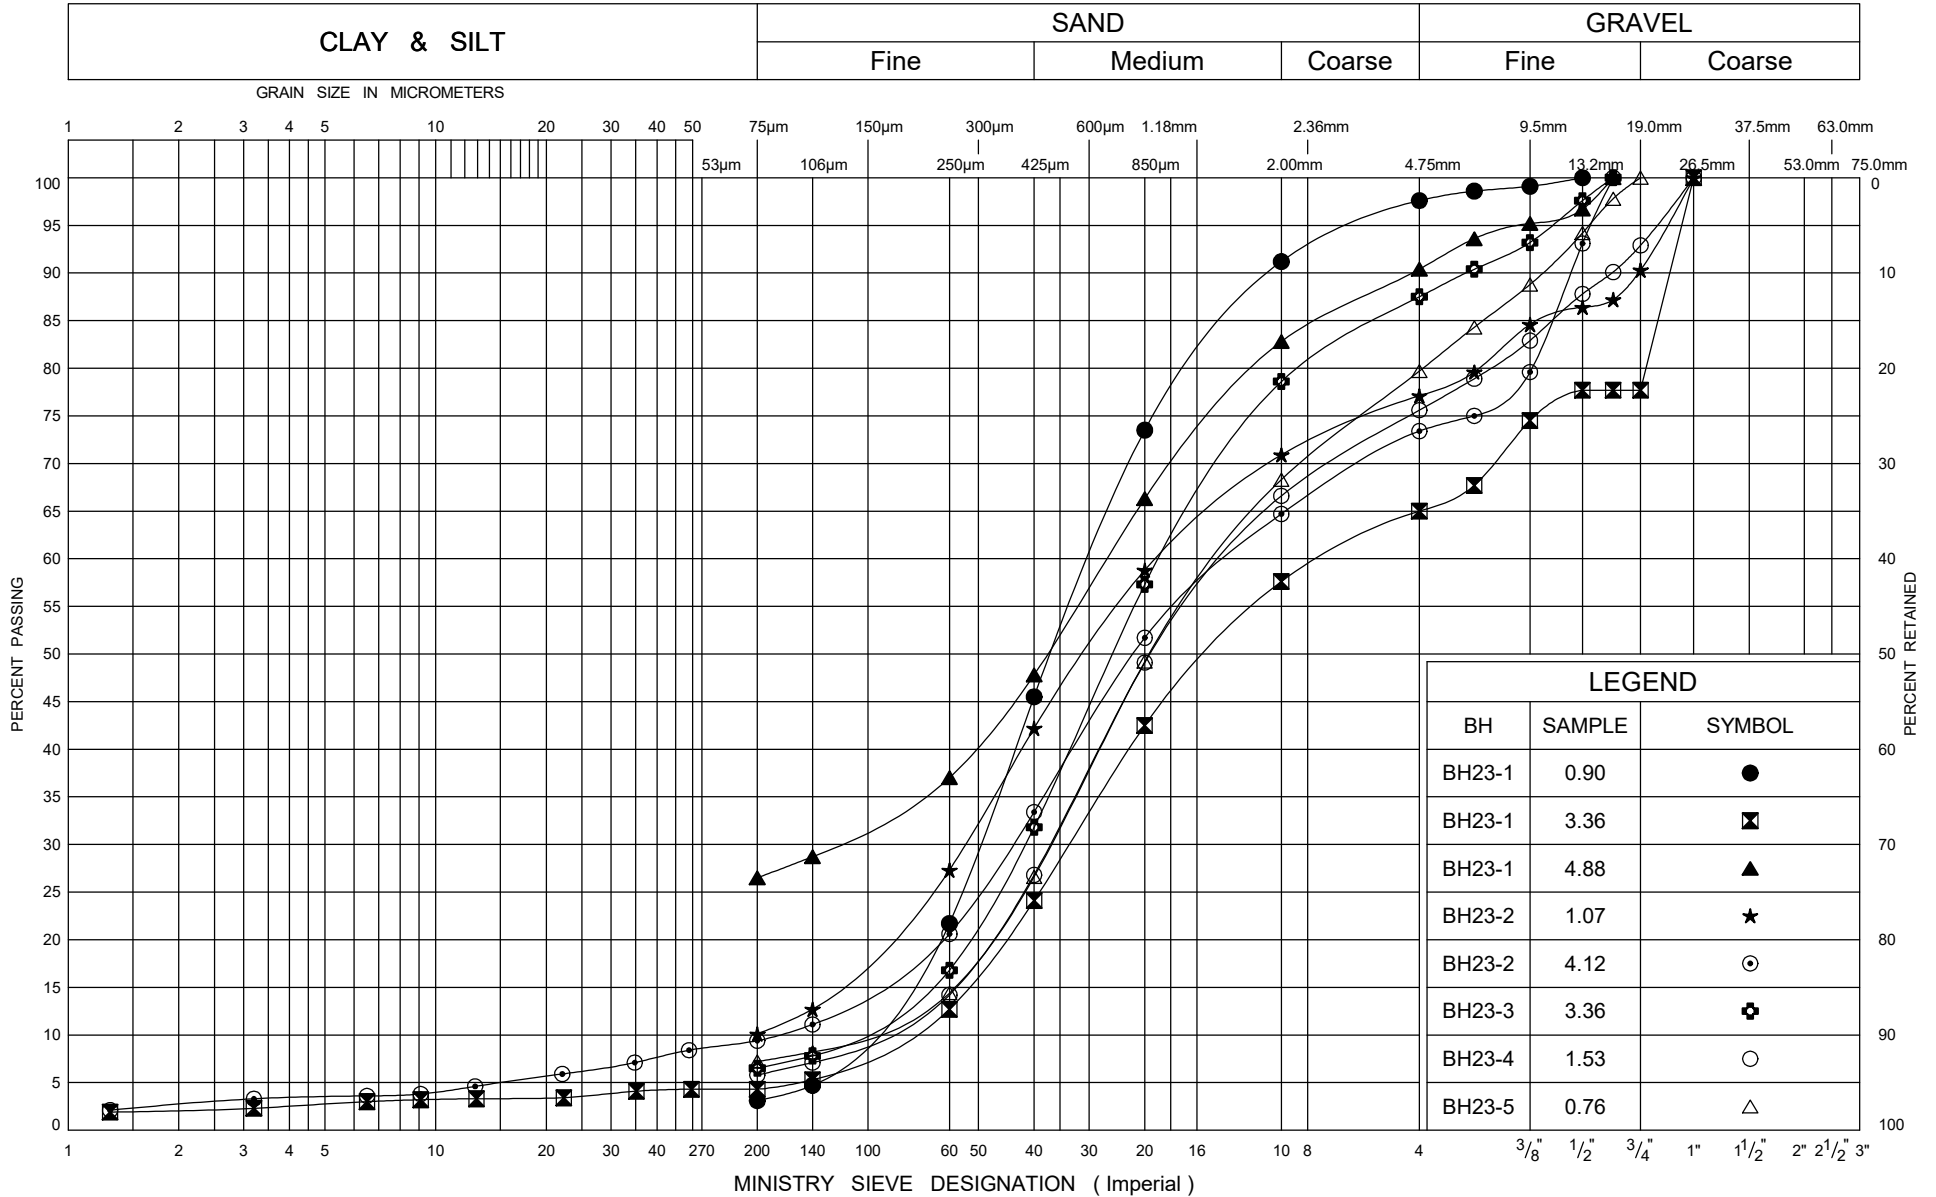
UNIFIED SOIL CLASSIFICATION SYSTEM

The results of the moisture content and grain size distribution tests are included on the borehole logs in Appendix C. The results of the grain size distribution test are also provided on Figure 1 and Figure 2 in Appendix D.

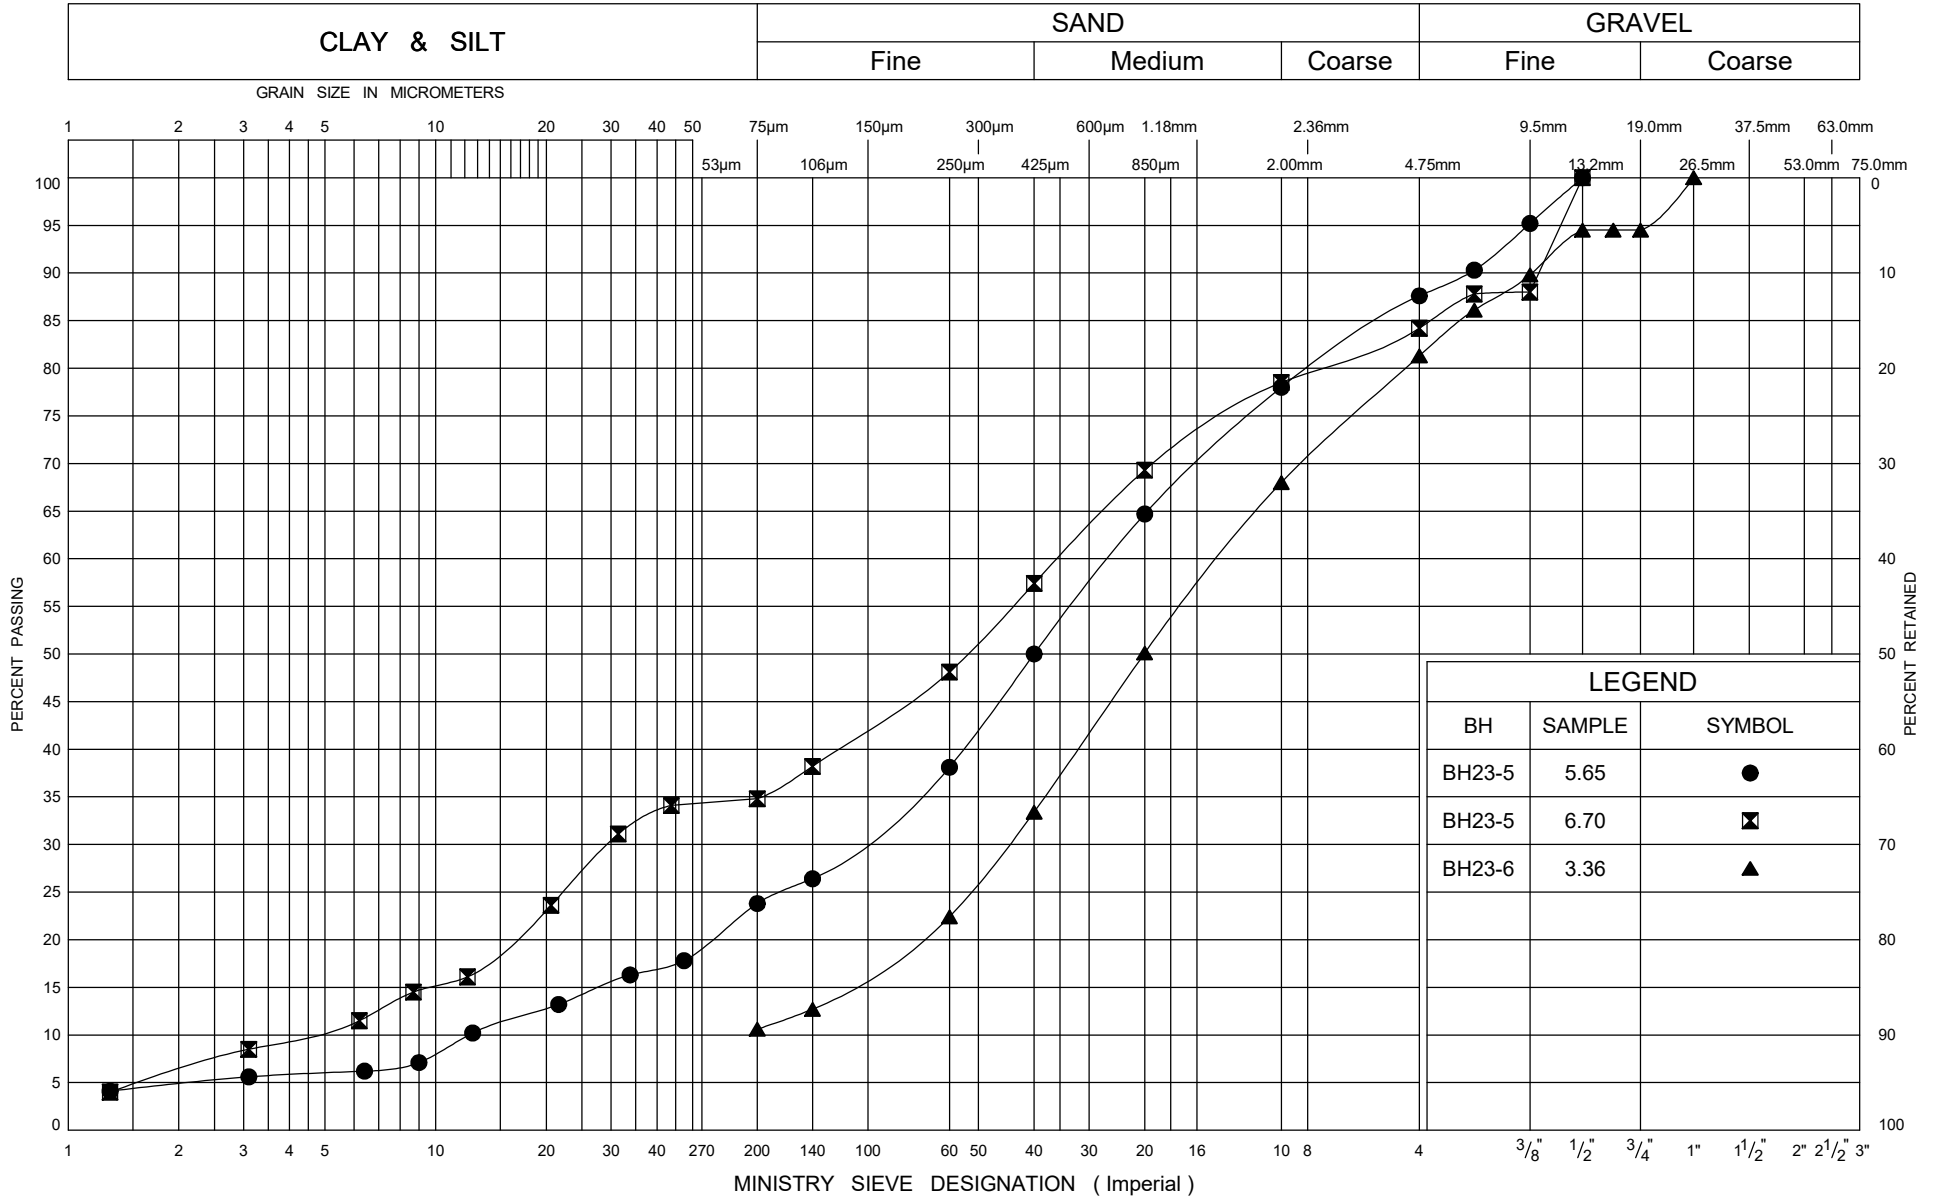
UNIFIED SOIL CLASSIFICATION SYSTEM
