THURBER ENGINEERING LTD.

**FINAL
FOUNDATION INVESTIGATION AND DESIGN REPORT
HIGHWAY 11 NON-STRUCTURAL CULVERT AT STATION 12+650
LEDGER TOWNSHIP, ONTARIO
AGREEMENT NO.: 6022-E-0038
ASSIGNMENT NO.: 1**

GEOCRES NO.: 52H01-001

Date: December 5, 2023

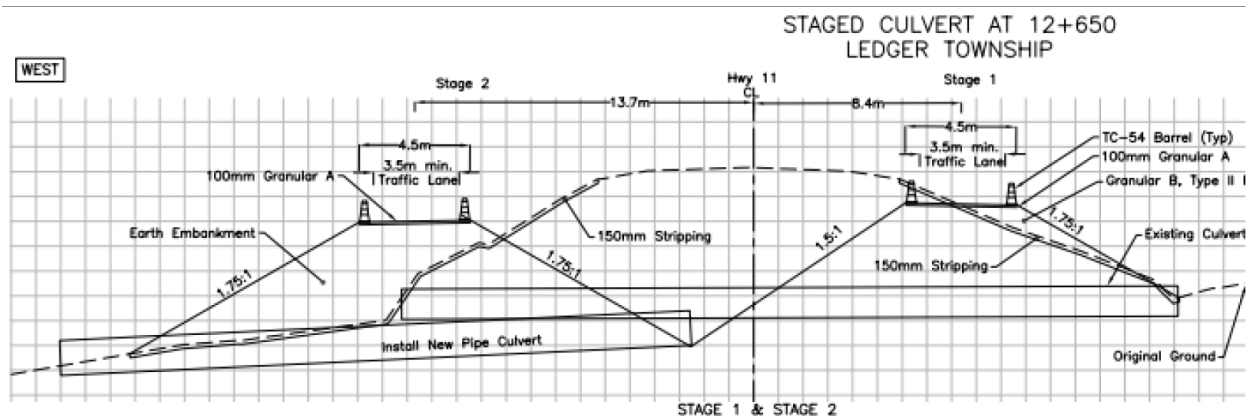
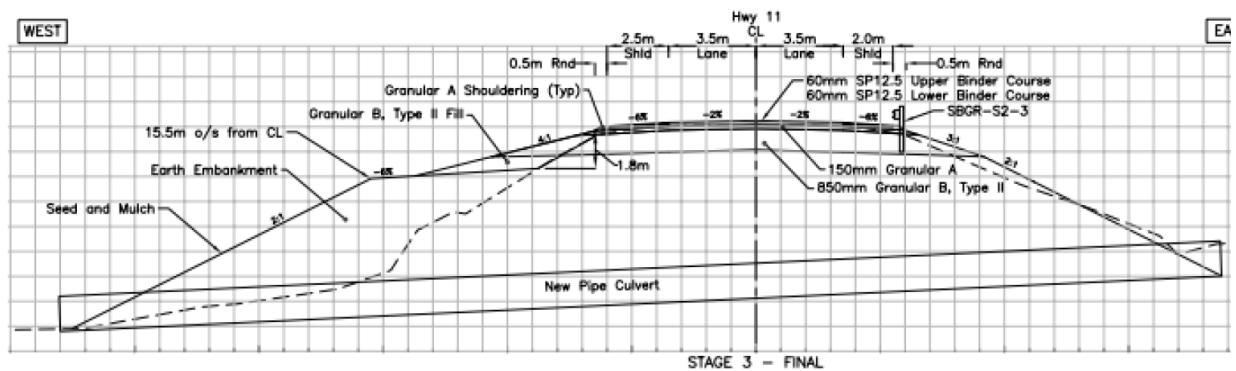
Figure 1: Culvert construction staging sequence (courtesy of MTO).

- **Stage 1:** Construct temporary embankment widening to the east of the existing highway alignment to facilitate one lane of traffic flow around excavation for the construction of the new culvert west of centreline. The centreline of the widened embankment will be approximately 8.4 m east of the centreline of the existing highway embankment. The temporary embankment will have a 1.75H:1V side slope to the east (outside) and a 1.5H:1V side slope of a cut into the existing highway embankment to the west (inside). The temporary embankment will be widened to the east using OPSS Granular B Type II and the maximum height of new fill is on the order of 1 m. Grade lowering of approximately 1.4 m is indicated.

The following culvert construction staging sequence has been provided by MTO in an email dated October 27, 2023.

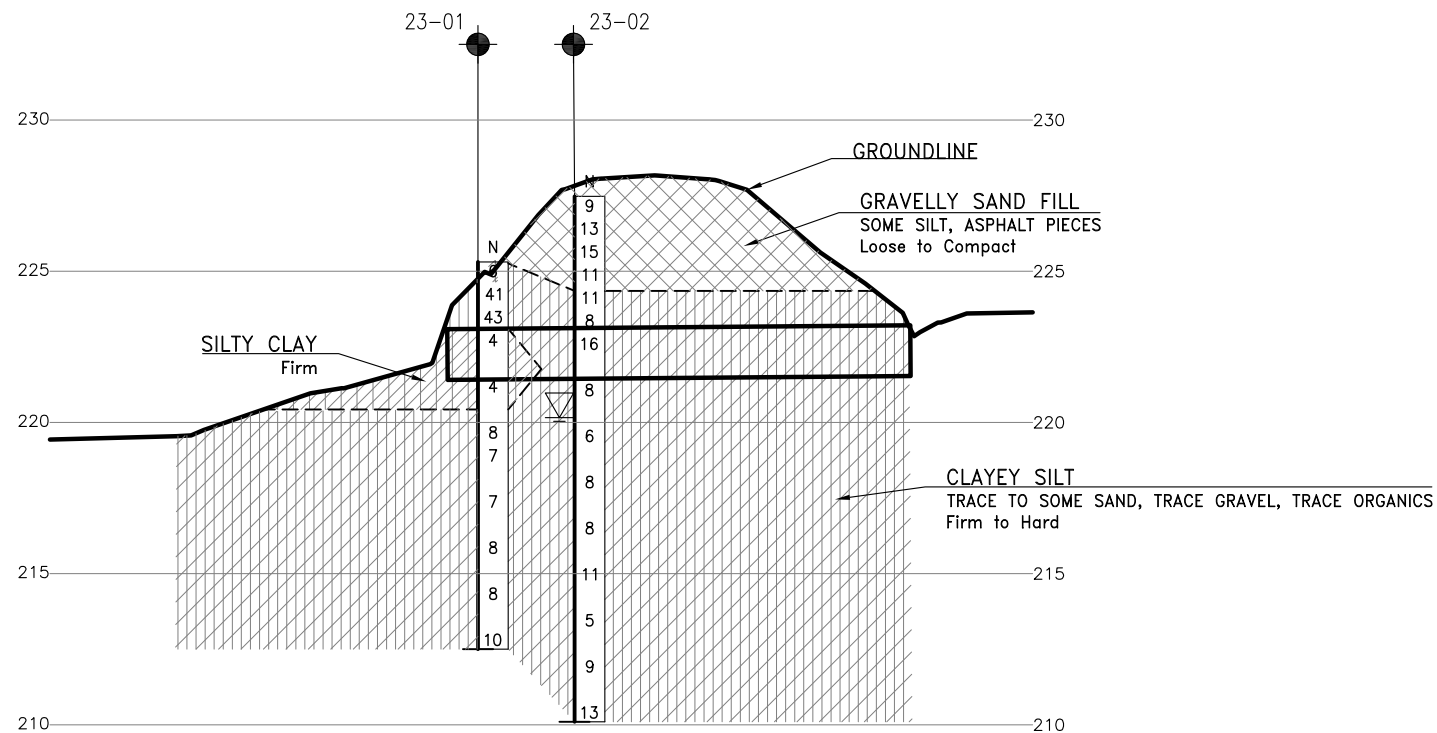
Borehole Locations and Strata Drawing

SECTION A-A' ALONG CULVERT

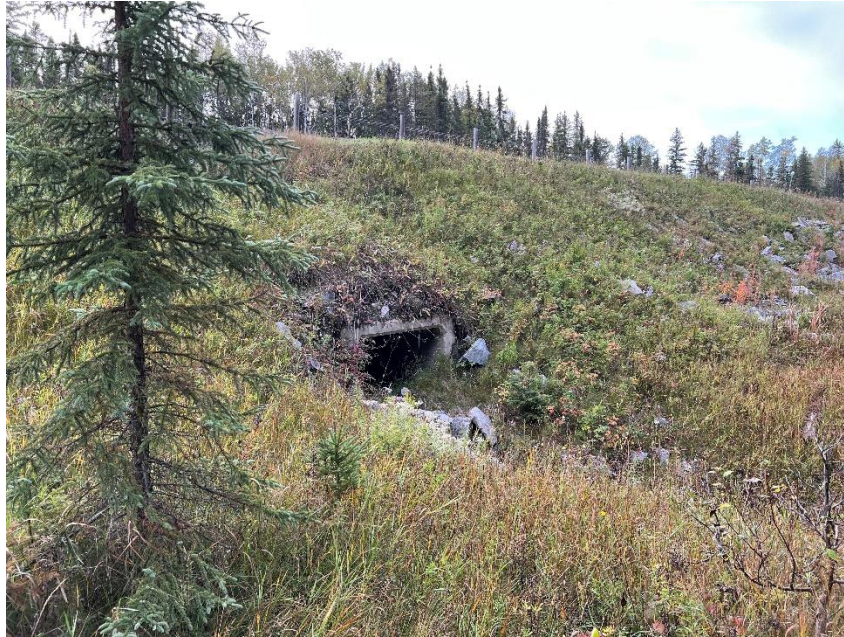
Photo 1: Culvert outlet *(taken on September 18, 2023)*

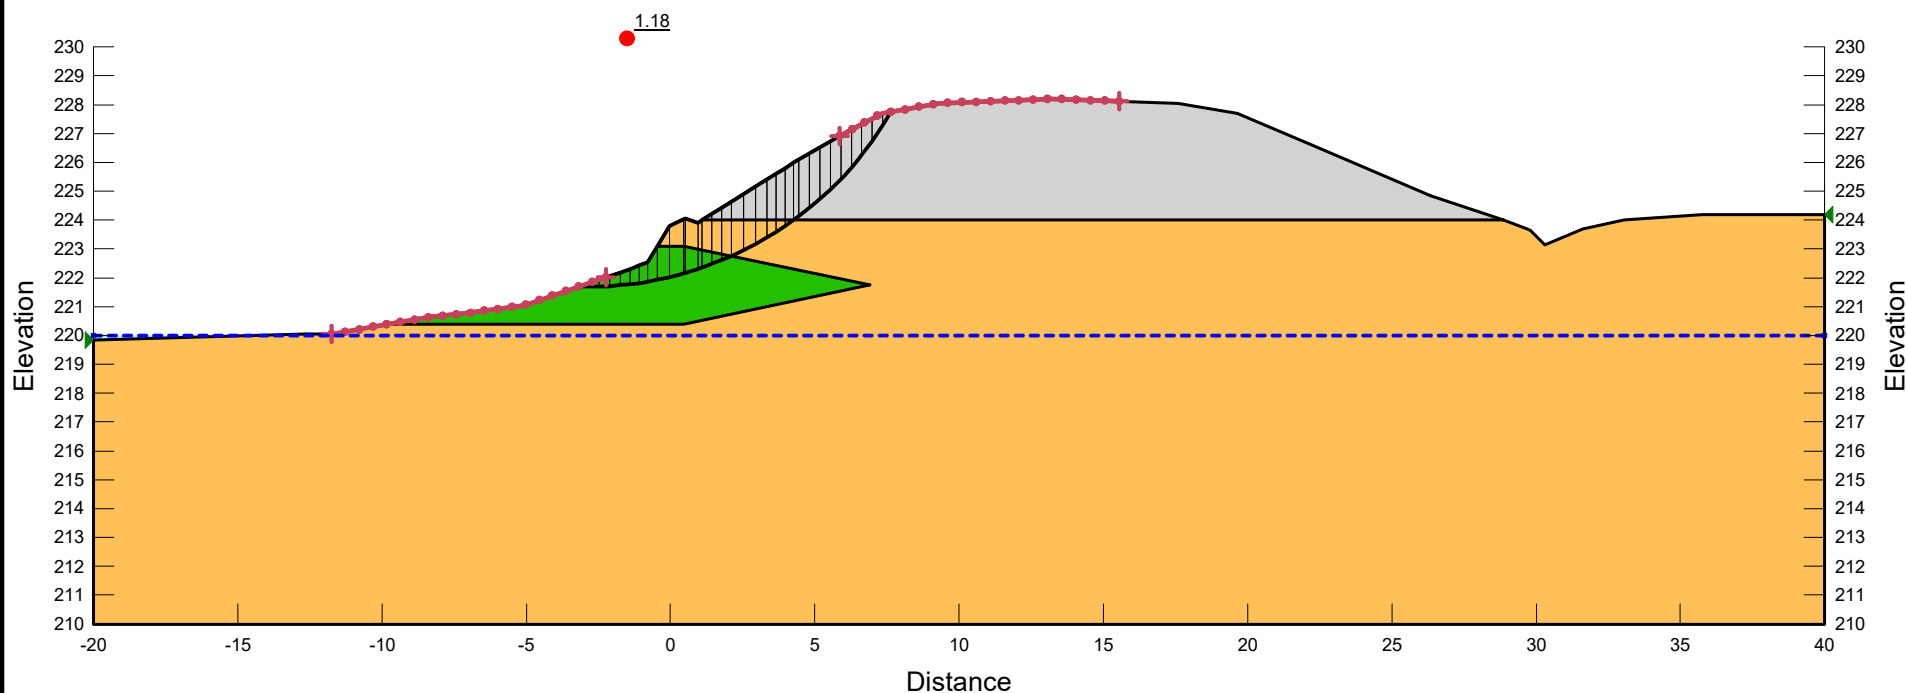
Figure E1

Color	Name	Unit Weight (kN/m³)	Effective Cohesion (kPa)	Effective Friction Angle (°)
■	Clayey Silt	19.5	0	29
■	Existing Fill	21	0	32
■	Silty Clay (ESA)	19	2	29

Project		
Hwy 11 Non-Structural Culvert		
Analysis		
Existing West Slope (Drained)		
Seismic Coefficient	Last Run	Scale
H: 0g, V: 0g	2023-11-10, 12:40:09 PM	1:262

Additional Details
 Name: Existing West Slope
 Comments: Sta. 12+650
 Method: Morgenstern-Price, Half-Sine
 Minimum Slip Surface Depth: 2 m
 Entry: (-3.1712249, 221.69342) m, Exit: (7.640094, 227.75207) m
 Center: (-2.8486719, 233.79326) m, Radius: 12.104138 m

Location	Cut or Fill	Height of New Fill	Embank. Fill	Side	Slope Incln.	Condition	Factor of Safety	Fig.
Existing Highway Embankment						Long Term (Drained)	1.18	E1
Stage 1 East Detour	Fill on East Side	~ 1.0 m	Gran. B Type II	East	1.75H:1V	Long Term (Drained)	1.39	E2

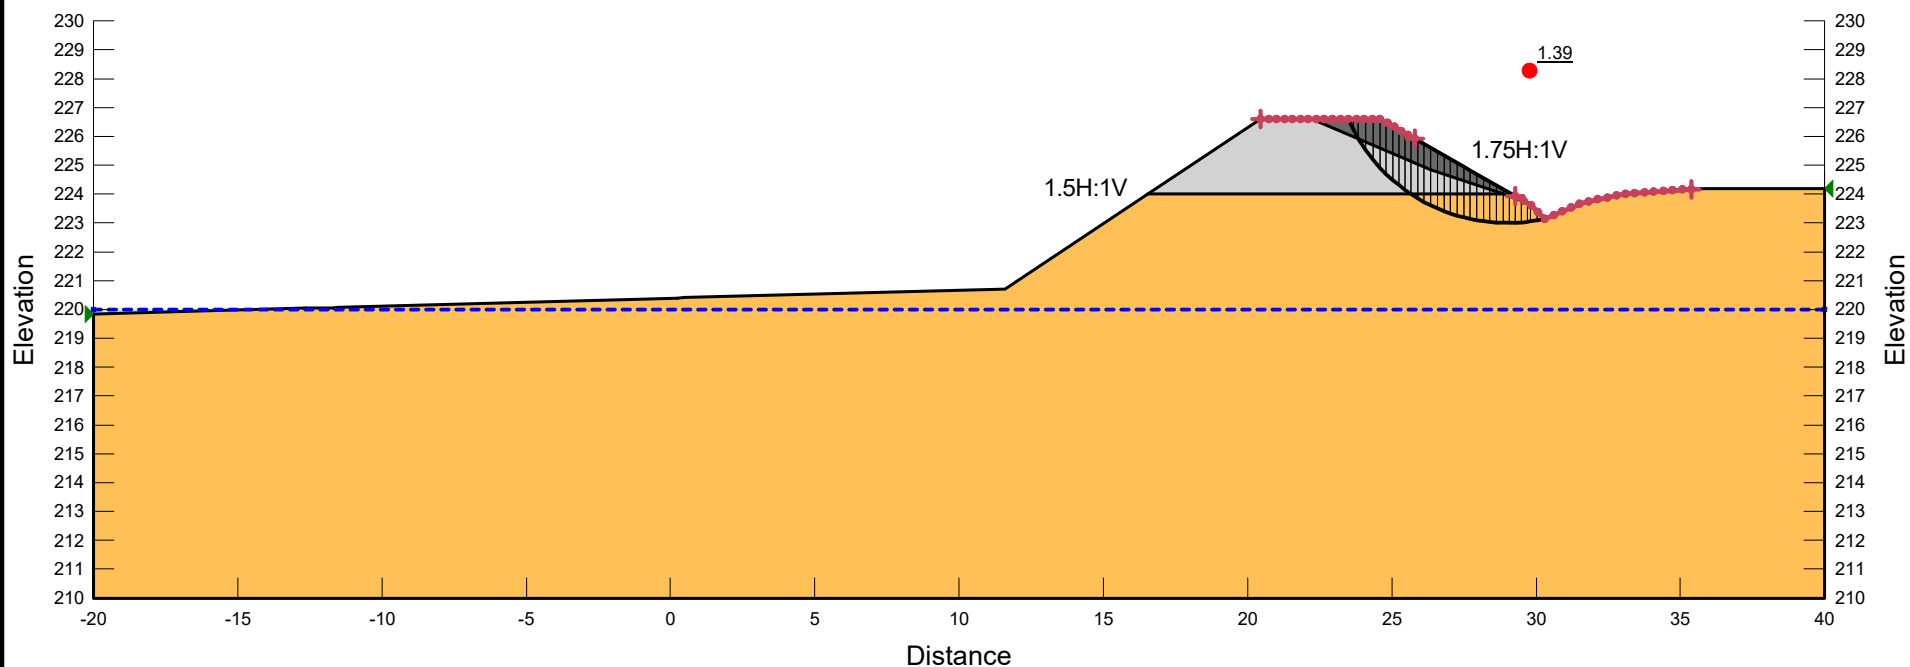
Figure E2

Color	Name	Unit Weight (kN/m³)	Effective Cohesion (kPa)	Effective Friction Angle (°)
	Clayey Silt	19.5	0	29
	Existing Fill	21	0	32
	OPSS Granular B Type II	22	0	35

Project		
Hwy 11 Non-Structural Culvert		
Analysis		
Stage 1 East Slope 1.75H:1V with Granular B Type II (Drained)		
Seismic Coefficient	Last Run	Scale
H: 0g, V: 0g	2023-11-10, 12:40:11 PM	1:262

Additional Details
Name: Stage 1 East Slope 1.75H:1V with Granular B Type II
Comments: Sta. 12+650
Method: Morgenstern-Price, Half-Sine
Minimum Slip Surface Depth: 2 m
Entry: (23.492695, 226.6) m, Exit: (30.299833, 223.15017) m
Center: (28.96344, 228.95399) m, Radius: 5.9556973 m

The temporary embankment to the east of the existing highway alignment (Stage 1) with a proposed side slope of 1.75H:1V to the east (outside) results in factor of safety of greater than 1.3 (Figure E2), however, the proposed side slope of 1.5H:1V to the west (inside) results in a marginal factor of safety of 1.0 (Figure E5). It is recommended that the west (inside) slope be flattened to 1.75H:1V while the east (outside) slope be steepened to 1.5H:1V by either lowering the grade by 230 mm or by maintaining the proposed grade and shifting the crest of the

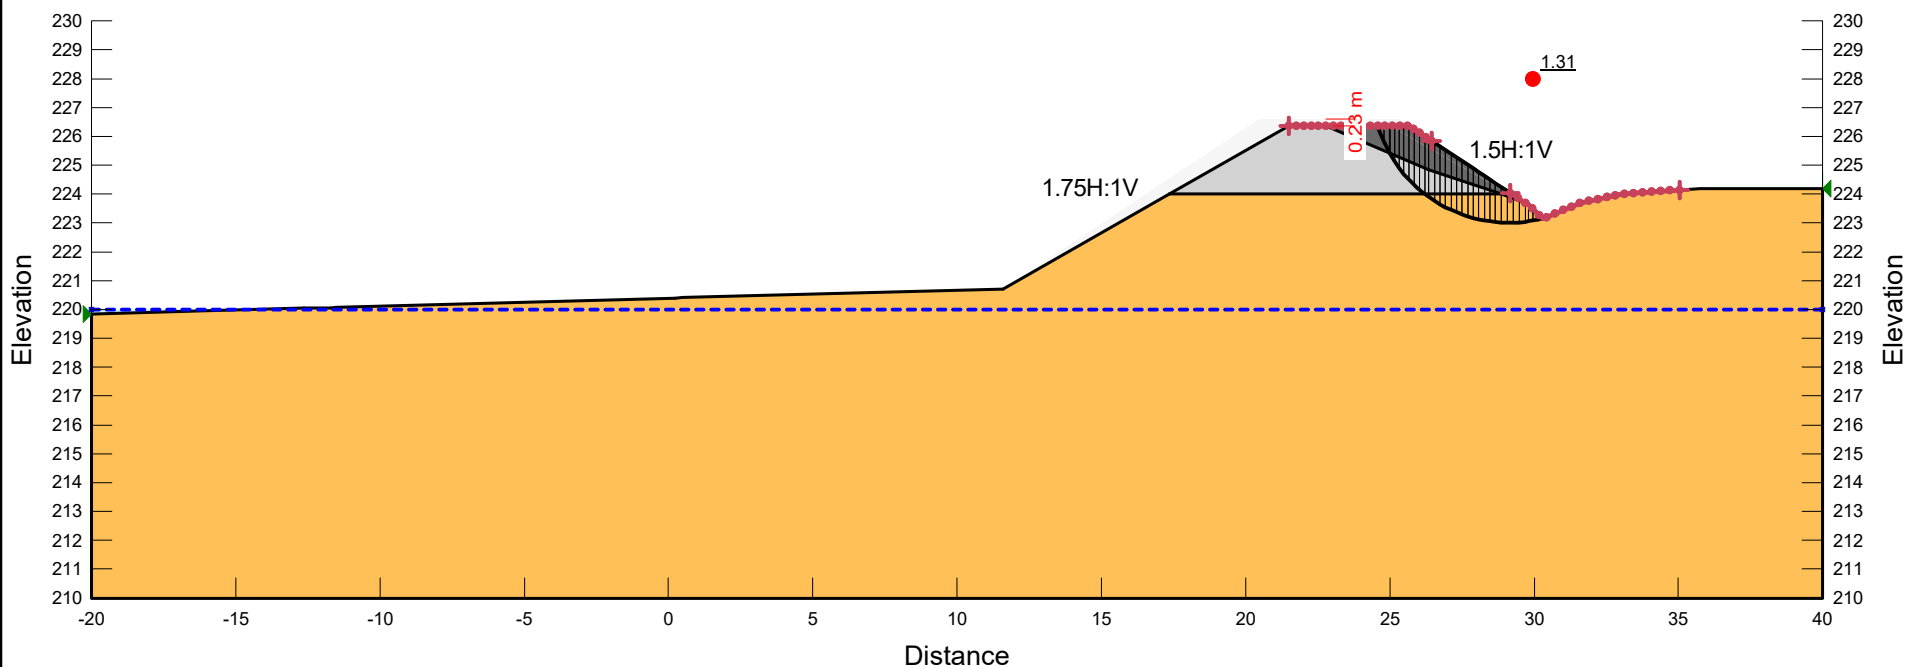
Figure E3

Color	Name	Unit Weight (kN/m³)	Effective Cohesion (kPa)	Effective Friction Angle (°)
	Clayey Silt	19.5	0	29
	Existing Fill	21	0	32
	OPSS Granular B Type II	22	0	35

Project		
Hwy 11 Non-Structural Culvert		
Analysis		
Stage 1 East Slope 1.5H:1V with Granular B Type II and Grade Lowering (Drained)		
Seismic Coefficient	Last Run	Scale
H: 0g, V: 0g	2023-11-10, 12:40:37 PM	1:262

Additional Details
Name: Stage 1 East Slope 1.5H:1V with Granular B Type II and Grade Lowering
Comments: Sta. 12+650
Method: Morgenstern-Price, Half-Sine
Minimum Slip Surface Depth: 2 m
Entry: (24.576168, 226.37) m, Exit: (30.296935, 223.15307) m
Center: (29.122418, 227.75956) m, Radius: 4.7538668 m

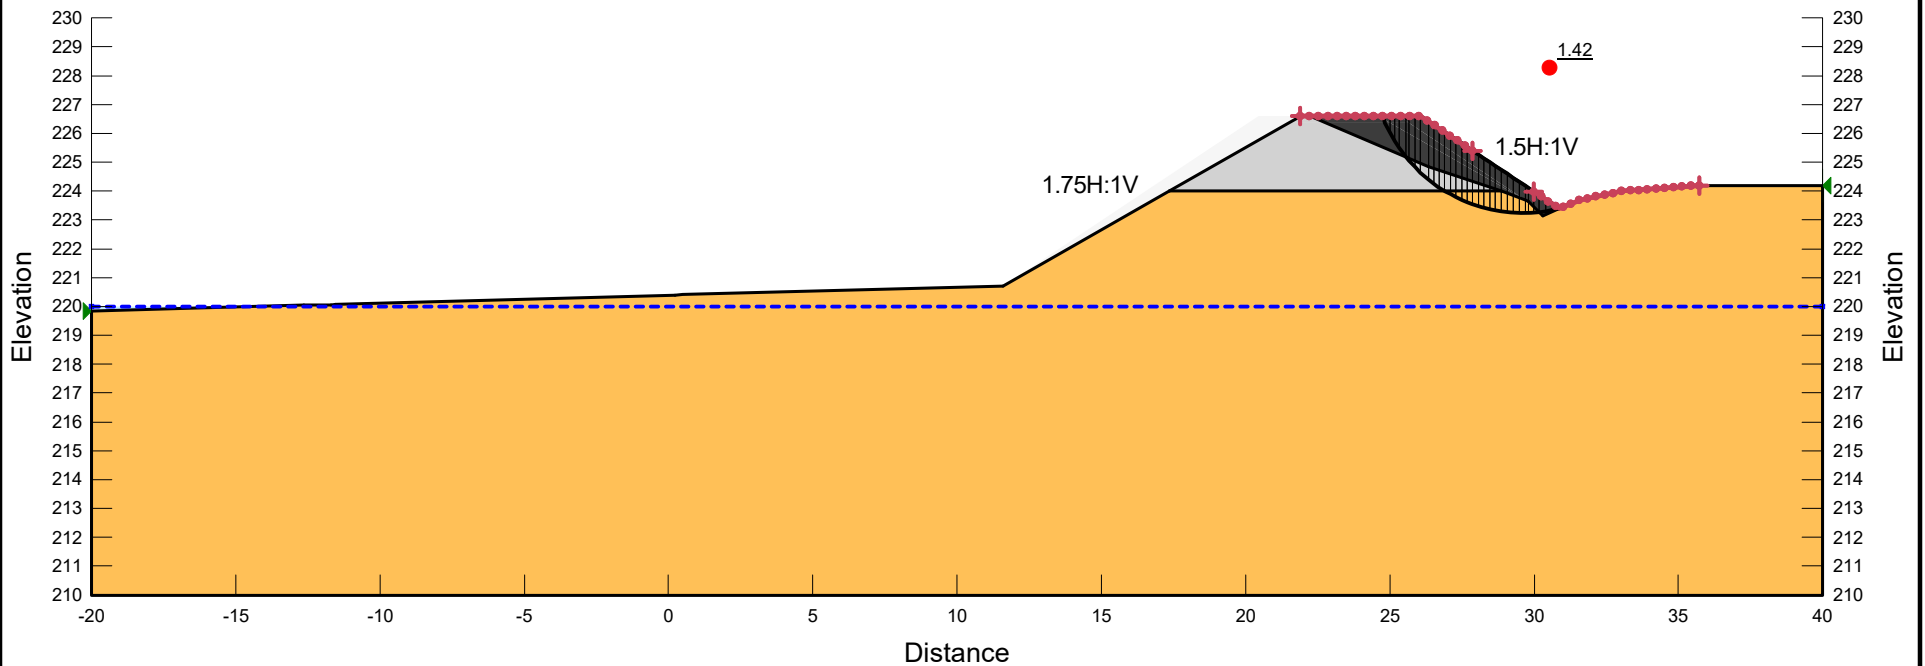
Color	Name	Unit Weight (kN/m³)	Effective Cohesion (kPa)	Effective Friction Angle (°)
	Clayey Silt	19.5	0	29
	Existing Fill	21	0	32
	Rock Fill	19	0	42

Project		
Hwy 11 Non-Structural Culvert		
Analysis		
Stage 1 East Slope 1.5H:1V with Rock Fill (Drained)		
Seismic Coefficient	Last Run	Scale
H: 0g, V: 0g	2023-11-10, 12:48:52 PM	1:262

Additional Details
 Name: Stage 1 East Slope 1.5H:1V with Rock Fill
 Comments: Sta. 12+650
 Method: Morgenstern-Price, Half-Sine
 Minimum Slip Surface Depth: 2 m
 Entry: (24.744481, 226.6) m, Exit: (30.865393, 223.3963) m
 Center: (29.603578, 228.43459) m, Radius: 5.1938938 m

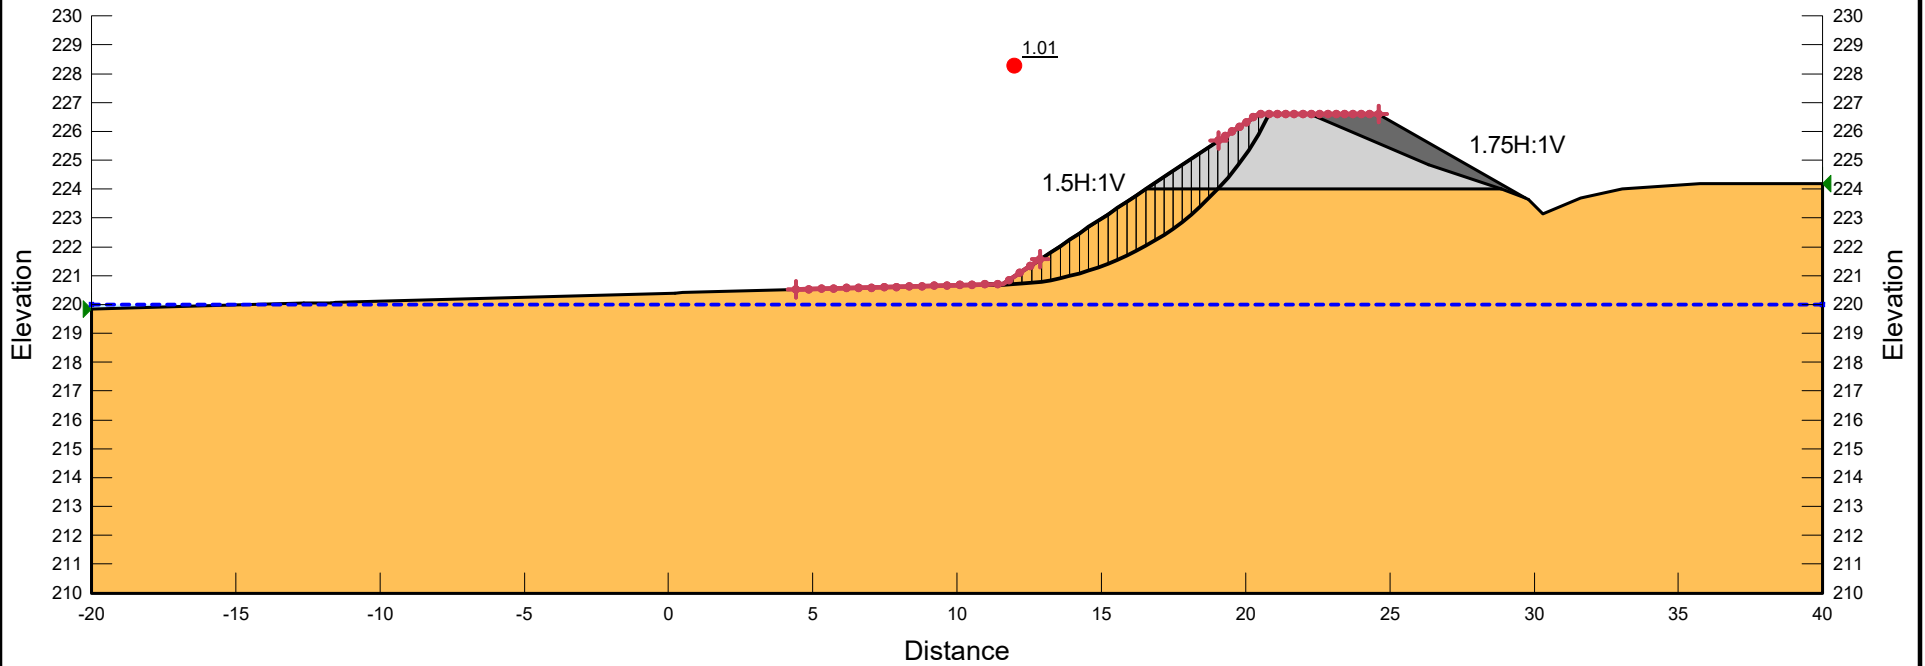
Figure E5

Project		
Hwy 11 Non-Structural Culvert		
Analysis		
Stage 1 West Slope 1.5H:1V (Drained)		
Seismic Coefficient	Last Run	Scale
H: 0g, V: 0g	2023-11-10, 12:48:24 PM	1:262

Additional Details
 Name: Stage 1 West Slope 1.5H:1V
 Comments: Sta. 12+650
 Method: Morgenstern-Price, Half-Sine
 Minimum Slip Surface Depth: 2 m
 Entry: (10.966995, 220.69271) m, Exit: (20.81896, 226.6) m
 Center: (11.416546, 231.11199) m, Radius: 10.42897 m

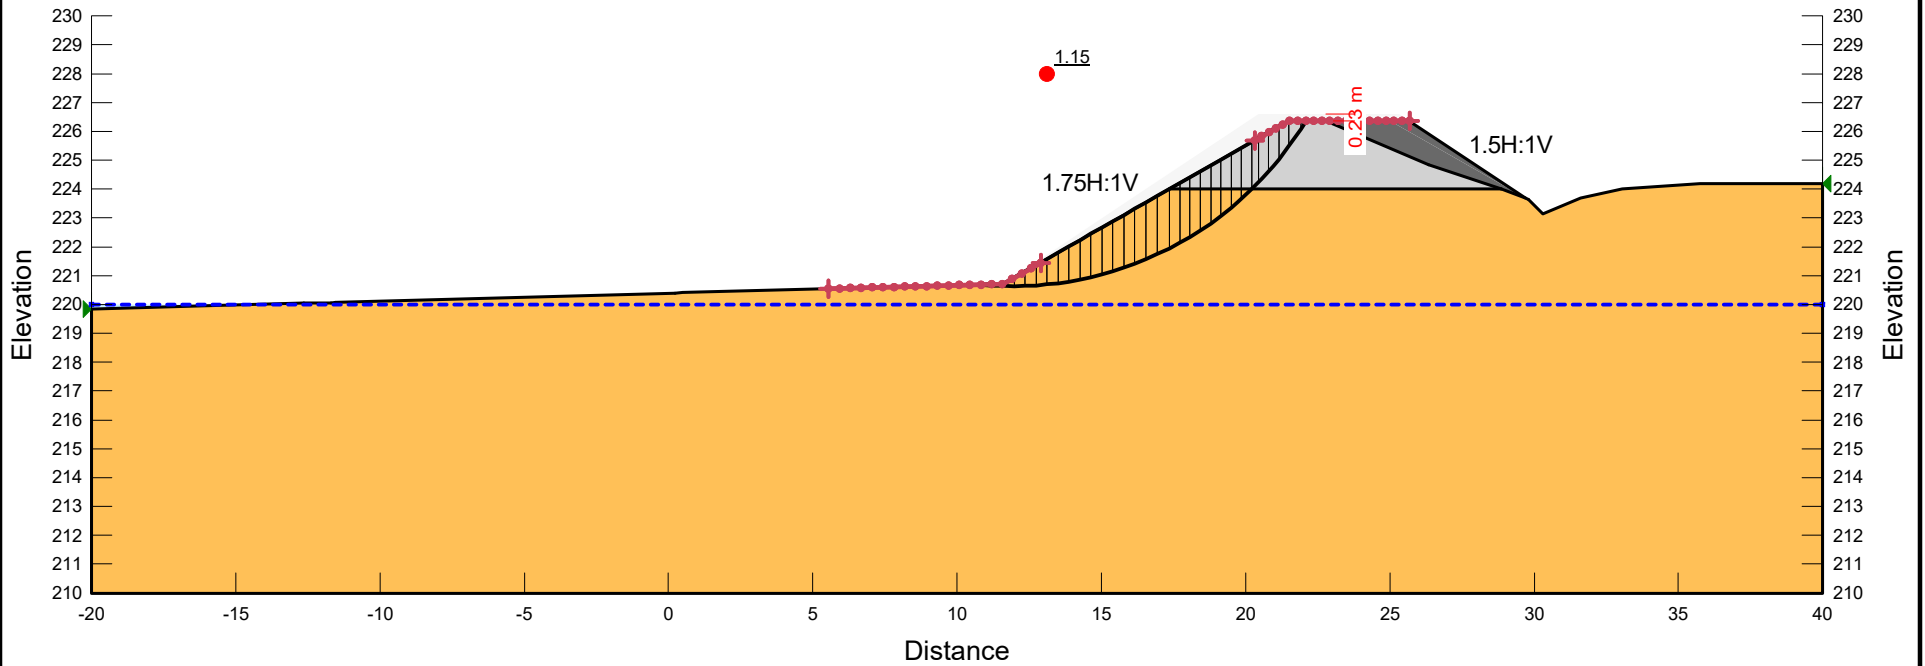
Figure E6

Color	Name	Unit Weight (kN/m³)	Effective Cohesion (kPa)	Effective Friction Angle (°)
	Clayey Silt	19.5	0	29
	Existing Fill	21	0	32
	OPSS Granular B Type II	22	0	35

Project		
Hwy 11 Non-Structural Culvert		
Analysis		
Stage 1 West Slope 1.75H:1V with Grade Lowering (Drained)		
Seismic Coefficient	Last Run	Scale
H: 0g, V: 0g	2023-11-10, 12:48:46 PM	1:262

Additional Details
 Name: Stage 1 West Slope 1.75H:1V with Grade Lowering
 Comments: Sta. 12+650
 Method: Morgenstern-Price, Half-Sine
 Minimum Slip Surface Depth: 2 m
 Entry: (10.82543, 220.68884) m, Exit: (22.088379, 226.37) m
 Center: (11.959007, 232.44655) m, Radius: 11.812225 m

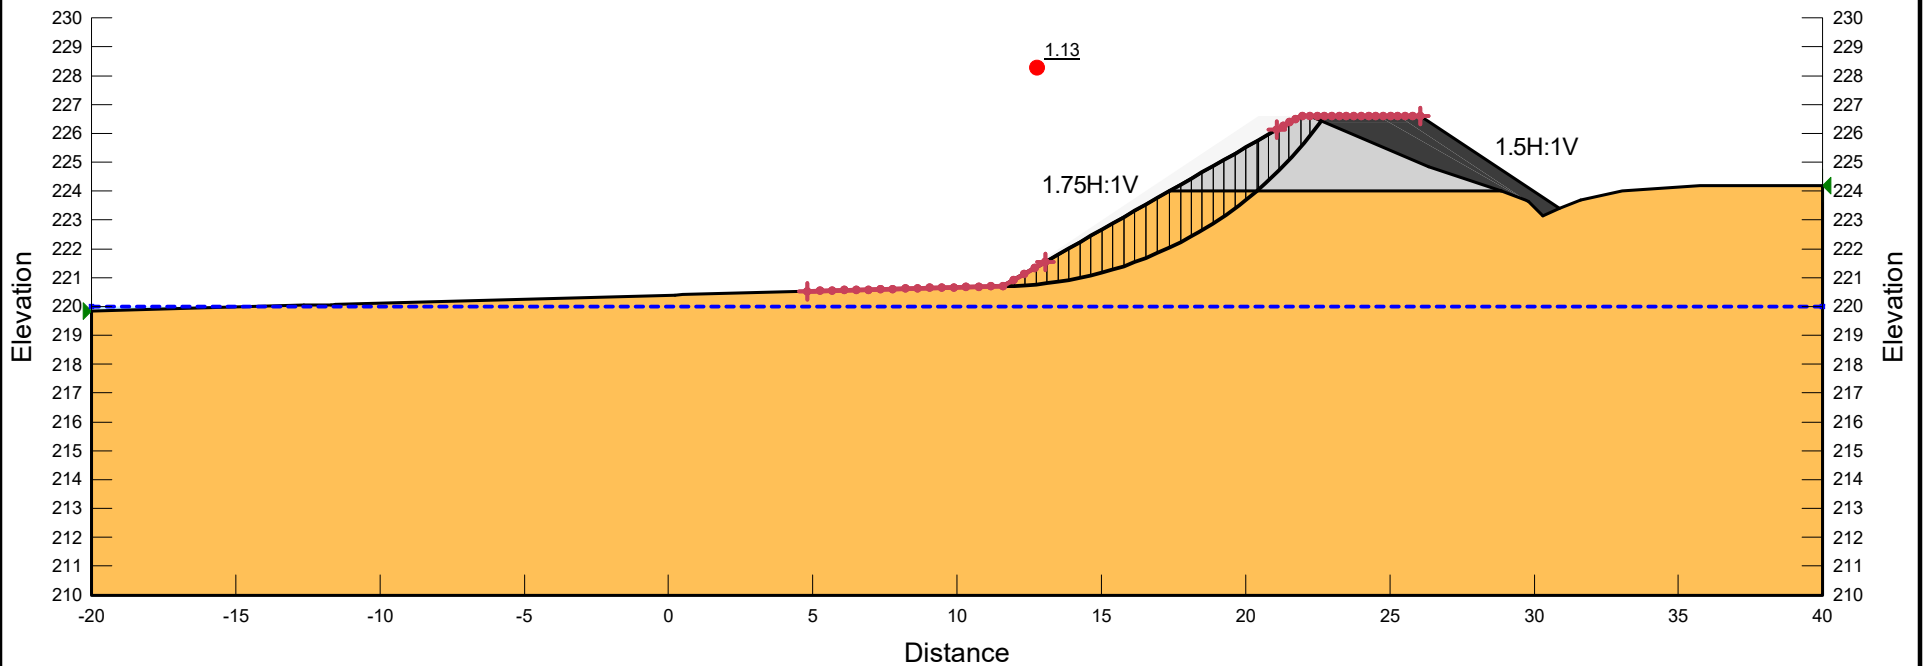
Figure E7

Color	Name	Unit Weight (kN/m³)	Effective Cohesion (kPa)	Effective Friction Angle (°)
	Clayey Silt	19.5	0	29
	Existing Fill	21	0	32
	Rock Fill	19	0	42

Project		
Hwy 11 Non-Structural Culvert		
Analysis		
Stage 1 West Slope 1.75H:1V (Drained)		
Seismic Coefficient	Last Run	Scale
H: 0g, V: 0g	2023-11-10, 12:48:51 PM	1:262

Additional Details
Name: Stage 1 West Slope 1.75H:1V
Comments: Sta. 12+650
Method: Morgenstern-Price, Half-Sine
Minimum Slip Surface Depth: 2 m
Entry: (11.165496, 220.69813) m, Exit: (22.736296, 226.6) m
Center: (11.446055, 234.44148) m, Radius: 13.746214 m

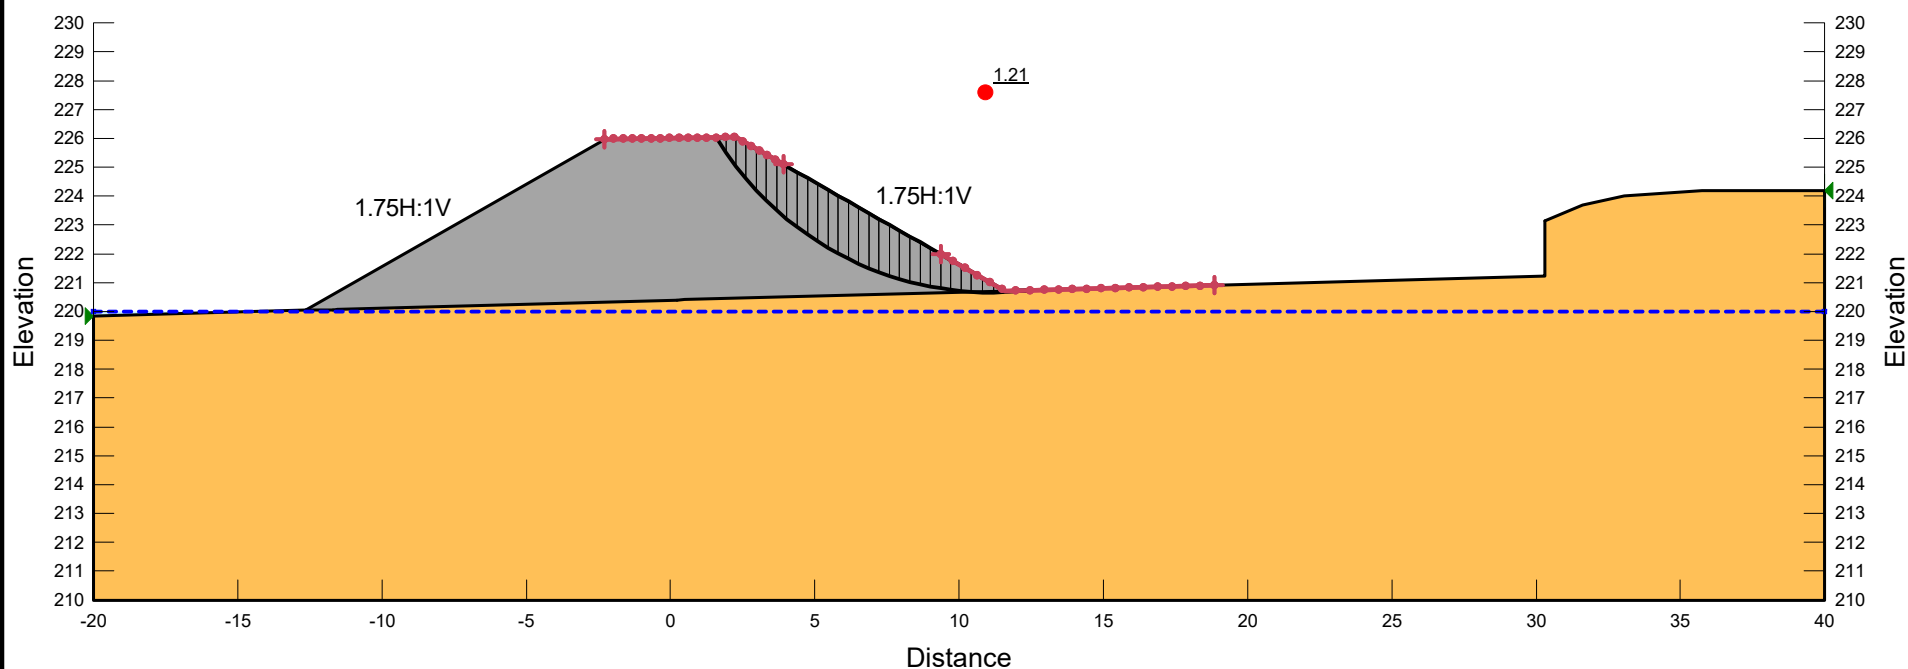
Figure E8

Color	Name	Unit Weight (kN/m³)	Effective Cohesion (kPa)	Effective Friction Angle (°)
	Clayey Silt	19.5	0	29
	Earth Fill	21	0	30

Project		
Hwy 11 Non-Structural Culvert		
Analysis		
Stage 2 East Slope 1.75H:1V with Earth Fill (Drained)		
Seismic Coefficient	Last Run	Scale
H: 0g, V: 0g	2023-11-10, 12:48:40 PM	1:262

Additional Details
 Name: Stage 2 East Slope 1.75H:1V with Earth Fill
 Comments: Sta. 12+650
 Method: Morgenstern-Price, Half-Sine
 Minimum Slip Surface Depth: 2 m
 Entry: (1.5788372, 226.03098) m, Exit: (12.458077, 220.7334) m
 Center: (11.135542, 231.83714) m, Radius: 11.182226 m

A minimum factor of safety of 1.3 is not achieved for the temporary embankment to the west of the existing highway alignment (Stage 2) with proposed side slopes of 1.75H:1V constructed using earth fill (Figures E8 and E10). It is recommended to place geogrid reinforcement with a minimum unfactored pullout resistance of 30 kN/m halfway up the detour embankment (approx. elev. 223 m) in order to achieve a minimum factor of safety of 1.3 (Figures E9 and E11).

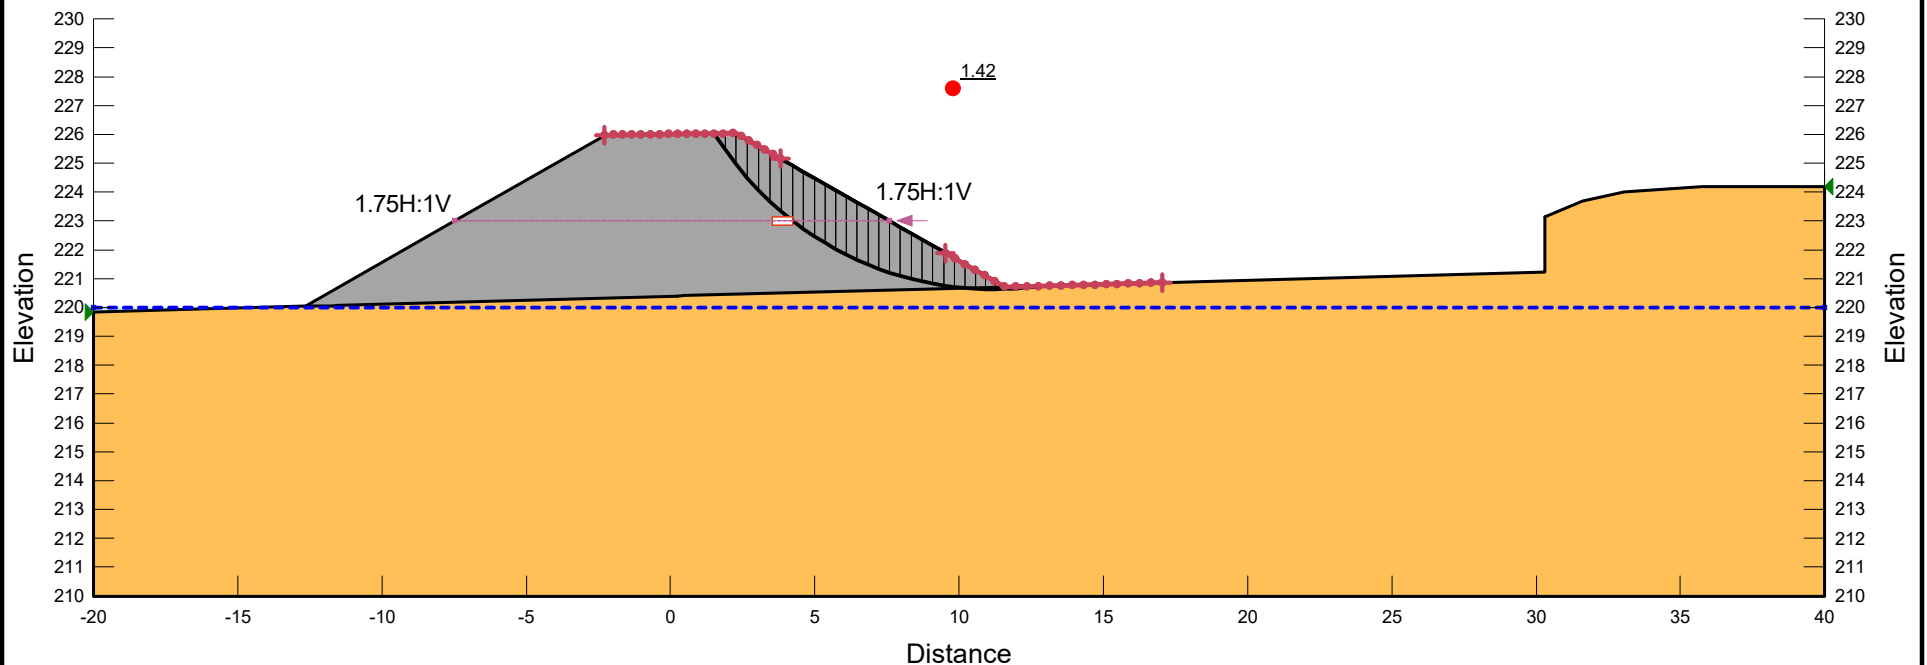
Figure E9

Color	Name	Unit Weight (kN/m³)	Effective Cohesion (kPa)	Effective Friction Angle (°)
	Clayey Silt	19.5	0	29
	Earth Fill	21	0	30

Project		
Hwy 11 Non-Structural Culvert		
Analysis		
Stage 2 East Slope 1.75H:1V with Earth Fill and Geogrid (Drailed)		
Seismic Coefficient	Last Run	
H: 0g, V: 0g	2023-11-10, 12:48:43 PM	
Scale		1:262

Additional Details
 Name: Stage 2 East Slope 1.75H:1V with Earth Fill and Geogrid
 Comments: Sta. 12+650
 Method: Morgenstern-Price, Half-Sine
 Minimum Slip Surface Depth: 2 m
 Entry: (1.5169837, 226.03016) m, Exit: (12.744263, 220.74121) m
 Center: (11.1715, 231.96357) m, Radius: 11.332039 m

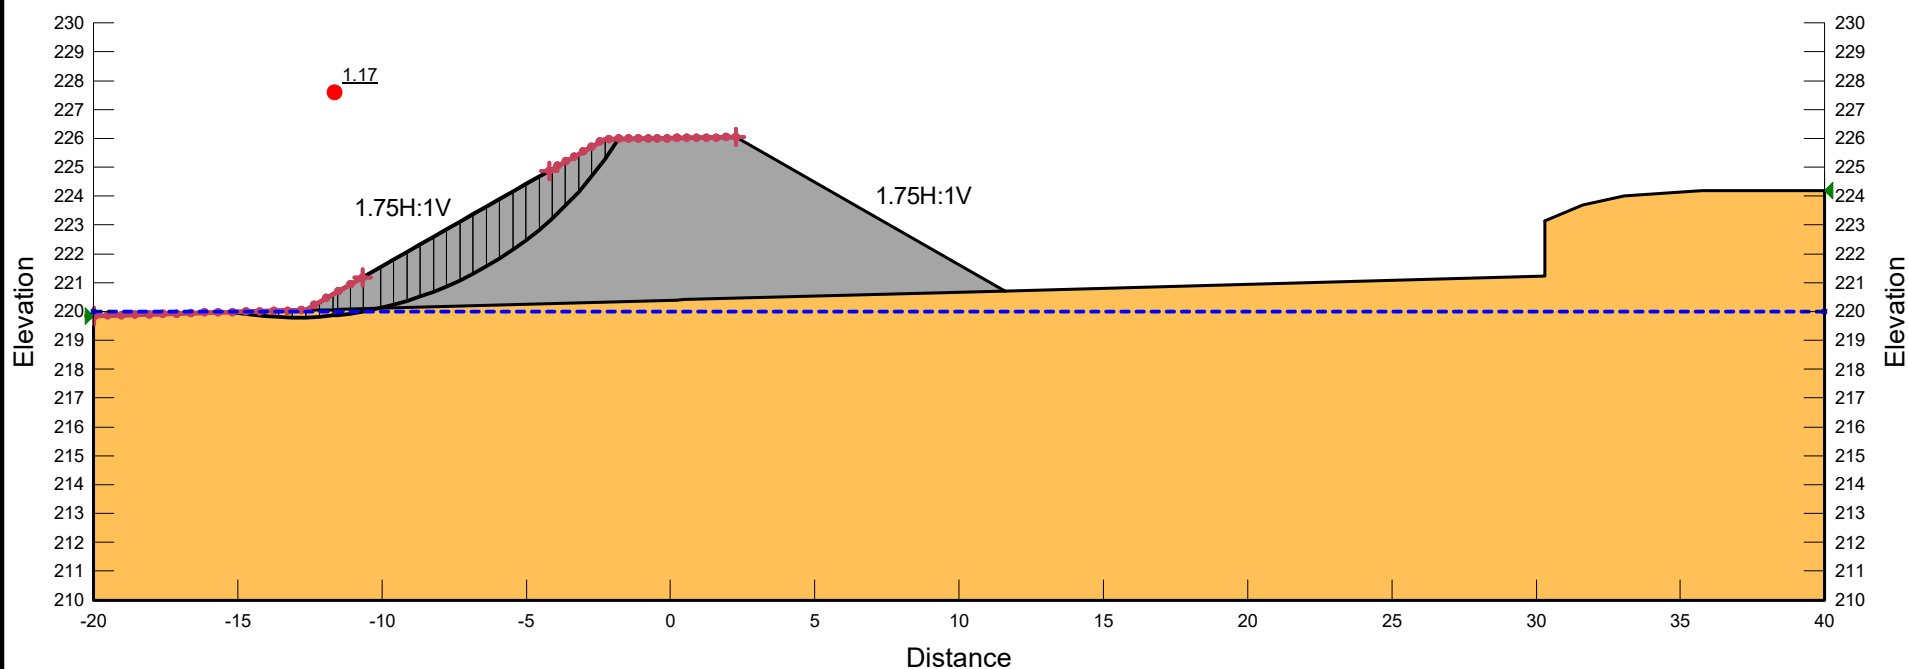
Figure E10

Color	Name	Unit Weight (kN/m³)	Effective Cohesion (kPa)	Effective Friction Angle (°)
	Clayey Silt	19.5	0	29
	Earth Fill	21	0	30

Project		Additional Details	
	Hwy 11 Non-Structural Culvert		Name: Stage 2 West Slope 1.75H:1V with Earth Fill	
	Analysis		Comments: Sta. 12+650	
	Stage 2 West Slope 1.75H:1V with Earth Fill (Drained)		Method: Morgenstern-Price, Half-Sine	
Seismic Coefficient		Last Run		Minimum Slip Surface Depth: 2 m Entry: (-15.189389, 219.98228) m, Exit: (-1.7984368, 225.98625) m Center: (-12.968872, 232.965) m, Radius: 13.171243 m
H: 0g, V: 0g		2023-11-10, 12:48:26 PM		
		Scale 1:262

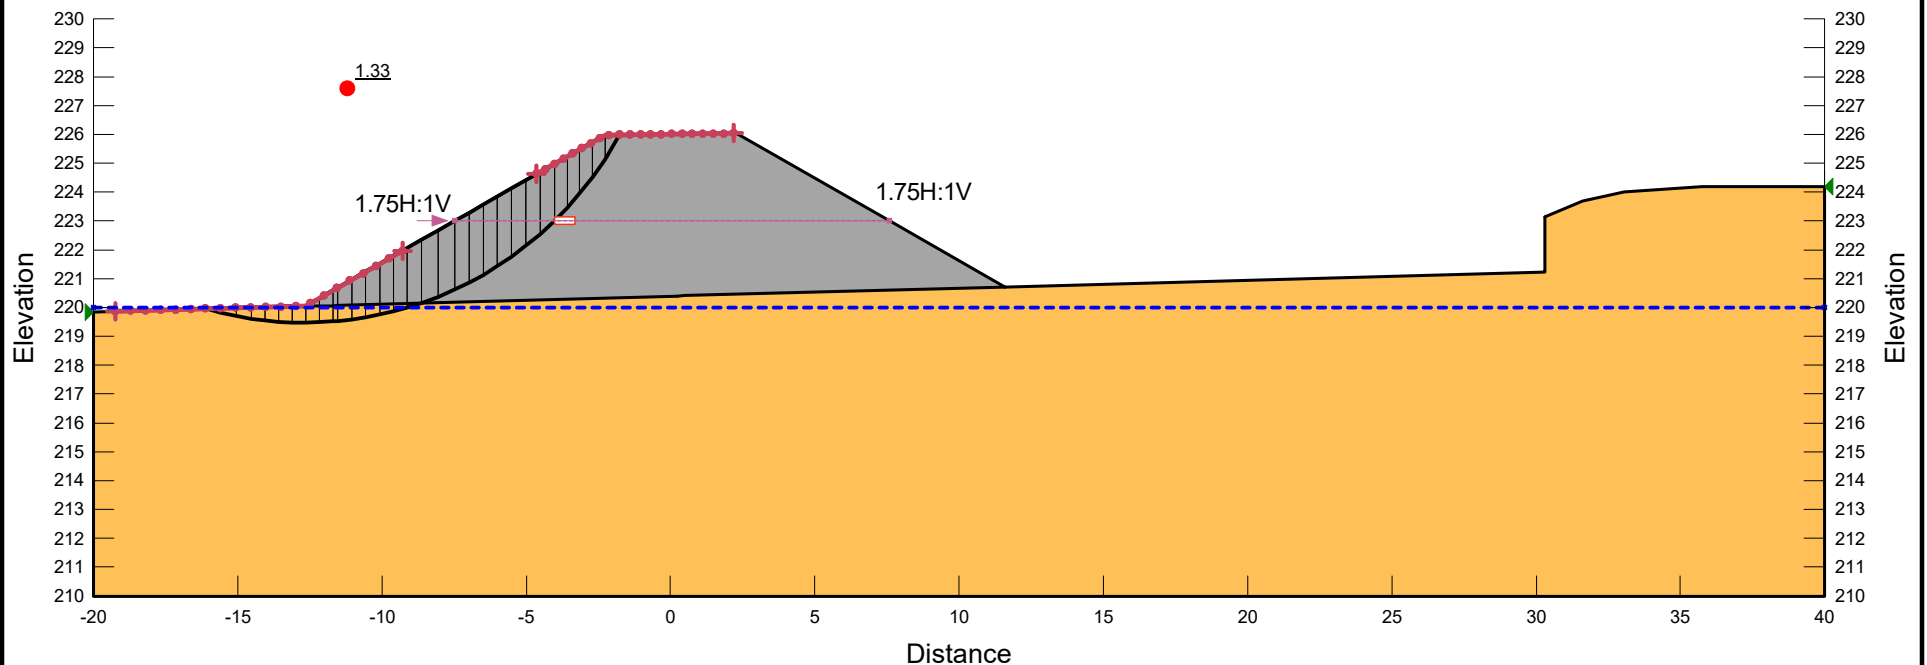
Figure E11

Color	Name	Unit Weight (kN/m³)	Effective Cohesion (kPa)	Effective Friction Angle (°)
	Clayey Silt	19.5	0	29
	Earth Fill	21	0	30

Project		
Hwy 11 Non-Structural Culvert		
Analysis		
Stage 2 West Slope 1.75H:1V with Earth Fill and Geogrid (Drained)		
Seismic Coefficient	Last Run	Scale
H: 0g, V: 0g	2023-11-10, 12:48:38 PM	1:262

Additional Details
Name: Stage 2 West Slope 1.75H:1V with Earth Fill and Geogrid
Comments: Sta. 12+650
Method: Morgenstern-Price, Half-Sine
Minimum Slip Surface Depth: 2 m
Entry: (-16.113033, 219.95765) m, Exit: (-1.7659185, 225.98668) m
Center: (-12.688504, 231.89363) m, Radius: 12.417528 m

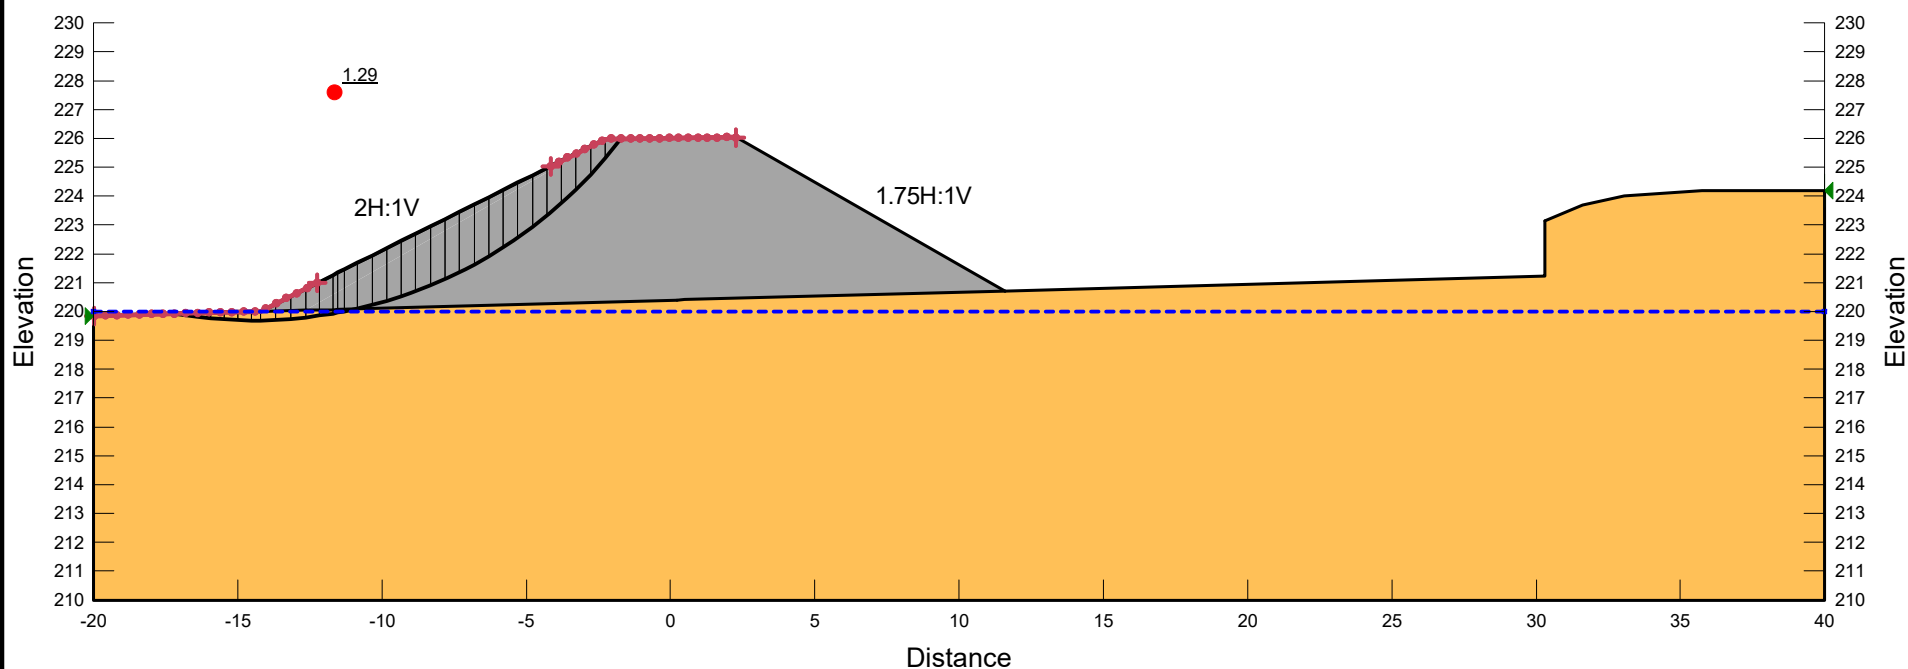
Figure E12

Color	Name	Unit Weight (kN/m³)	Effective Cohesion (kPa)	Effective Friction Angle (°)
	Clayey Silt	19.5	0	29
	Earth Fill	21	0	30

Project		Additional Details	
	Hwy 11 Non-Structural Culvert		Name: Stage 2 West Slope 2H:1V with Earth Fill	
	Analysis		Comments: Sta. 12+650	
	Stage 2 West Slope 2H:1V with Earth Fill (Drained)		Method: Morgenstern-Price, Half-Sine	
Seismic Coefficient	Last Run		Minimum Slip Surface Depth: 2 m	
H: 0g, V: 0g	2023-11-10, 12:48:28 PM		Entry: (-17.196226, 219.92788) m, Exit: (-1.7178062, 225.98731) m	
	Scale		Center: (-14.447393, 235.70519) m, Radius: 16.014975 m	
	1:262

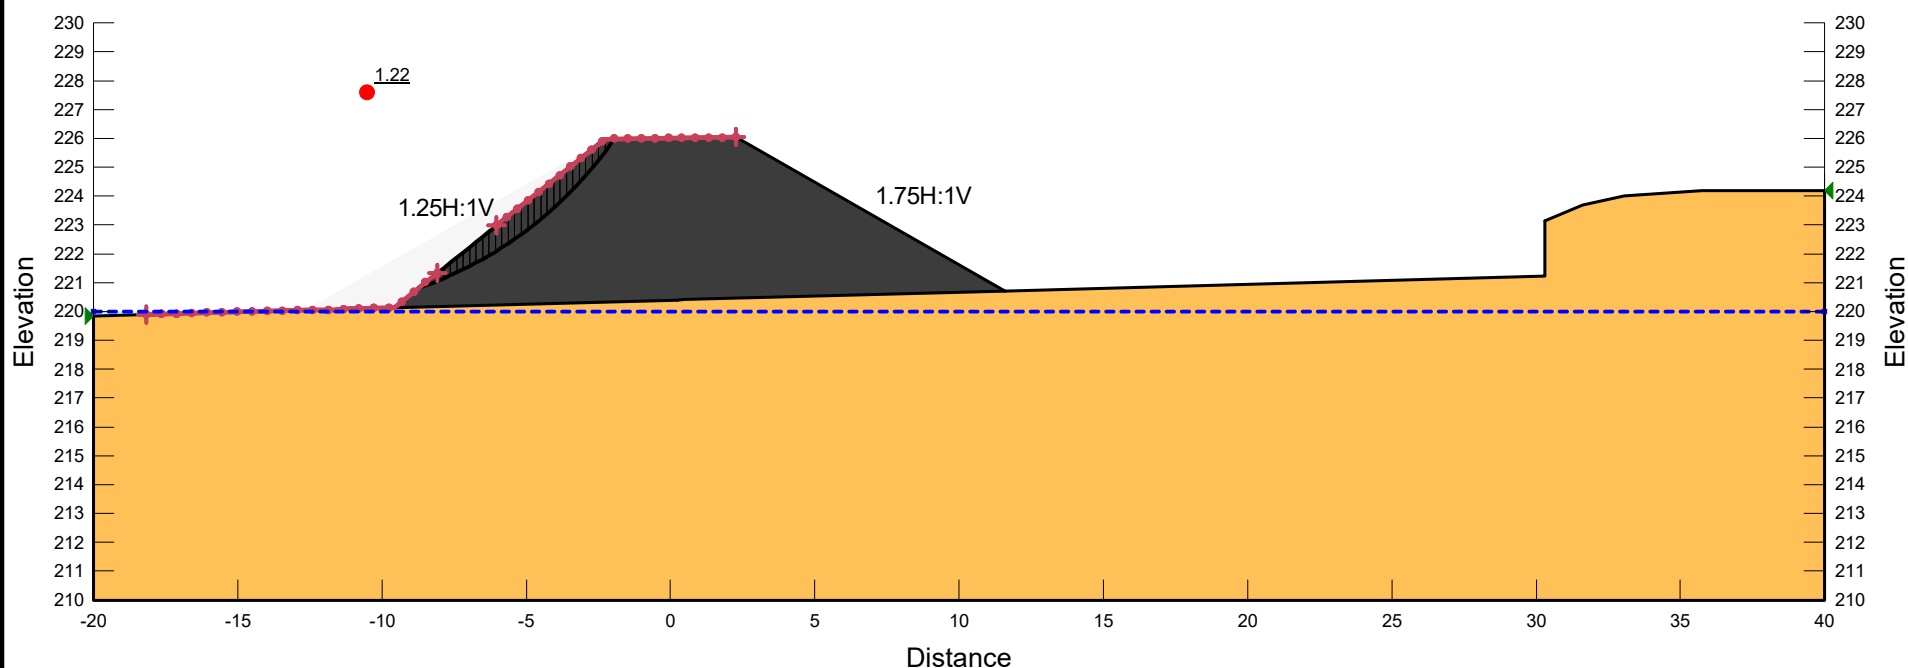
Figure E13

Color	Name	Unit Weight (kN/m³)	Effective Cohesion (kPa)	Effective Friction Angle (°)
	Clayey Silt	19.5	0	29
	Rock Fill	19	0	42

Project		
Hwy 11 Non-Structural Culvert		
Analysis		
Stage 2 West Slope 1.25H:1V with Rock Fill (Drained)		
Seismic Coefficient	Last Run	
H: 0g, V: 0g	2023-11-10, 12:48:35 PM	
Scale		1:262

Additional Details
Name: Stage 2 West Slope 1.25H:1V with Rock Fill
Comments: Sta. 12+650
Method: Morgenstern-Price, Half-Sine
Minimum Slip Surface Depth: 1 m
Entry: (-8.7484829, 220.79913) m, Exit: (-1.9468331, 225.98428) m
Center: (-13.295076, 233.81677) m, Radius: 13.788782 m
