THURBER ENGINEERING LTD.

**FINAL
FOUNDATION INVESTIGATION AND DESIGN REPORT
HIGHWAY 11 NON-STRUCTURAL CULVERT AT STATION 12+650
LEDGER TOWNSHIP, ONTARIO
AGREEMENT NO.: 6022-E-0038
ASSIGNMENT NO.: 1**

GEOCRES NO.: 52H01-001

Date: December 5, 2023

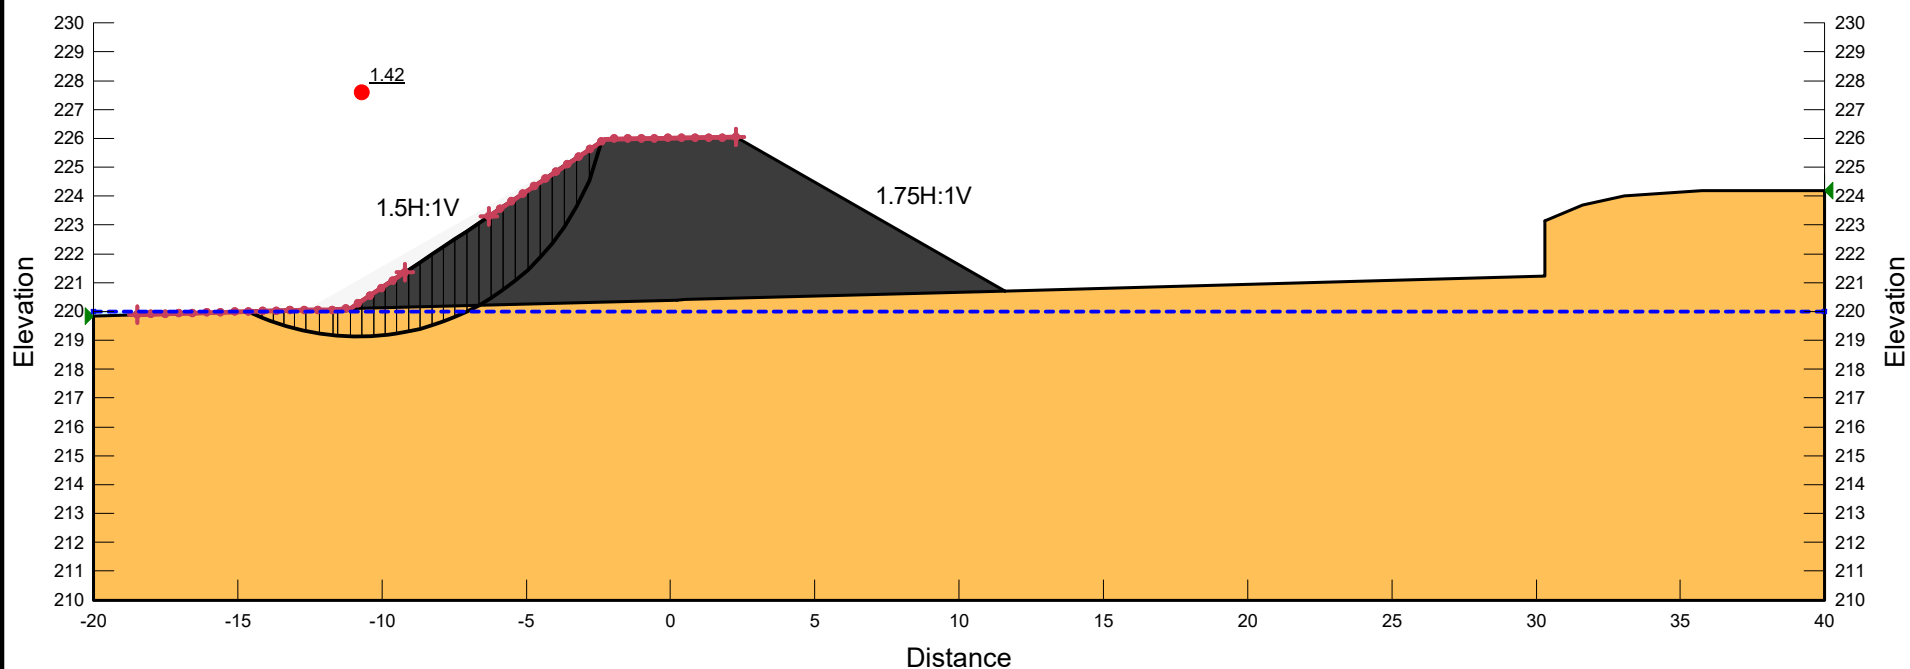
Figure E14

Color	Name	Unit Weight (kN/m³)	Effective Cohesion (kPa)	Effective Friction Angle (°)
	Clayey Silt	19.5	0	29
	Rock Fill	19	0	42

Project		
Hwy 11 Non-Structural Culvert		
Analysis		
Stage 2 West Slope 1.5H:1V with Rock Fill (Drained)		
Seismic Coefficient	Last Run	Scale
H: 0g, V: 0g	2023-11-10, 12:48:33 PM	1:262

Additional Details
Name: Stage 2 West Slope 1.5H:1V with Rock Fill
Comments: Sta. 12+650
Method: Morgenstern-Price, Half-Sine
Minimum Slip Surface Depth: 1 m
Entry: (-14.629564, 219.99721) m, Exit: (-2.3975679, 225.89495) m
Center: (-10.849639, 227.79113) m, Radius: 8.6621595 m

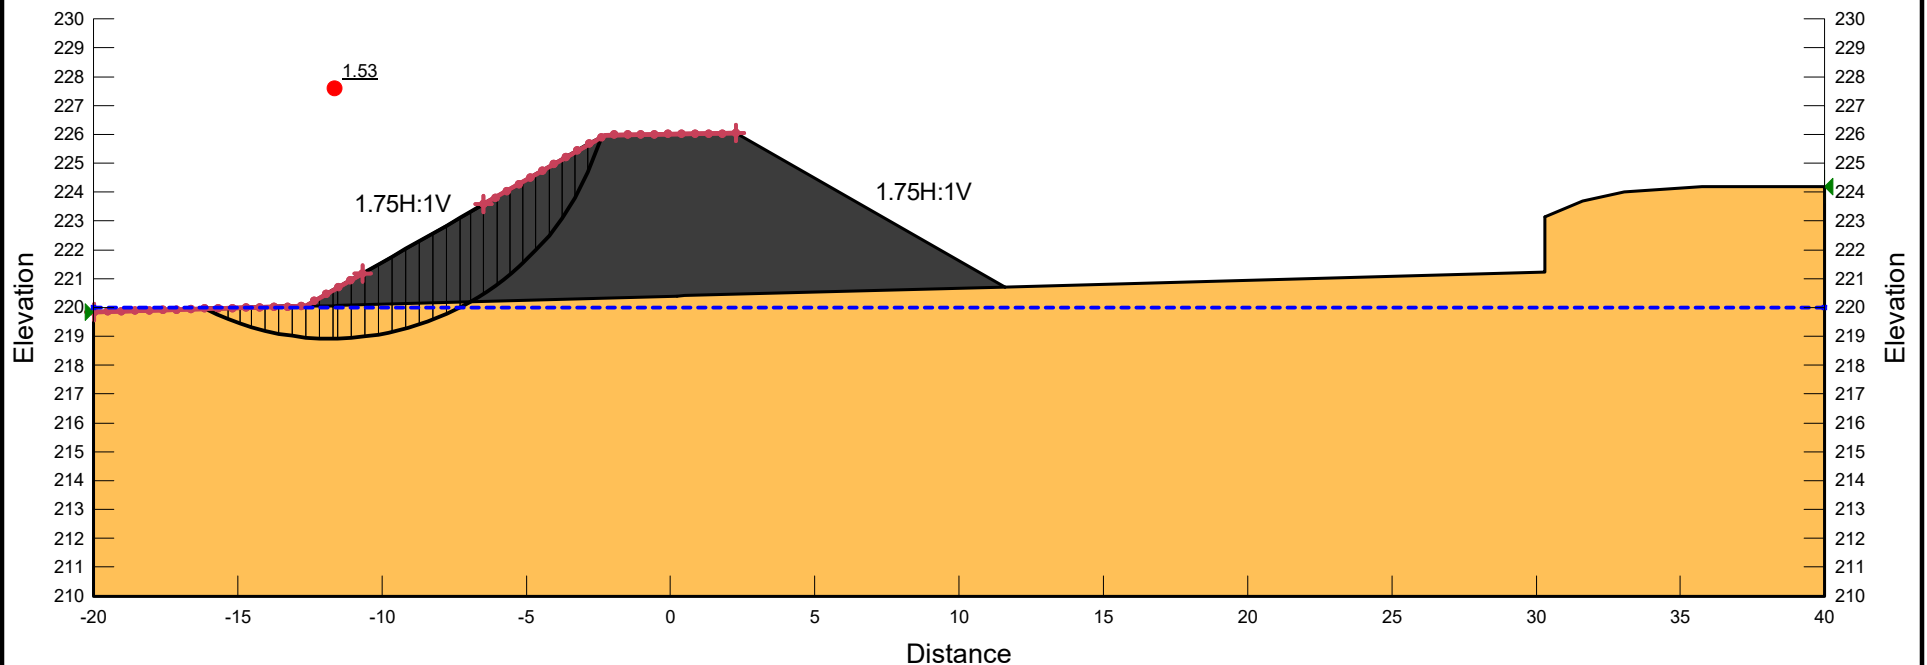
Color	Name	Unit Weight (kN/m³)	Effective Cohesion (kPa)	Effective Friction Angle (°)
	Clayey Silt	19.5	0	29
	Rock Fill	19	0	42

Project		
Hwy 11 Non-Structural Culvert		
Analysis		
Stage 2 West Slope 1.75H:1V with Rock Fill (Drained)		
Seismic Coefficient	Last Run	Scale
H: 0g, V: 0g	2023-11-10, 12:48:30 PM	1:262

Additional Details
Name: Stage 2 West Slope 1.75H:1V with Rock Fill
Comments: Sta. 12+650
Method: Morgenstern-Price, Half-Sine
Minimum Slip Surface Depth: 1 m
Entry: (-16.149533, 219.95668) m, Exit: (-2.4081365, 225.90108) m
Center: (-11.771658, 228.69142) m, Radius: 9.7704406 m
