**FINAL  
FOUNDATION INVESTIGATION REPORT  
WESTBOUND VARIABLE MESSAGING SIGN ON HIGHWAY 11/17  
SHABAQUA CORNERS, ONTARIO  
AGREEMENT NO.: 6022-E-0038  
ASSIGNMENT NO.: 3**

**GEOCRES NO.: 52A12-001**

**Client Name:** Ministry of Transportation

**Date:** December 22, 2023

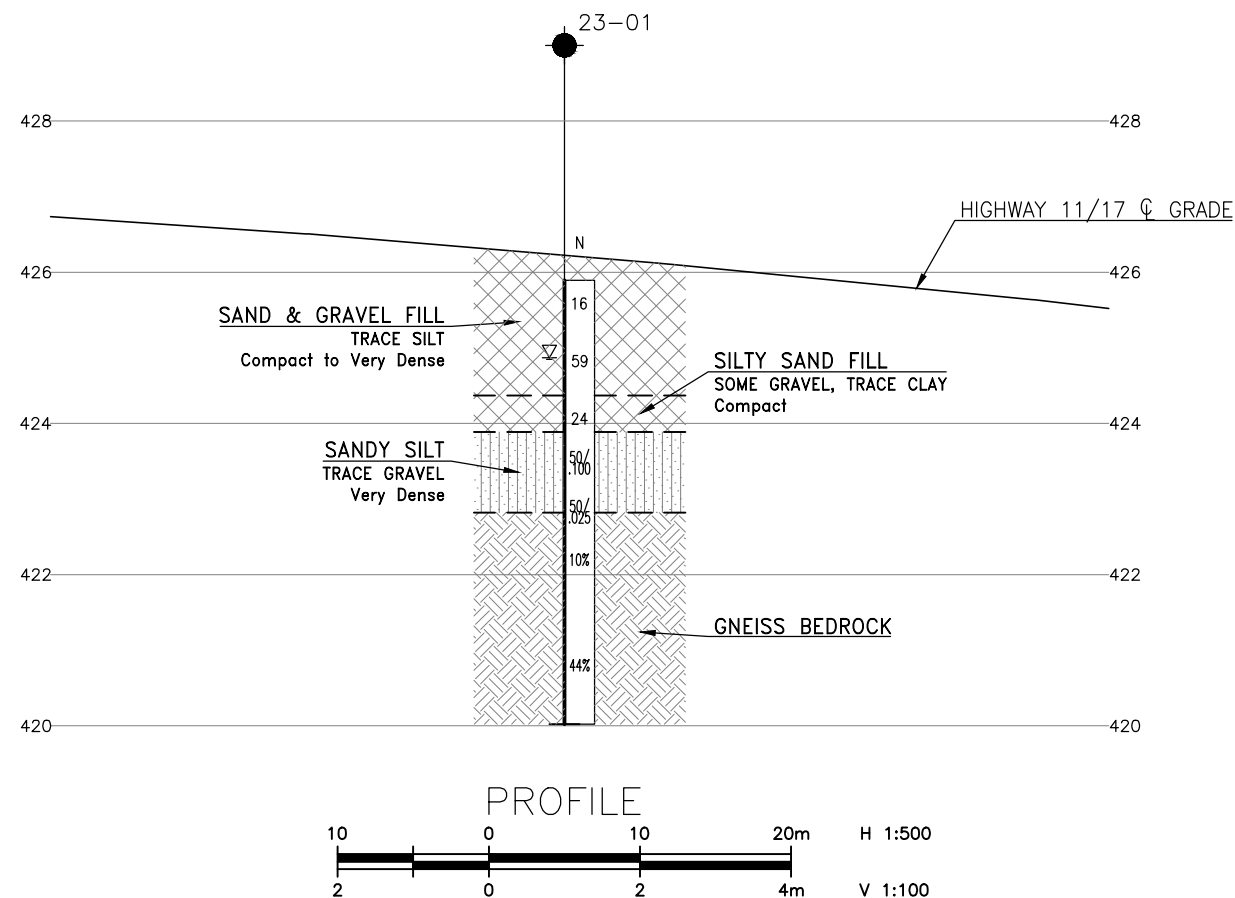
### BOREHOLE LOCATIONS AND SOIL STRATA

### Borehole Locations and Strata Drawing

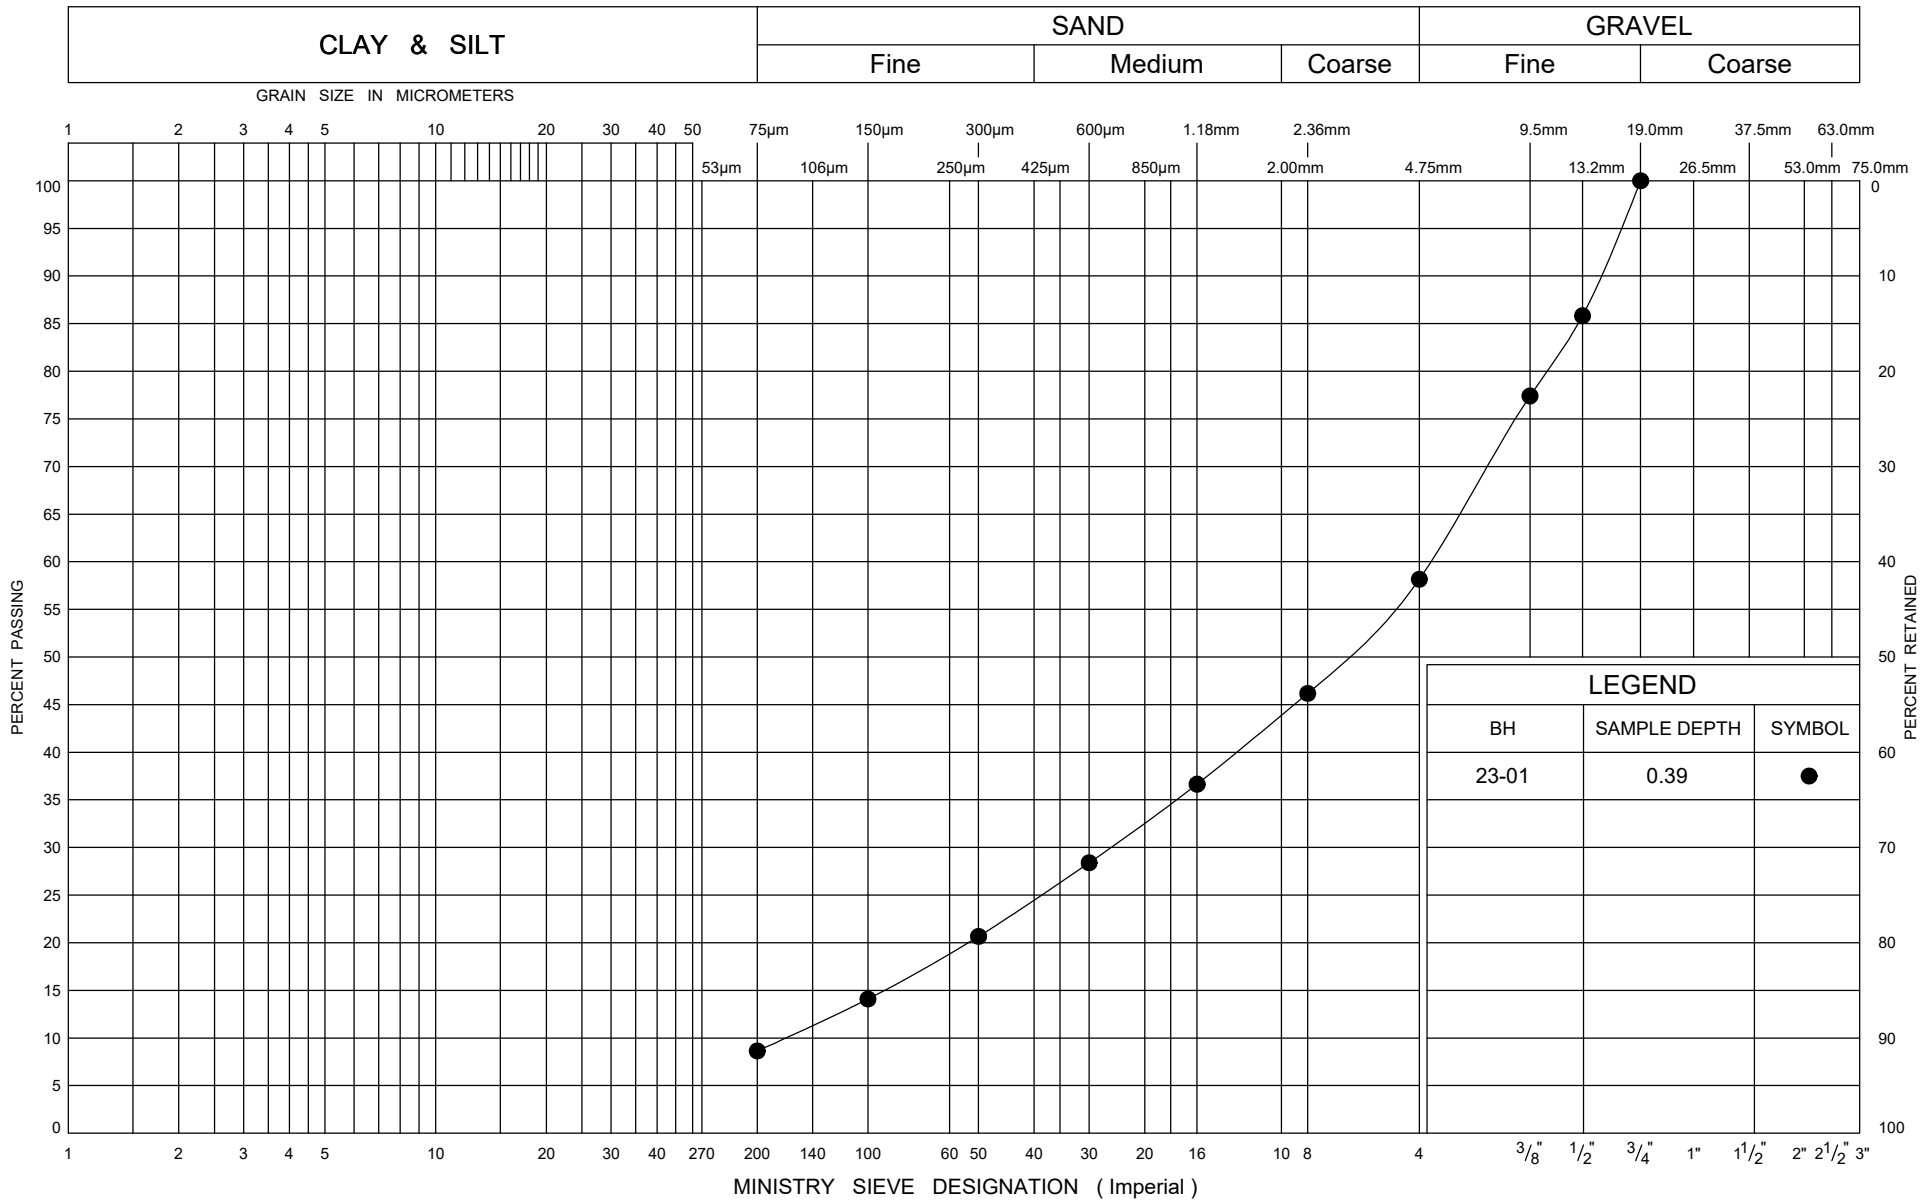
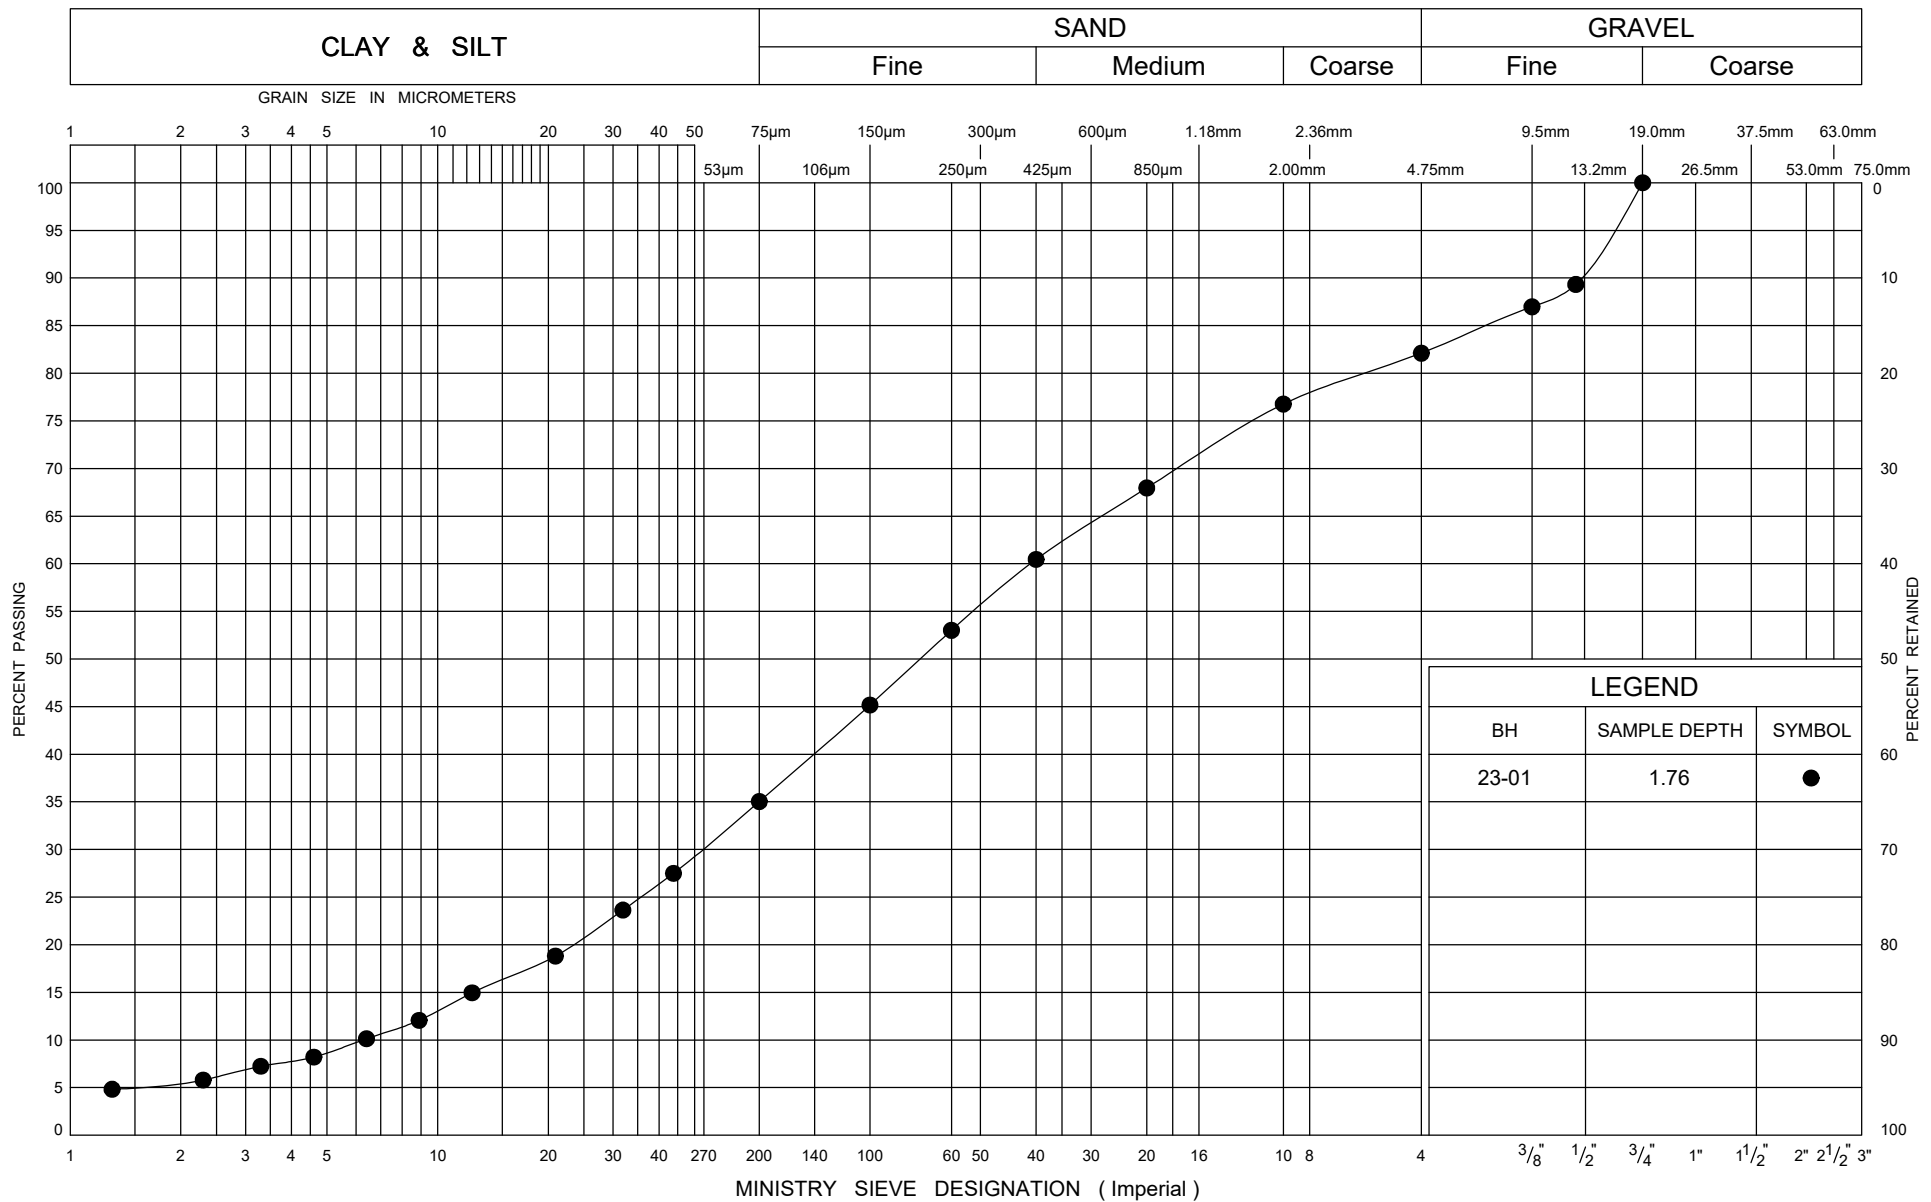
### Laboratory Test Results

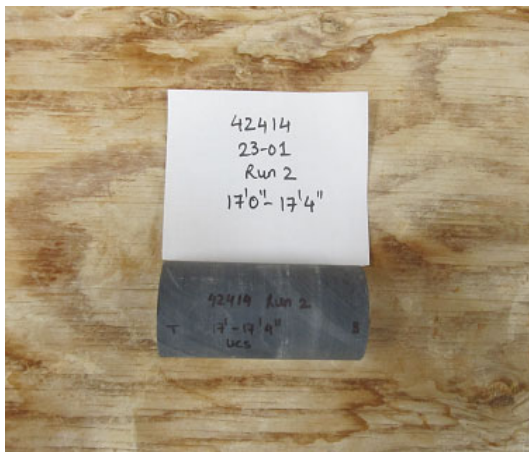
ORIGINAL SPECIMEN

Avg. Height (cm):	9.7	Weight (g):	470.2
Avg. Diameter (cm):	4.7	Wet Density (kg/m <sup>3</sup> ):	2,794
H. to Dia. Ratio*:	2.1:1	Dry Density (kg/m <sup>3</sup> ):	2,550
Cross Sectional Area (cm <sup>2</sup> ):	17.35	Moisture Content (%):	N/A
Sample Volume (cm <sup>3</sup> ):	168.29

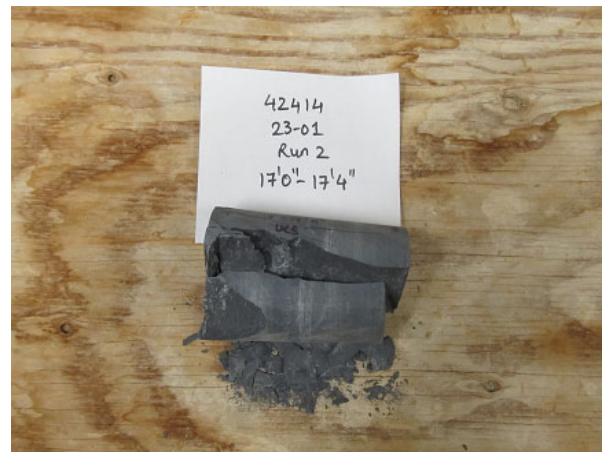
FRACTURED SPECIMEN

AVG. RATE OF STRAIN TO FAILURE:	1.5% / min
MAXIMUM COMPRESSIVE LOAD:	176.7 kN
UNCONFINED COMPRESSIVE STRENGTH:	101.8 MPa

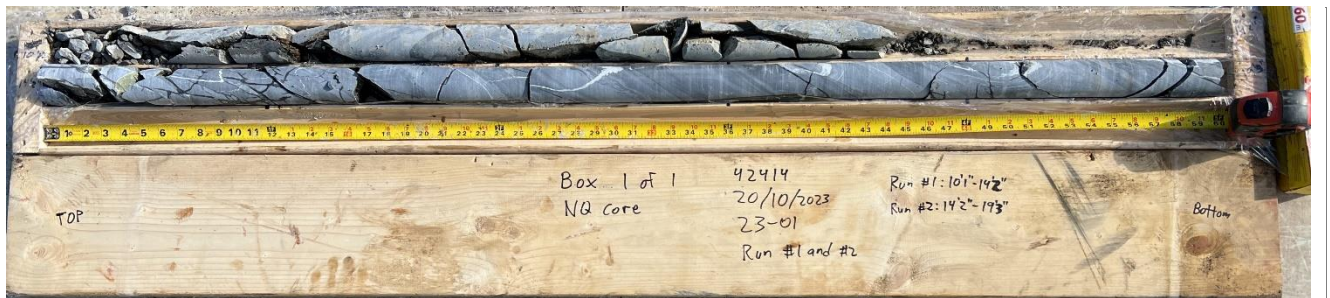
## ROCK CORE PHOTOGRAPH

Borehole 23-01, Runs 1 and 2 (of 2), 3.1 to 5.9 m

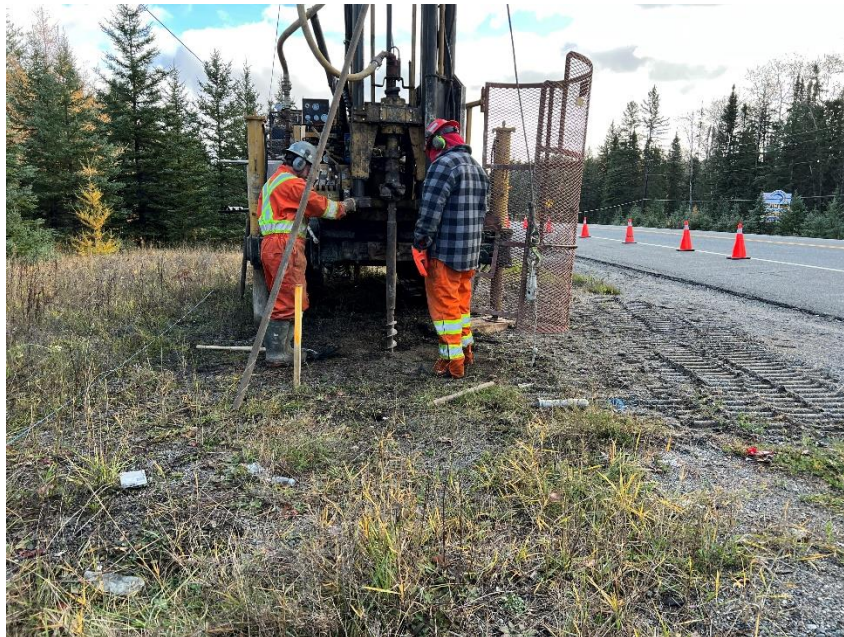
Photo 2: Looking east at Borehole 23-01 during drilling (taken on October 20, 2023)
