**PRELIMINARY FOUNDATION INVESTIGATION REPORT
HIGHWAY 401 WIDENING, HIGHWAY 16 TO MAITLAND ROAD
BLUE CHURCH ROAD UNDERPASS, SITE NO. 16X-0165/B0
GWP 4024-20-00 / ASSIGNMENT NO. 4019-E-0010.2**

SITE NO. 16X-0165/B0

Geocres No.: 31B12-002

March 2024
Thurber File No.: 29381

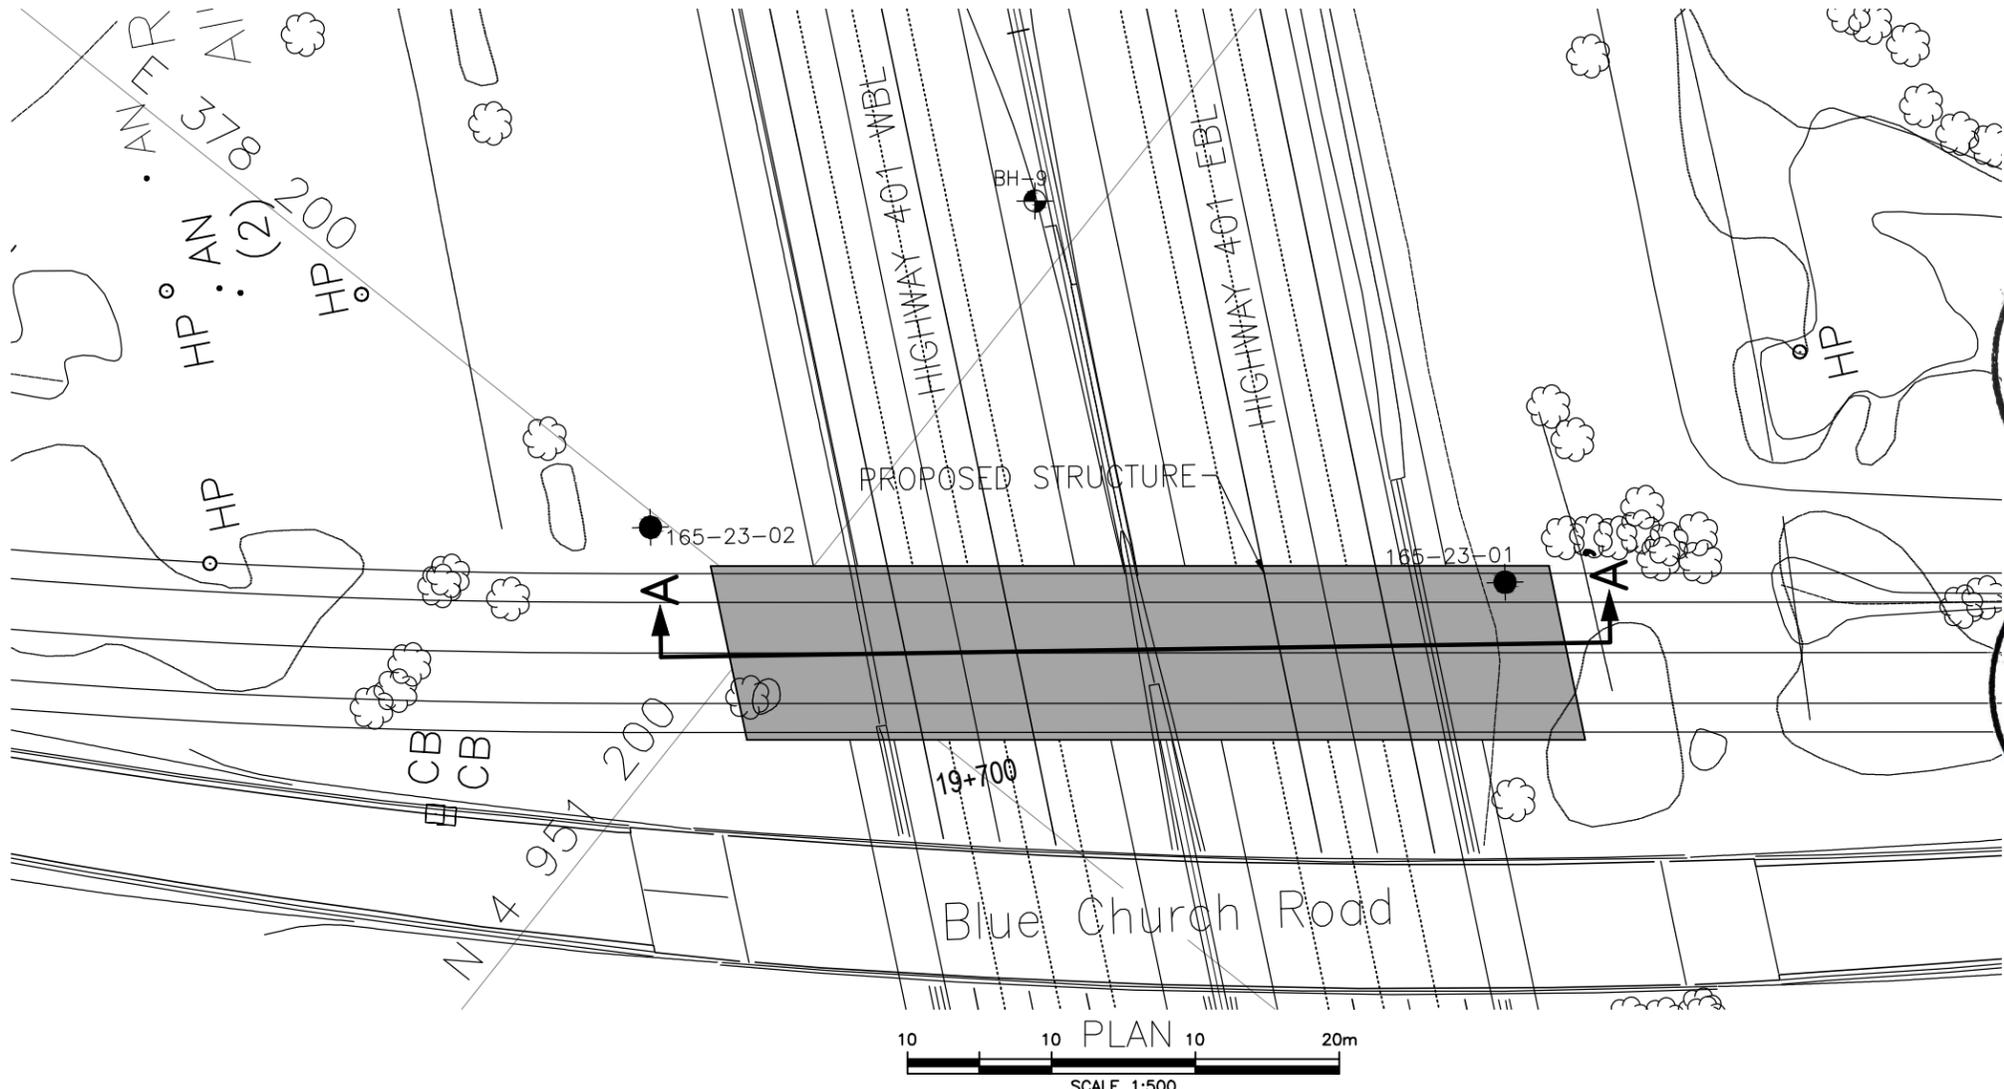
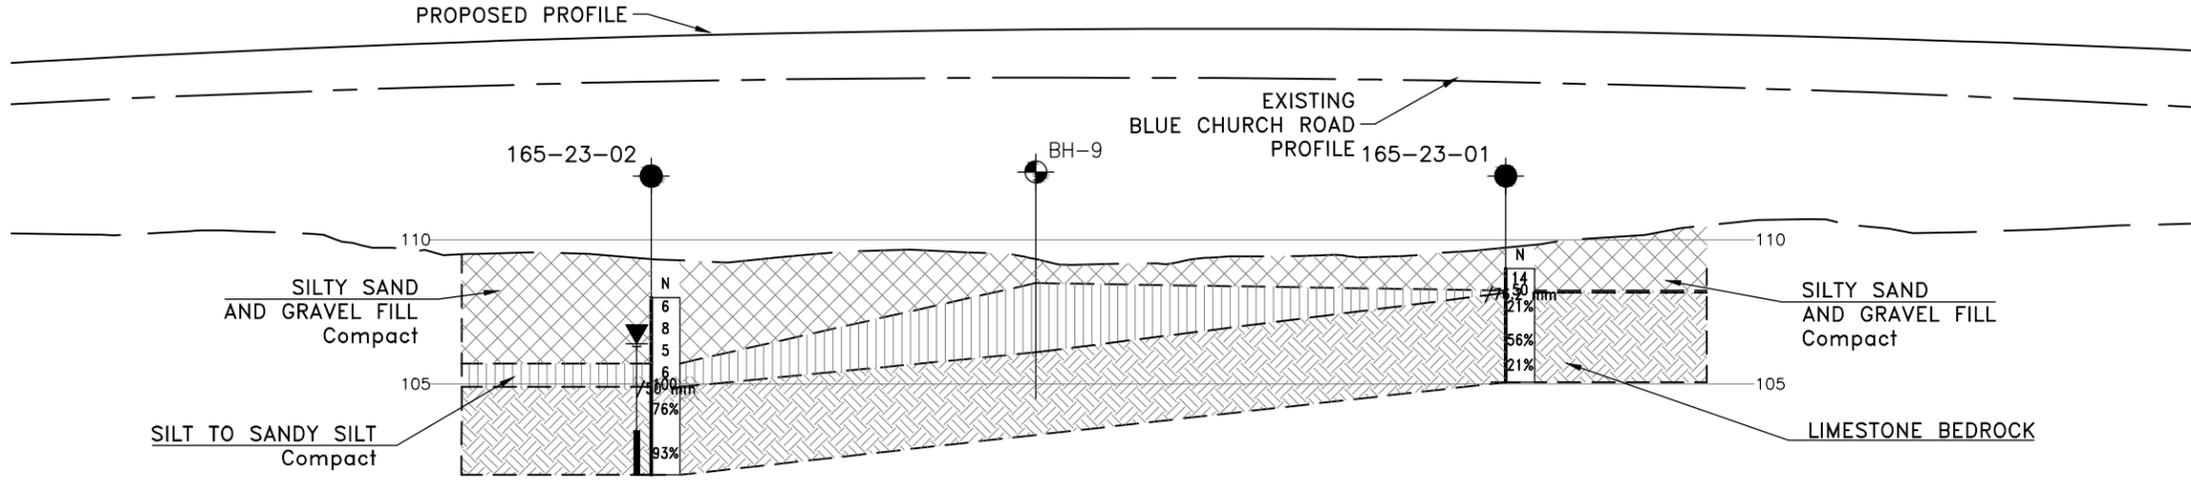
HIGHWAY 401
BLUE CHURCH ROAD
BRIDGE REPLACEMENT
BOREHOLE LOCATIONS AND SOIL STRATA

- 1) The boundaries between soil strata have been established only at Borehole locations. Between Boreholes the boundaries are assumed from geological evidence.
- 2) This drawing is for subsurface information only. Surface details and features are for conceptual illustration.
- 3) Coordinate system is MTM NAD 83 Zone 9.

PLAN
SCALE 1:500

PROFILE ALONG BLUE CHURCH ROAD

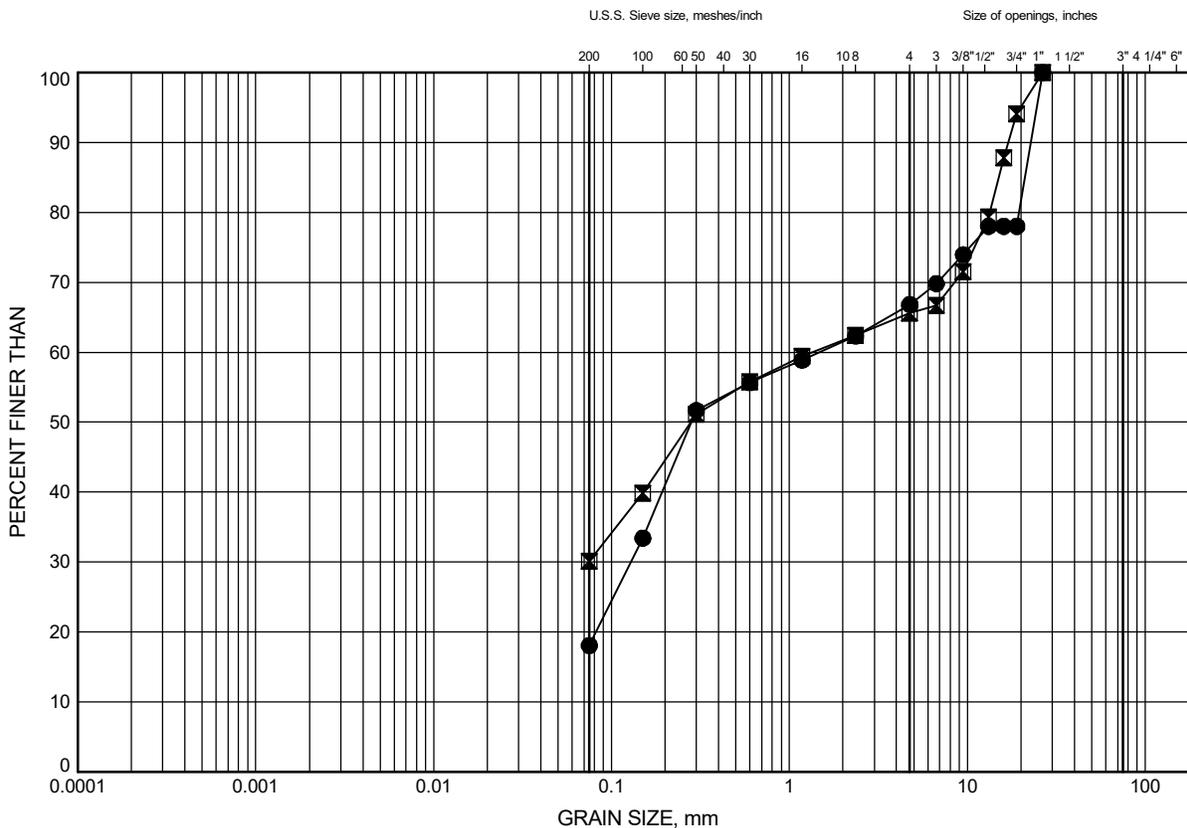
GRAIN SIZE DISTRIBUTION

FILL: Gravelly Silty Sand

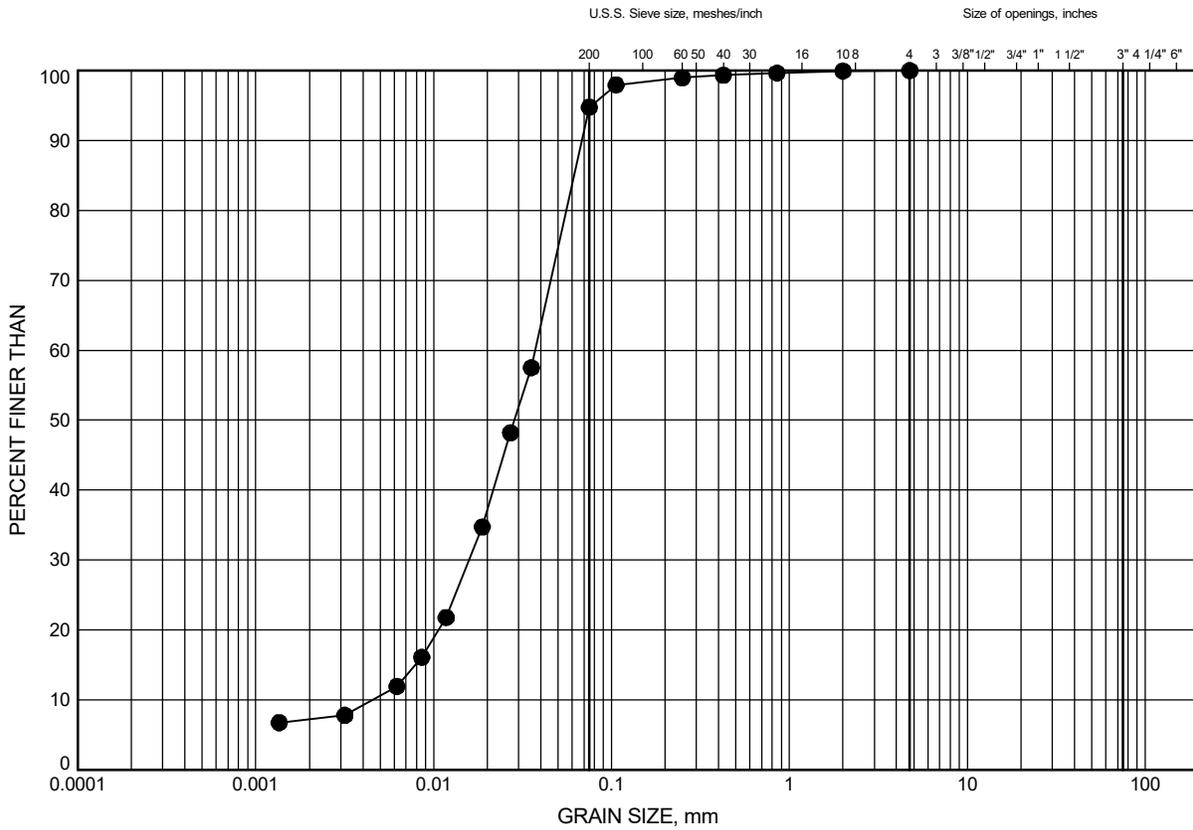
GRAIN SIZE DISTRIBUTION

Silt

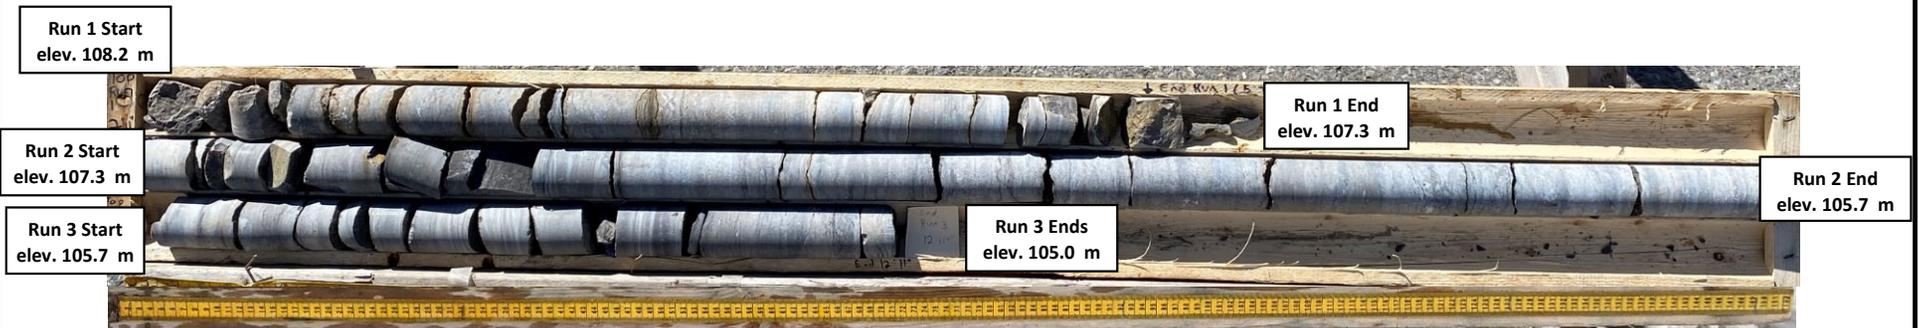
Borehole 165-23-01
Runs 1 to 3
Depth 0.8 to 3.9 m
Elevation 108.2 to 105.0 m
Dry Sample

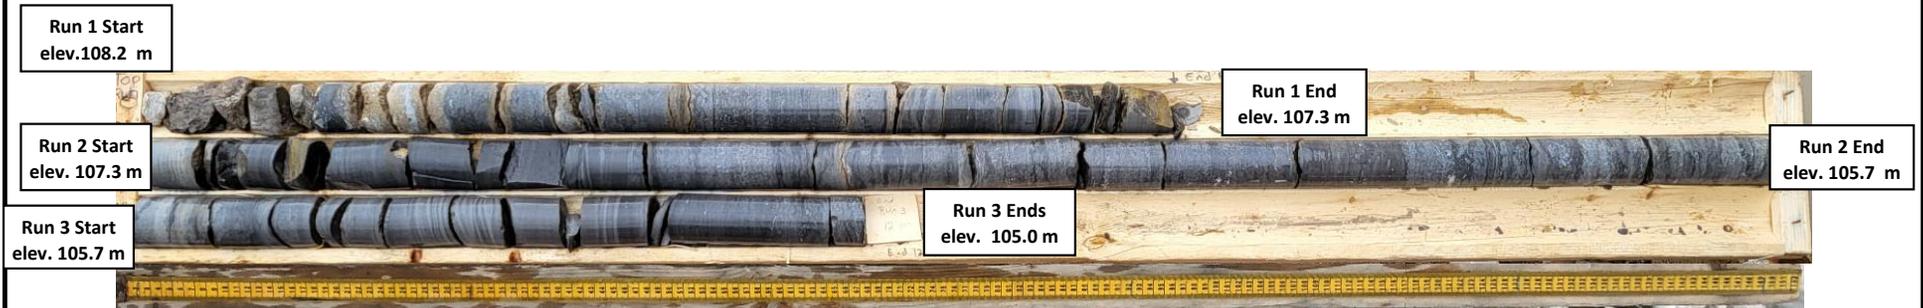
Borehole 165-23-01
Runs 1 to 3
Depth 0.8 to 3.9 m
Elevation 108.2 to 105.0 m
Wet Sample

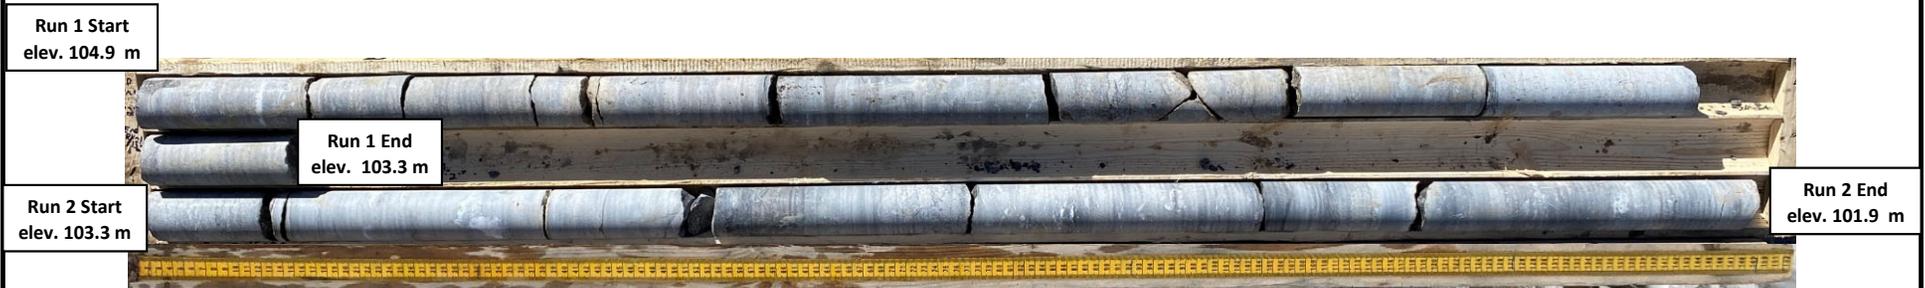
Borehole 165-23-02
Runs 1 to 2
Depth 3.1 to 6.1 m
Elevation 104.9 to 101.9 m
Dry Sample

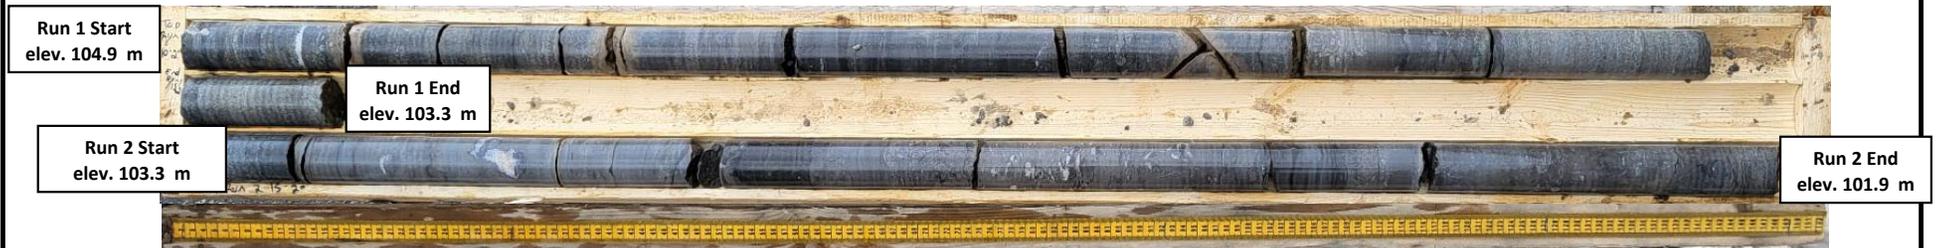
Borehole 165-23-02
Runs 1 to 2
Depth 3.1 to 6.1 m
Elevation 104.9 to 101.9 m
Wet Sample

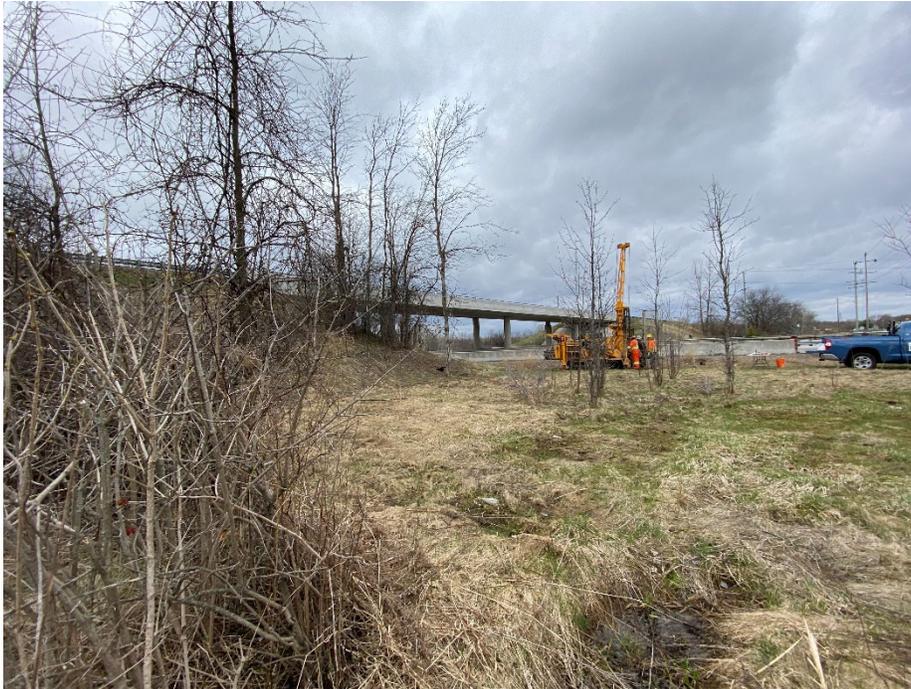
Photo 1: Looking northwest toward existing bridge (2023/04/18)

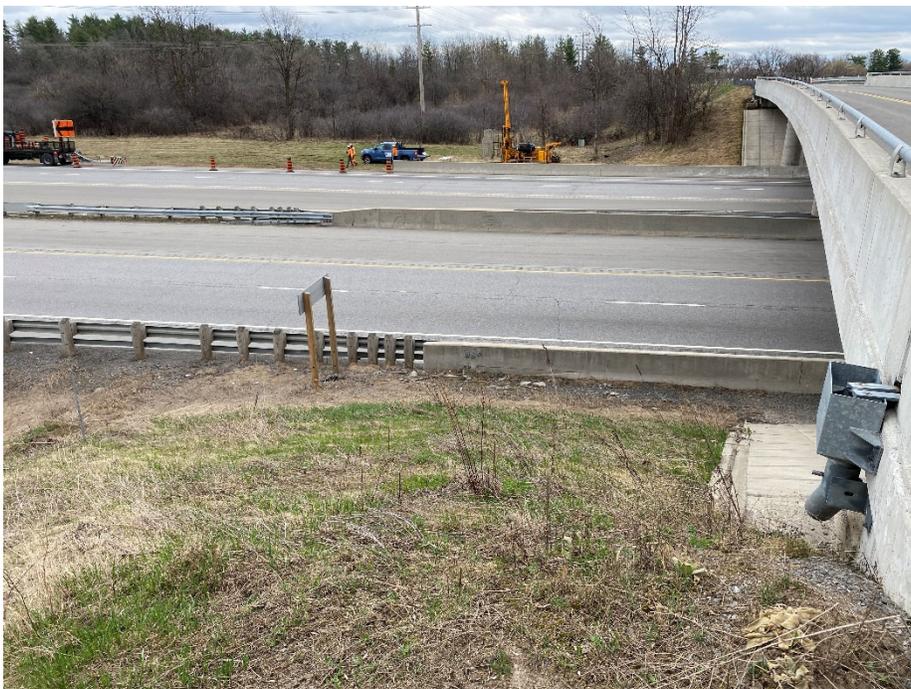
Photo 2: Looking south along east side of existing bridge (2023/04/18)

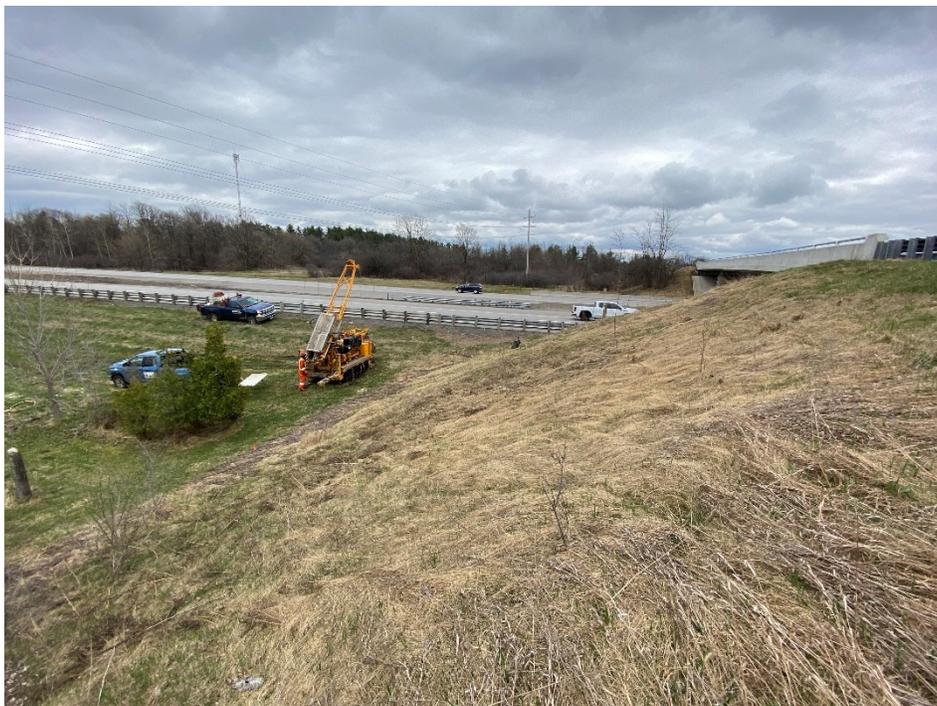
Photo 4: Looking south along north embankment (2023/04/18)
