# FOUNDATION INVESTIGATION AND DESIGN REPORT

## REHABILITATION OF HIGHWAY 35 AT CARNARVON AND FOUR BRIDGE REHABILITATIONS ON HIGHWAY 35

## PROPOSED HALLS LAKE DAM BRIDGE REMOVAL

GWP: 5288-14-00  
MINISTRY OF TRANSPORTATION (MTO)  
NORTHEAST REGION  
Assignment No. 5018-E-0024

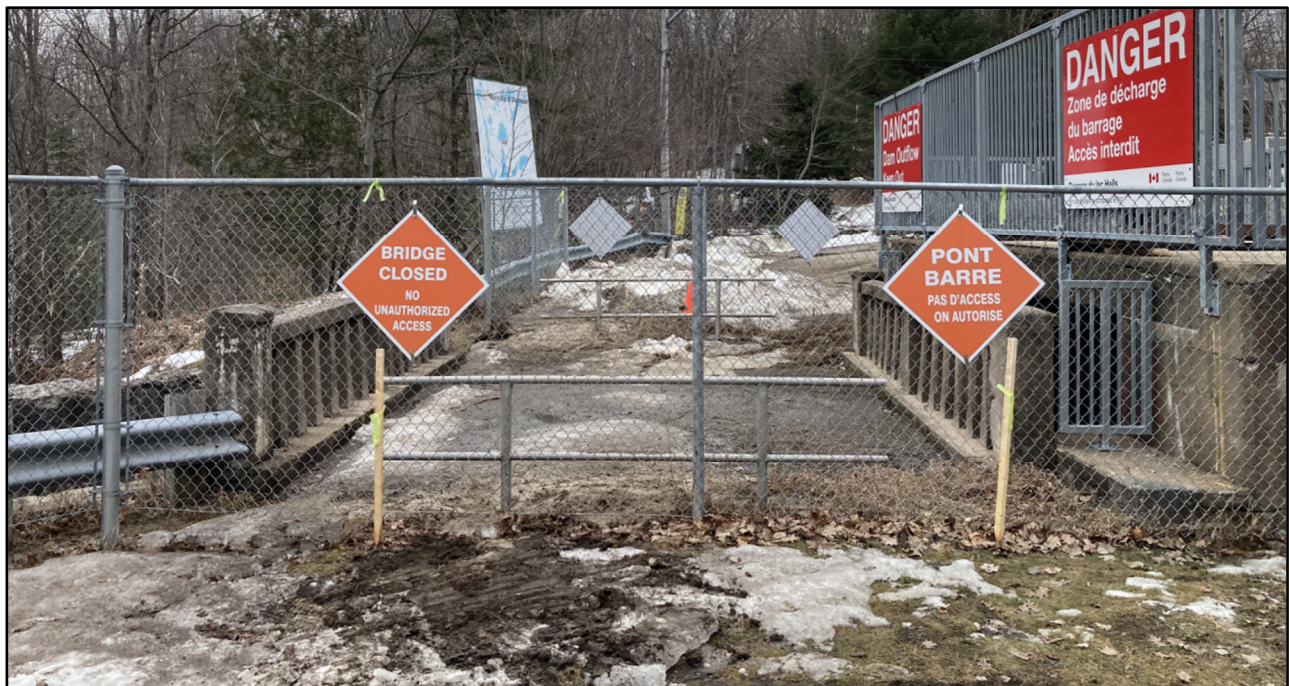
**Photograph 1 – Looking Construction North at existing Halls Lake Dam Bridge (Dam directly on the right)**

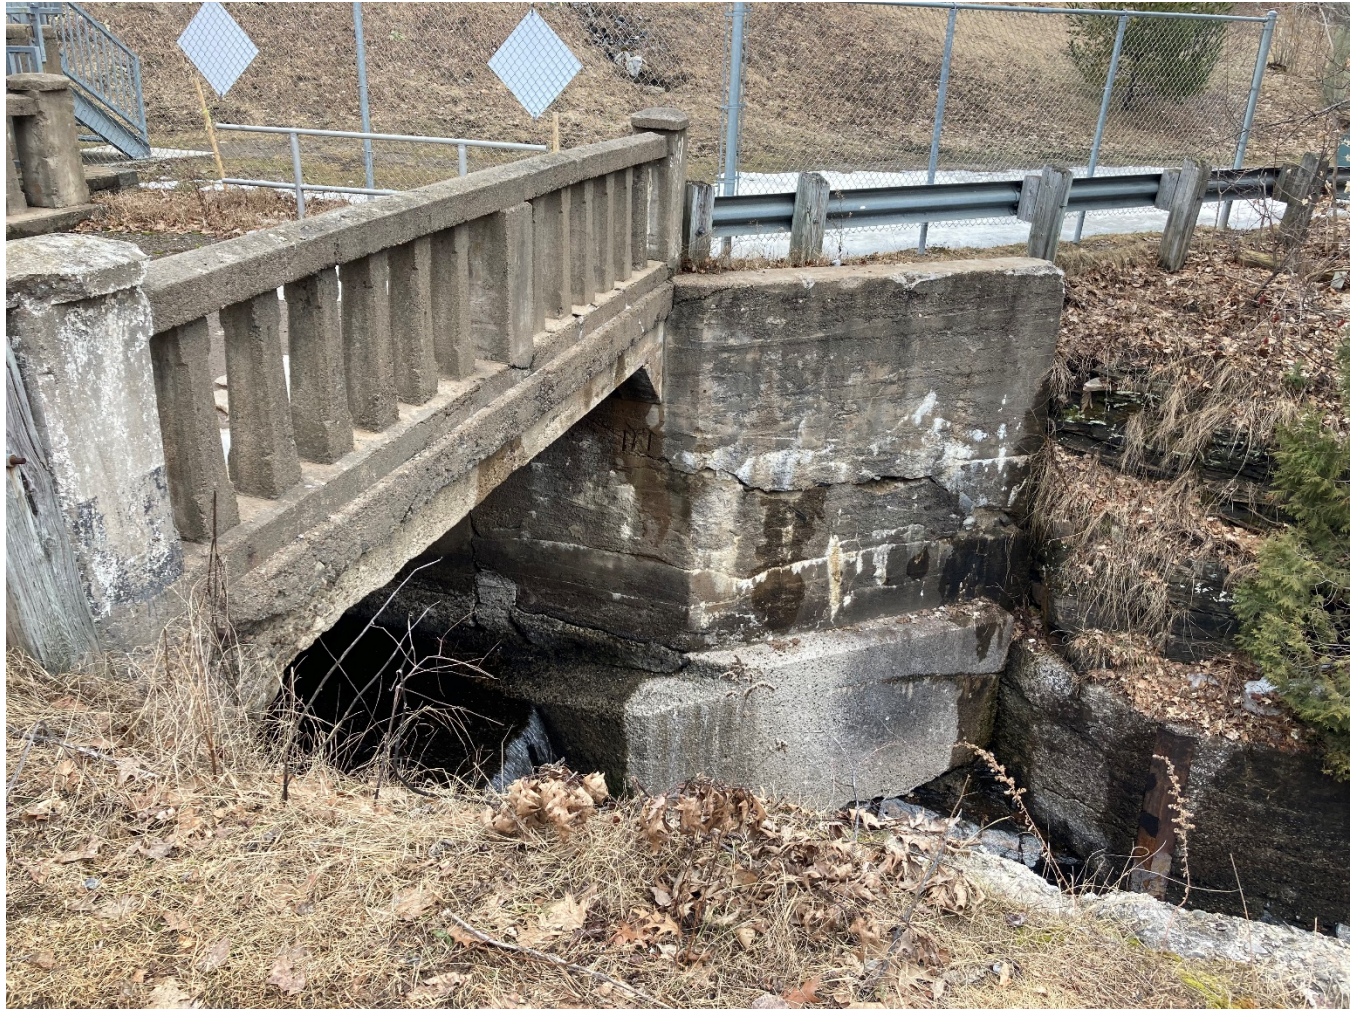
**Photograph 2 – Looking Construction South at existing Halls Lake Dam Bridge Abutment Wing Wall**

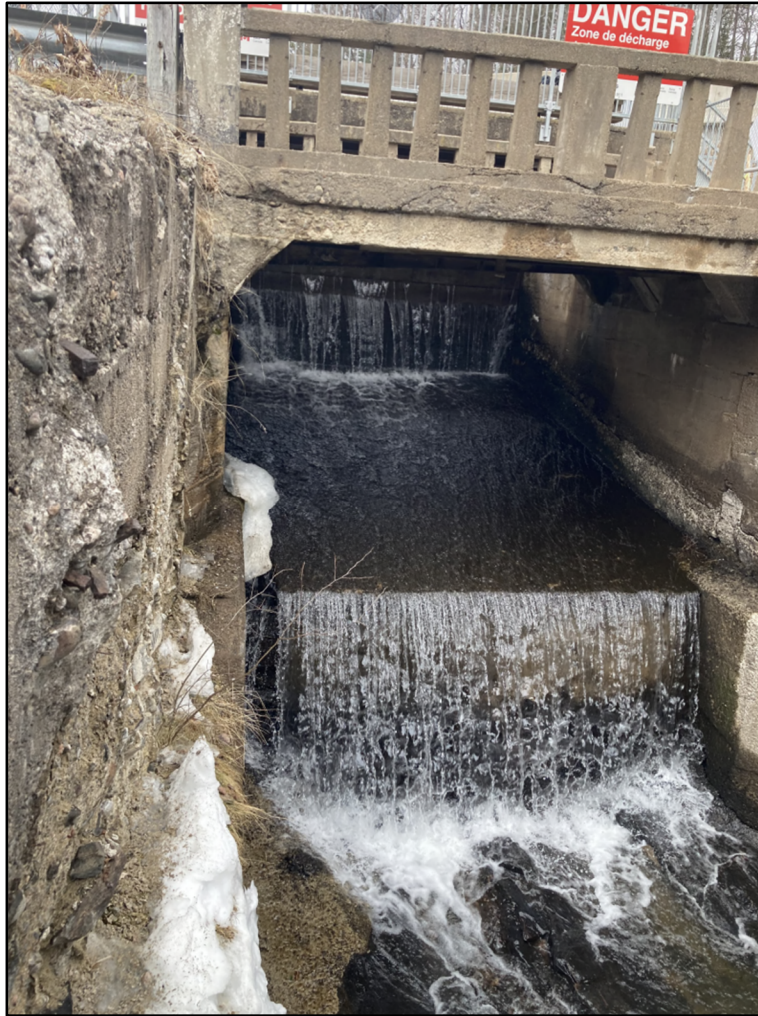
**Photograph 3 – Looking upstream towards Halls Lake Dam Bridge (Dam in far background)**

The Halls Lake Dam bridge includes a single span of approximately 5.3 m between the abutment walls made up of four cast-in-place T-beams, which support an exposed concrete deck. In addition to the T-beam, there is a single W-section that spans between the abutments along the centreline of the bridge. A picture of the existing Halls Lake Dam Bridge is shown in Photograph 3 below.

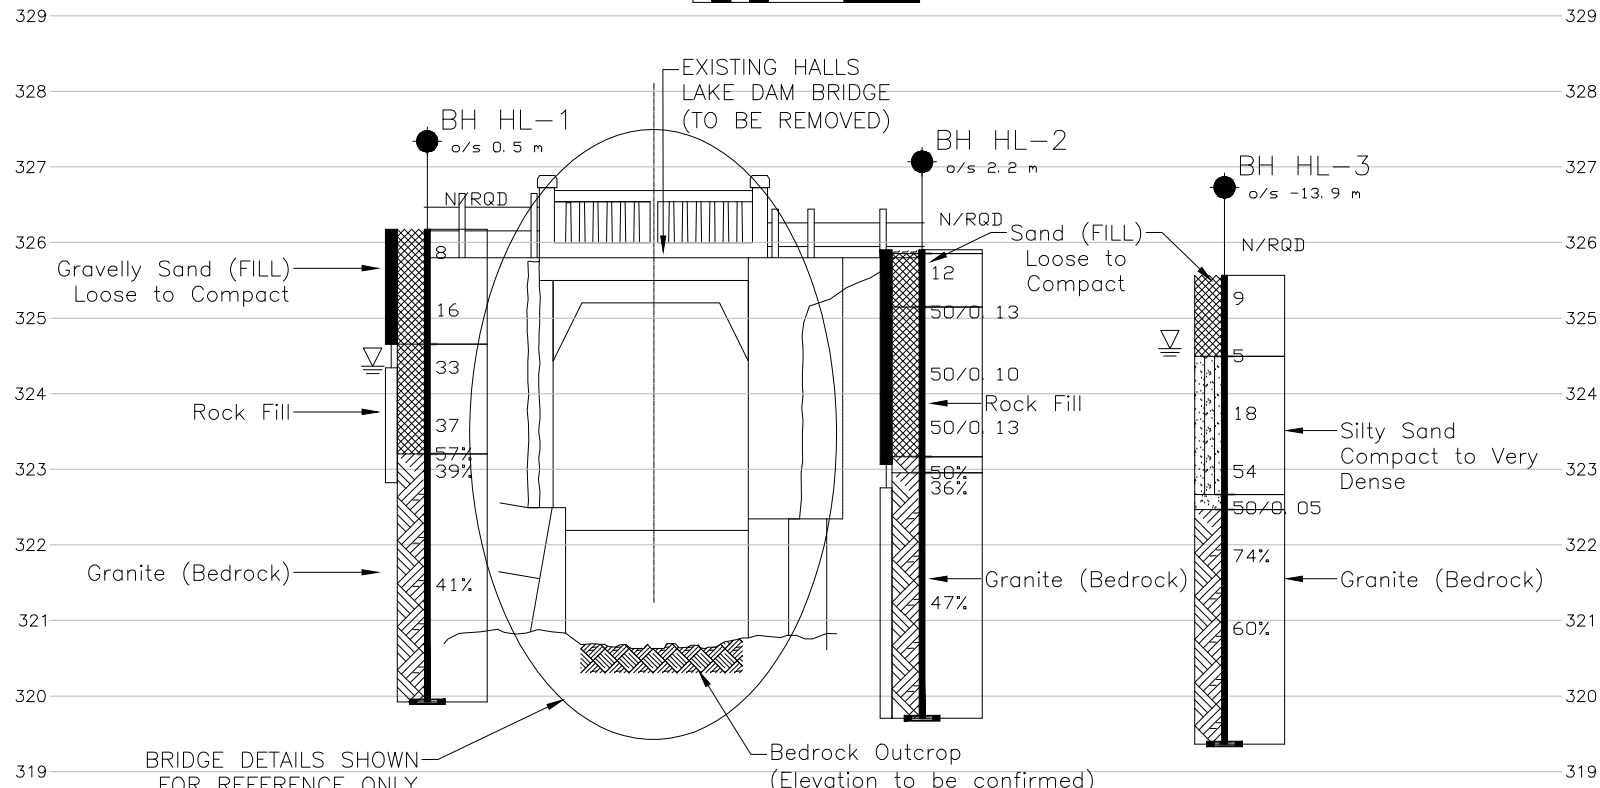
NO.	DATE	BY	REVISION
Geocres No. 31E-423			
HWY. 35	PROJECT NO. 22519794	DIST. CENTRAL	
SUBM'D. PP	CHKD. PP	DATE: 06/27/2023	SITE: .
DRAWN: DD	CHKD. KJB	APPD. KJB	DWG. 1

PLAN

PROFILE A-A'

The subsurface soil, bedrock and groundwater conditions encountered in the boreholes and the results of in-situ testing from the investigation are shown on the borehole and drillhole records presented in **Appendix B**. The results of the geotechnical laboratory testing are presented on the borehole records as well as on figures provided in **Appendix C**. The test pit records are provided in **Appendix D**. The borehole and test pit locations and the interpreted stratigraphic profile projected along the bridge alignment are provided on the drawing provided in **Appendix A**. It is noted that the existing bridge profile shown on Drawing 1 is approximate and not to scale.

The overburden soils are underlain by granite bedrock as confirmed by NQ-sized bedrock core samples (ranging from 2.5 m to 3.3 m in length) recovered in the three drilled boreholes. In addition, bedrock outcrop was observed at the bottom of the dam spillway directly downstream of the bridge as identified in Drawing 1.

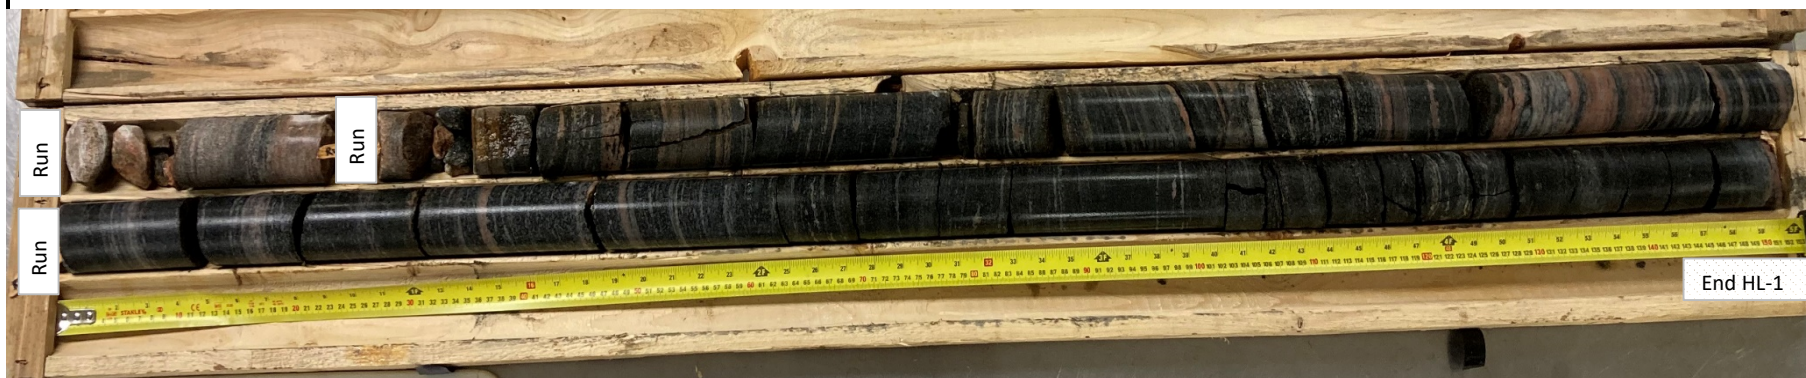
Client: MTO		Title: Core Photograph BH HL-1, RUN #1 to RUN #3
Project#: 19M-01435-00	Figure #: BH HL-1	Project: Foundation Investigation Rehabilitation of Halls Lake Dam Pedestrian Bridge
Drawn: TL	Approved:	
Date: April 2022	Scale: N. T. S.

Run 1: 9'9" ~ 10'6" (2.97m ~ 3.2m)  
 Run 2: 10'6" ~ 15'6" (3.2m ~ 4.72m)  
 Run 3: 15'6" ~ 20'6" (4.72m ~ 6.25m)  
 \*Notes: (suspected fractures / voids at start of Run 2  
 due to lost water return)

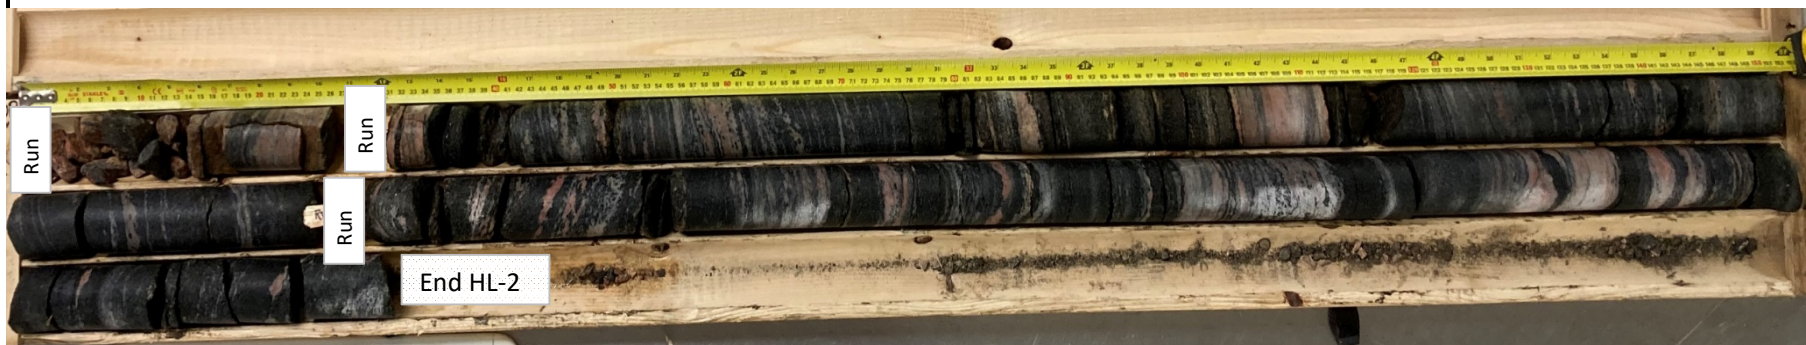
Client: MTO		Title: Core Photograph BH HL-2, RUN #1 to RUN #3	
Project#: 19M-01435-00	Figure #: BH HL-2	Project: Foundation Investigation Rehabilitation of Halls Lake Dam Pedestrian Bridge	
Drawn: TL	Approved:		
Date: April 2022	Scale: N. T. S.		
Size: Letter	Rev: 0	wsp

Run 1: 9'8" ~ 10'4" (2.95m ~ 3.15m)  
 Run 2: 10'4" ~ 15'4" (3.15m ~ 4.67m)  
 Run 3: 15'4" ~ 20'4" (4.67m ~ 6.20m)

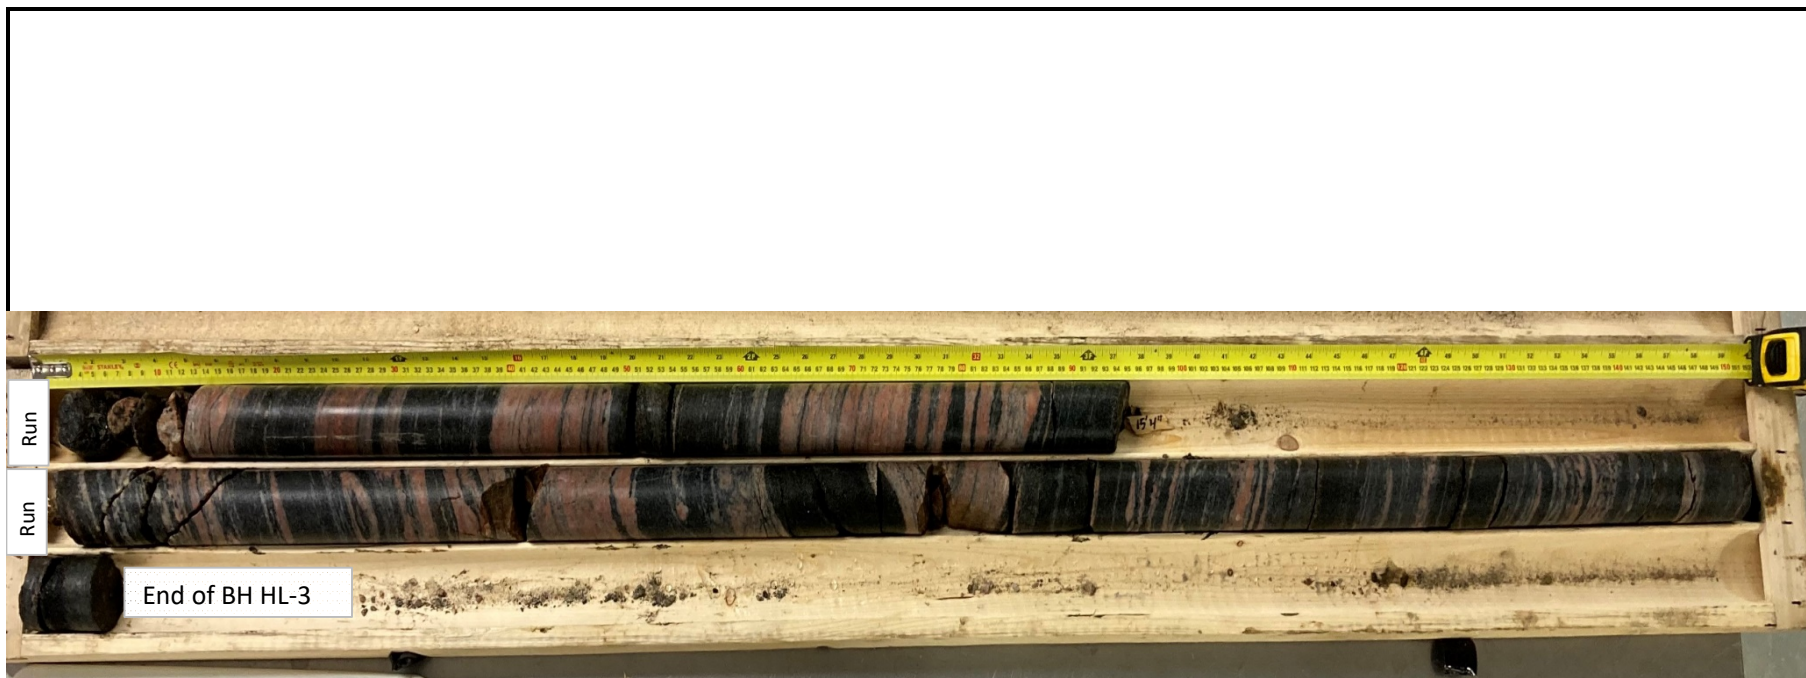
Client: MTO		Title: Core Photograph BH HL-3, RUN #1 to RUN #2	
Project#: 19M-01435-00	Figure #: BH HL-3	Project: Foundation Investigation Rehabilitation of Halls Lake Dam Pedestrian Bridge	
Drawn: TL	Approved:		
Date: April 2022	Scale: N. T. S.		
Size: Letter	Rev: 0	wsp

Run 1: 12'2" ~ 15'4" (3.71m ~ 4.67m)  
Run 2: 15'4" ~ 20'4" (4.67 ~ 6.20m)

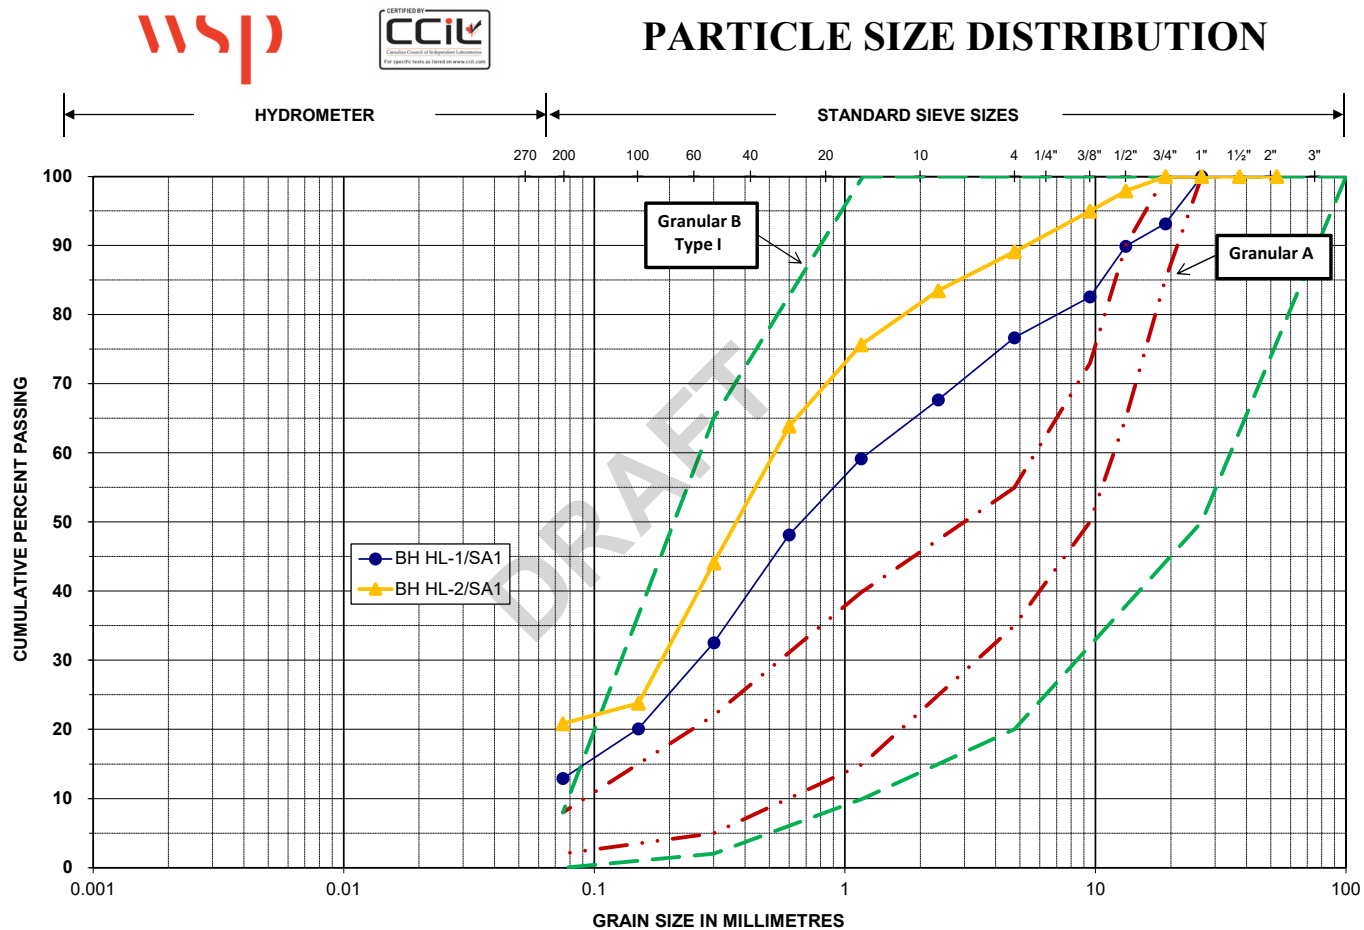
FIGURE C-1 - SAND TO GRAVELLY SAND (FILL)

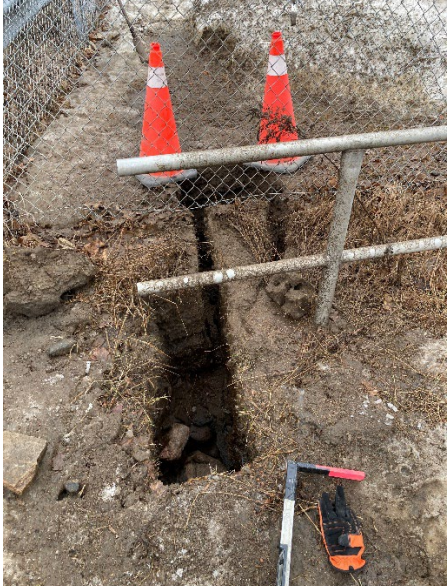
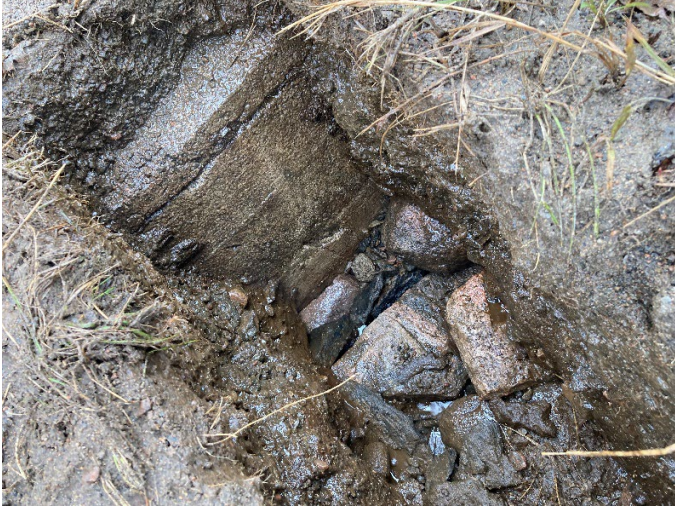
<p><b>Looking West</b></p>

<p><b>Looking Downhole and East</b></p>

**Comments:** Test Pit was extended to locate bridge structural elements. No further progress due to the presence of cobbles and boulders used as backfill around approach. Approximately 0.2 m of sand and gravel fill on surface of slab. Cross sectional sketch was completed showing further details. Elevation surveyed was approximate location.

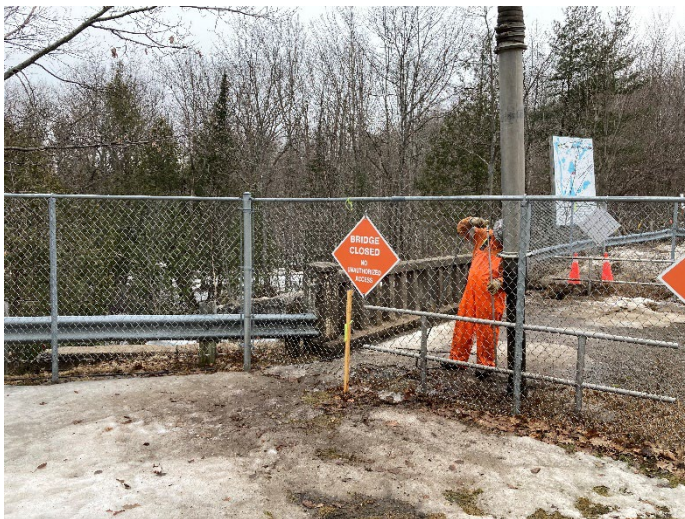
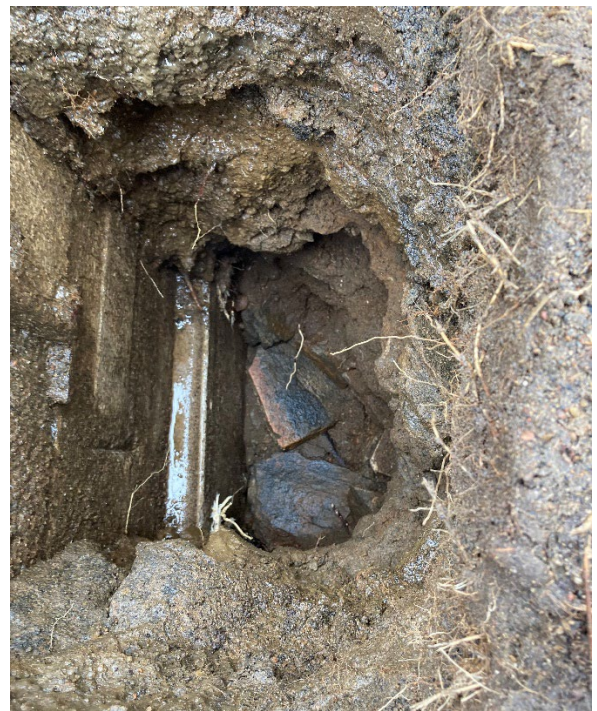
**TP-2 Location Looking South West**

**Looking Downhole at Exposed I-Beam and Rockfill**

**Comments:** No further progress due to the presence of cobbles and boulders used as backfill around approach. Approximately 0.2 m of sand and gravel fill on surface of slab. Cross sectional sketch was completed showing further details. Elevation surveyed was approximate location.

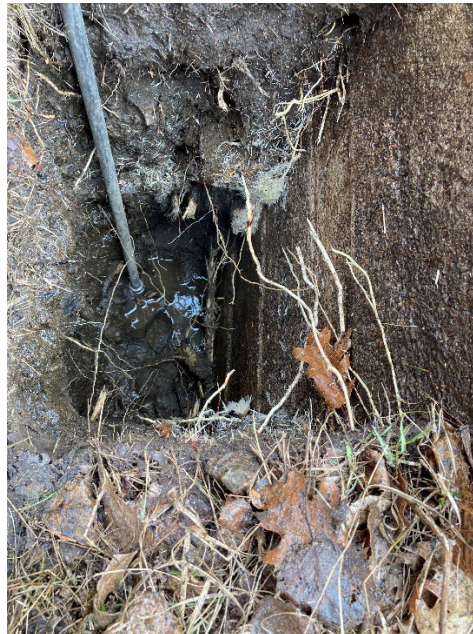
### Looking Downhole Along SE Wingwall

**Comments:** No further progress due to the presence of cobbles and boulders used as backfill around wingwall. Elevation surveyed was approximate location.

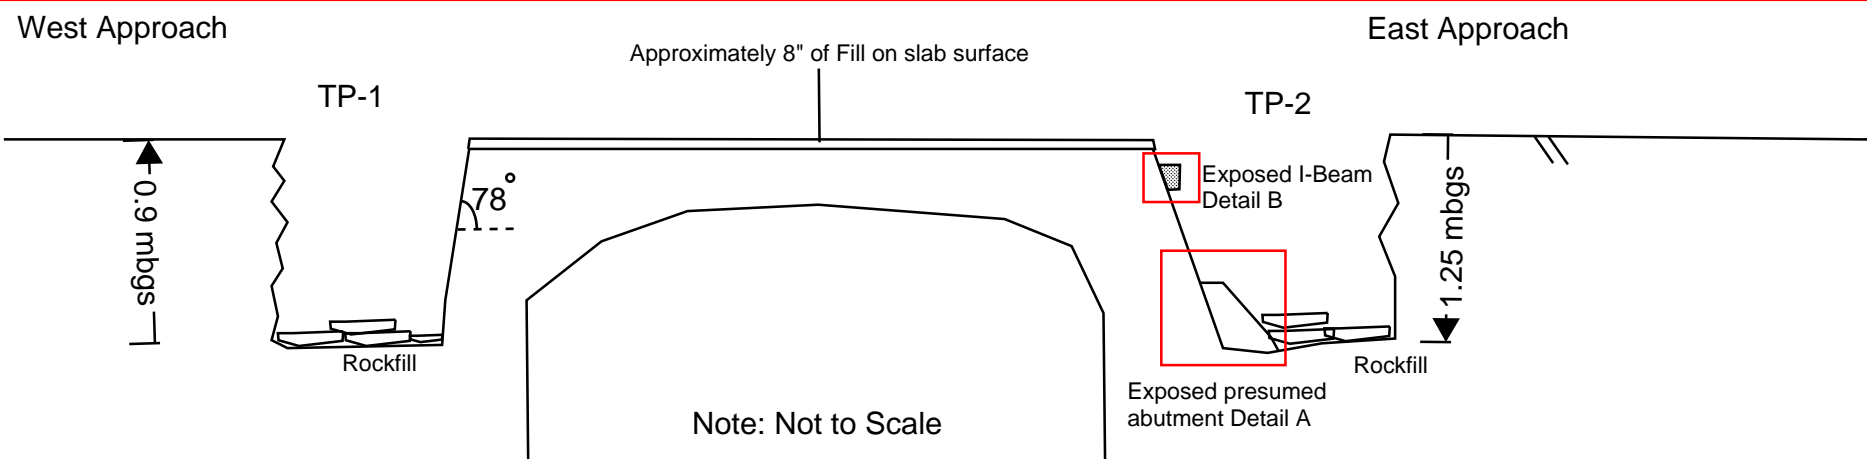
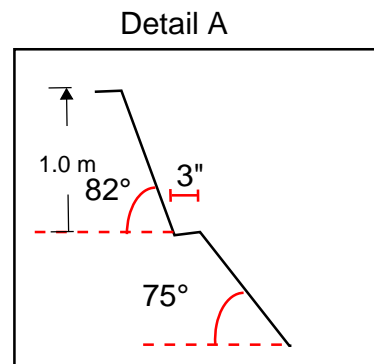
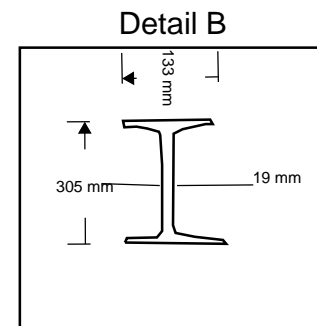
Figure D1 : Sketch of observations at Test Pits TP-1 and TP-2.

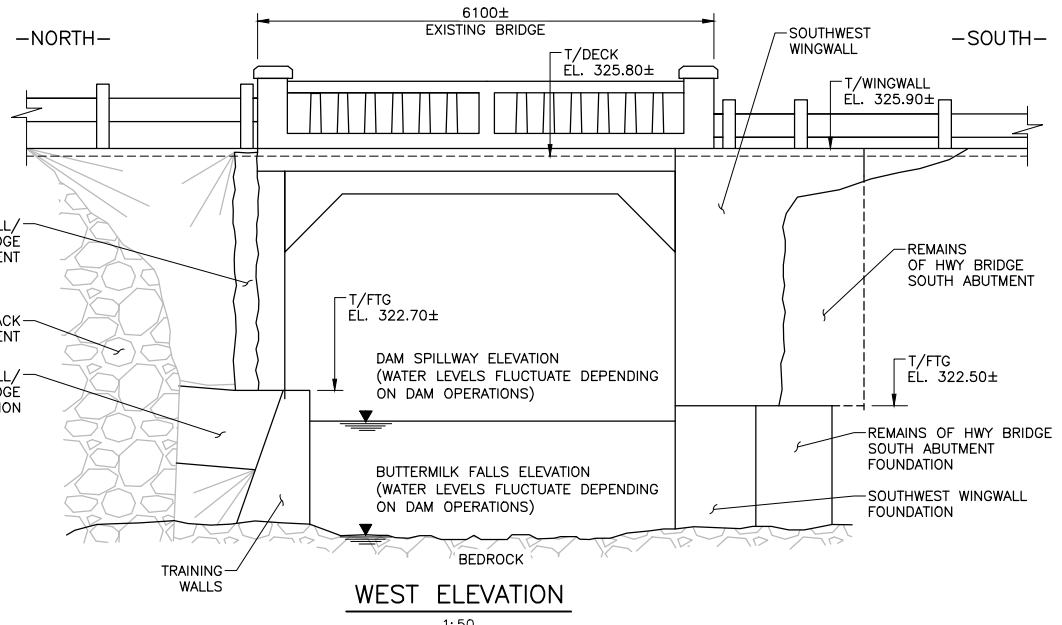
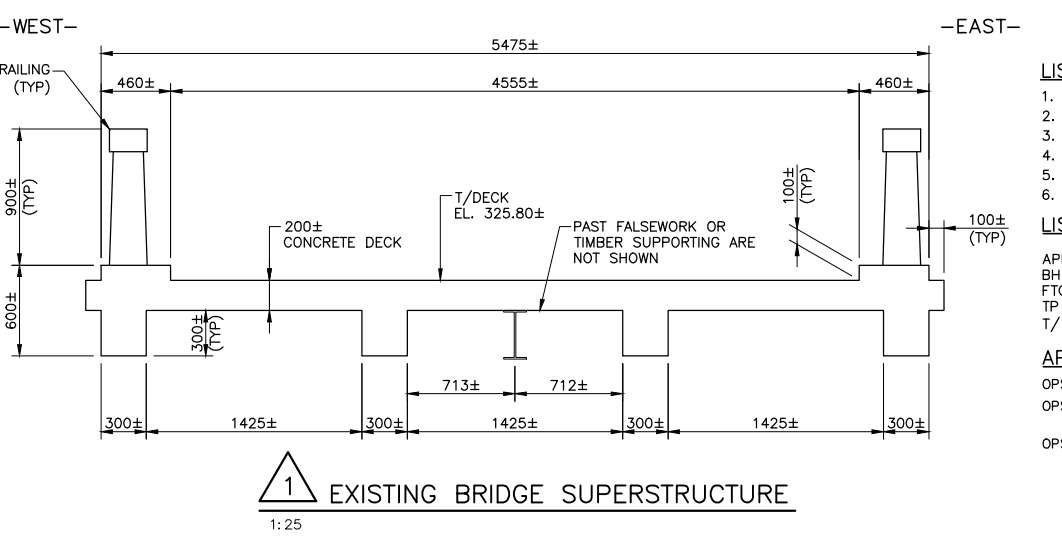
HWY 35 CONT. No. WP No. 5214-19-01	
HALLS LAKE DAM PEDESTRIAN BRIDGE REMOVAL AND ASSOCIATED SITE WORK	SHEET
GENERAL ARRANGEMENT	93
	METRIC

- REFACE/REPAIR TOP HORIZONTAL SURFACE OF REMAINING ABUTMENT WALL FOLLOWING REMOVALS.
- PLACE ROCK FILL AT TOE OF SLOPE AT NORTHWEST.
- PLACE COMPACTED GRANULAR A BASE FOR NEW GABIONS AT ABUTMENT WALLS.
- PLACE GABIONS AT ABUTMENT WALLS.
- PLACE COMPACTED GRANULAR A BASE FOR CONCRETE SLAB BELOW GABIONS.
- INSTALL DOWELS INTO TOP OF SOUTHWEST AND NORTHWEST WINGWALL FOOTINGS.
- INSTALL DOWELS INTO BEDROCK AT NEW SOUTHWEST RETAINING WALL.
- PLACE REINFORCED CONCRETE SLABS FOR GABIONS.
- INSTALL GABION WALLS AT NORTHWEST AND SOUTHWEST.
- BACKFILL GABION WALLS.
- PLACE RIP-RAP ON SLOPE BEHIND NORTHWEST GABION WALL.
- PLACE ROCK PROTECTION AT END OF SOUTHWEST GABION WALL.
- PLACE NEW ASPHALT WHERE REMOVED ON NORTH APPROACH TO BRIDGE.
- RESTORE ALL DISTURBED AREAS WITH TOPSOIL AND HYDROSEED.
- INSTALL NEW CHAIN LING FENCE AND GUIDE RAIL.

The preliminary General Arrangement (GA) Drawing and associated removals / reinstatement drawings (dated June 2023) were provided by the design team and used to develop the following geotechnical recommendations. A copy of the preliminary GA is provided in **Appendix F**. Gabion walls have been identified as the preferred retaining wall type for the reinstatement. Based on the GA Drawing, the existing Halls Lake Dam Bridge is to be removed along with the southwest and northwest retaining walls (footing to remain). The remnants of the previous Highway 35 north and south abutment walls are to be removed. The footing at the previous highway bridge north abutment is to remain and the footing at the south abutment is to be removed.

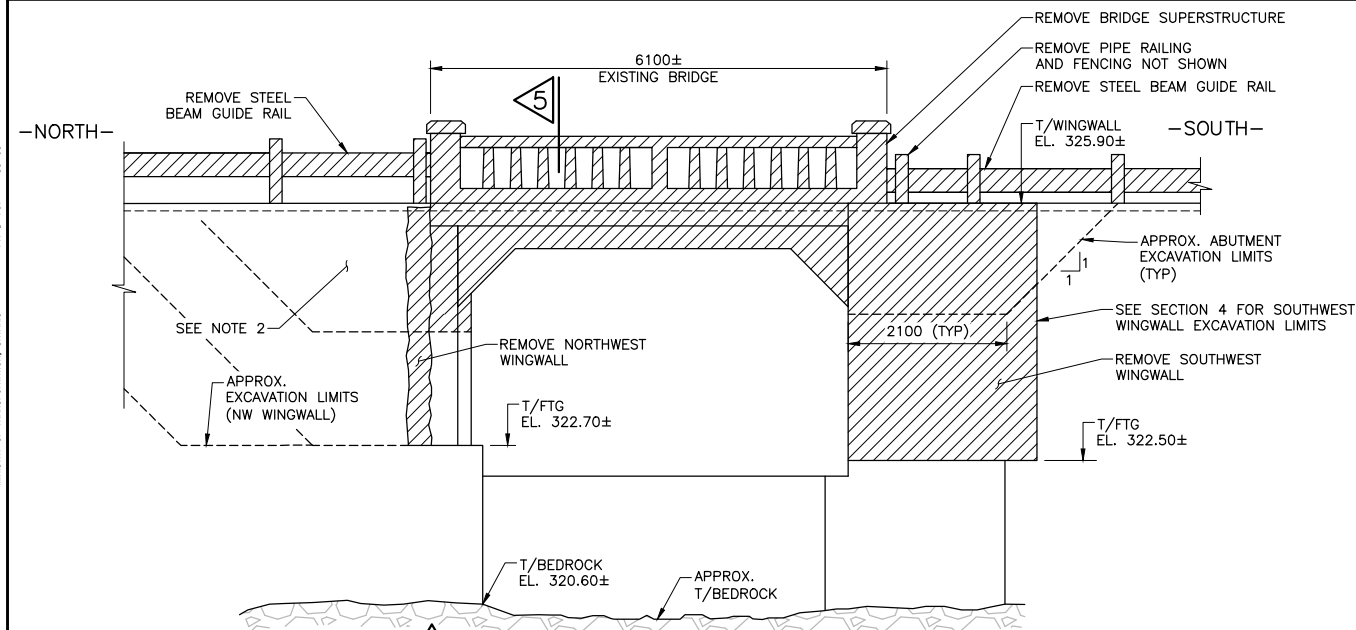
**1** REMOVALS AT PEDESTRIAN BRIDGE  
1:50 (DWG. 2)  
(OLD BRIDGE ABUTMENT AT SOUTHWEST NOT SHOWN FOR CLARITY)

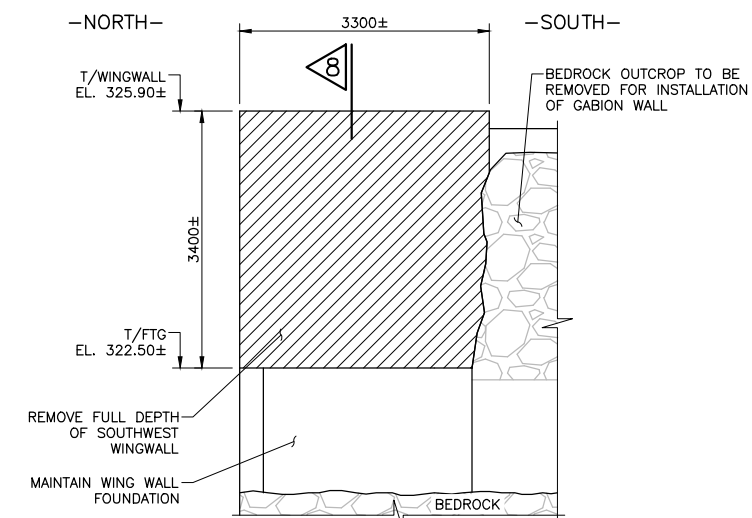
**4** REMOVALS AT SOUTHWEST WINGWALL  
1:50 (DWG. 2)  
(PEDESTRIAN BRIDGE NOT SHOWN FOR CLARITY)

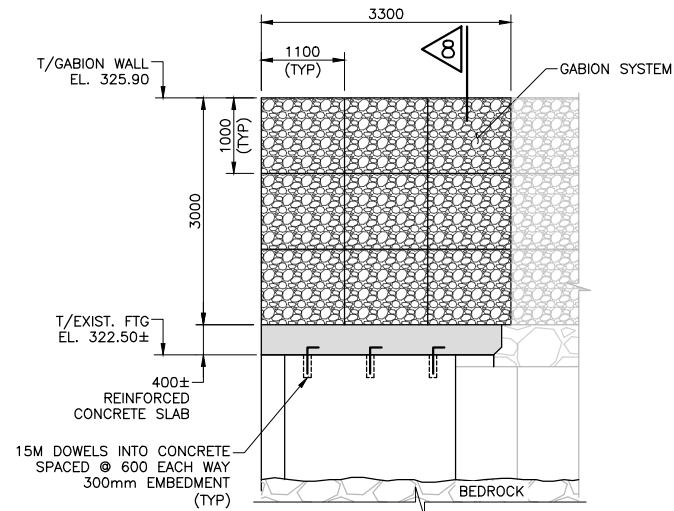
**4** REINSTATEMENT AT SOUTHWEST WING WALL  
1:50 (DWG. 4)

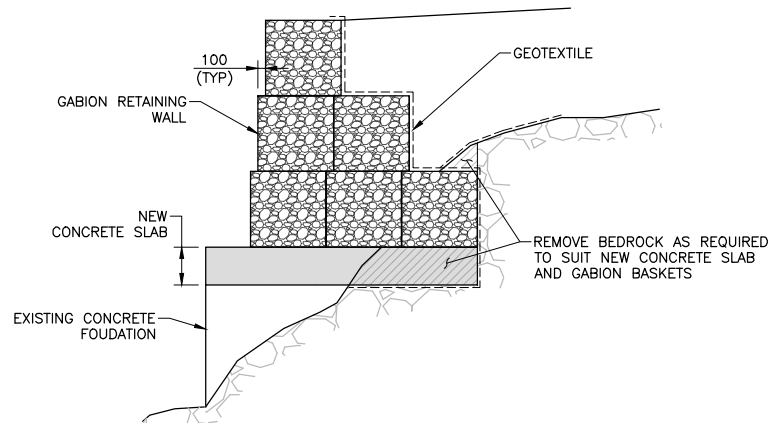
**A** TYPICAL DETAIL  
BEDROCK INTERFERE WITH GABION WALL  
1:50

will need to be checked by visual inspection to confirm bedrock surface is competent to support the new gabion wall / spillway system. Consideration could be given to leaving the existing foundation in place (particularly any tie-backs which are assumed to be present in this area based on design drawings) in some areas to reduce disturbance to the bedrock within the new gabion wall foundation zone of influence.
