MERLEX ENGINEERING LTD.

FINAL
FOUNDATION INVESTIGATION AND DESIGN REPORT
ROADWAY PROTECTION AT KENOGAMI LAKE BRIDGE
STATIONS 10+104 TO 10+132– TWP. of Grenfell
GWP 162-98-00 – Site No. 47-009
MEL Site E

MEL Ref. No.: 09/10/09181E

January 14, 2011

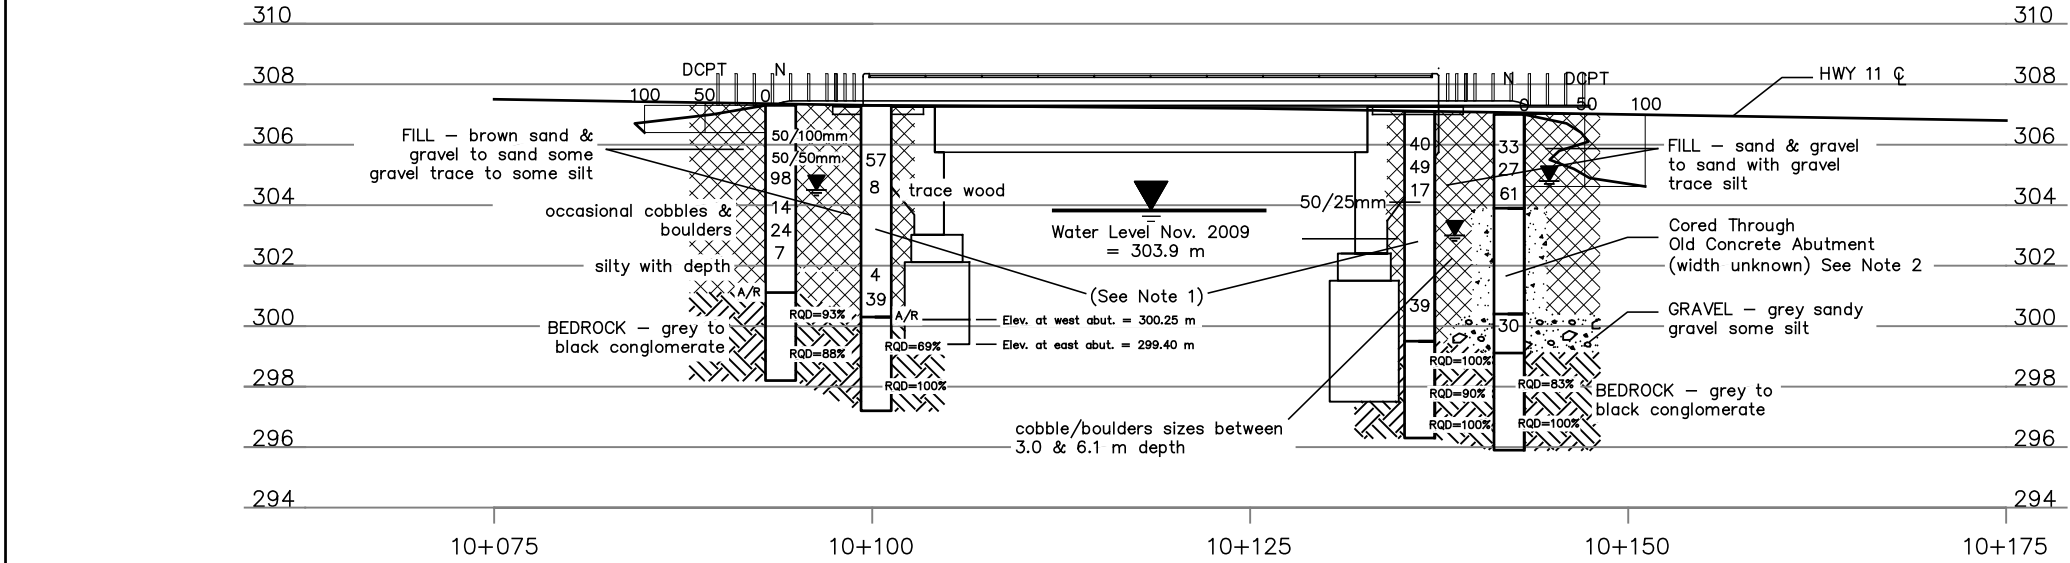
Figure No. E-1: Borehole Locations & Soil Strata

SUBSURFACE PROFILE A - A

Note :
1. Ran NQ Core through nest of cobbles and boulder sizes/rock fill in granular matrix. (See Record of Boreholes)
2. Ran NQ Core through old concrete abutment from elevation 303.9 to 300.4 m (width unknown)

Details of the subsurface conditions revealed by the investigation program are presented on the enclosed Record of Borehole Logs (Appendix B) and on Figure No. E-1 (Appendix C). Please note that stratigraphic delineation presented on the borehole logs and soil strata plot are the results of non-continuous sampling, response to drilling progress, the results of SPT and Dynamic Cone Penetration Test (DCPT), plus field observations. Typically such boundaries represent transitions from one zone to another and are generally not an exact demarcation of specific geological unit. Additional consideration should be given to the fact that subsurface conditions may vary markedly between adjacent boreholes and beyond any specific boring location, and are shown on the drawings as a conceptual model for design purposes only. At the time of the subsurface investigation, the ground surface elevations at Boreholes Nos. 1 to 4 were recorded at 307.3, 307.3, 307.1, and 307.0 m respectively.

A plan and profile showing the borehole locations and stratigraphic sequences is shown on Figure No. E-1, Appendix C. During the course of the exploration program, four (4) sampled boreholes were put down at this site, with Borehole Nos. 1 and 2 advanced at the south end of the existing bridge, to the right of the centerline, while Borehole Nos. 3 and 4 were advanced at north end of the bridge, to the left of the centerline.

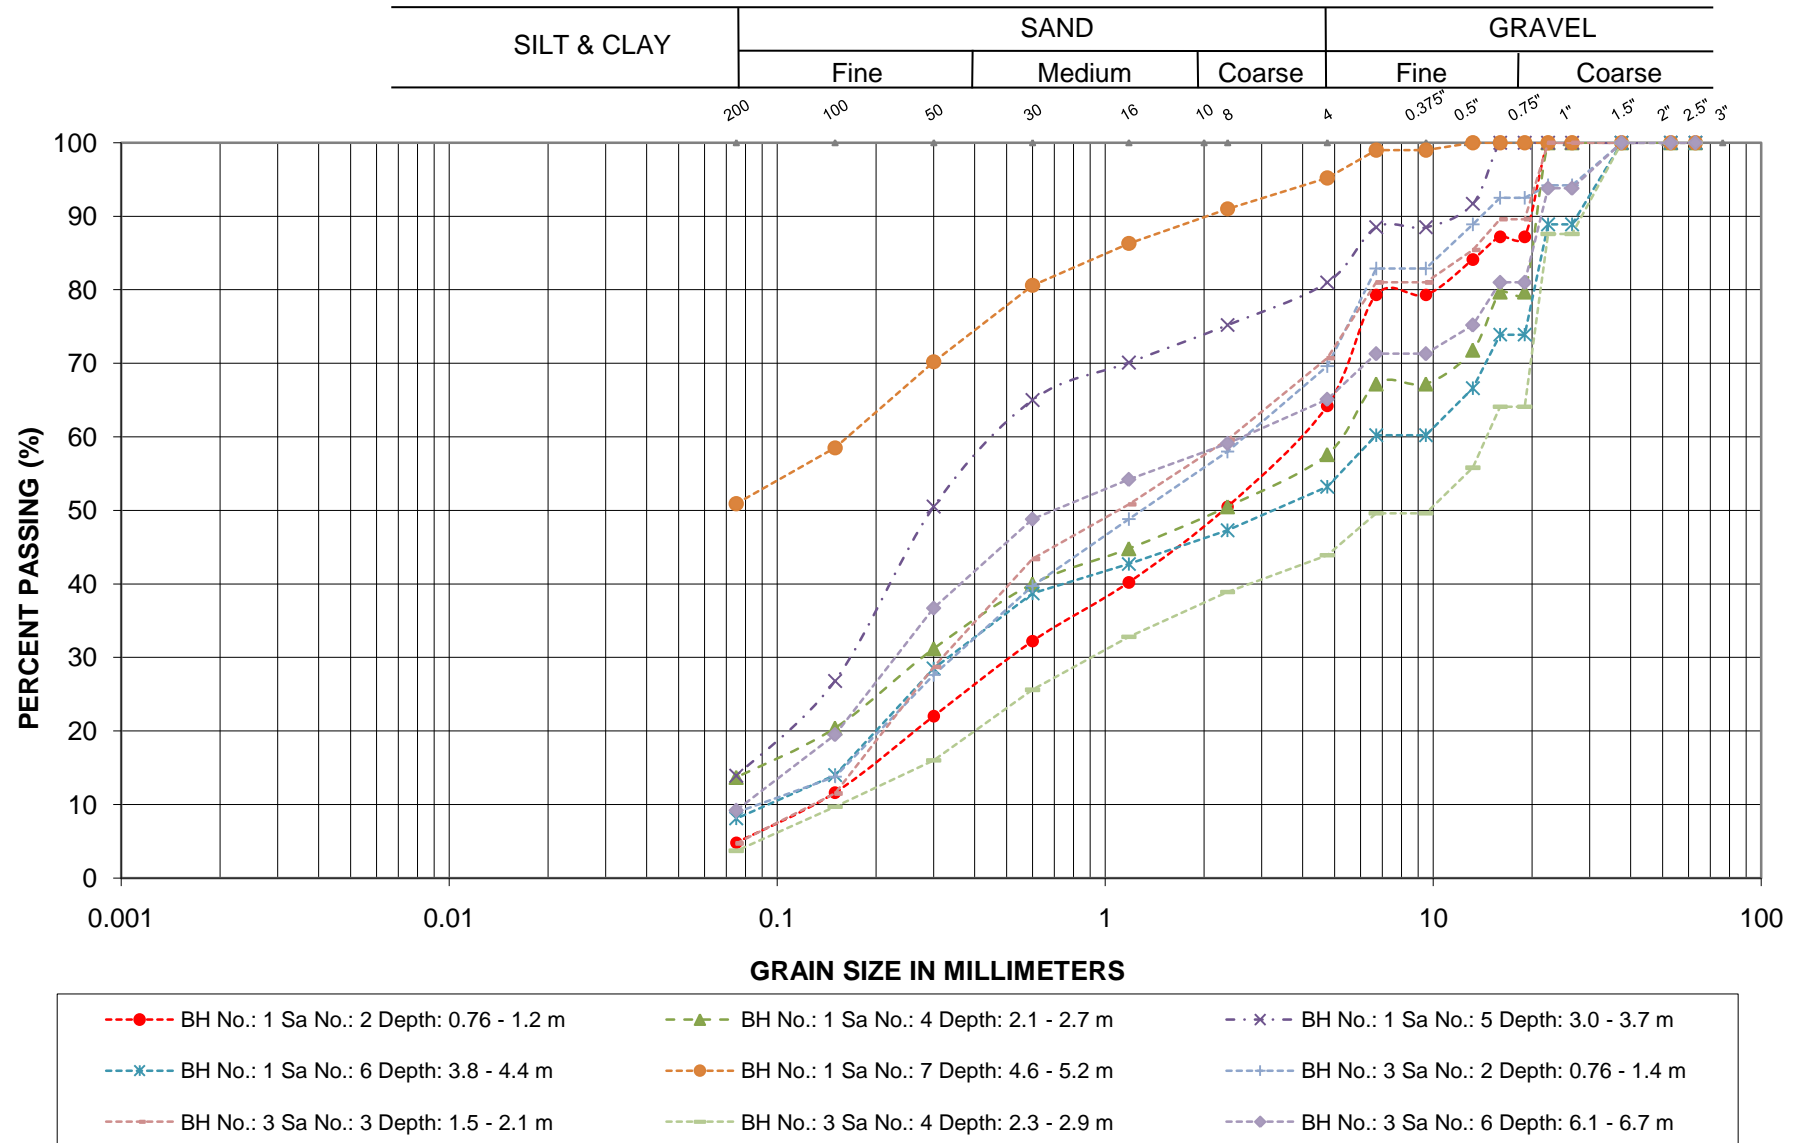
GRAIN SIZE ANALYSIS

PROJECT: G.W.P. 162-98-00 FILL - Gravel and Sand to Gravelly Sand Trace to Some Silt, to Sandy Silt Trace Gravel
LOCATION: Hwy 11 MEL Kenogami Lake Bridge

boreholes, labeling and preparation of samples for transport to our North Bay laboratory, plus overall drill supervision. All samples received a visual confirmatory inspection in our laboratory. Laboratory testing of select samples included routine testing for natural moisture content determination and particle size analysis. The results of the laboratory testing are presented on the individual Record of Borehole Sheets (Appendix B), with a summary of results presented on the laboratory sheets in Figures Nos. L-1 to L-3, Appendix C.

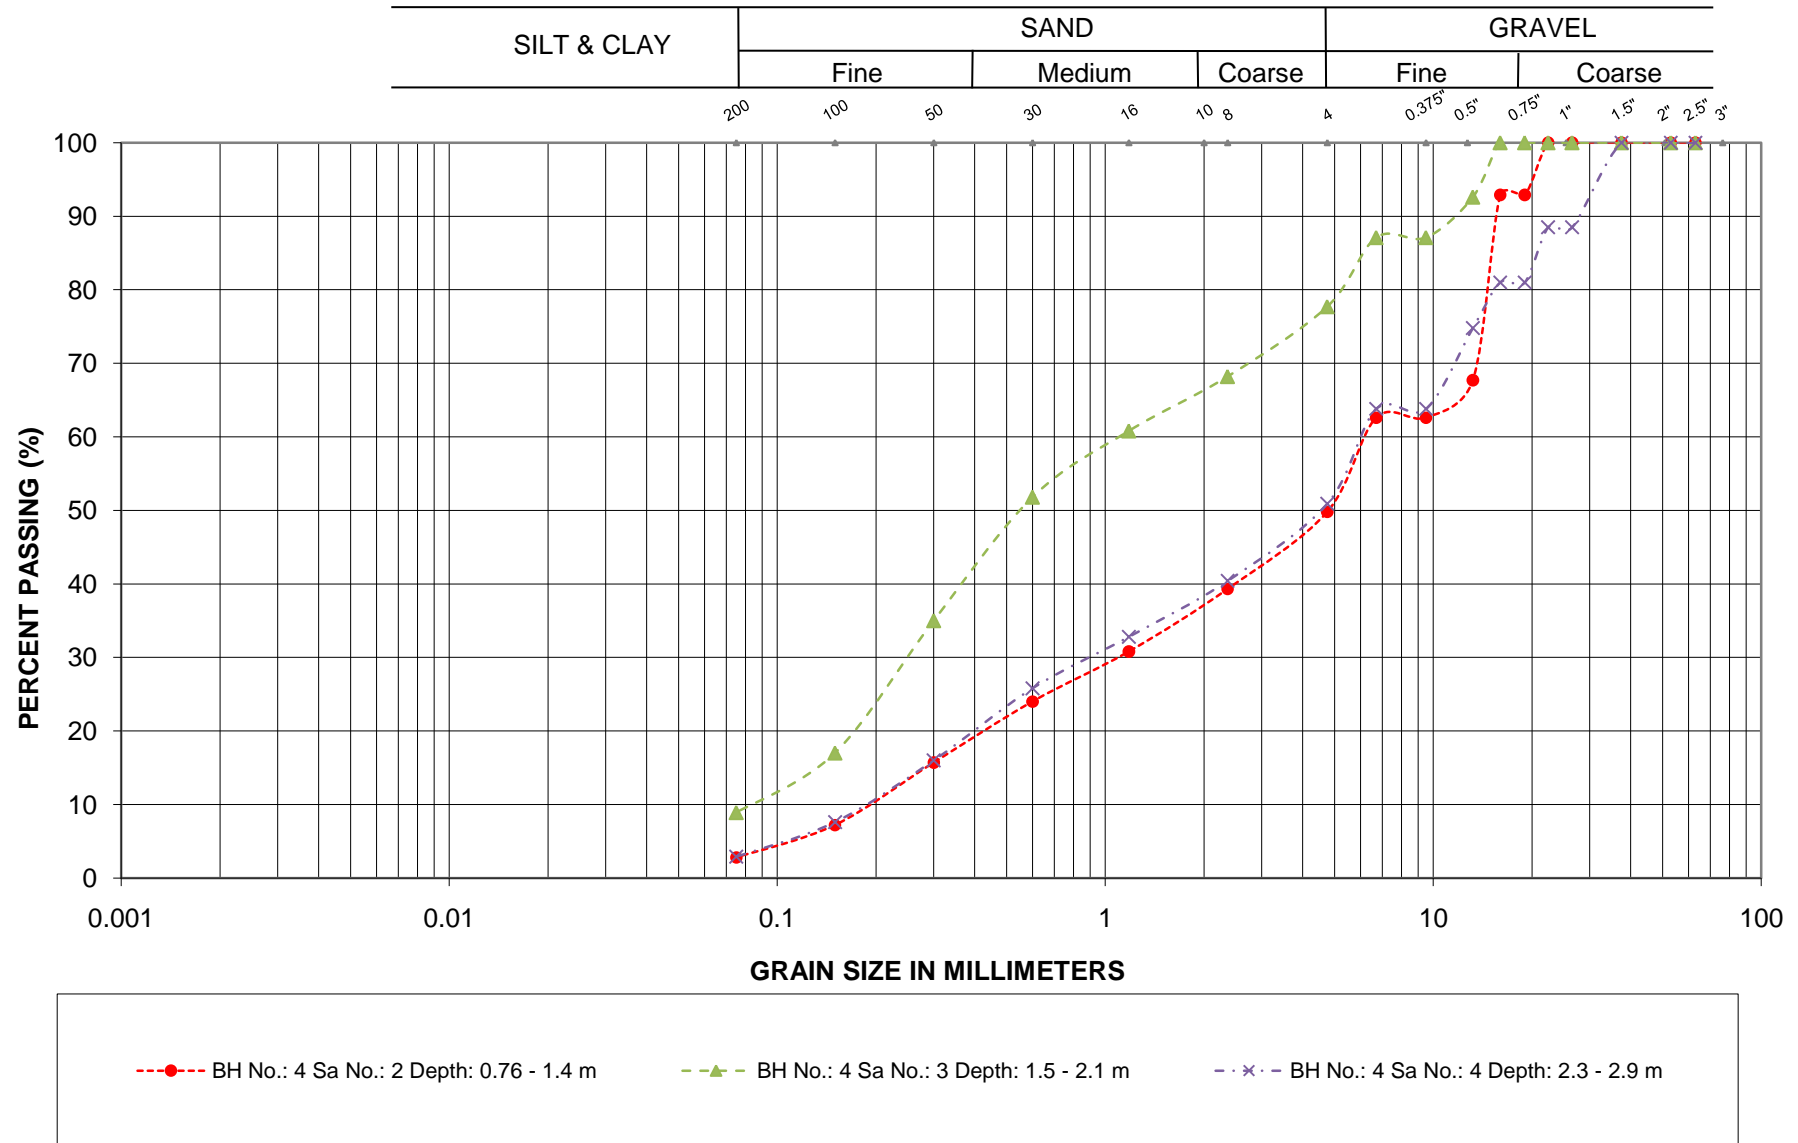
GRAIN SIZE ANALYSIS

FILL - Gravel and Sand to Sand With Gravel, Trace Silt

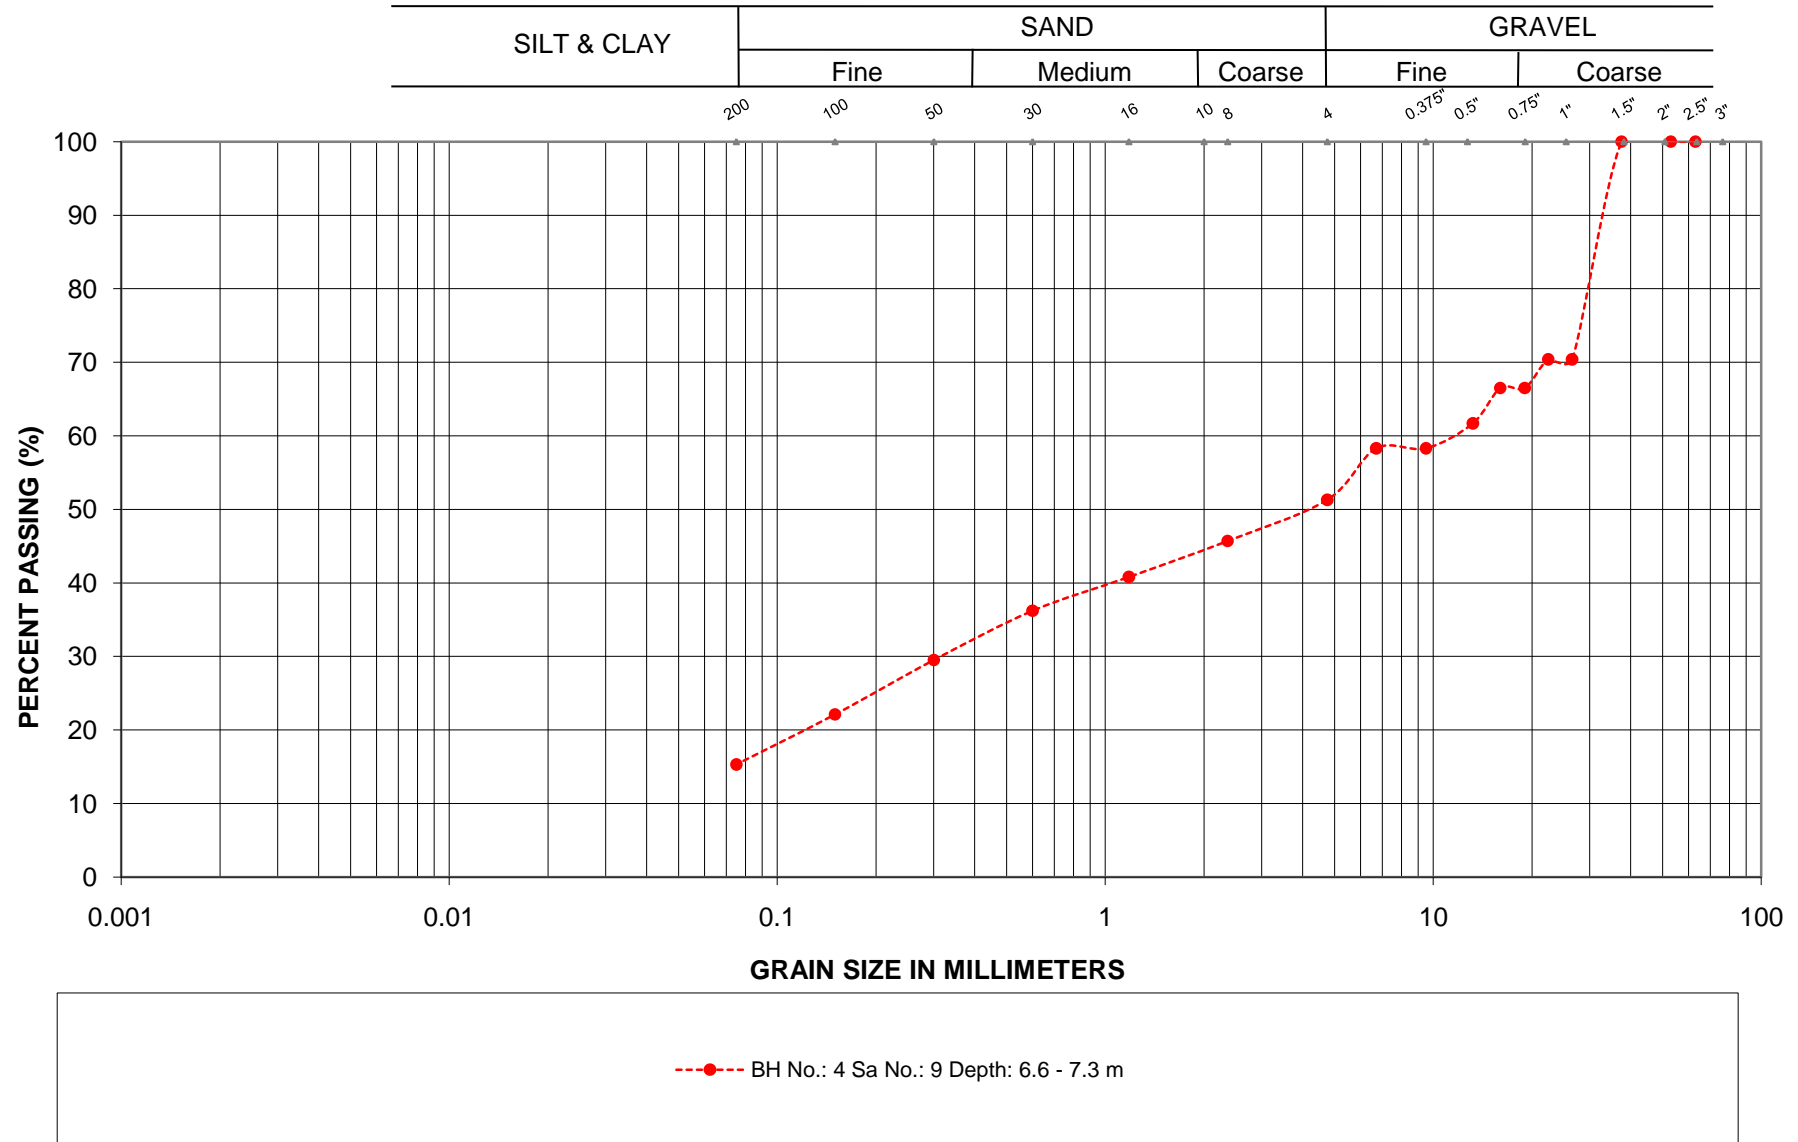
GRAIN SIZE ANALYSIS

GRAVEL - Sandy Gravel, Some Silt
MERLEX ENGINEERING LTD.

Underlying the concrete at Borehole No. 4, a 1.3 m thick deposit of grey sandy gravel some silt was penetrated. The natural moisture content from a sample of this deposit was in the order of 11%. A gradation analysis was carried out on one sample of this deposit, the results of which indicated 51% gravel size particles, 34% sand size particles, and 15% silt and clay size particles (see Figure No. L-3, Appendix C). Based on the STP value of 30 blows per 300 mm penetration, the compactness of this deposit was described as dense. Auger refusal was encountered in this deposit at a depth of 7.9 m below ground surface (elevation 299.1 m).
