**Highway 65 Rehabilitation
Culvert Replacement
Station 12+548 - Twp. of Dymond
GWP 5574-04-00**

FINAL FOUNDATION INVESTIGATION AND DESIGN REPORT

Date: November 21, 2013
Ref. N^o: 12/03/12028-F2

Geocres No. 31M-103

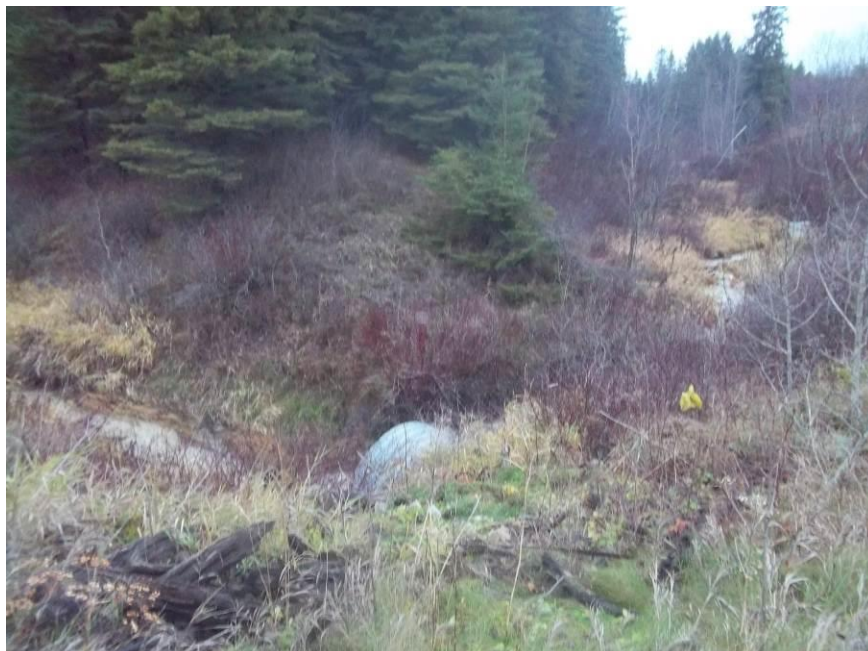
Photo: 2

Culvert Inlet – Looking East

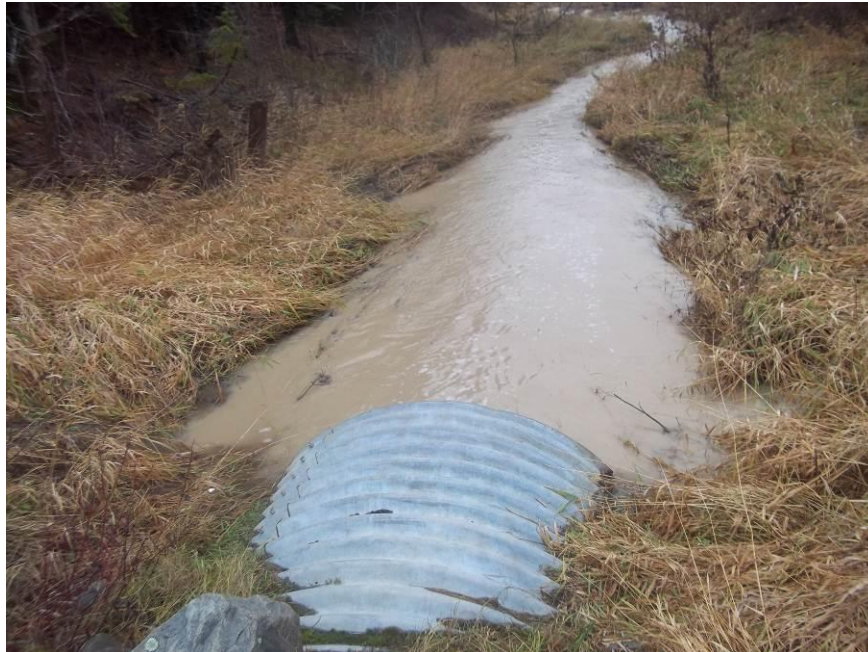
Photo: 3

Culvert Outlet – Looking South

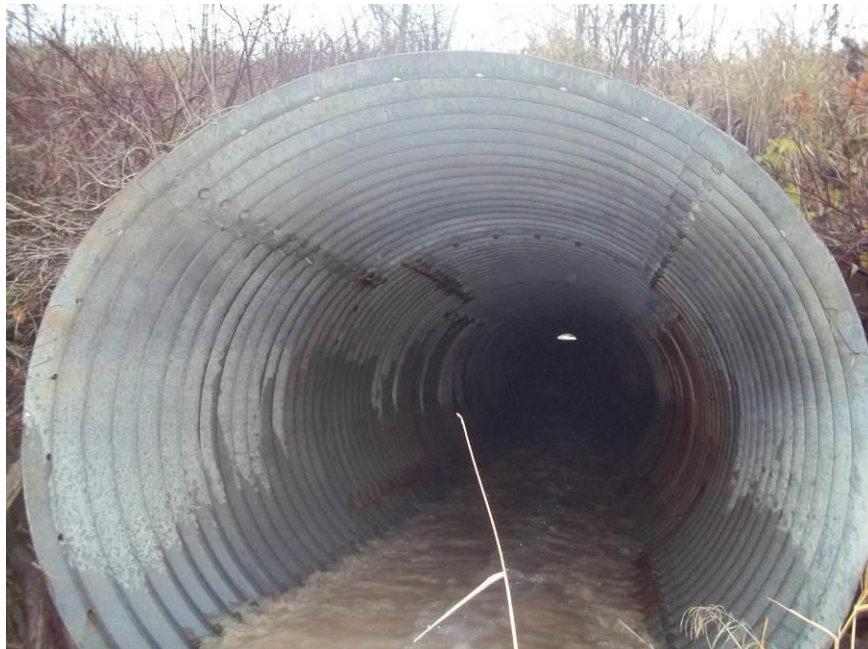
Photo: 4

View Through Culvert – Looking South
