**Bridge Rehabilitation
Highway 11
Oro Line 3 UP (Simcoe Road 57)
Site No 30-469
GWP 2087-15-00**

FINAL FOUNDATION INVESTIGATION REPORT

Date: February 20, 2018
Ref. Nº: P-0014012-0-00-100-01-F1

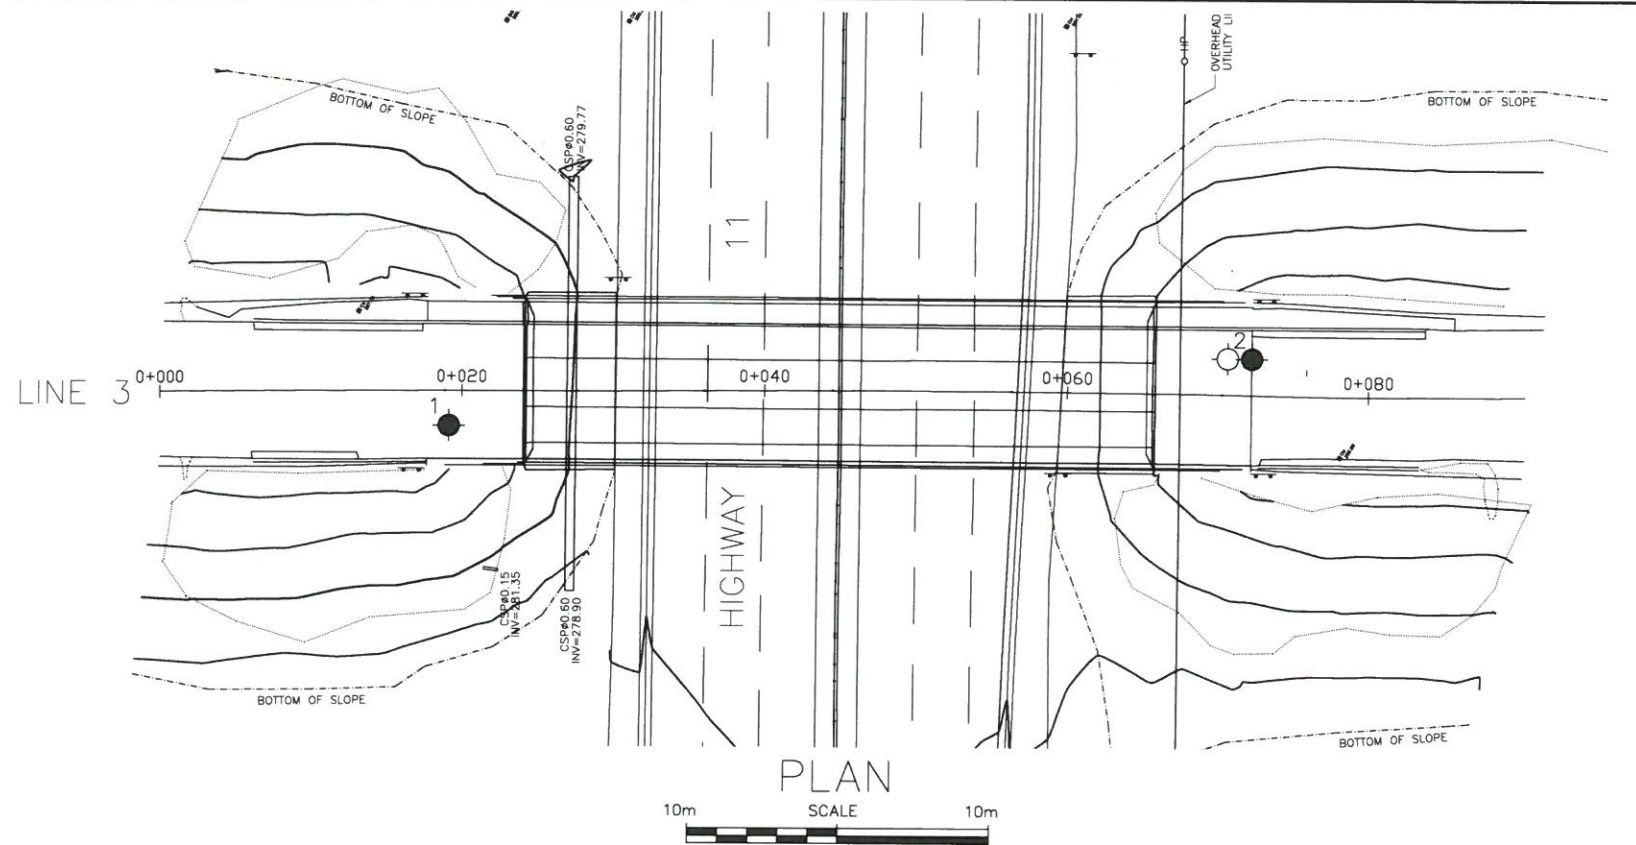
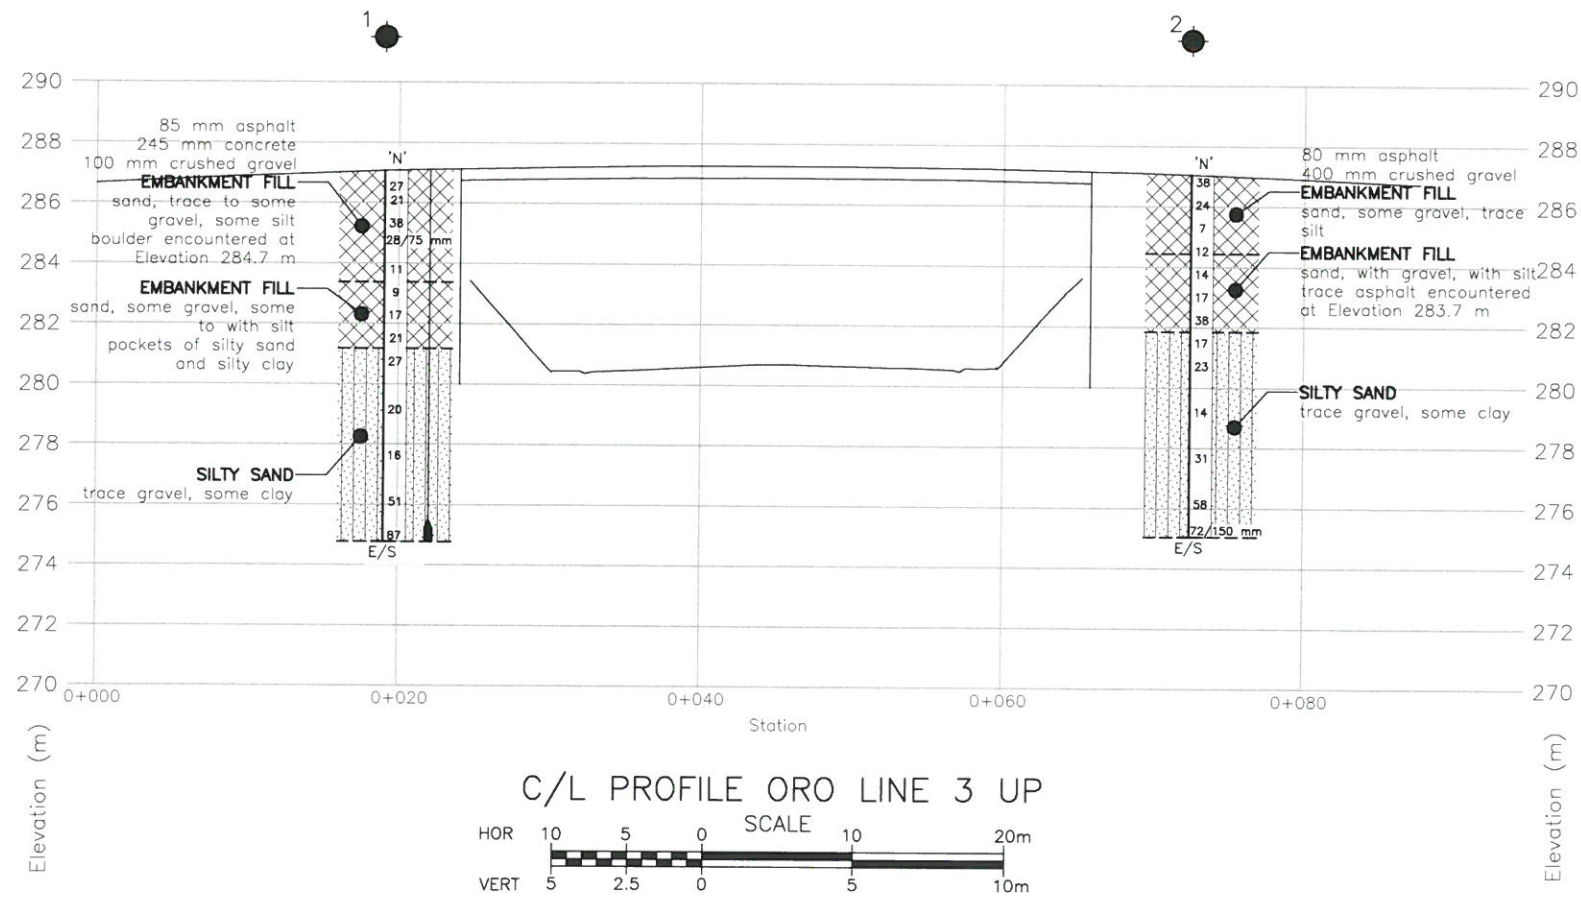
HWY 11
ORO LINE 3 UP (SIMCOE ROAD 57)
SITE NO. 30-469
BOREHOLE LOCATIONS
AND SOIL STRATIGRAPHY

Details of the subsurface conditions revealed by the investigation program are presented on the enclosed Records of Borehole Logs (Enclosure Nos. 2 and 3, Appendix 2) and on Drawing No. 2 (Appendix 3). Please note that stratigraphic delineation presented on the borehole logs and soil strata

A plan and profile illustrating the borehole locations and stratigraphic sequences is shown on Drawing No. 2, Appendix 3. During the course of the exploration program, two (2) sampled boreholes were put down at this site, with Borehole No. 1 advanced through the north approach of the bridge and Borehole No. 2 advanced to the south approach of the bridge. At the time of the subsurface investigation, the ground surface elevations at Boreholes Nos. 1 and 2 were recorded at Elevations 287.1 m.

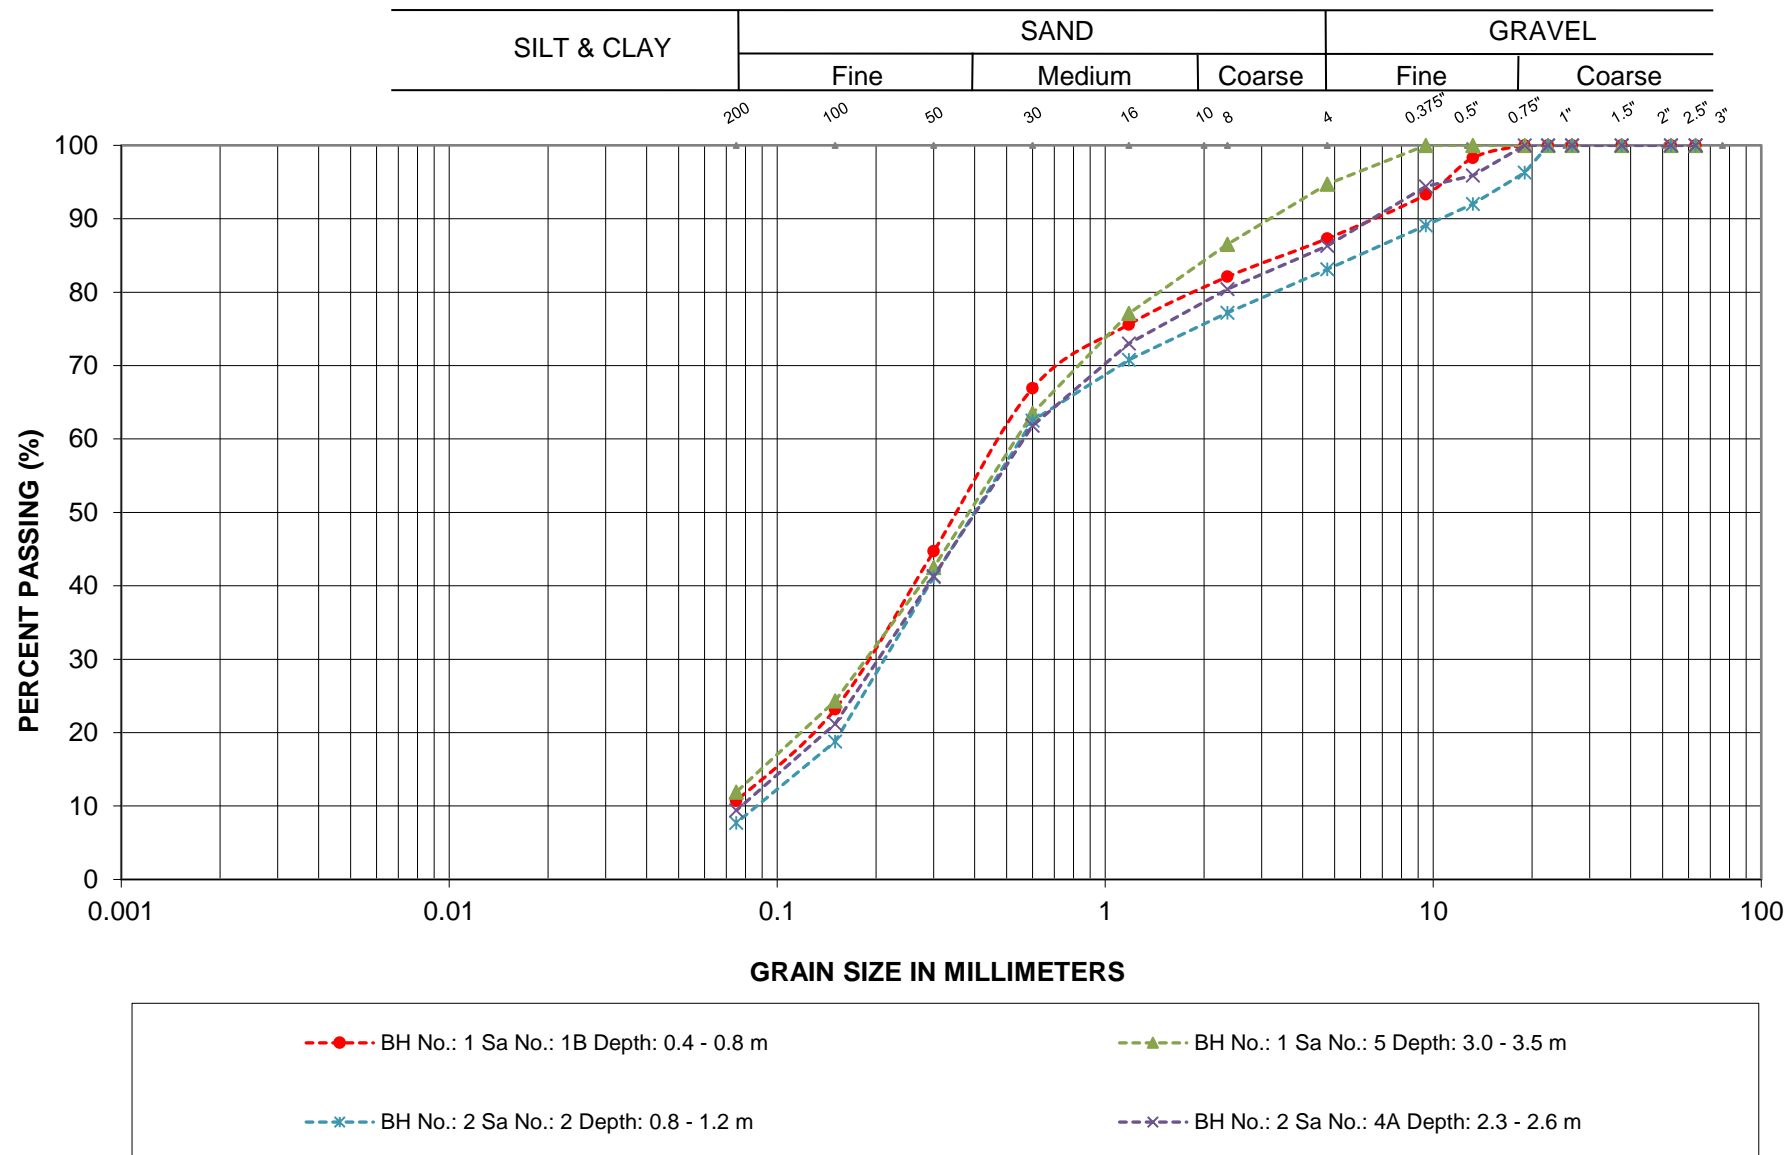
FIGURE L-1

EMBANKMENT FILL, sand

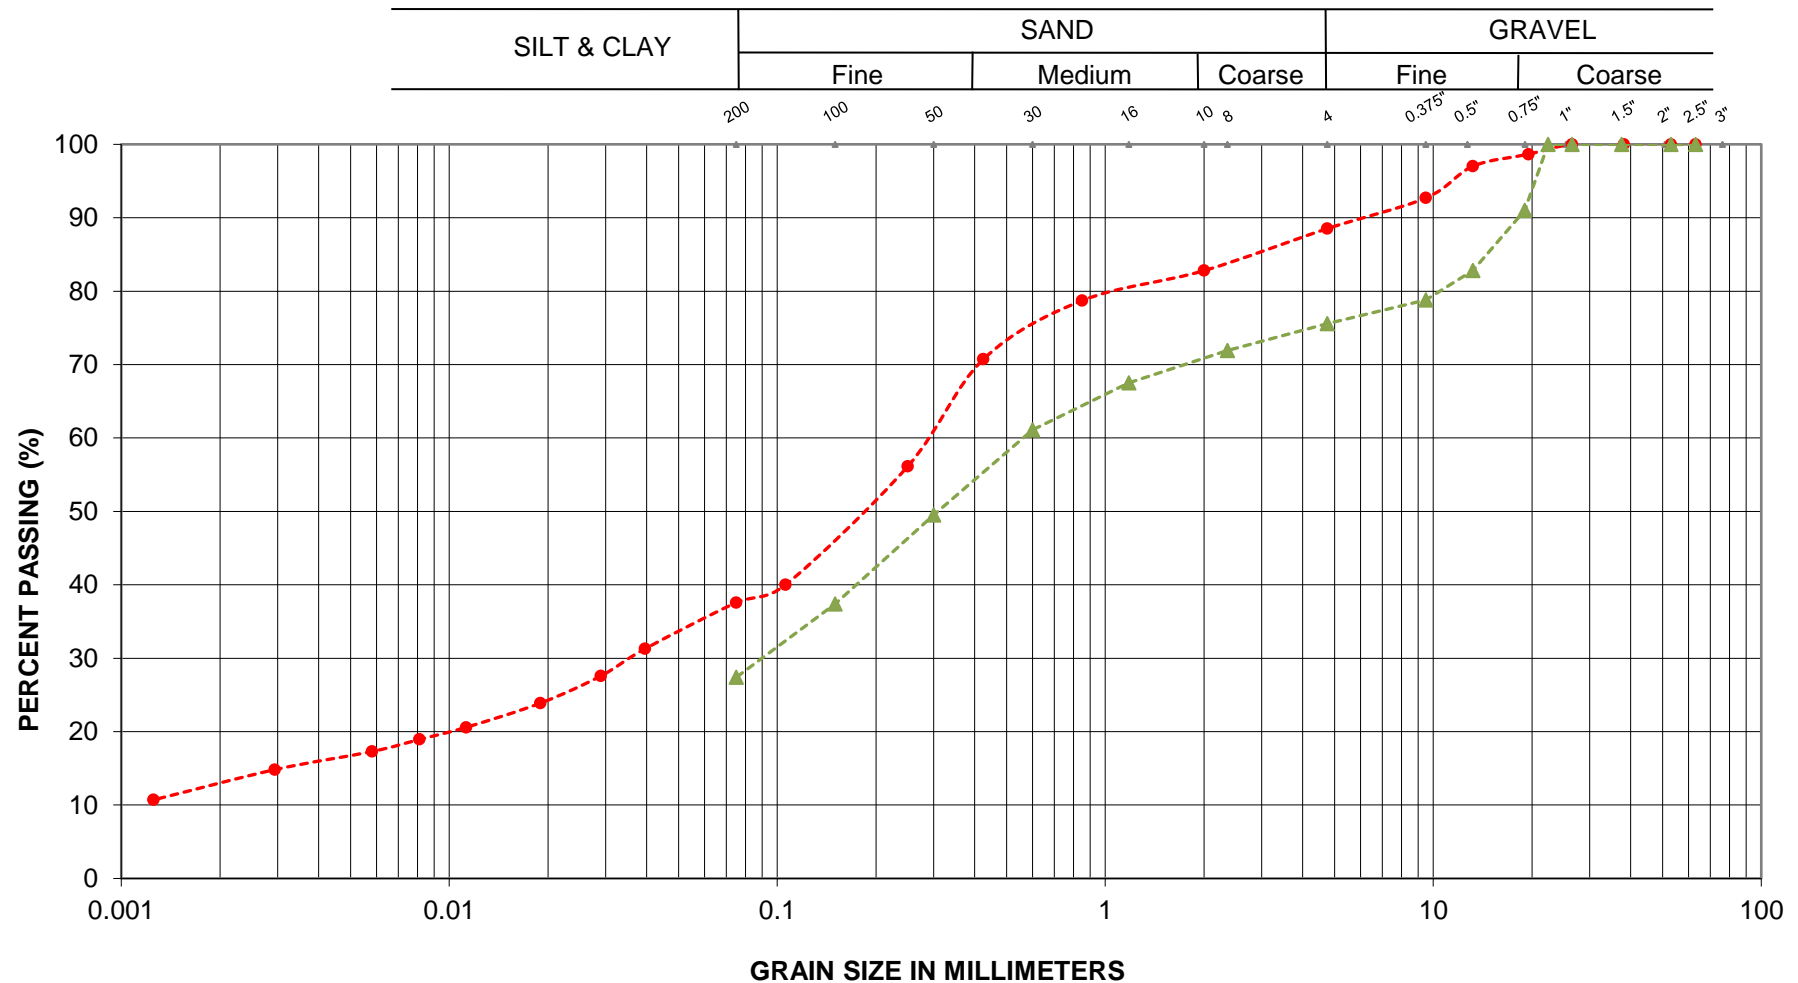
FIGURE L-2

EMBANKMENT FILL, sand with silt

testing results indicated 24% gravel size particles, 49% sand size particles, and 27% silt and clay size particles (Figure No. L-2, Appendix 3). Additional gradation (hydrometer) analysis was carried out on one (1) sample of this fill layer and the testing results indicated 11% gravel size particles, 51% sand size particles, 25% silt size particles and 13% clay size particles (Figure No. L-2, Appendix 3). Based on SPT 'N' values of 9 to 38 blows per 300 mm penetration, the compactness of this layer was described as loose to dense, generally compact on average. This fill layer of sand with silt was encountered to depths of 5.9 and 5.2 m below grade at Borehole Nos. 1 and 2, respectively (Elevation 281.2 and 281.9 m, respectively).

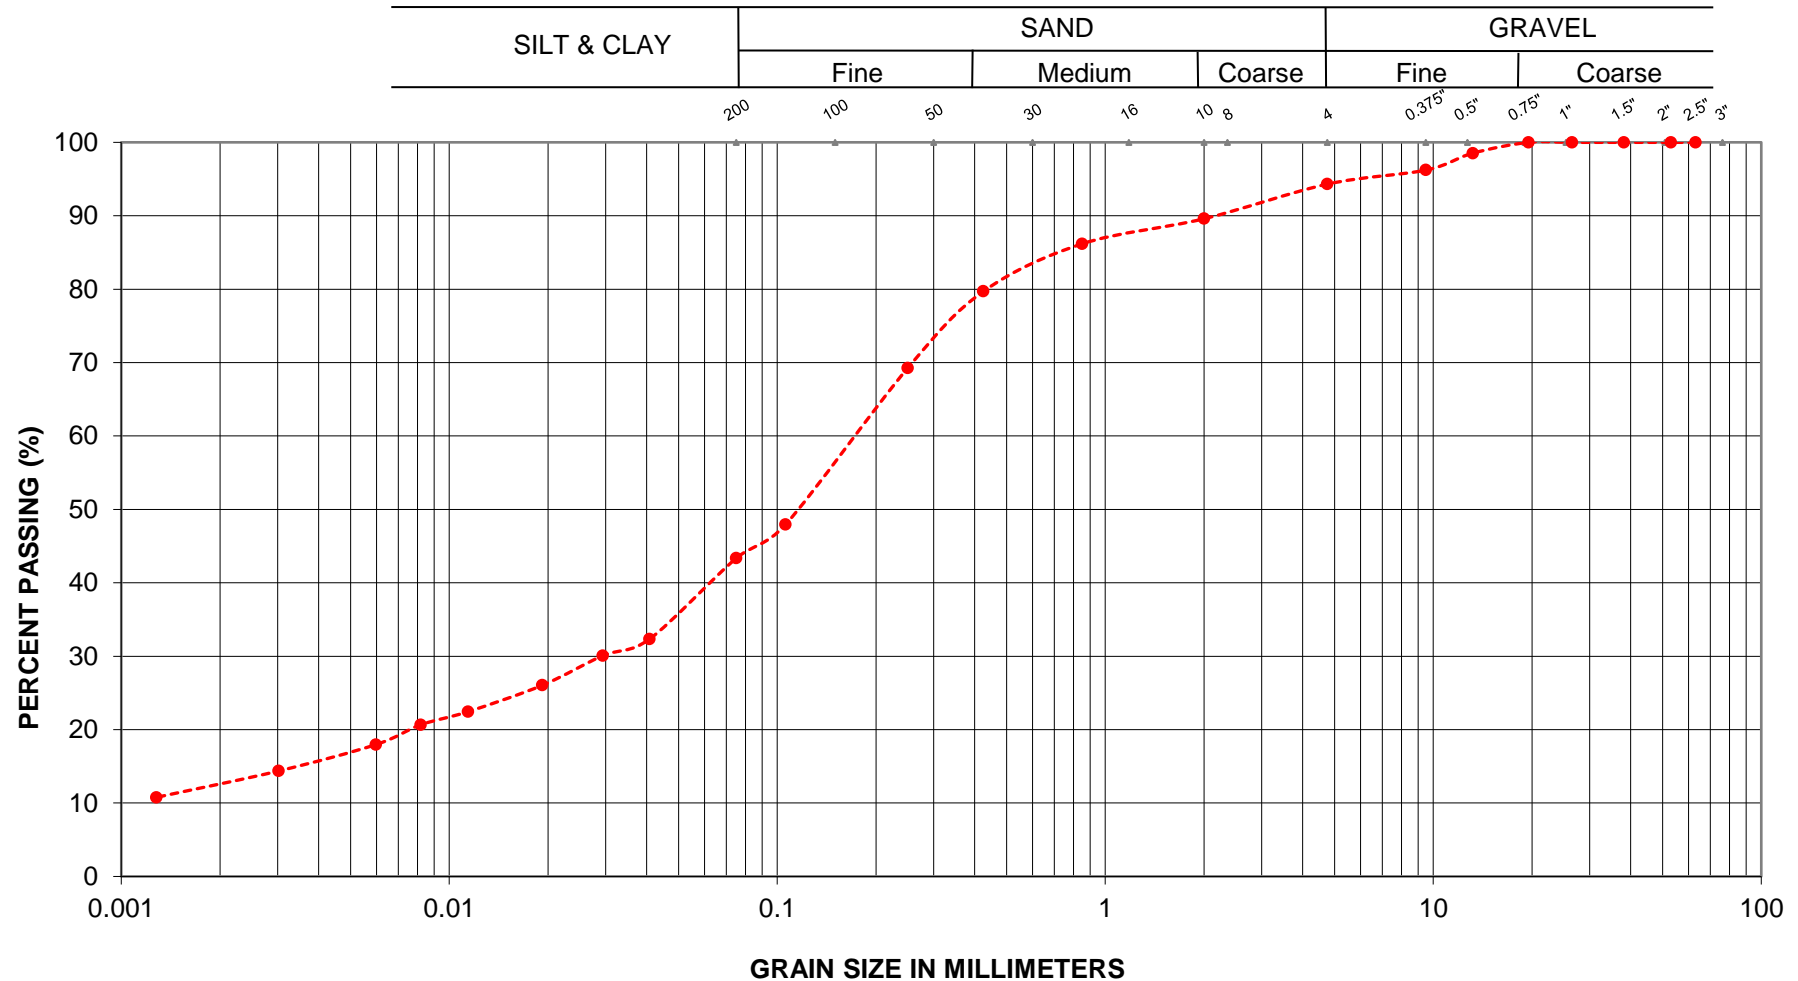
FIGURE L-3

---●--- BH No.: 2 Sa No.: 10 Depth: 7.6 - 8.1 m

SILTY SAND

Underlying the embankment fill at Borehole Nos. 1 and 2, a deposit of silty sand, trace gravel, some clay was encountered. The natural moisture content measured on samples of this deposit was in the order of 3 to 13%. A gradation (hydrometer) analysis was carried out on one (1) sample of this layer and the testing results indicated 6% gravel size particles, 51% sand size particles, 31% silt size particles and 12% clay size particles (Figure No. L-3, Appendix 3). Based on SPT 'N' values of 14 to 87 blows per 300 mm penetration, compactness of this deposit was described as compact to very dense. Sampling was terminated in this deposit at depths of 12.3 and 12.0 m below grade at Borehole Nos. 1 and 2, respectively (Elevations 274.8 and 275.1 m, respectively).

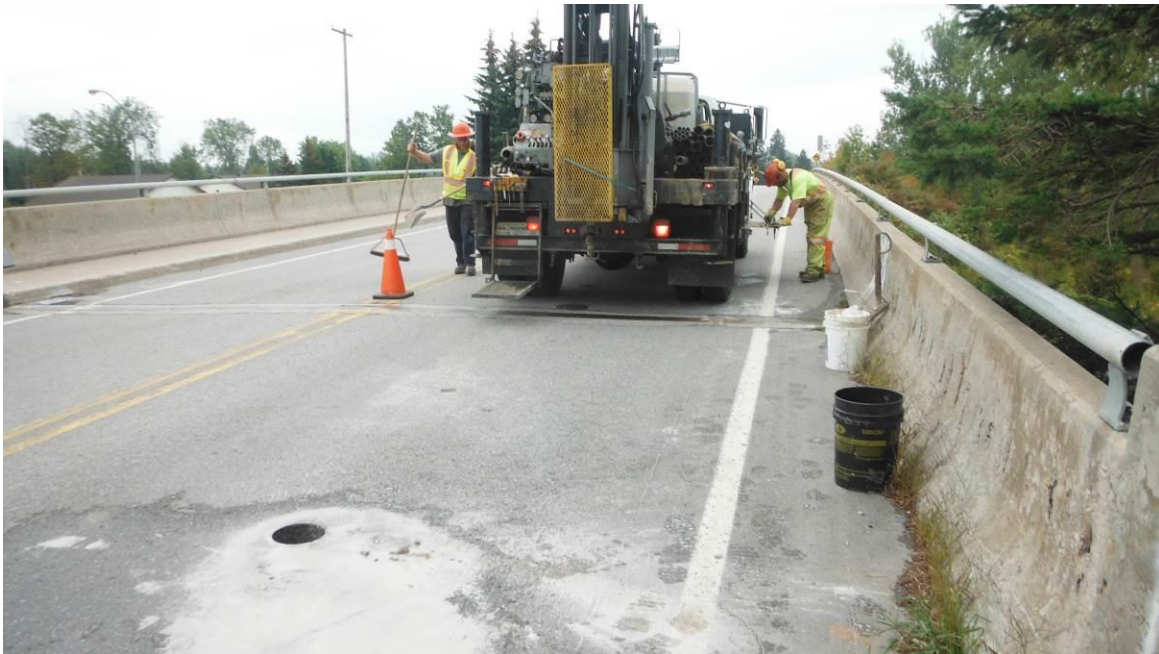
Photo: 1

Existing Bridge, North Approach – Looking South

The existing bridge underpass is located approximately between Stations 0+024 and 0+066 on Oro Line 3 and crosses over Highway 11 in the Township of Oro-Medonte (Site No. 30-469). The existing Oro Line 3 Underpass embankment currently supports two undivided lanes, locally running in a north-south direction. A visual review of the roadway to the north and south of the bridge approaches indicates that, in general, the approaches are in fair to good condition (see Photo Essay in Appendix 4).
