**FOUNDATION INVESTIGATION REPORT
OVERHEAD SIGN SUPPORT STRUCTURES
HIGHWAY 406 TWINNING
PORT ROBINSION ROAD TO EAST MAIN STREET
AGREEMENT No. 2008-E-0016, W.P. 280-99-00
GEOCRES No: 30M3-268**

File No. 1-09-4135
January 25, 2011

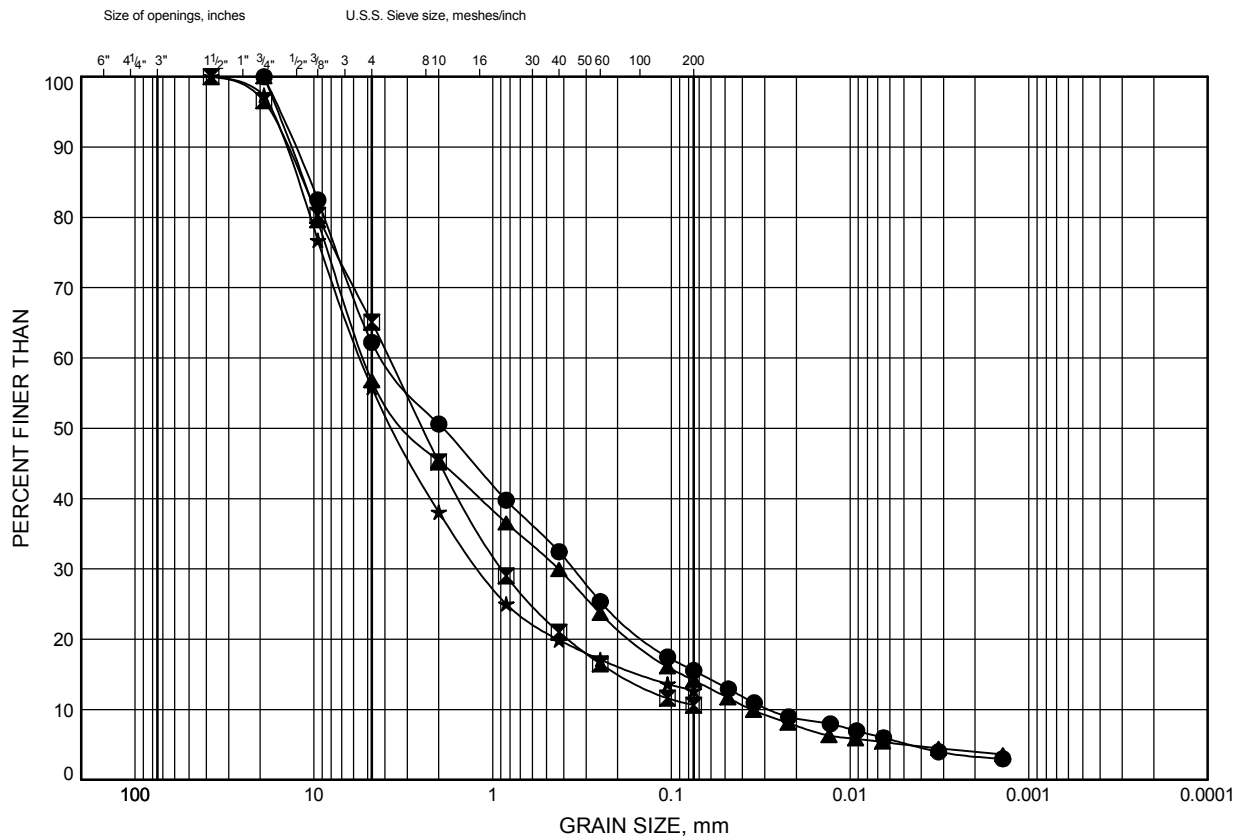
FIGURE B1

The grain size distribution curves of tested samples of this granular fill are presented in Figure B1. These results show a grain size distribution consisting of 35-44% gravel, 43-54% sand, 10-13% silt and 0-4% clay size particles.

FILL - Sand and Gravel

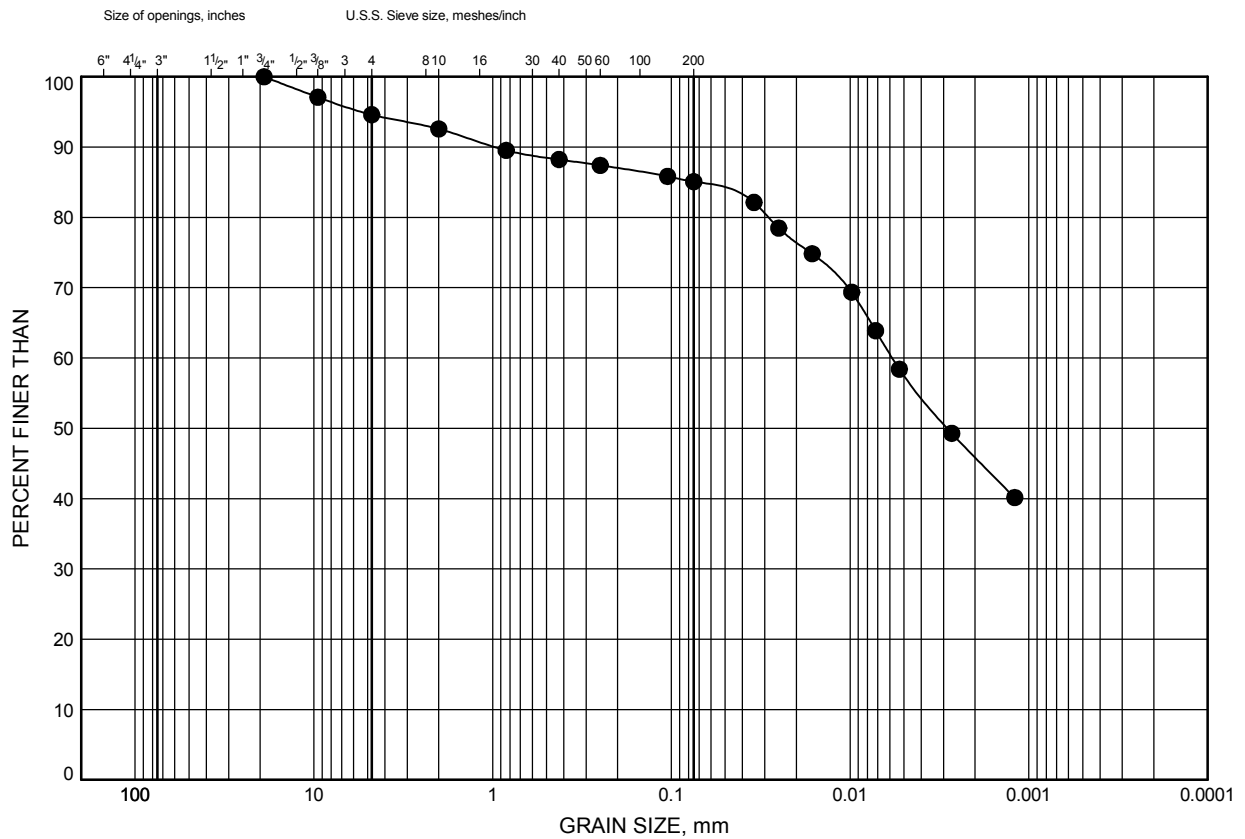
FIGURE B2

The grain size distribution curve of a sample of this fill is shown in Figure B2. The results show a grain size distribution consisting of 5% gravel, 10% sand, 39% silt and 46% clay size particles.

FILL - Silty Clay

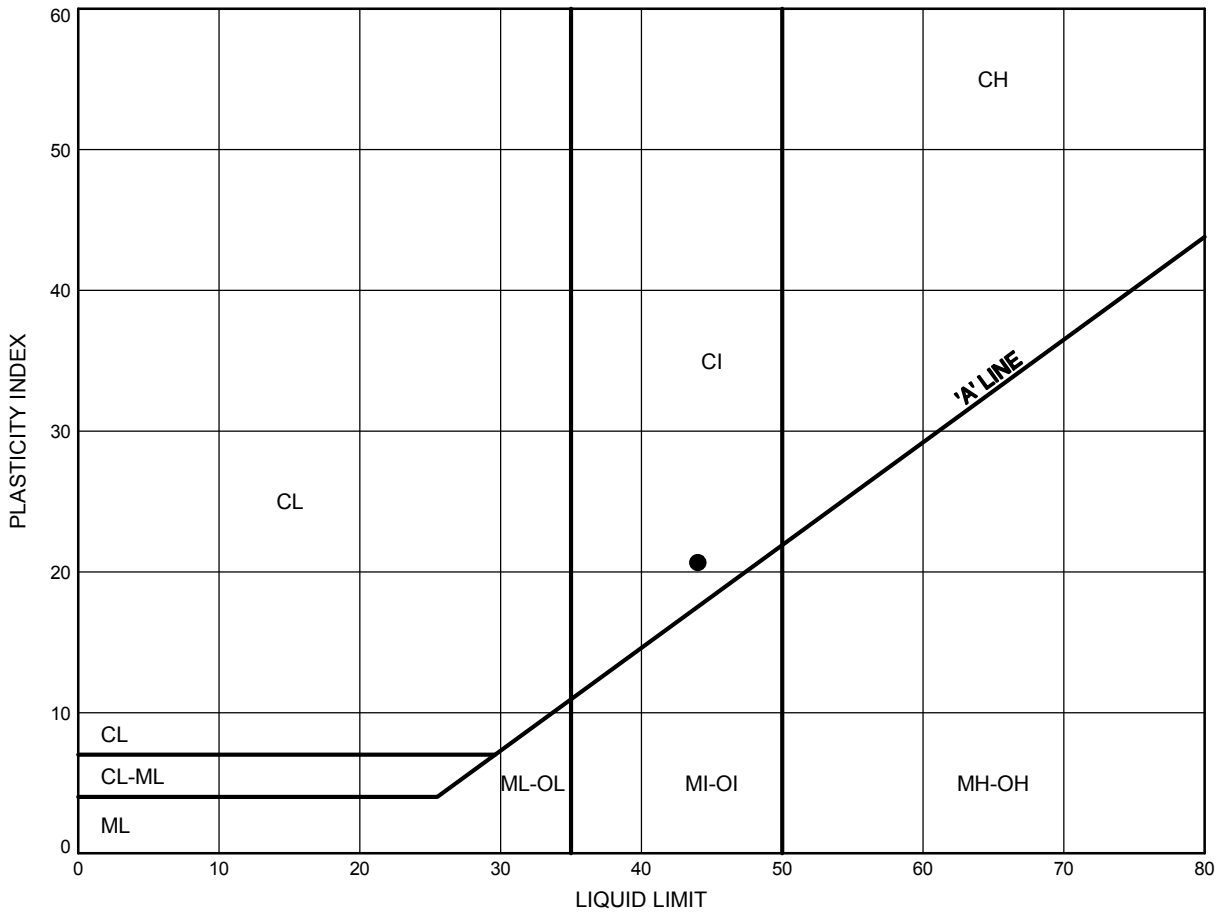
FIGURE B3

A sample was also subjected to an Atterberg Limits test and the results are plotted on the plasticity chart in Figure B3. The summarized index values from this test are presented below.

Liquid Limit:	44%
Plastic Limit:	23%
Plasticity Index:	21%
Natural Moisture Content:	22%

These values are characteristic of clayey soils of intermediate plasticity.

FILL - Silty Clay

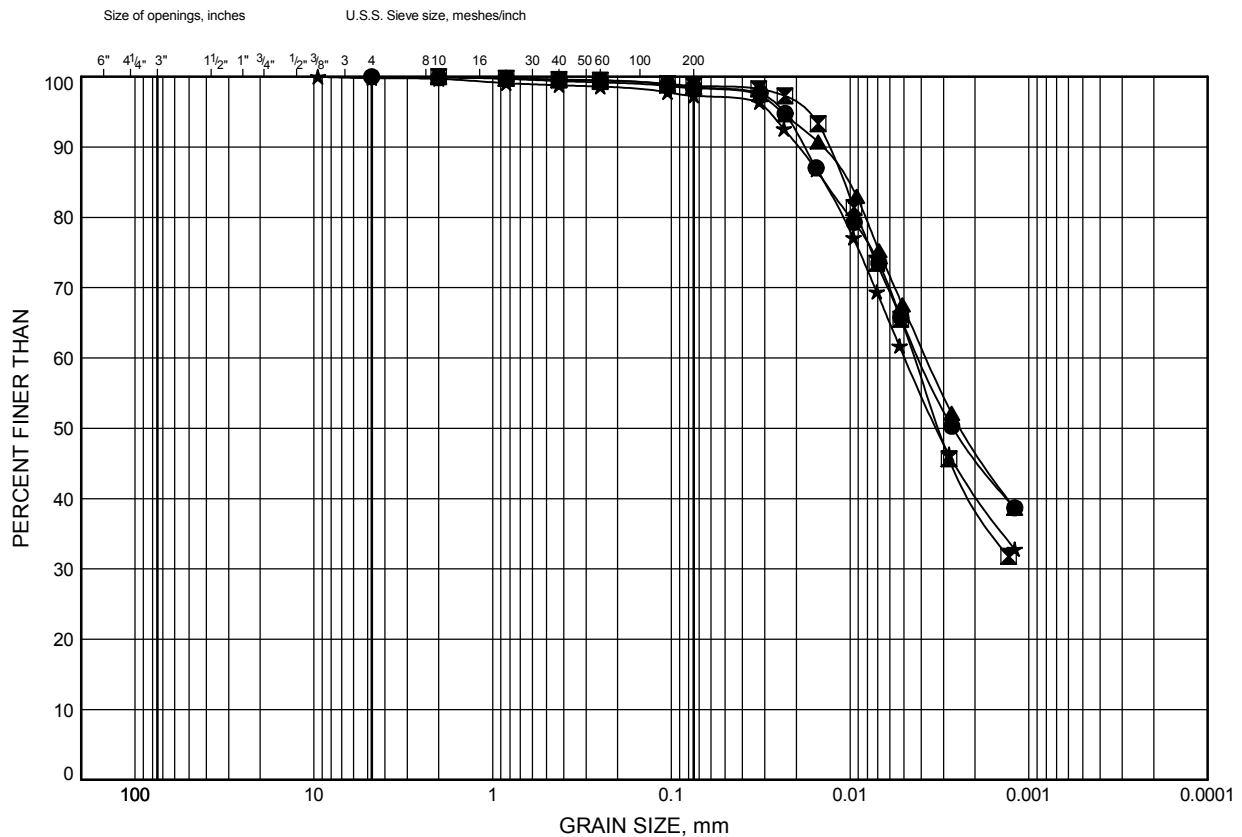
FIGURE B4

The results of grain size distribution tests conducted on samples obtained from this deposit are illustrated in Figures B4 and B5. These results show a grain size distribution consisting of 0% gravel, 1-4% sand, 51-68% silt and 28-47% clay size particles.

SILTY CLAY

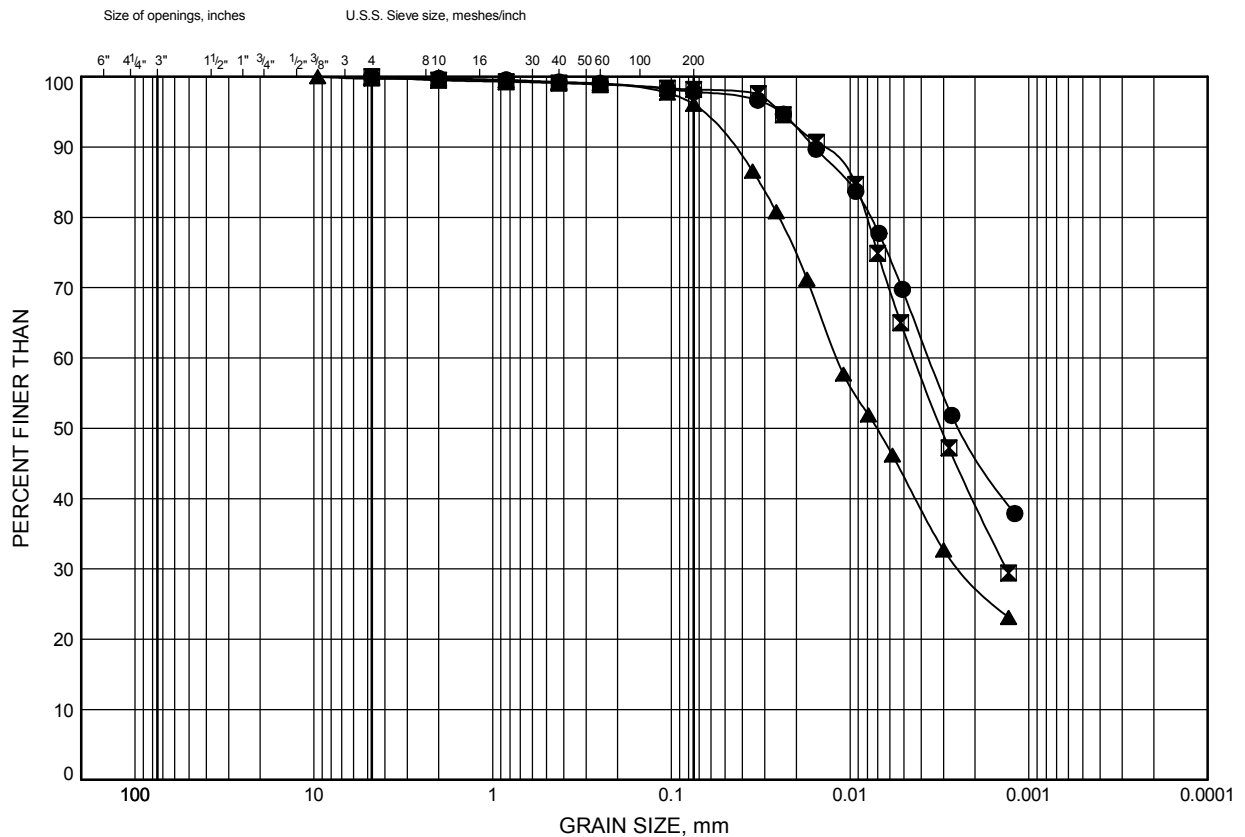
FIGURE B5

SILTY CLAY

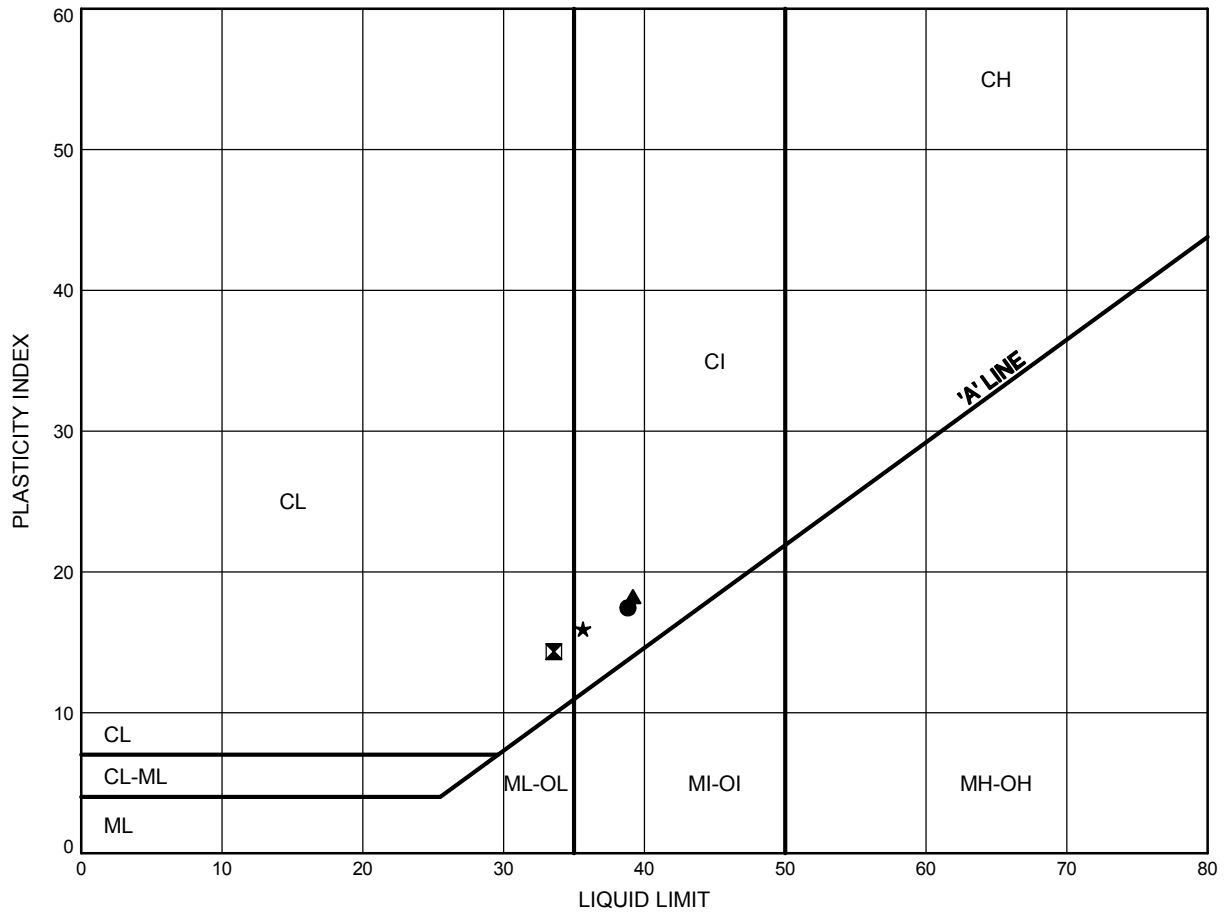
FIGURE B6

Samples were also subjected to Atterberg Limits tests and the results are presented on the plasticity charts, Figures B6 and B7. The index values from these tests are summarized below:

Liquid Limit:	24-39%
Plastic Limit:	15-23%
Plasticity Index:	9-18%
Natural Moisture Content:	20-23%

These values indicate that the silty clay has a generally low to intermediate plasticity.

SILTY CLAY

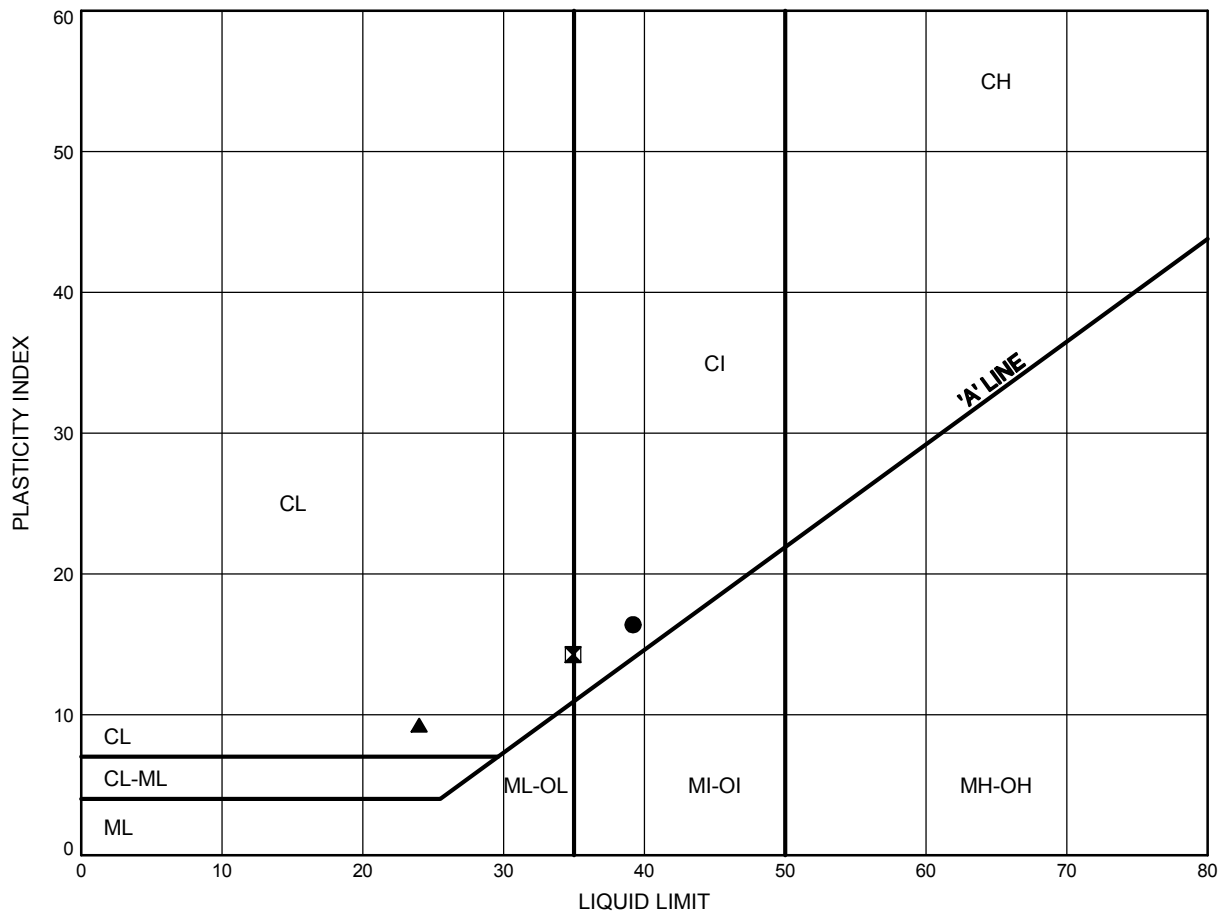
FIGURE B7

SILTY CLAY

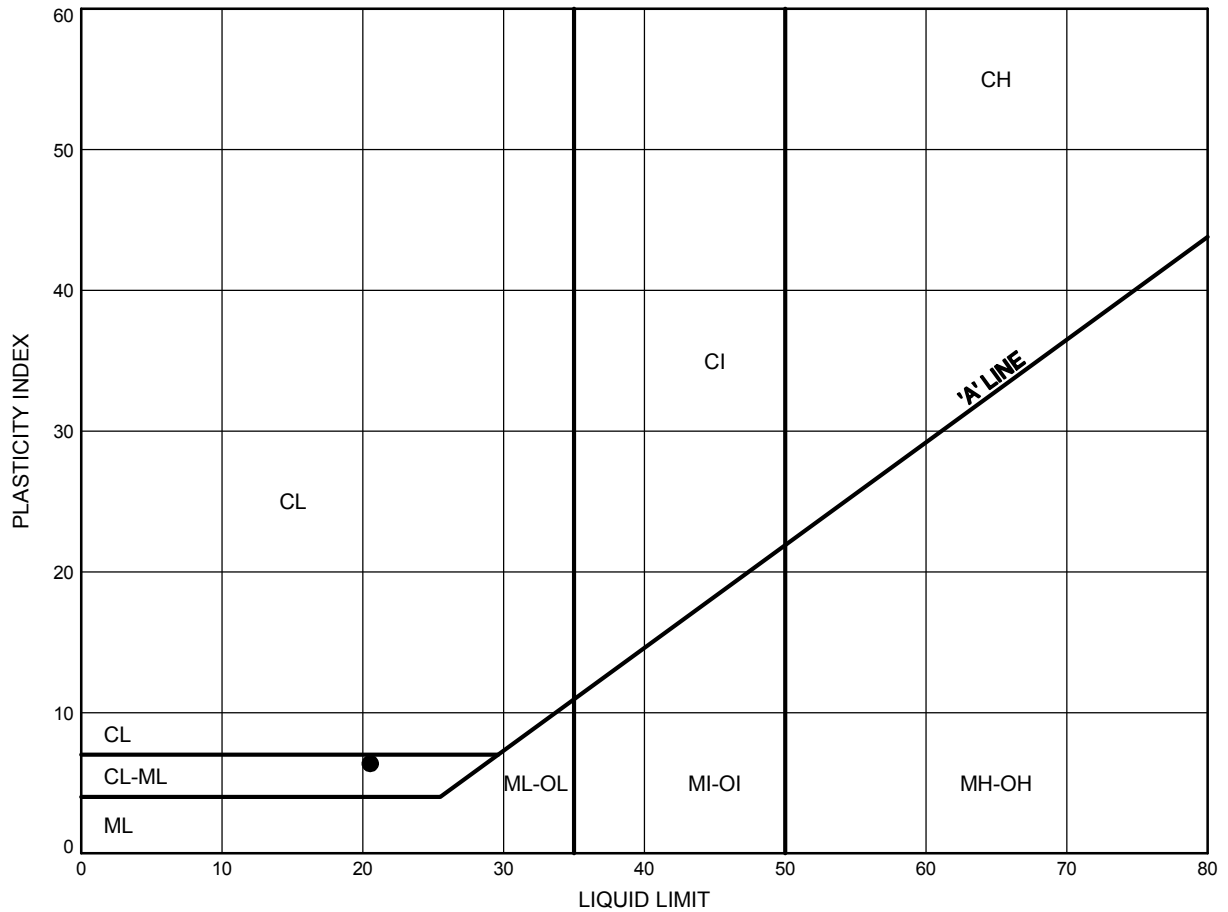
FIGURE B9

A sample of this soil was also subjected to an Atterberg Limits test and the results are shown on the plasticity chart, Figure B9. The index values from this test are summarized below:

Liquid Limit:	21%
Plastic Limit:	14%
Plasticity Index:	7%
Natural Moisture Content:	14%

These results are typical for low plasticity clayey silt soils.

CLAYEY SILT

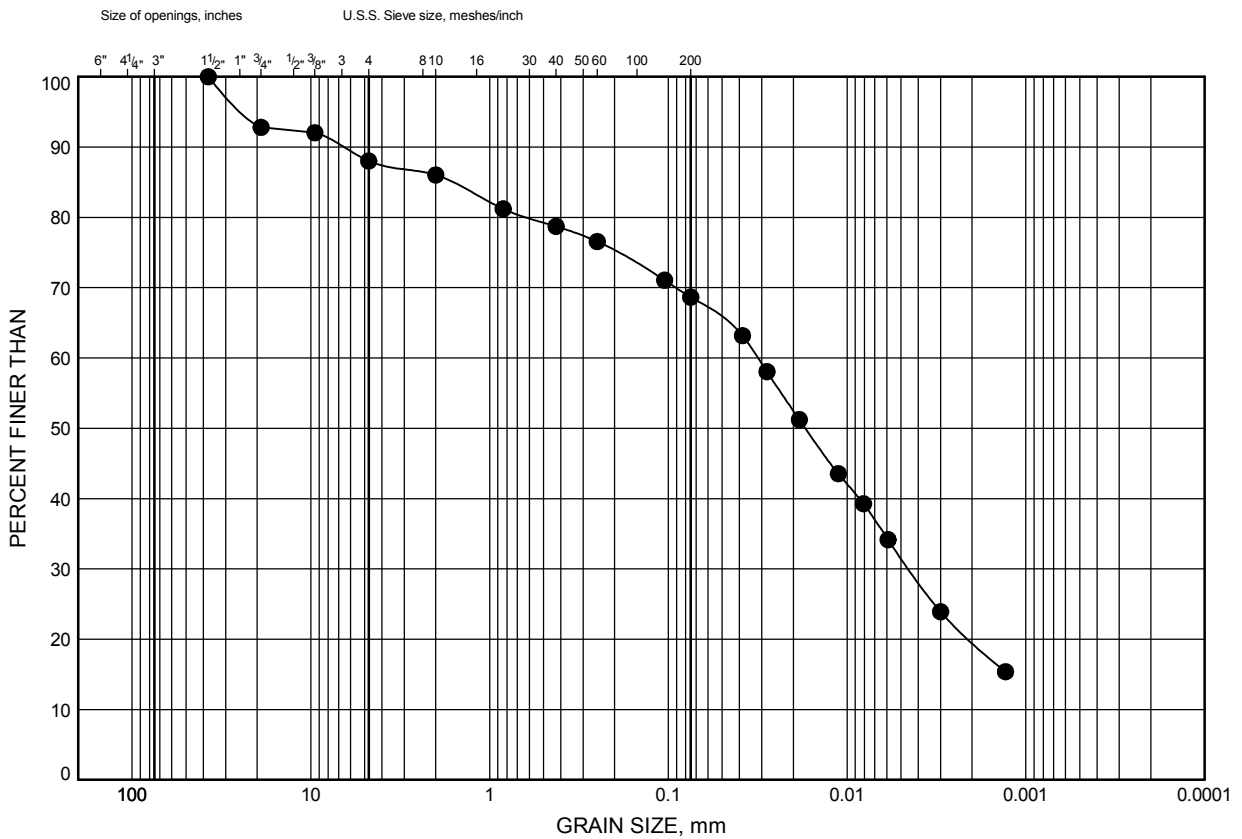
FIGURE B10

The grain size distribution curve of a tested sample from this stratum is depicted in Figure B10. These results show a grain size distribution consisting of 12% gravel, 19% sand, 49% silt and 20% clay size particles. Till soils will also contain random cobble and boulder inclusions.

SILTY CLAY TO CLAYEY SILT TILL

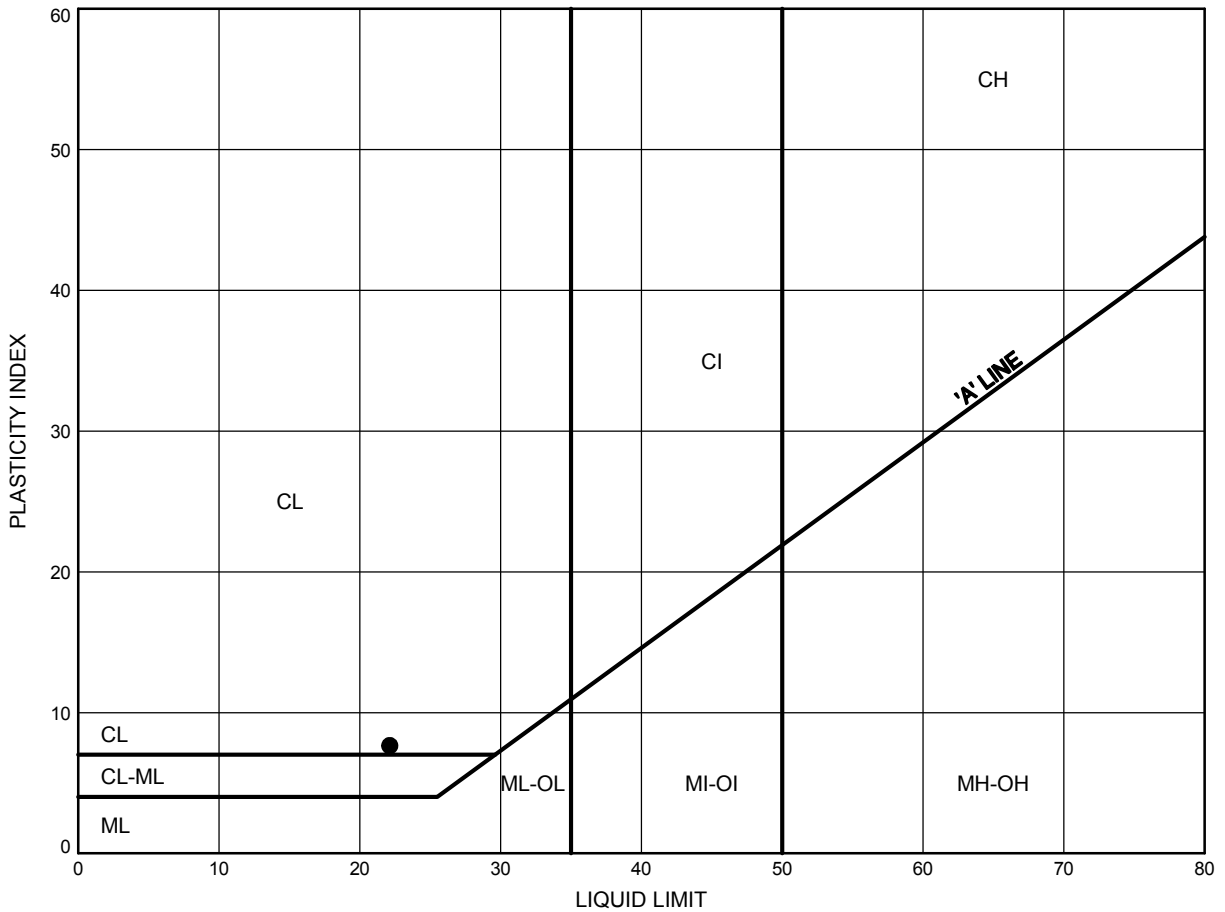
FIGURE B11

A sample was also subjected to an Atterberg Limits test and the results are plotted on the plasticity chart, Figure B11. The index values from these tests are summarized below:

Liquid Limit:	22%
Plastic Limit:	14%
Plasticity Index:	8%
Natural Moisture Content:	12%

These values are typical of clayey soils of low plasticity.

SILTY CLAY TO CLAYEY SILT TILL

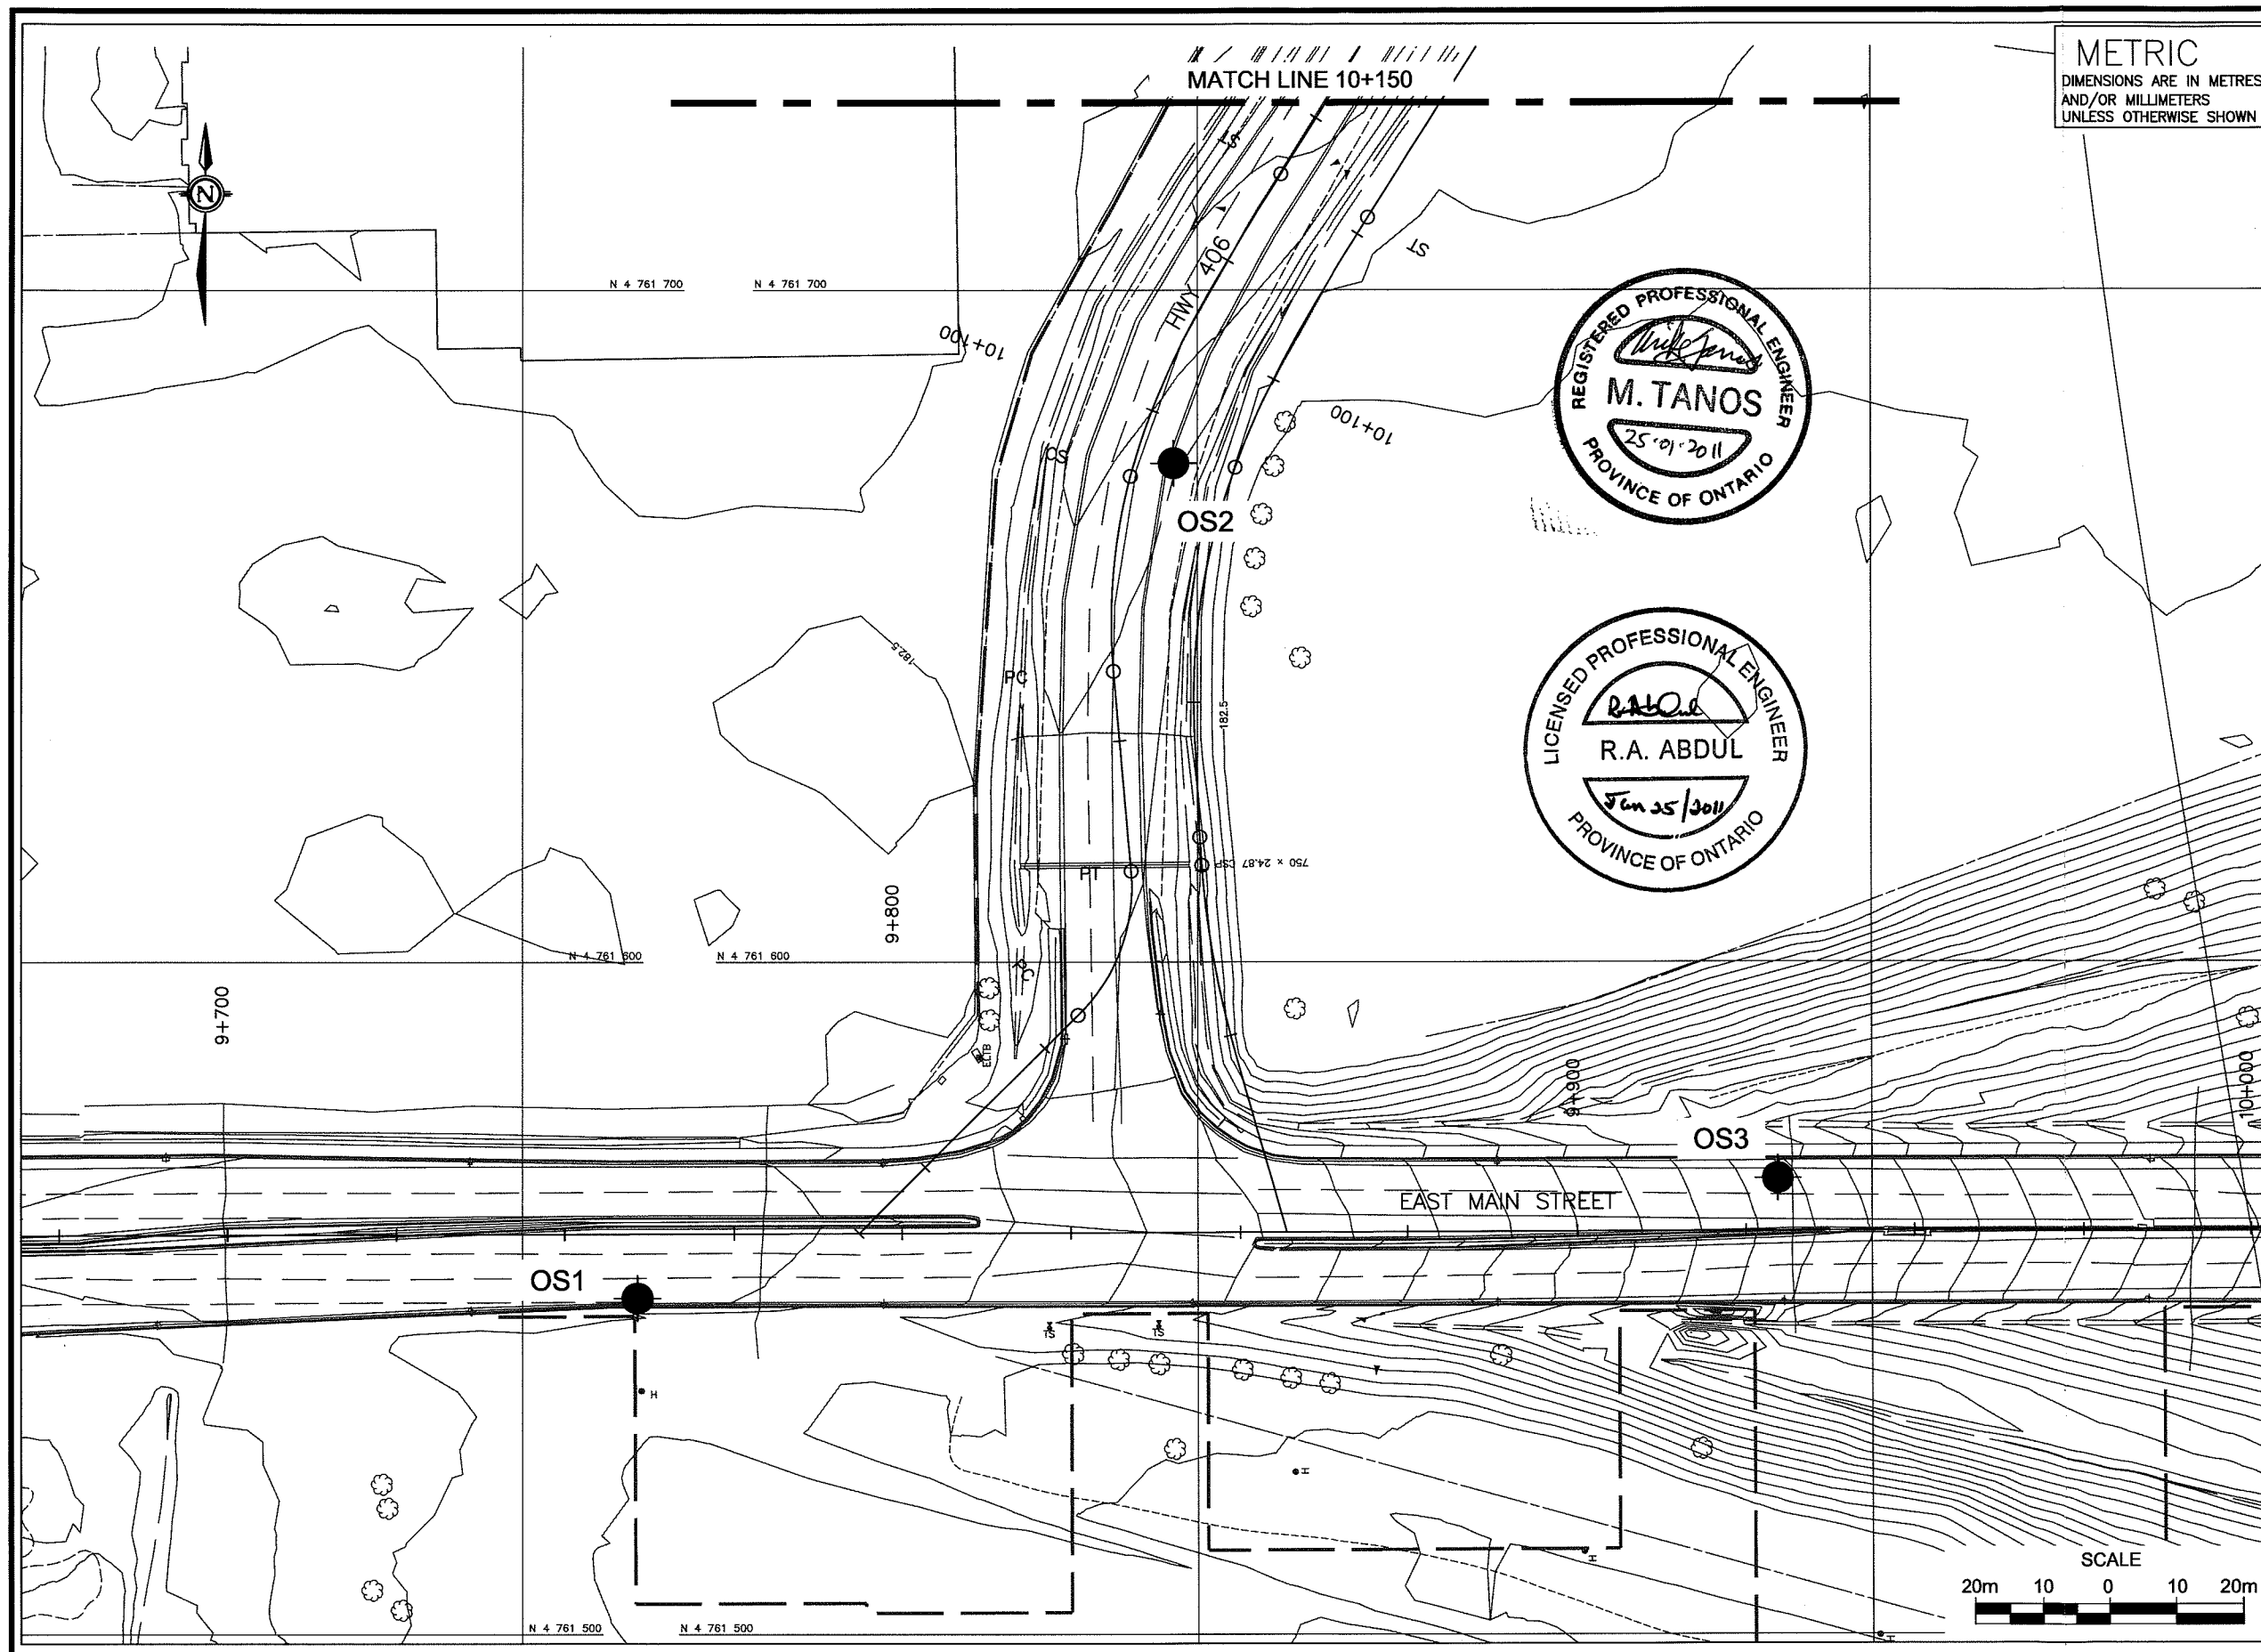
The site investigation and field testing for this project were carried from October 19, 2010 to October 20, 2010 and consisted of drilling and sampling four boreholes to depths ranging from 8.1 m to 8.5 m. The boreholes were numbered OS1, OS2, OS3 and OS5 and their approximate locations are shown on the attached Borehole Locations Drawings in Appendix C.
