**FOUNDATION INVESTIGATION REPORT
GENEVA STREET UNDERPASS
BRIDGE REHABILITATION
HIGHWAY 406
ST. CATHARINES, ONTARIO
G.W.P. 2257-13-00; SITE No. 18-230**

GEOCRES NO. 30M3-293

Date: January 23, 2017
File: 11336

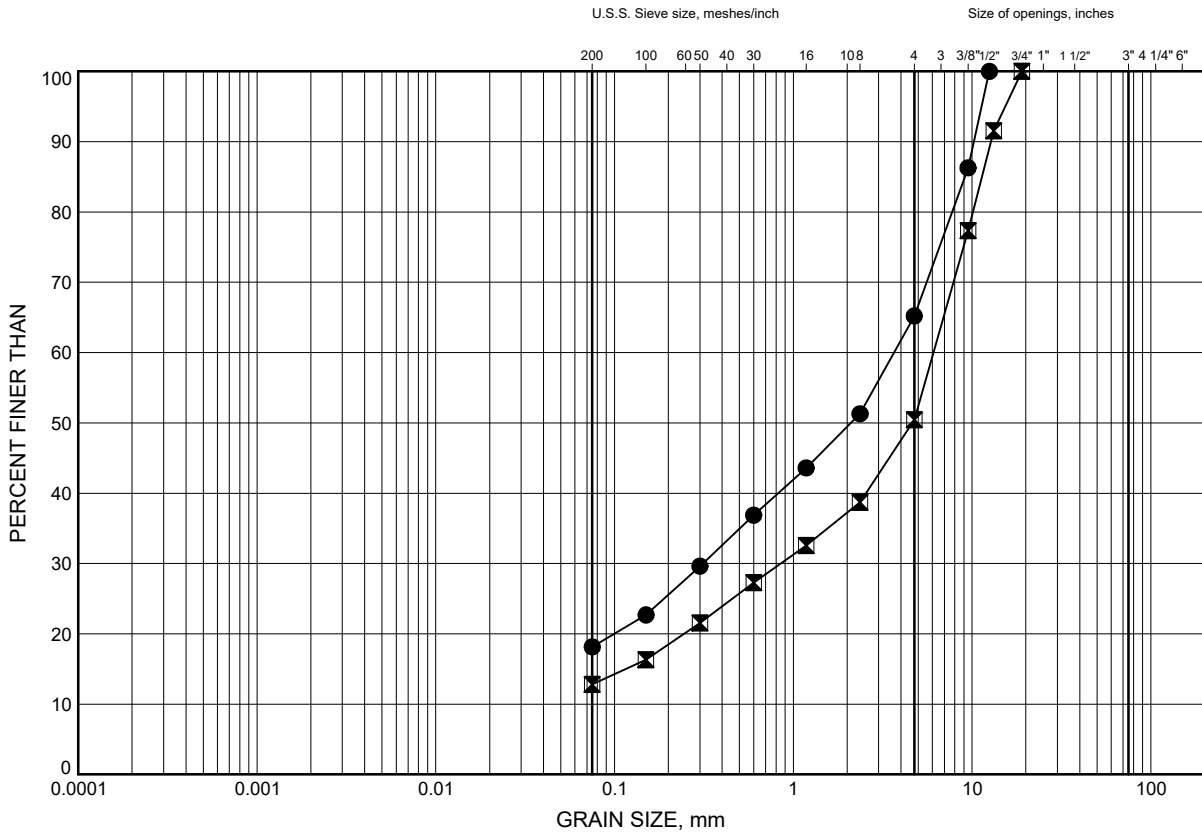
FIGURE B1

The results of grain size analyses conducted on two sand and gravel fill samples are presented on the Record of Borehole sheets in Appendix A, and are illustrated in Figure B1 of Appendix B. The laboratory test results are summarized in the following table.

Soil Particle	Percentage (%)
Gravel	35 to 50
Sand	38 to 47
Silty and Clay	12 to 18

SAND and GRAVEL FILL

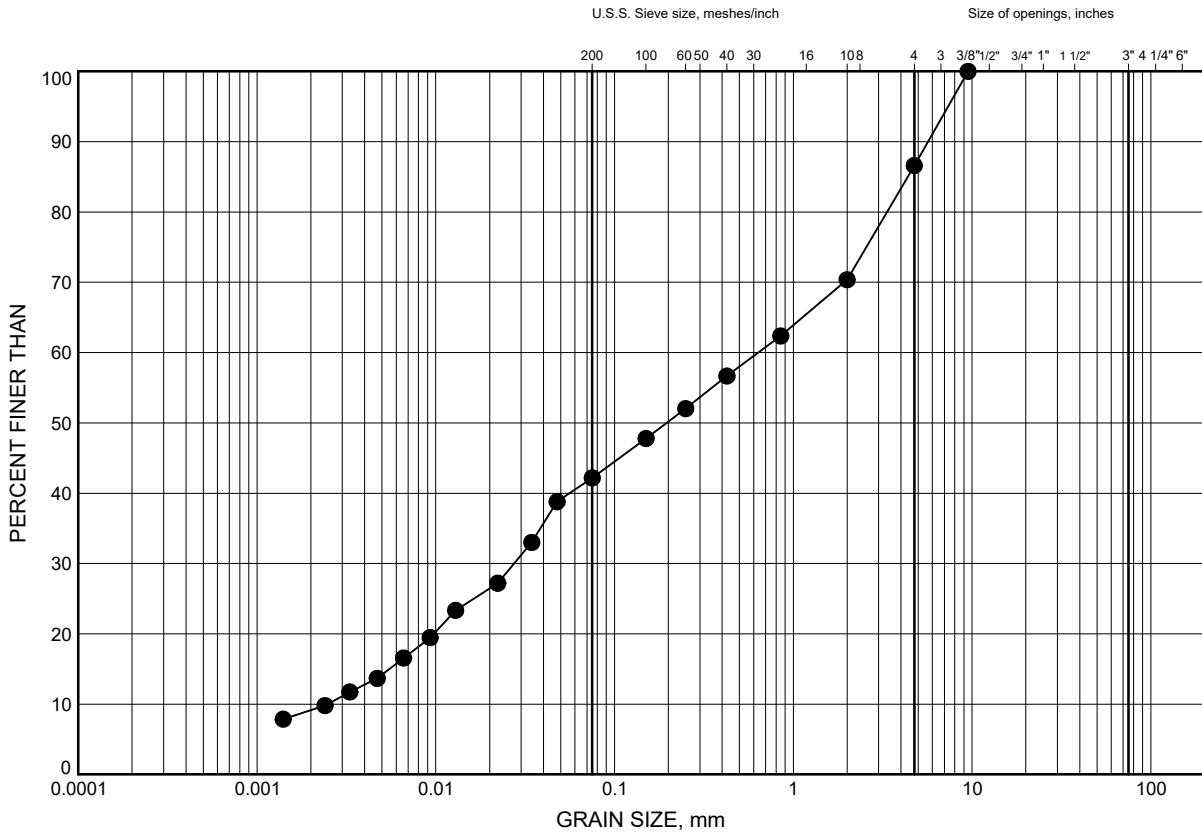
FIGURE B2

The results of grain size analyses conducted on one silty sand fill and two silty clay fill samples

are presented on the Record of Borehole sheets in Appendix A, and are illustrated in Figures B2 and B3 of Appendix B. The laboratory test results are summarized in the following table.

Soil Particle	Silty Sand Fill Percentage (%)	Silty Clay Fill Percentage (%)
Gravel	13	7 to 11
Sand	44	22 to 28
Silt	33	29 to 38
Clay	10	32 to 33

Silty SAND FILL

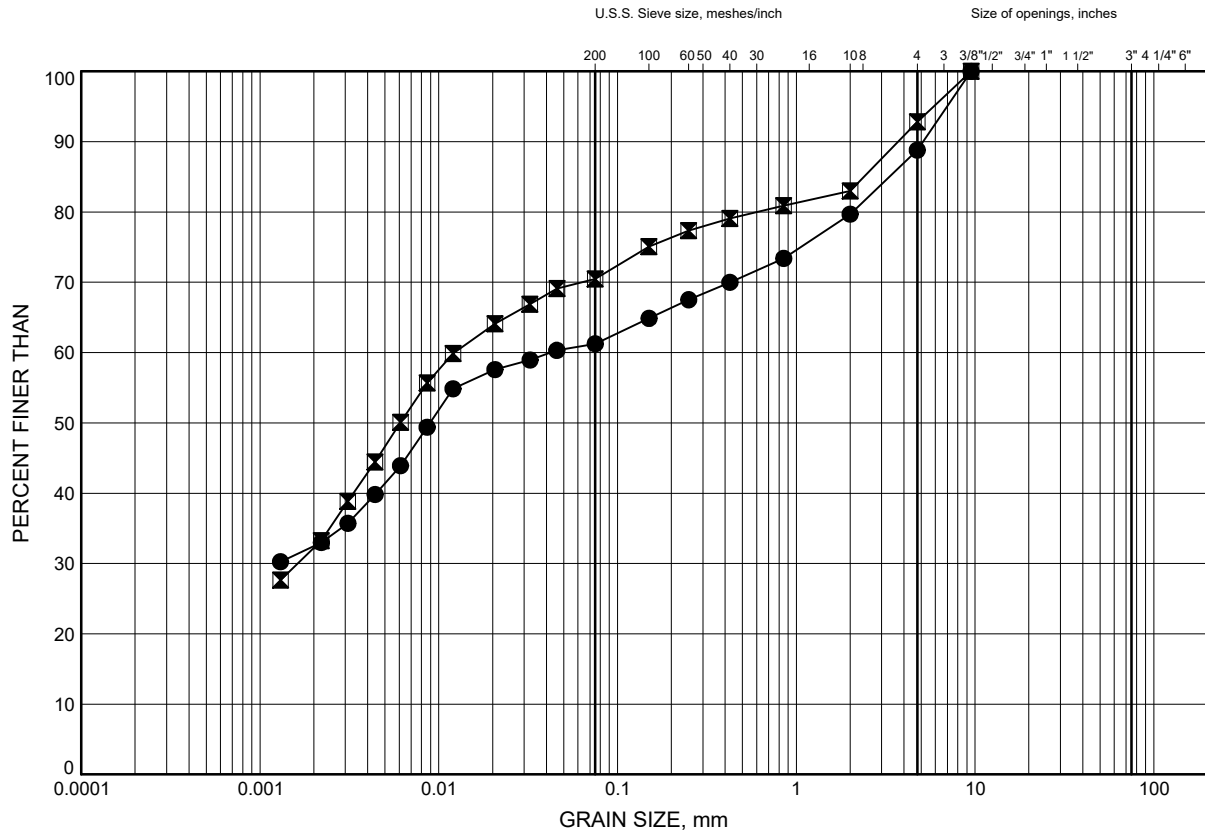
FIGURE B3

Silty CLAY FILL

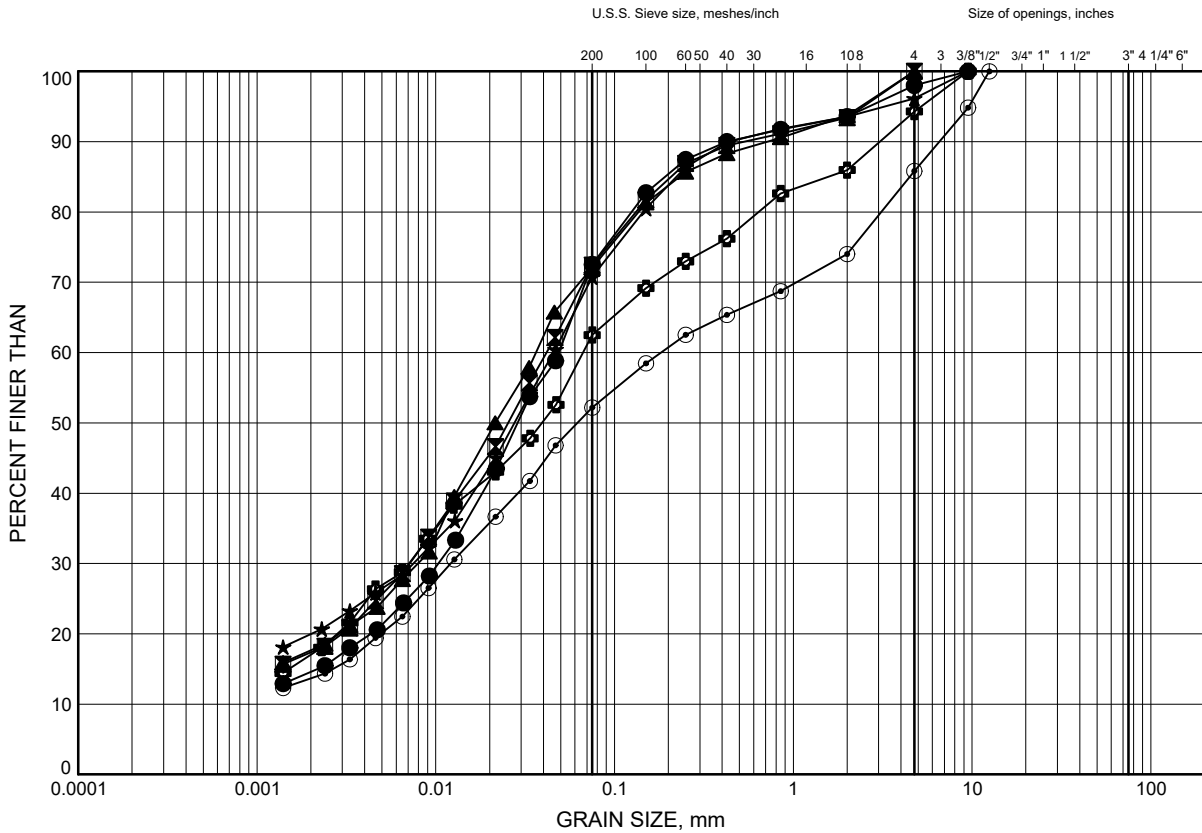
FIGURE B4

The results of grain size analyses conducted on samples of the clayey silt till are provided on the Record of Borehole sheets in Appendix A, and illustrated in Figures B4 and B5 of Appendix B. The results are summarized as follows:

Soil Particle	Percentage (%)
Gravel	0 to 14
Sand	22 to 34
Silt	39 to 59
Clay	12 to 20

Clayey SILT TILL, with Sand

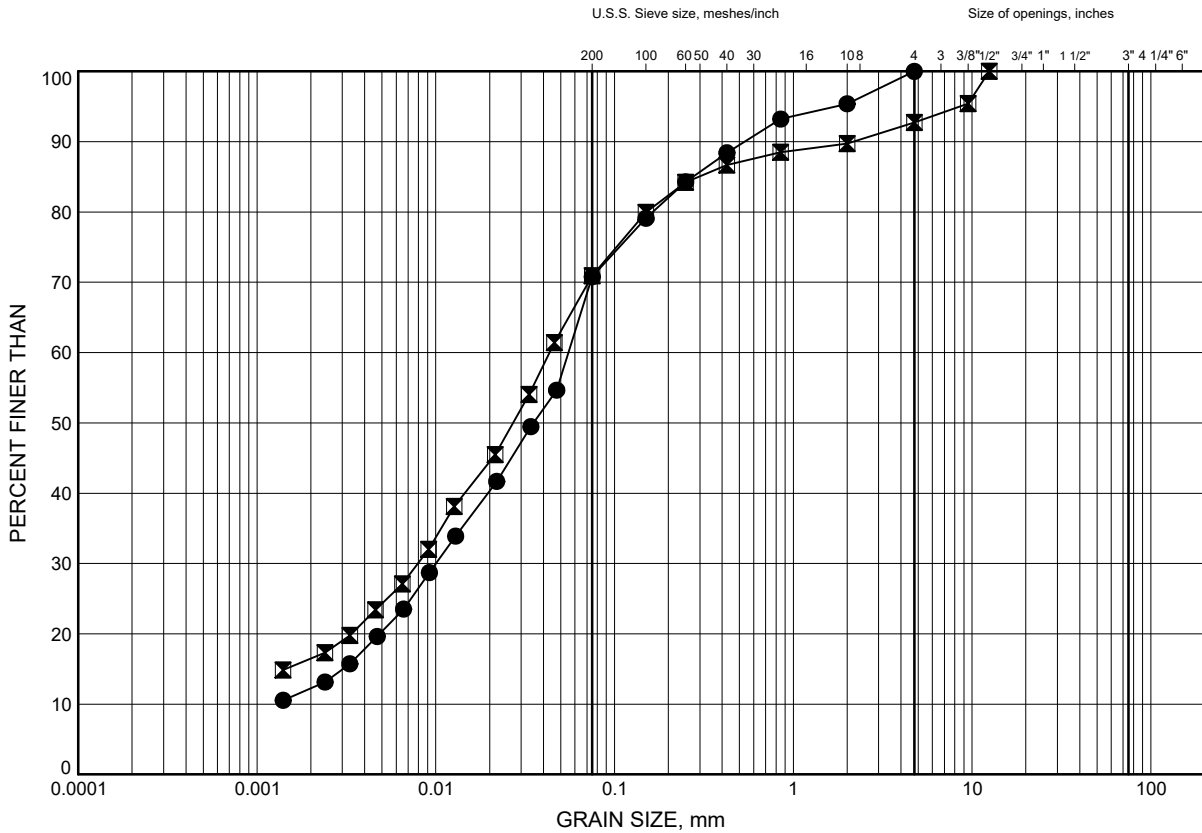
FIGURE B5

Clayey SILT TILL, with Sand

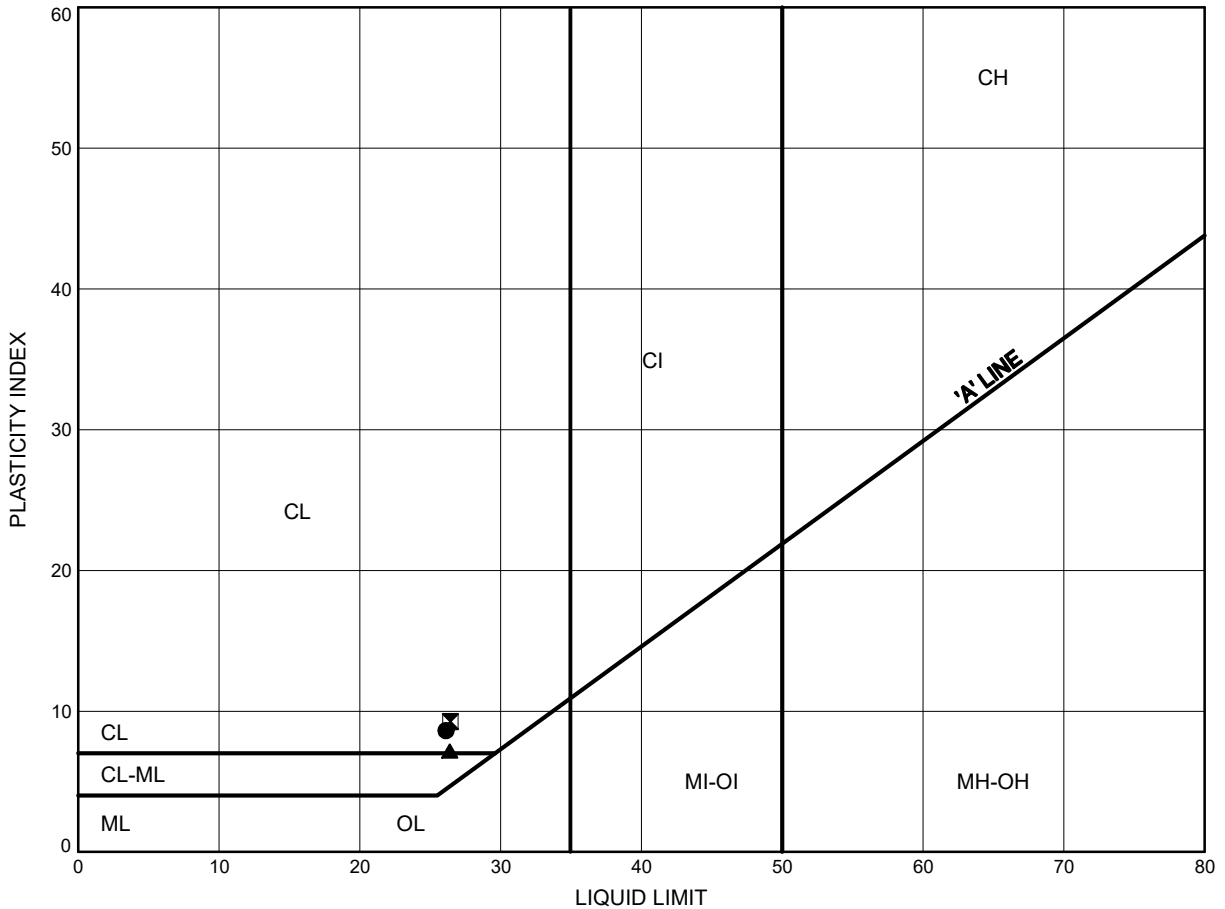
FIGURE B6

The results of Atterberg Limits tests conducted on samples of the clayey silt till are provided on the Record of Borehole sheets in Appendix A and illustrated in Figure B6 of Appendix B. The results are summarized as follows:

Index Property	Percentage (%)
Liquid Limit	26
Plasticity Index	7 to 9

The results of the Atterberg Limits testing indicate the deposit to be of low plasticity with group symbols CL and CL-ML.

Clayey SILT TILL, with Sand

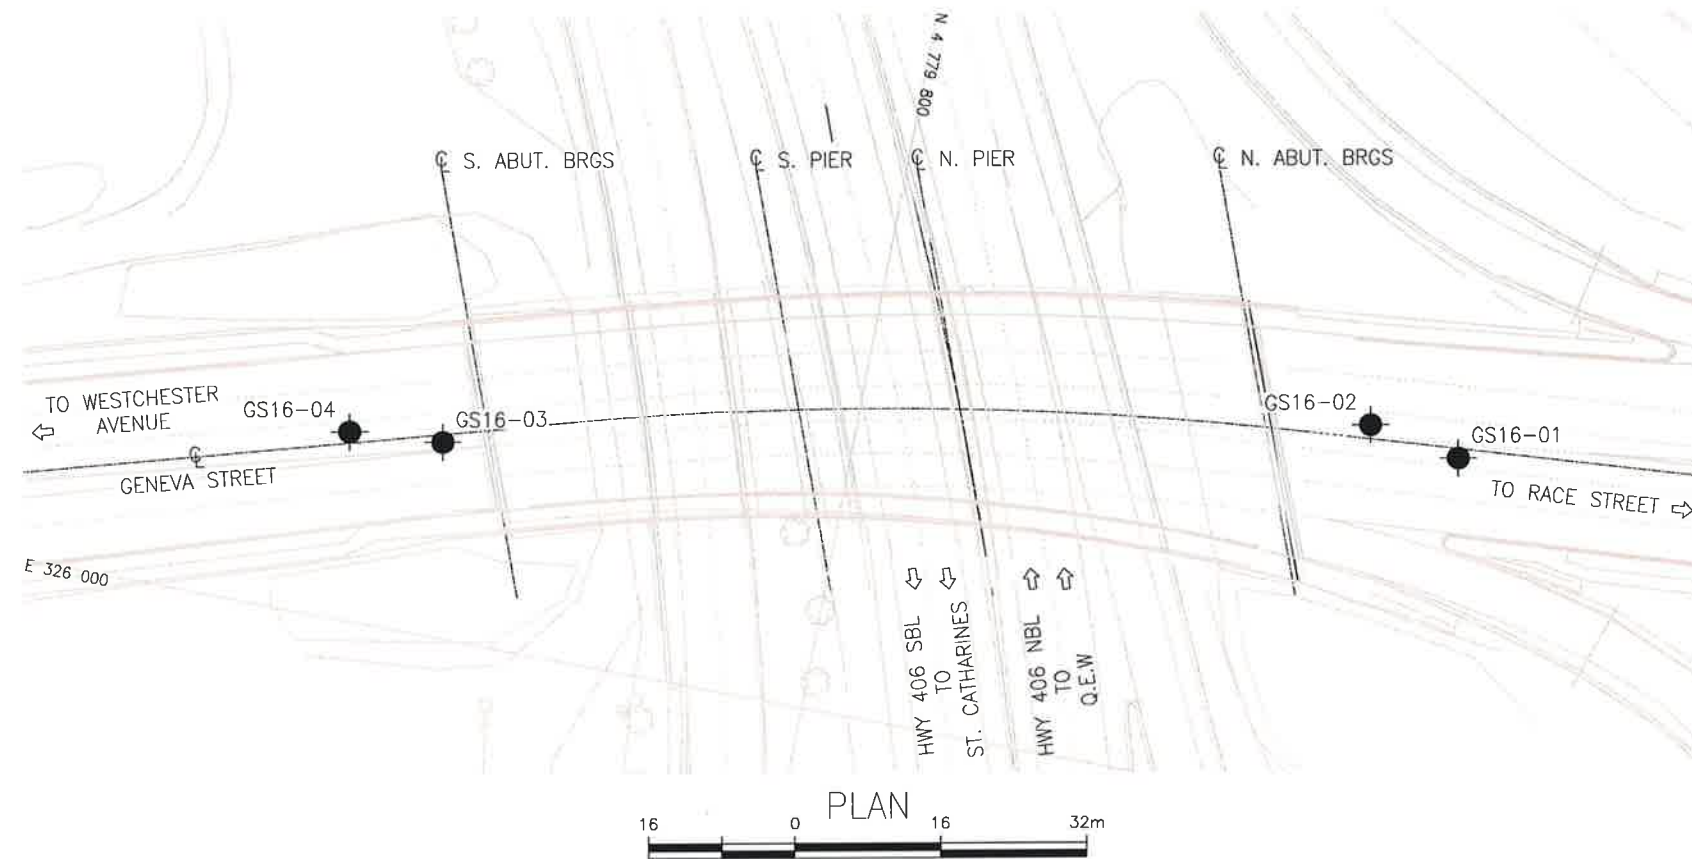
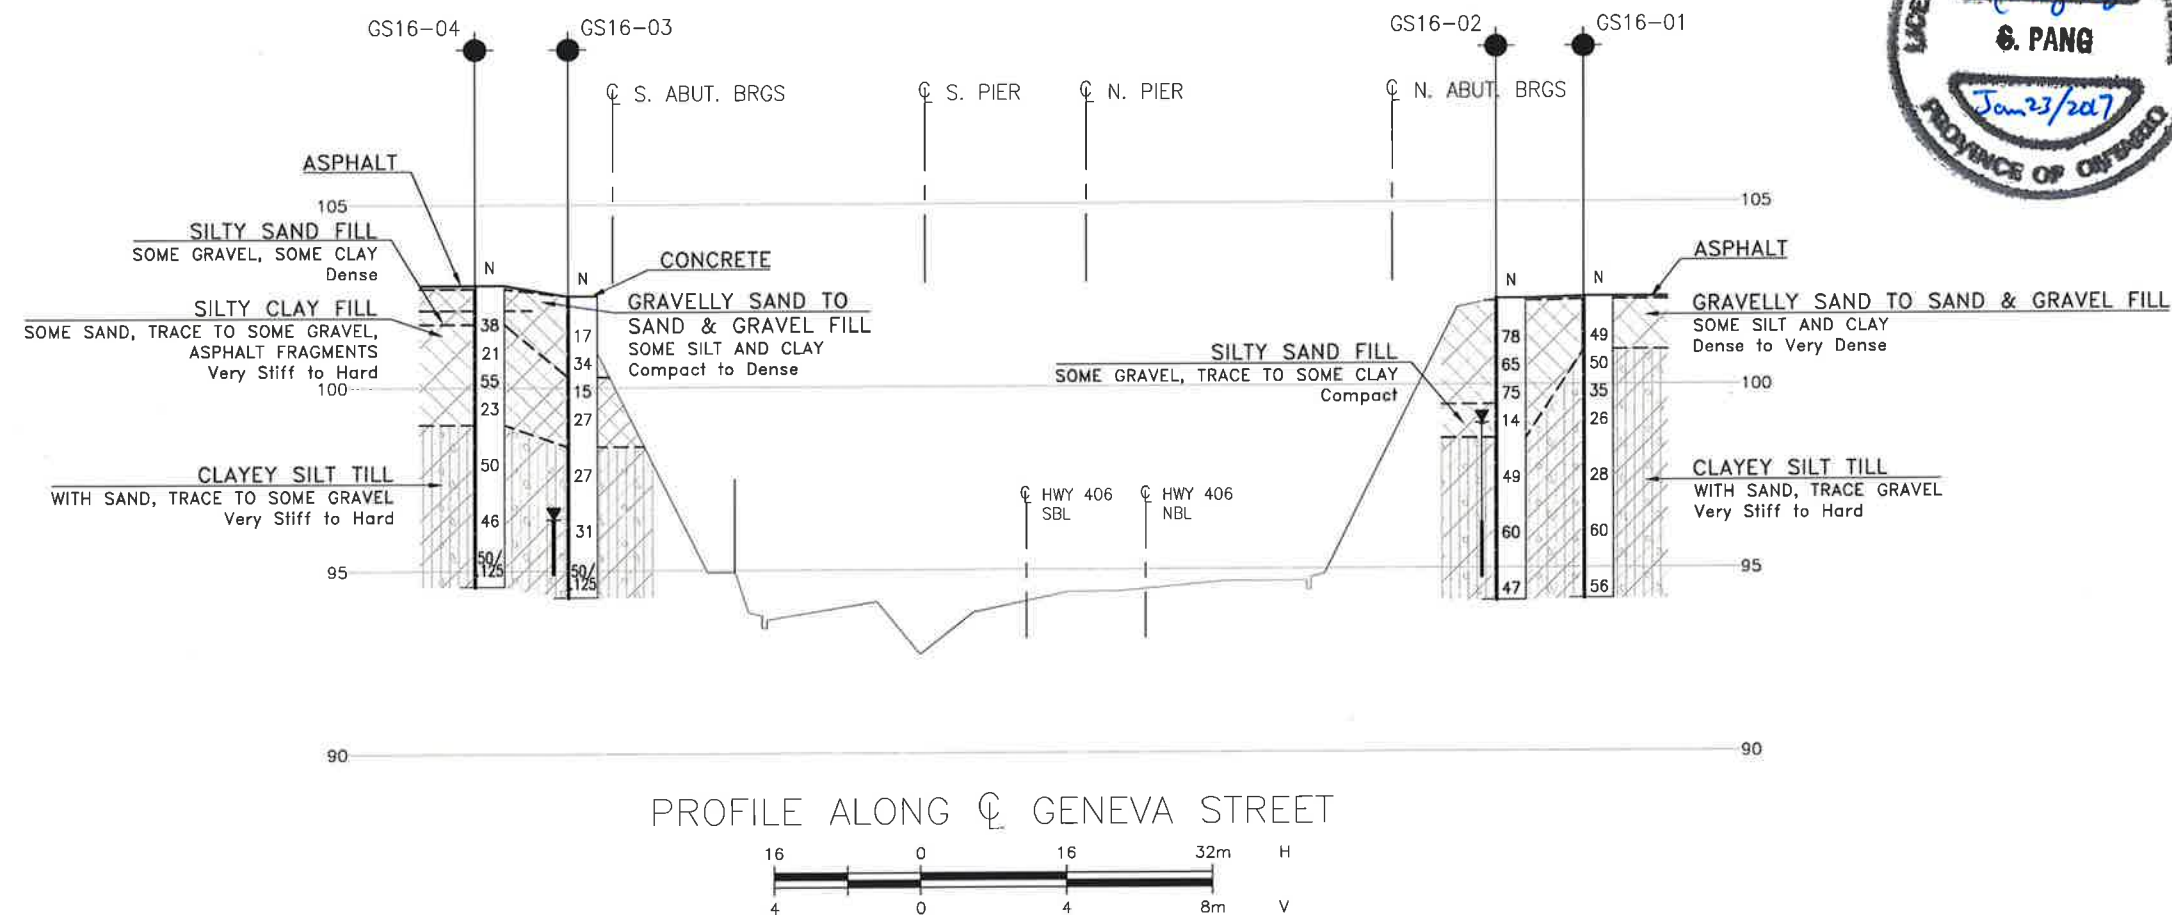
HIGHWAY 406
GENEVA STREET UNDERPASS
BRIDGE REHABILITATION
BOREHOLE LOCATIONS AND SOIL STRATA

Reference is made to the Record of Borehole sheets in Appendix A for details of the encountered soil stratigraphy. A soil profile of the Geneva Street Underpass site is presented on the “Borehole Locations and Soil Strata” drawing in Appendix C. An overall description of the stratigraphy is given in the following paragraphs. However, the factual data presented in the Record of Borehole sheets governs any interpretation of the site conditions. It must be recognized that soil conditions

In general, the subsurface conditions encountered in the boreholes drilled at the Geneva Street Underpass consist of asphalt and concrete (approach) slab underlain by granular fill which overlies silty clay and silty sand embankment fill. A deposit of native clayey silt till was contacted below the fill in all the boreholes. Groundwater levels are generally in the order of 3.4 m and 6.1 m below ground surface, at the north and south approaches, respectively. More detailed descriptions of the individual stratum are presented below.
