**DRAFT PRELIMINARY
FOUNDATION INVESTIGATION AND DESIGN REPORT
PROPOSED TWINNING AND NORTH APPROACH EMBANKMENT
HIGHWAY 62 NORRIS WHITNEY BRIDGE EA
BELLVILLE, ONTARIO
SITE No. 28-28
G.W.P. 4194-15-00**

Date: April 20, 2021
File: 11566

HIGHWAY 62
NORRIS WHITNEY BRIDGE TWINNING
AT THE NORTH EMBANKMENT
BOREHOLE LOCATIONS AND SOIL STRATA

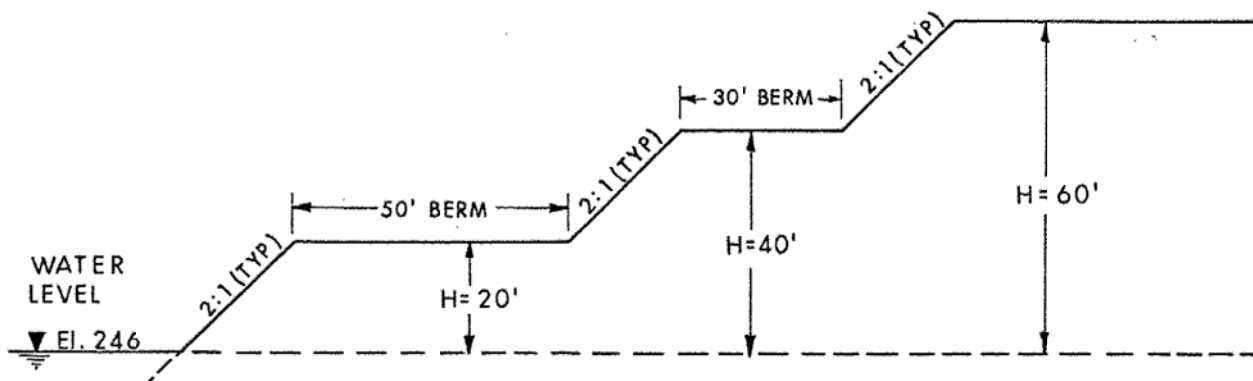
Case C

- Fill heights up to 20 feet above the water line will be stable with side slopes of 2:1.
- Fills up to 40 feet above the waterline with 50 foot long counterbalancing berms at midheight on both the forward and side slopes of the embankment would be stable with 2:1 slopes.
- Fill heights of up to 60 feet above the water line would require the following berm configuration for stability against deep seated rotational failure (also see sketch below):

berm at 1/3 height 50 feet long
berm at 2/3 height 30 feet long
all side slopes 2:1 maximum

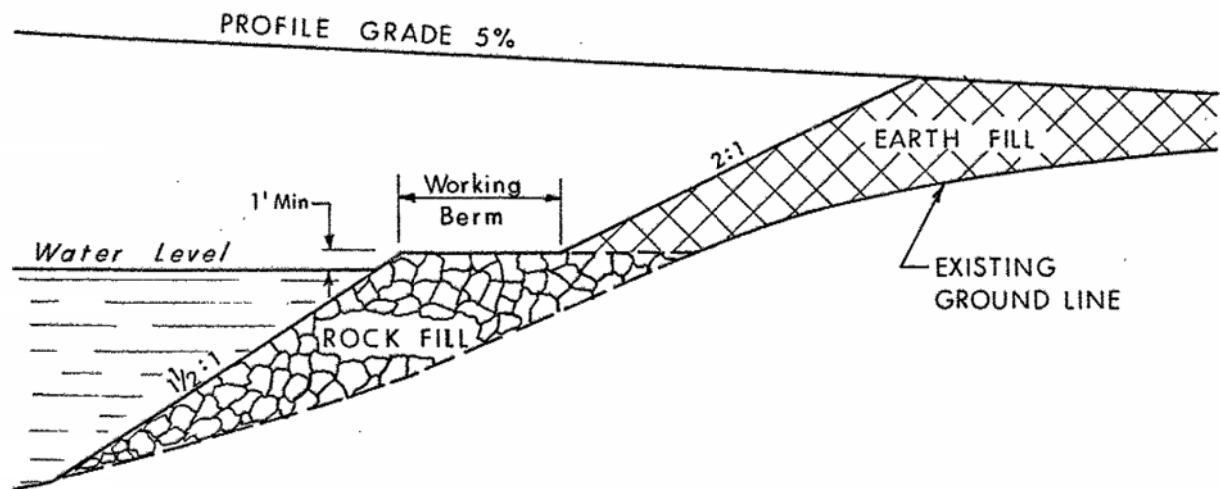
The subsoil is such that the anticipated fill heights will be stable with respect to deep seated rotational failure with forward and side slopes of 2 horizontal to 1 vertical. If the forward slopes extend into the bay the embankment should be constructed by placing rockfill to extend to a height of one

foot above the water level with side and forward slopes of $1\frac{1}{2}$ to 1. The fill may then be completed by the placing of earthfill with a slope of 2 to 1. It may be advantageous for construction to provide a 10 foot berm between the crest of the rockfill slope and the toe of the earthfill slope. See sketch below.

Furthermore, the earthfill should be protected against wave action by rip-rapping to an elevation as per hydrological requirements.

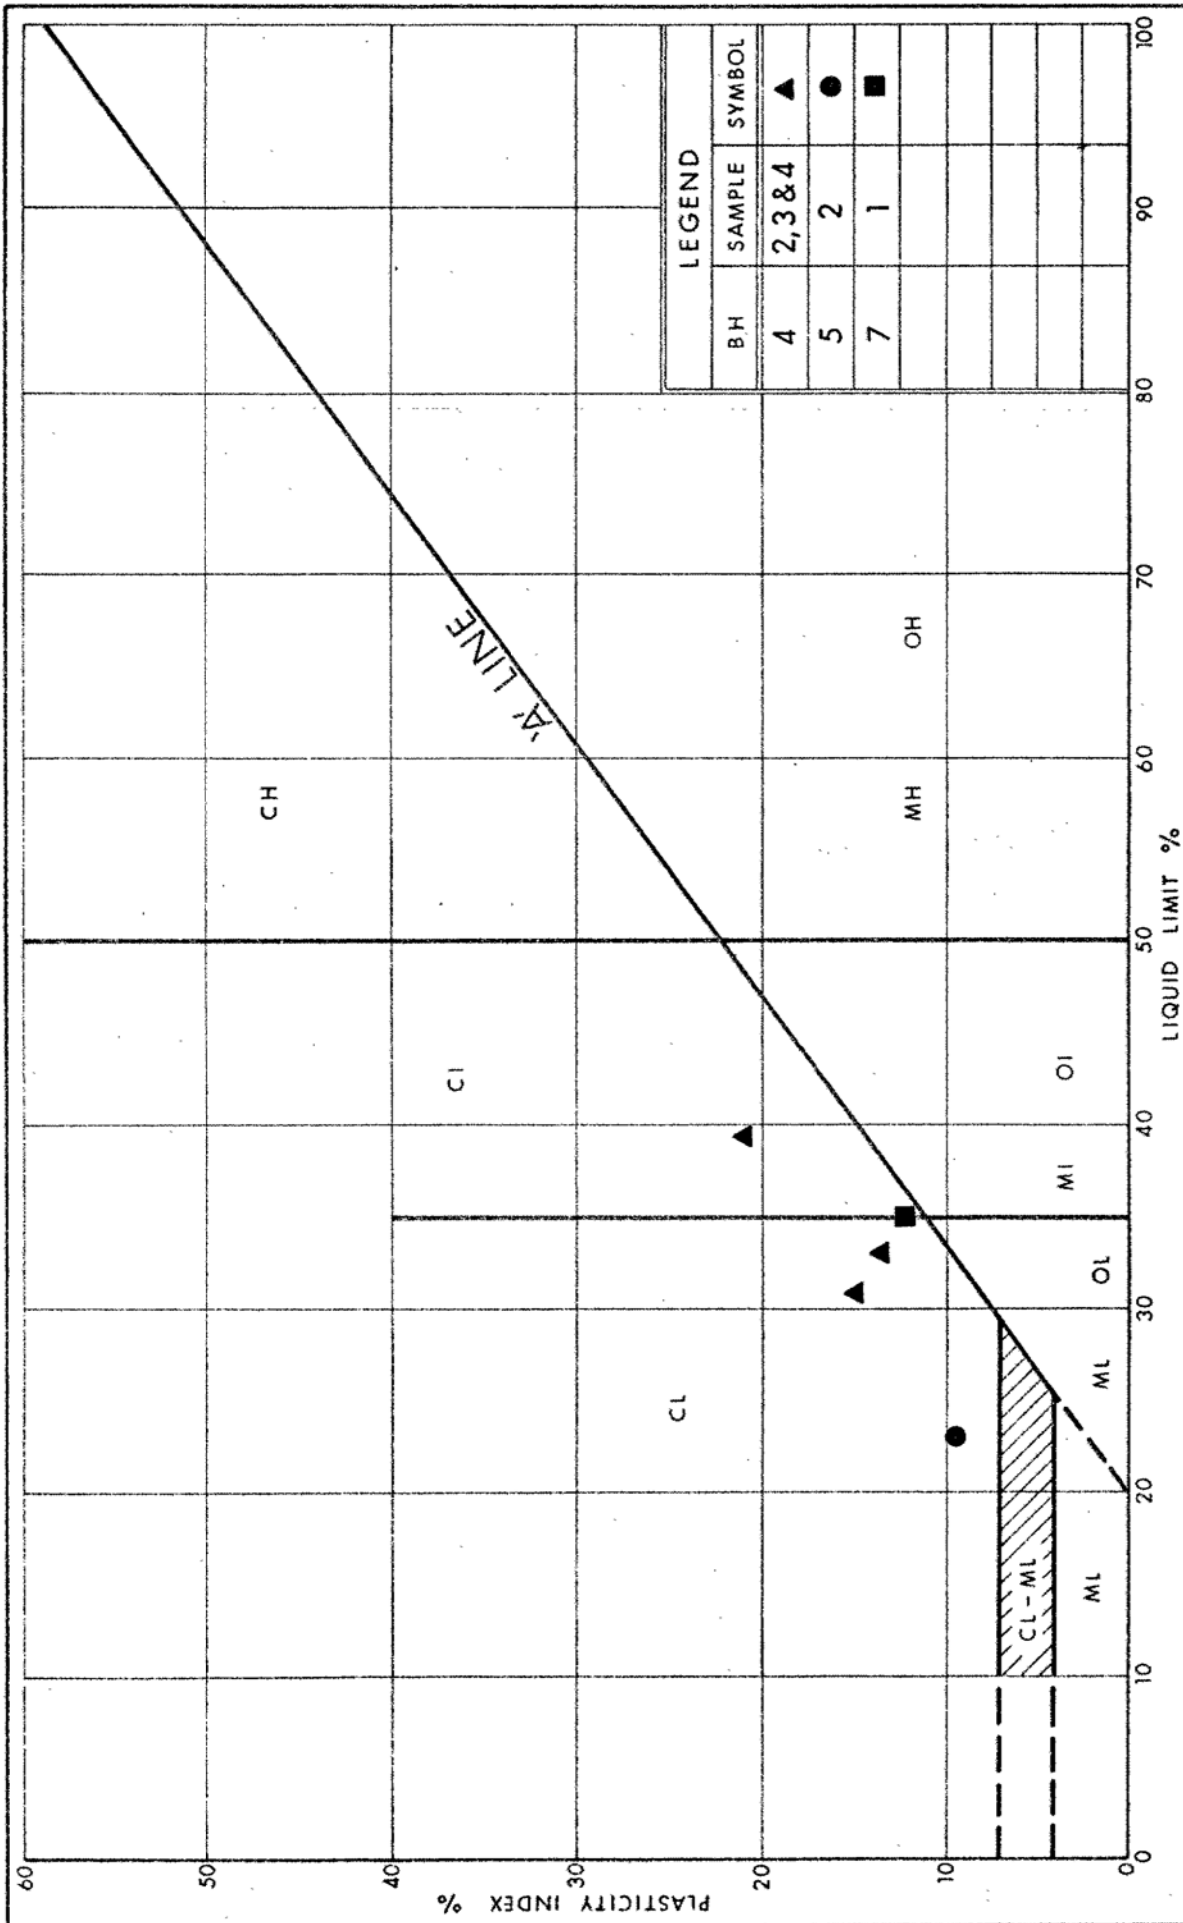
PLASTICITY CHART

FILL MATERIAL (in Zwicks Park)
COHESIVE POCKETS OF CLAYEY SILT

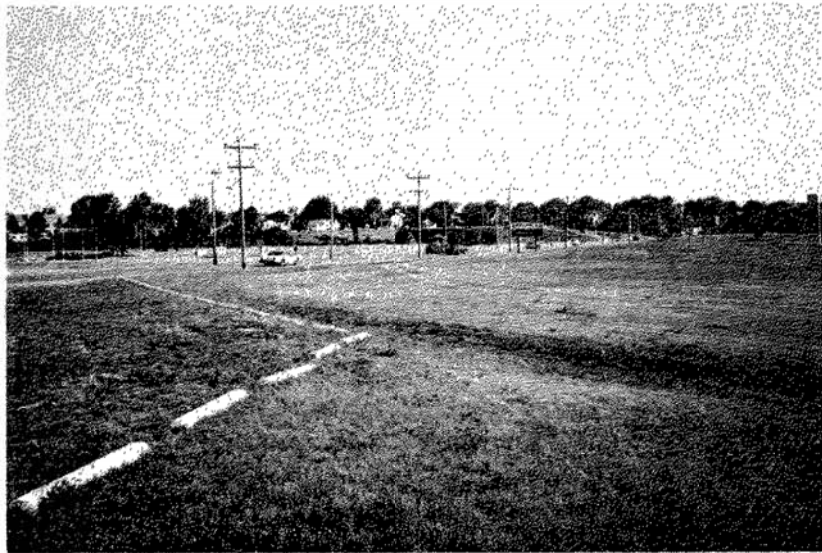
PHOTO 2 (LOOKING NORTH FROM ZWICK'S PARK PUMP HOUSE)
PROPOSED HWY. 14 APPROACH ON ZWICK'S PARK

The north approach will extend through generally flat terrain immediately east of existing Hwy. 14 within Zwick's Park (Refer to Photo 2 in the Appendix). Maps of the area prior to 1890 show the area now occupied by Zwick's Park to be largely open water except for an island. This piece of land, about 4 acres in area, was named Zwick's Island and now comprises the southwestern portion of Zwick's Park. The island was joined to the mainland by means of a causeway as part of the original 1890 Bay of Quinte Bridge. It is believed that this causeway resulted in the development of the swamp areas as shown in maps as early as the 1920's. In the 1960's the swamp area was used for sanitary landfill. The western portion has been sodded and extensively developed into a park for day users. The municipality of Belleville is presently placing clean landfill east of Hwy. 14 with the intention of developing it for recreational uses.
