**Highway 631 Rehabilitation - GWP 548-00-00
Culvert Replacement – Picnic Lake Culvert
Station 11+758 - Twp. of Hunt**

FINAL FOUNDATION INVESTIGATION AND DESIGN REPORT

Date: March 11, 2014
Ref. N^o: 13/03/13042-F1

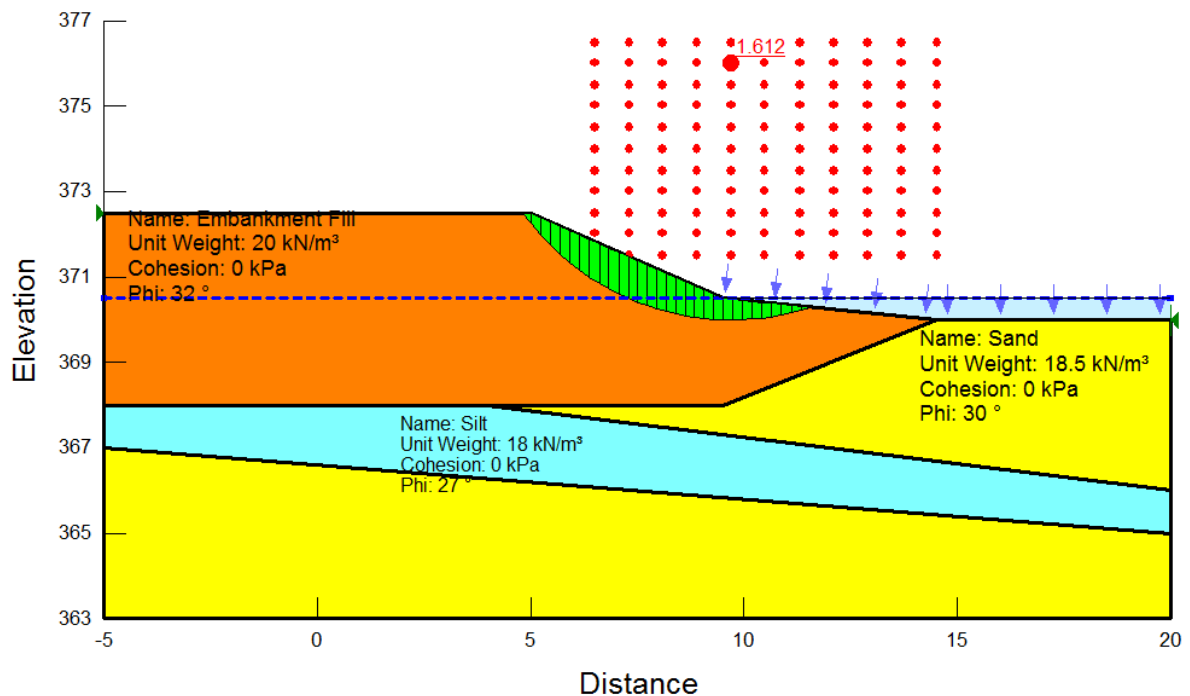
Figure S-1: Slope Stability Station 11+758, Twp of Hunt

Slope/W (GeoStudio 2007, version 7.17, Geo-Slope International Ltd.), was carried out at this location with embankment slopes of 2H:1V in granular fill. The embankment was modeled as a granular fill at the culvert location, as per backfilling recommendation in Section 5.6, and in consideration of the existing 2H:1V embankments slopes. For the purpose of these analyses, the materials were modeled using the following parameters;

PARAMETER	MATERIAL		
	EMBANKMENT FILL	SANDS	SILTS
Unit Weight (kN/m ³)	20	18.5	18.0
Effective Friction Angle (degrees)	32	30	27

The unit weights and friction angles for the slope calculations are based on general representative values for soil types, obtained through laboratory testing and tactile analysis. The results of the analysis indicated a factor of safety in the order of 1.6 against failure through the underlying native sand subgrade (as shown below in Figure No. S-1). As such, the stability of the final embankment will not be an issue provided it is properly constructed as outlined in Section 5.6.

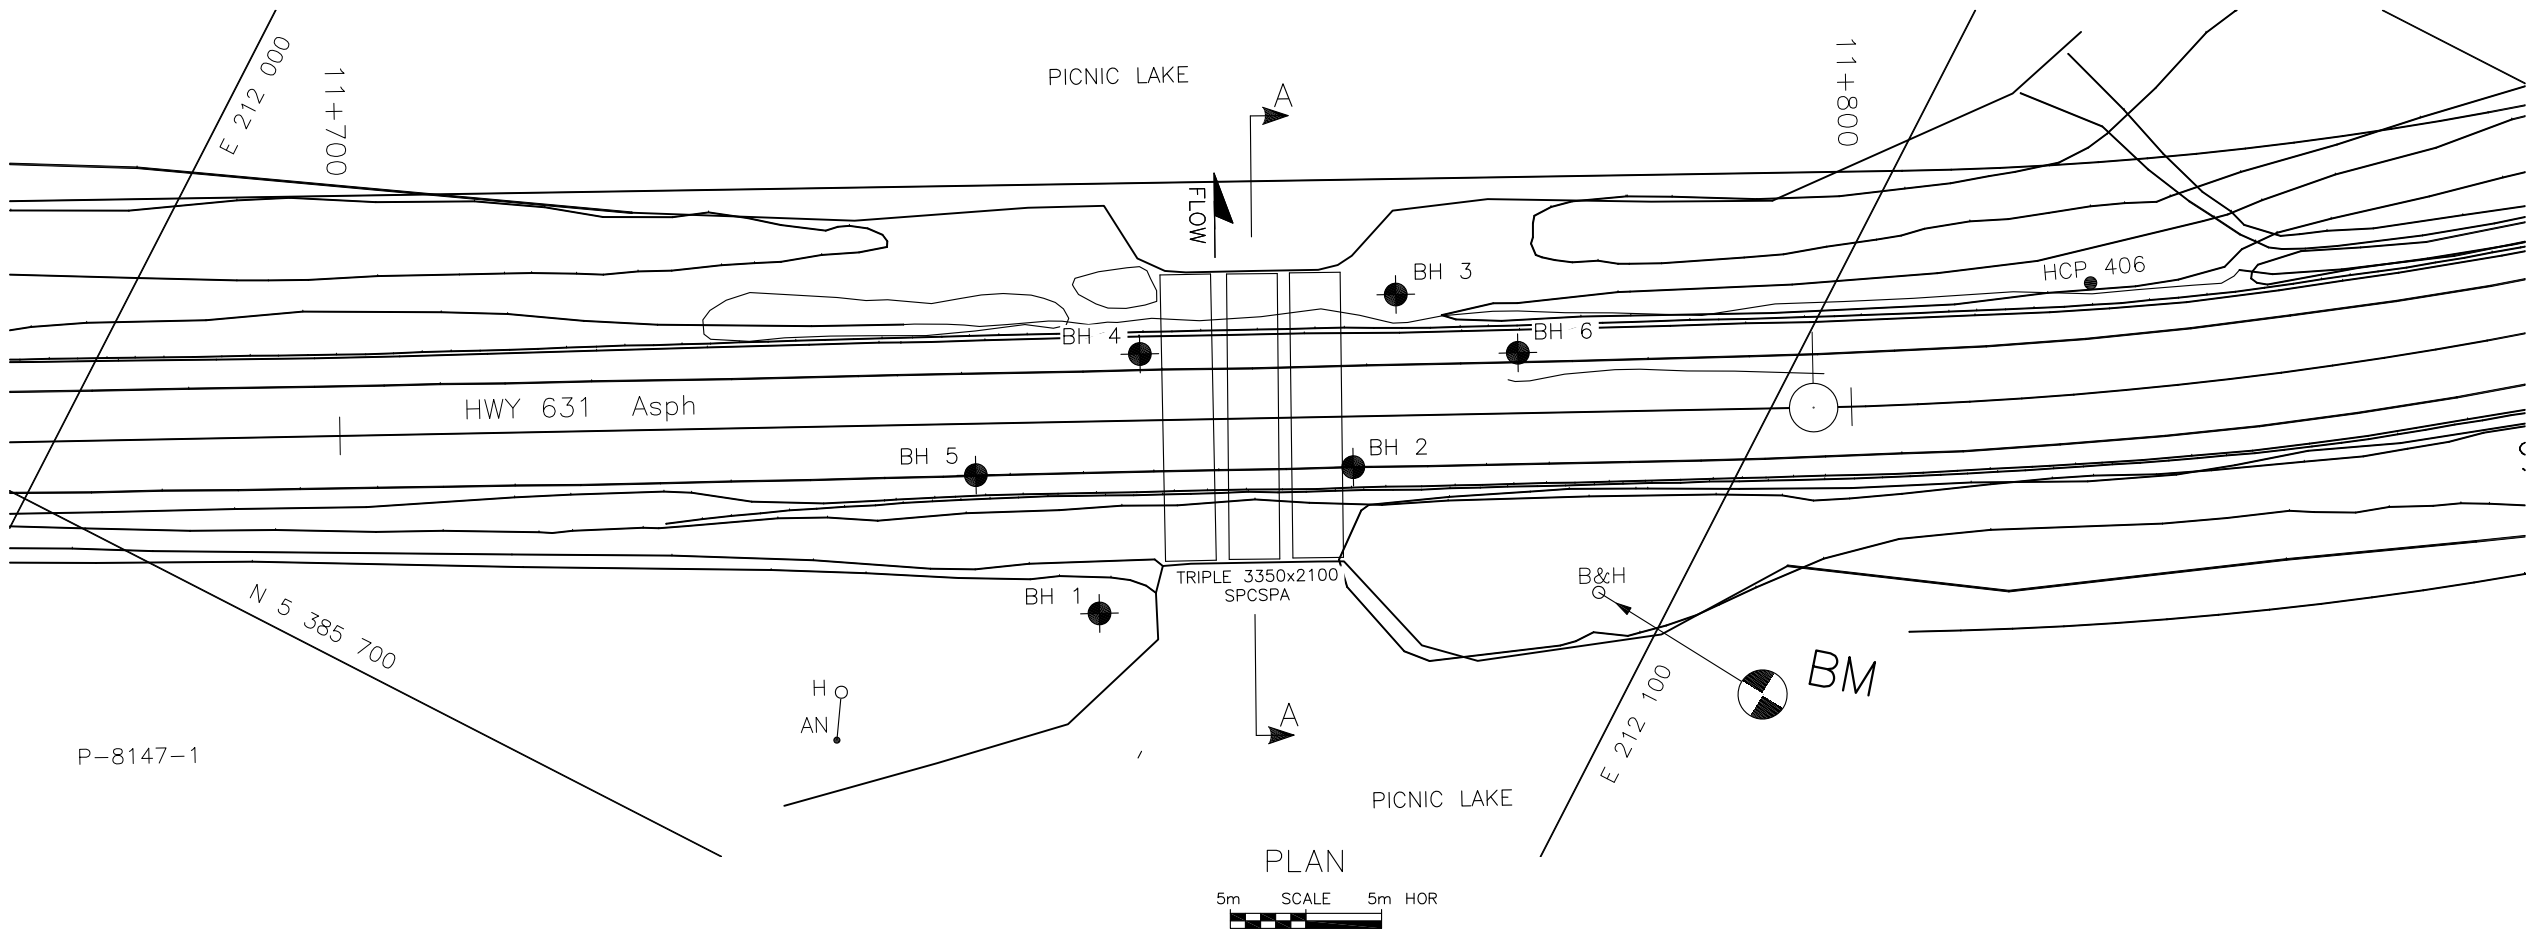
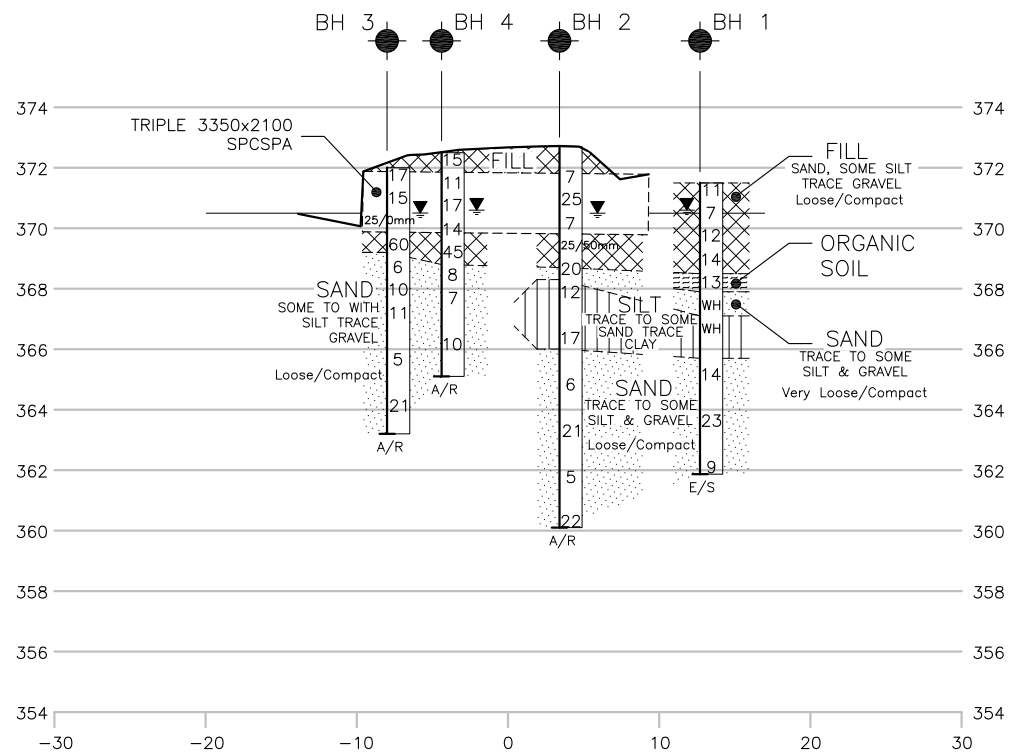
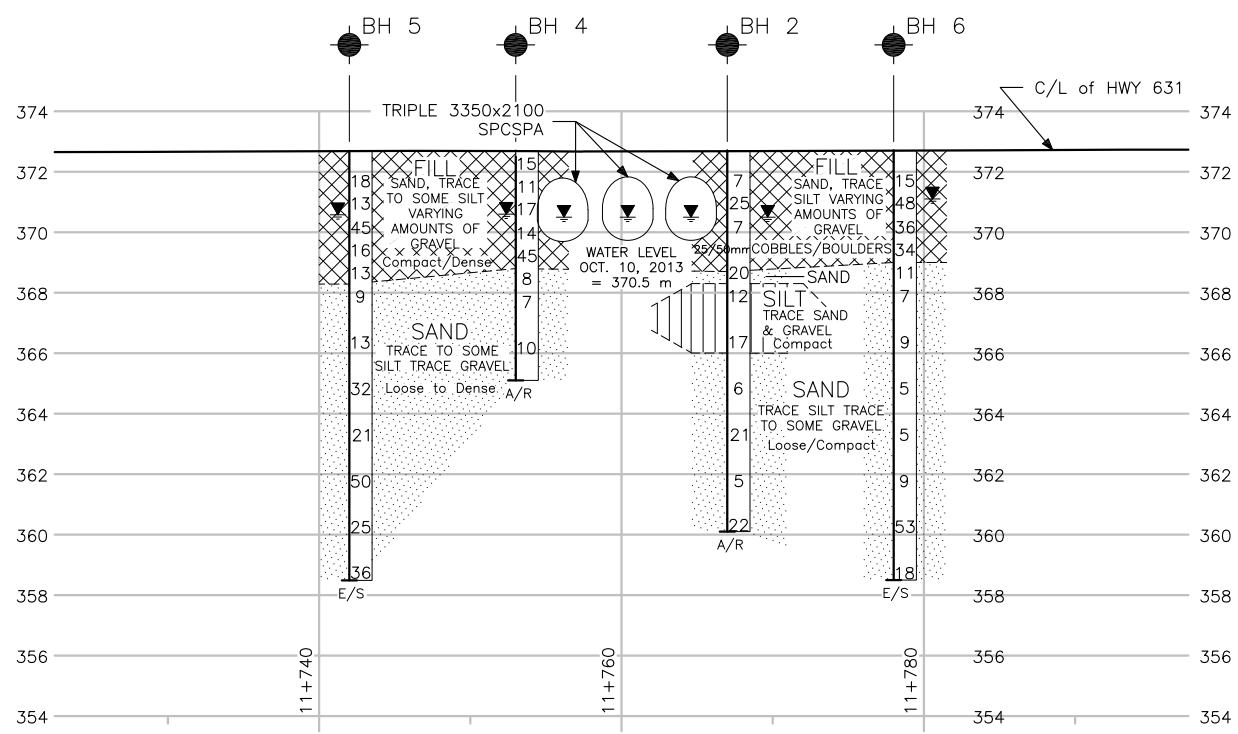
HWY 631
PICNIC LAKE CULVERT (SITE 38C-072)
HUNT TOWNSHIP
BOREHOLE LOCATIONS & SOIL STRATA

CROSS SECTION A - A

CENTRELINE PROFILE

Details of the subsurface conditions revealed by the investigation program are presented on the enclosed Record of Borehole Logs (Appendix 2) and on Drawing No. 2 (Appendix 3). It should be noted that the stratigraphic delineations presented on the borehole logs and soil strata plot are the result of non-continuous sampling, response to drilling progress, SPT and Dynamic Cone Penetration Test (DCPT) results, plus field observations at the time of drilling. Typically such boundaries represent transitions from one zone to another and are not an exact demarcation of a specific geological unit. Additional consideration should therefore be given to the fact that subsurface conditions may vary markedly between adjacent boreholes and beyond any specific boring location, and are shown on the drawings for illustration purposes only.

A plan and profile illustrating the borehole locations and stratigraphic sequences is provided on Drawing No. 2, Appendix 3. During the course of the exploration program, six (6) sampled boreholes were put down at this site, with Borehole Nos. 2, 4, 5, and 6 advanced through the embankment, and Borehole Nos. 1 and 3 advanced at the culvert outlet and inlet, respectively. At the time of the subsurface investigation, the ground surface elevations at Boreholes Nos. 1 to 6 were recorded at 371.5, 372.7, and 372.0, 372.7, 372.7, and 372.7 m, respectively.

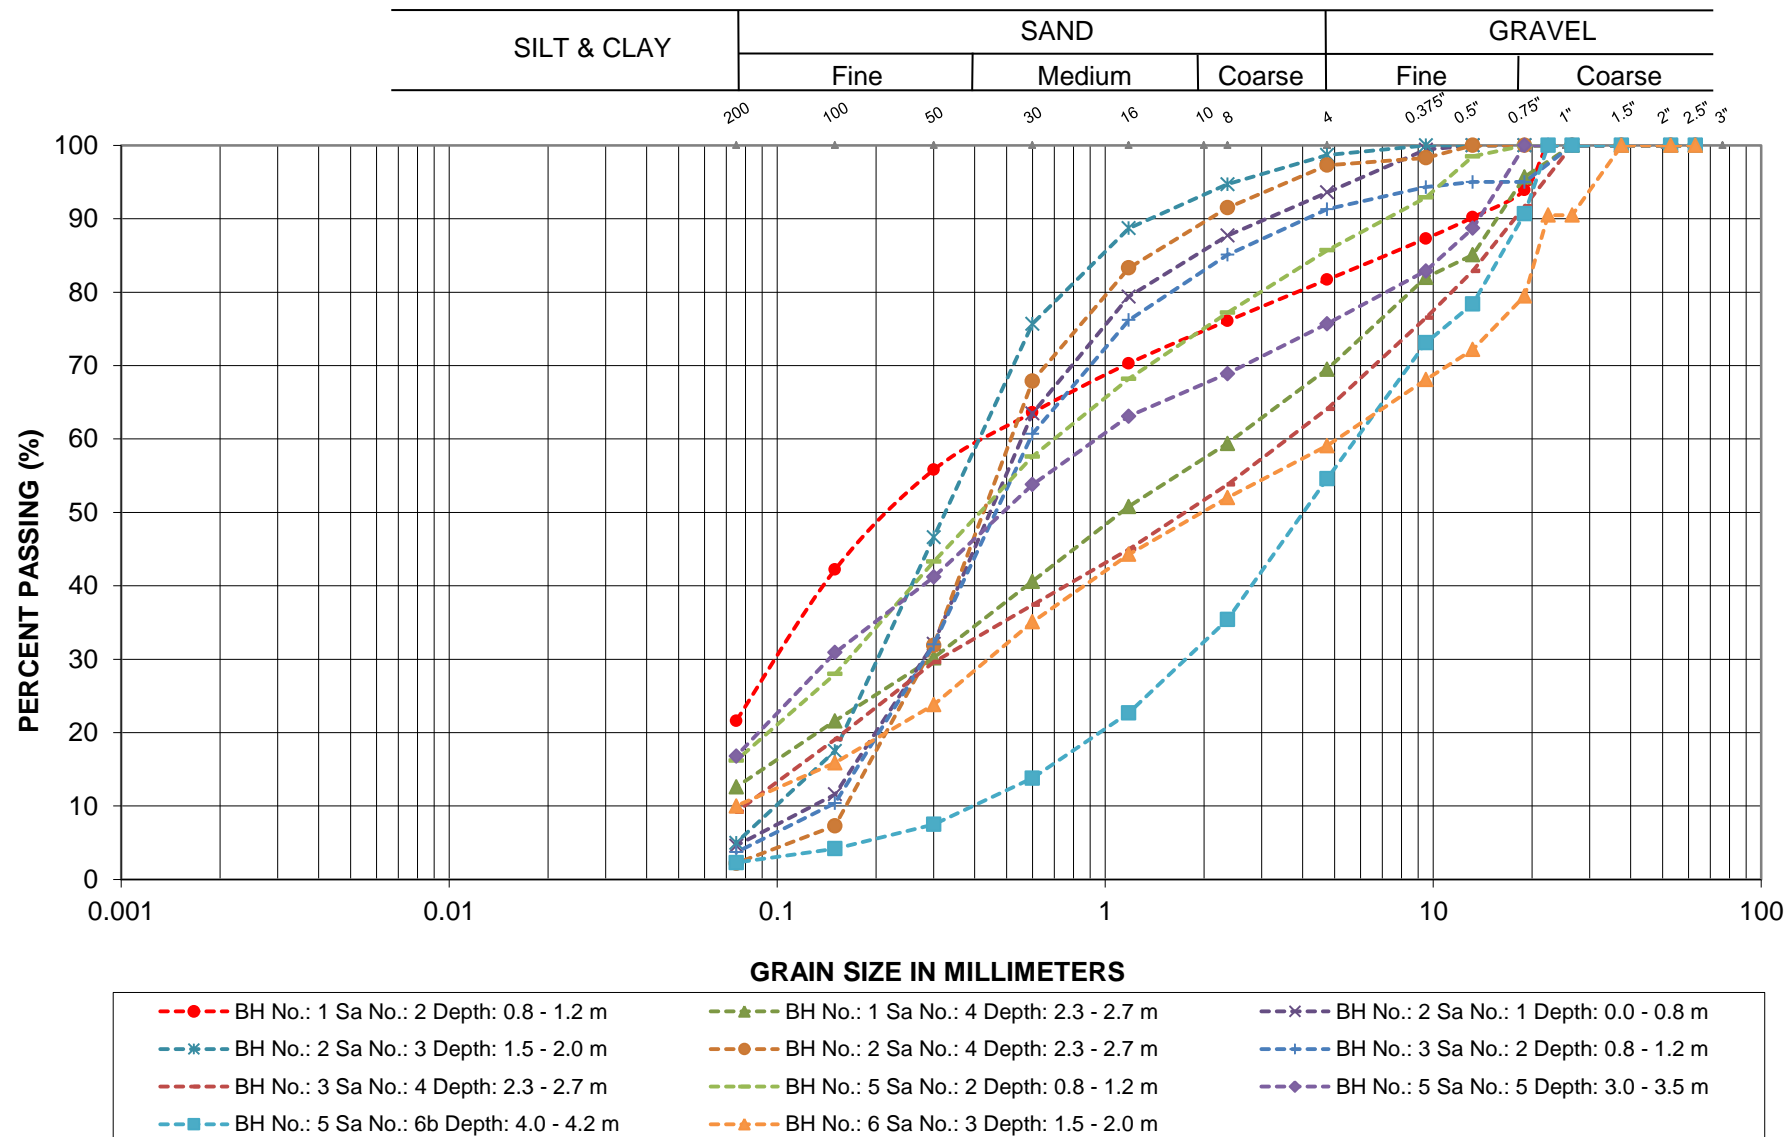
FILL

on eleven (11) samples of this deposit, the results of which indicated 1 to 45% gravel size particles, 53 to 96% sand size particles, and 1 to 22% silt and clay size particles (Figure No. L-1, Appendix 3). Based on SPT 'N' values of 7 to 60 blows per 300 mm penetration, the compactness of this deposit was described as loose to very dense, generally compact. The fill layer was encountered to depths of 2.8 to 4.4 m below grade (Elevation 369.2 to 368.3 m)

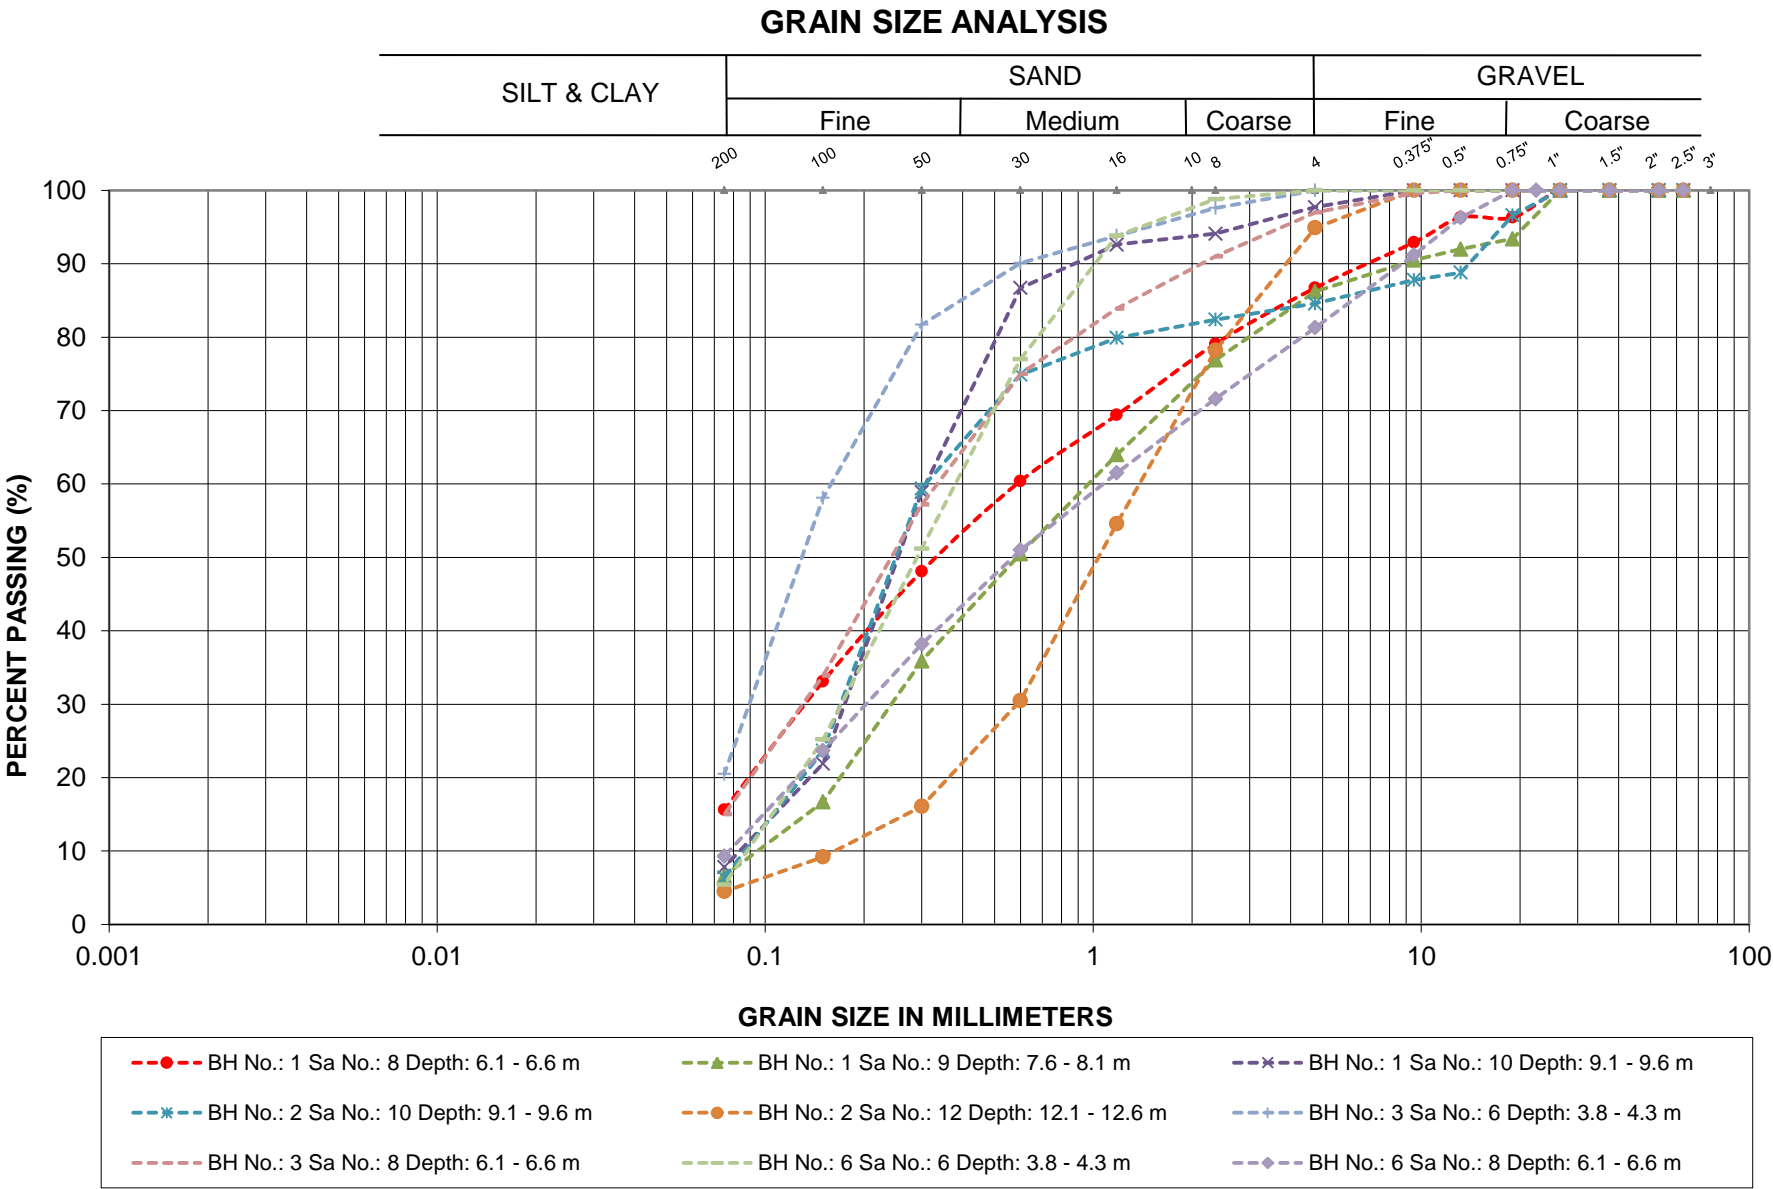
SAND

Gradation analyses were carried out on nine (9) samples of this deposit, the results of which indicated 0 to 20% gravel size particles, 71 to 95% sand size particles, and 5 to 21% silt and clay size particles (see Figure No. L-4, Appendix 3). Based on SPT 'N' values of 5 to 53 blows per 300 mm penetration, this deposit was described as loose to very dense, generally compact. Auger refusal was encountered in this deposit at depths of 12.6, 8.8, and 7.4 m below grade at Borehole Nos. 2, 3 and 4, respectively (Elevations 360.1, 363.2 and 365.3 m, respectively). Sampling was terminated in this deposit at depths of 9.6, 14.2, and 14.2 m below grade at Borehole Nos. 1, 5, and 6, respectively (Elevations 361.9, 358.5, and 358.5 m, respectively).

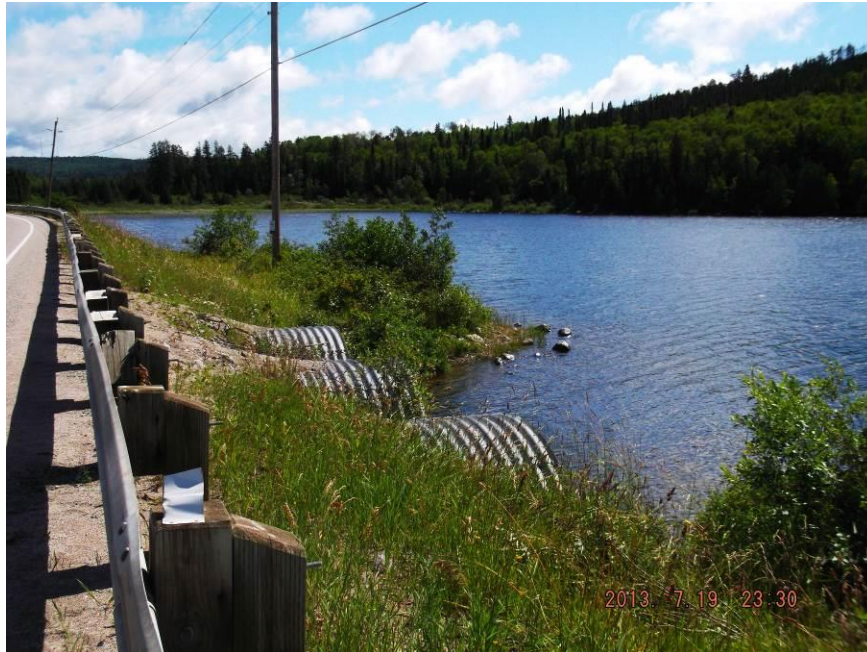
Photo: 1

Culvert Inlet – Right Side, Looking North

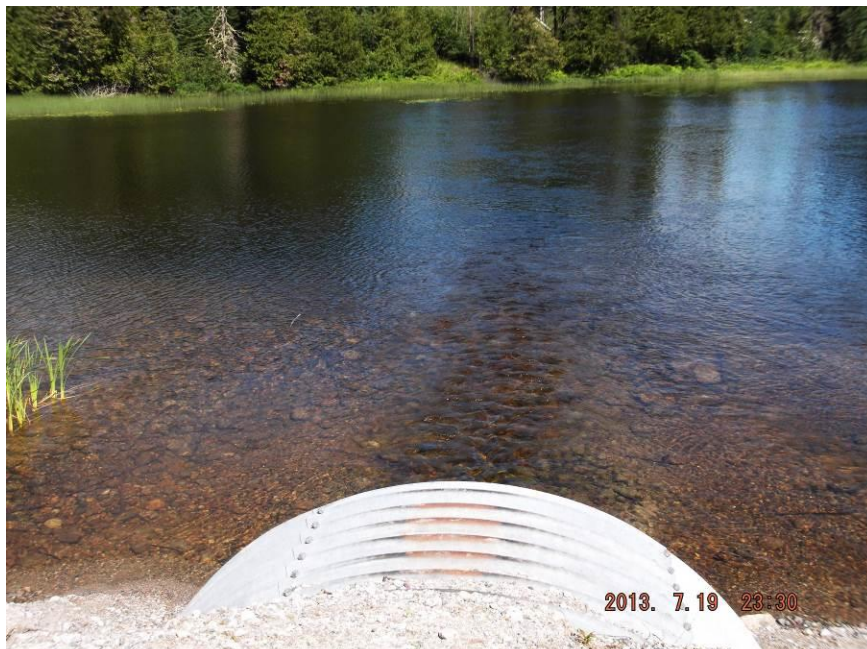
Photo: 2

Culvert Outlet – Left Side Looking West

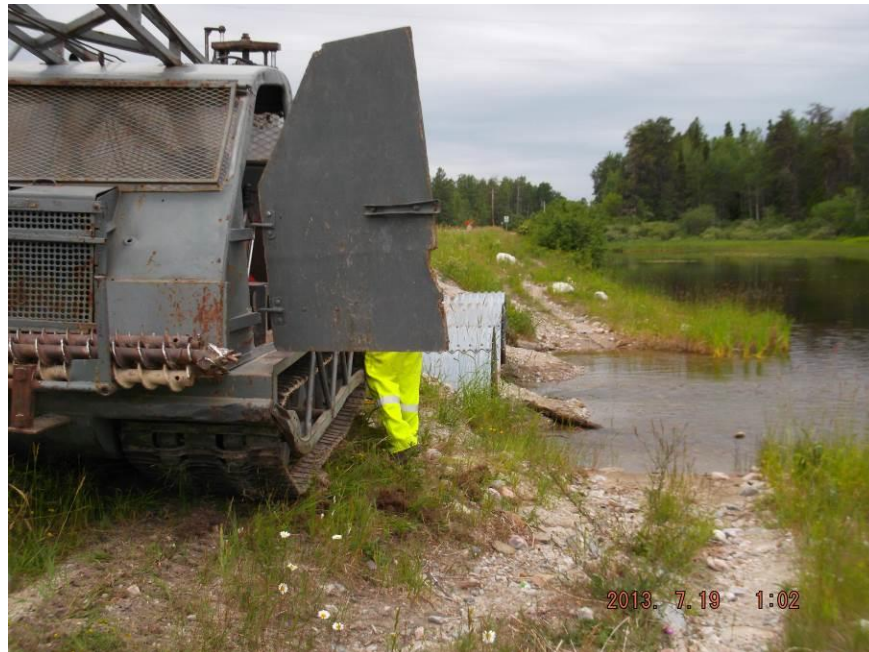
Photo: 3

Culvert Outlet – Left Side, Looking South

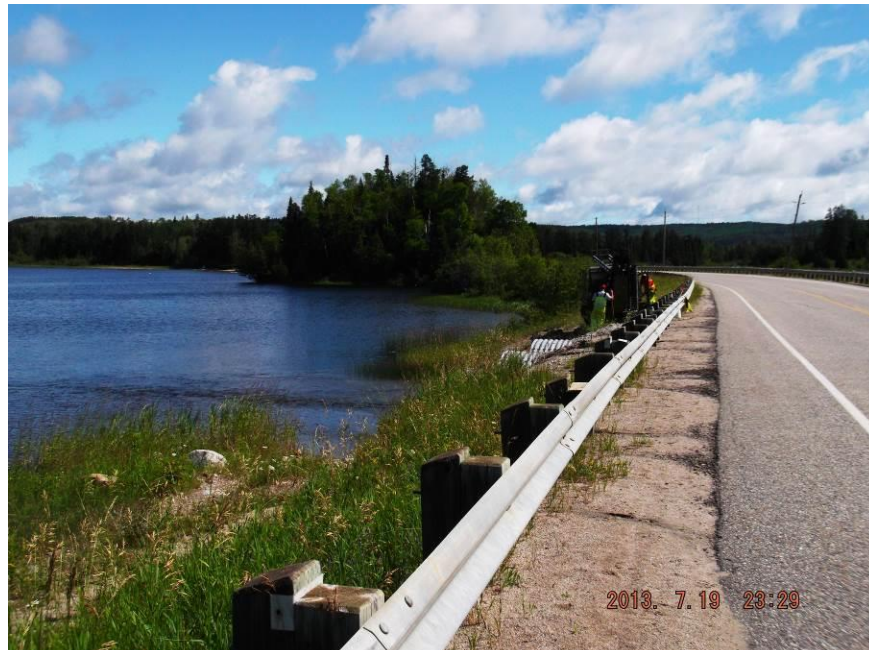
Photo: 4

Culvert Outlet – Left Side Looking North
