TECHNICAL MEMORANDUM

DATE October 17, 2018 **Project No.** 1541608 - 16000 (Part E)

**SUMMARY OF FOUNDATION INVESTIGATION AT CULVERT STA. 20+100, CLERGUE TWP.
HIGHWAY 11, FROM WEST JUNCTION OF HIGHWAY 101 NORTHERLY 34.4 KM
GWP 5205-10-00, AGREEMENT NUMBER 5015-E-0012, ASSIGNMENT NO. 16, PART E
GEOCRES NUMBER 42A-126**

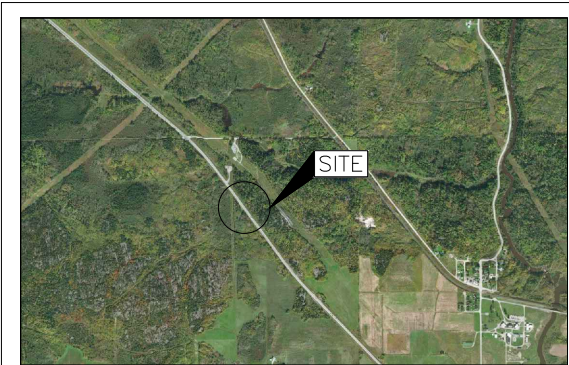
CONT No. . GWP No. 5205-10-00		 SHEET
HIGHWAY 11 BOREHOLE LOCATION

BOREHOLE CO-ORDINATES (MTM NAD83 ZONE 12)			
No.	ELEVATION	NORTHING	EASTING
Borehole No. 18-1	278.0	5390054.9	326780.5

The field work for the foundation investigation was carried out on August 8, 2018, during which time one borehole (Borehole 18-1) was advanced at the location of the proposed culvert replacement on the left shoulder of Highway 11 adjacent to the existing culvert as shown on Drawing 1. The borehole was advanced using a truck-mounted CME-75 drill rig, supplied and operated by Landcore Drilling Ltd of Chelmsford Ontario.

BOREHOLE NUMBER	NORTHING (LATITUDE)	EASTING (LONGITUDE)	GROUND SURFACE ELEVATION	BOREHOLE DEPTH
1	5390054.9 (48.648620)	326780.5 (-80.701671)	278.0 m	14.3 m

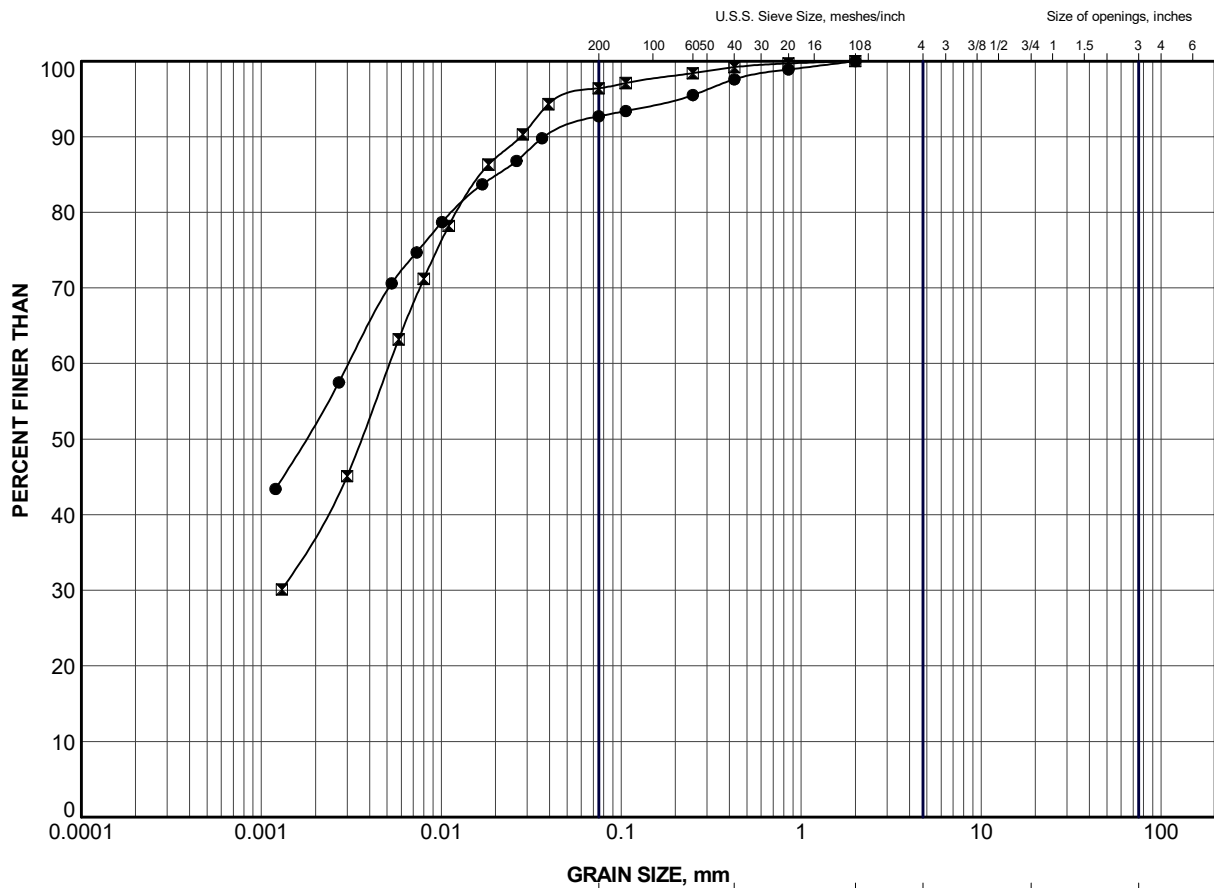
Borehole 18-1 was advanced through the existing Highway 11 embankment and penetrated a 5.9 m thick layer of fill. The embankment fill consists of a 2.7 m thick layer of granular material comprised of brown, moist sand, some gravel, trace to some silt (refer to Figure 1); cobbles were encountered within the granular fill from 100 mm to 1.5 m depths. Underling the granular fill a 3.2 m thick layer of silty clay fill was encountered extending to a depth of 5.9 m (Elevation 272.1 m). The silty clay fill is brown to grey, moist and contains trace sand (refer to Figure 2) and trace organics; a 200 mm thick seam of moist, brown sand and gravel fill was encountered interlayered with the silty clay fill at a depth of 3.2 m. Atterberg limits tests on two samples of the cohesive fill measured liquid limits of about 43 percent and 36 percent, plastic limits of about 19 per cent and 17 per cent, and corresponding plasticity indices of about 24 per cent and 18 per cent. The test results are presented on Figure 3 and indicate that the cohesive fill is silty clay of intermediate plasticity.

The SPT 'N'-values measured within the silty clay fill range from 9 blows to 10 blows per 0.3 m of penetration, and one field vane test measured an undrained shear strength of the silty clay greater than 100 kPa, indicating a stiff to very stiff consistency. The moisture content of two samples of the silty clay fill is 23 per cent and 29 per cent.

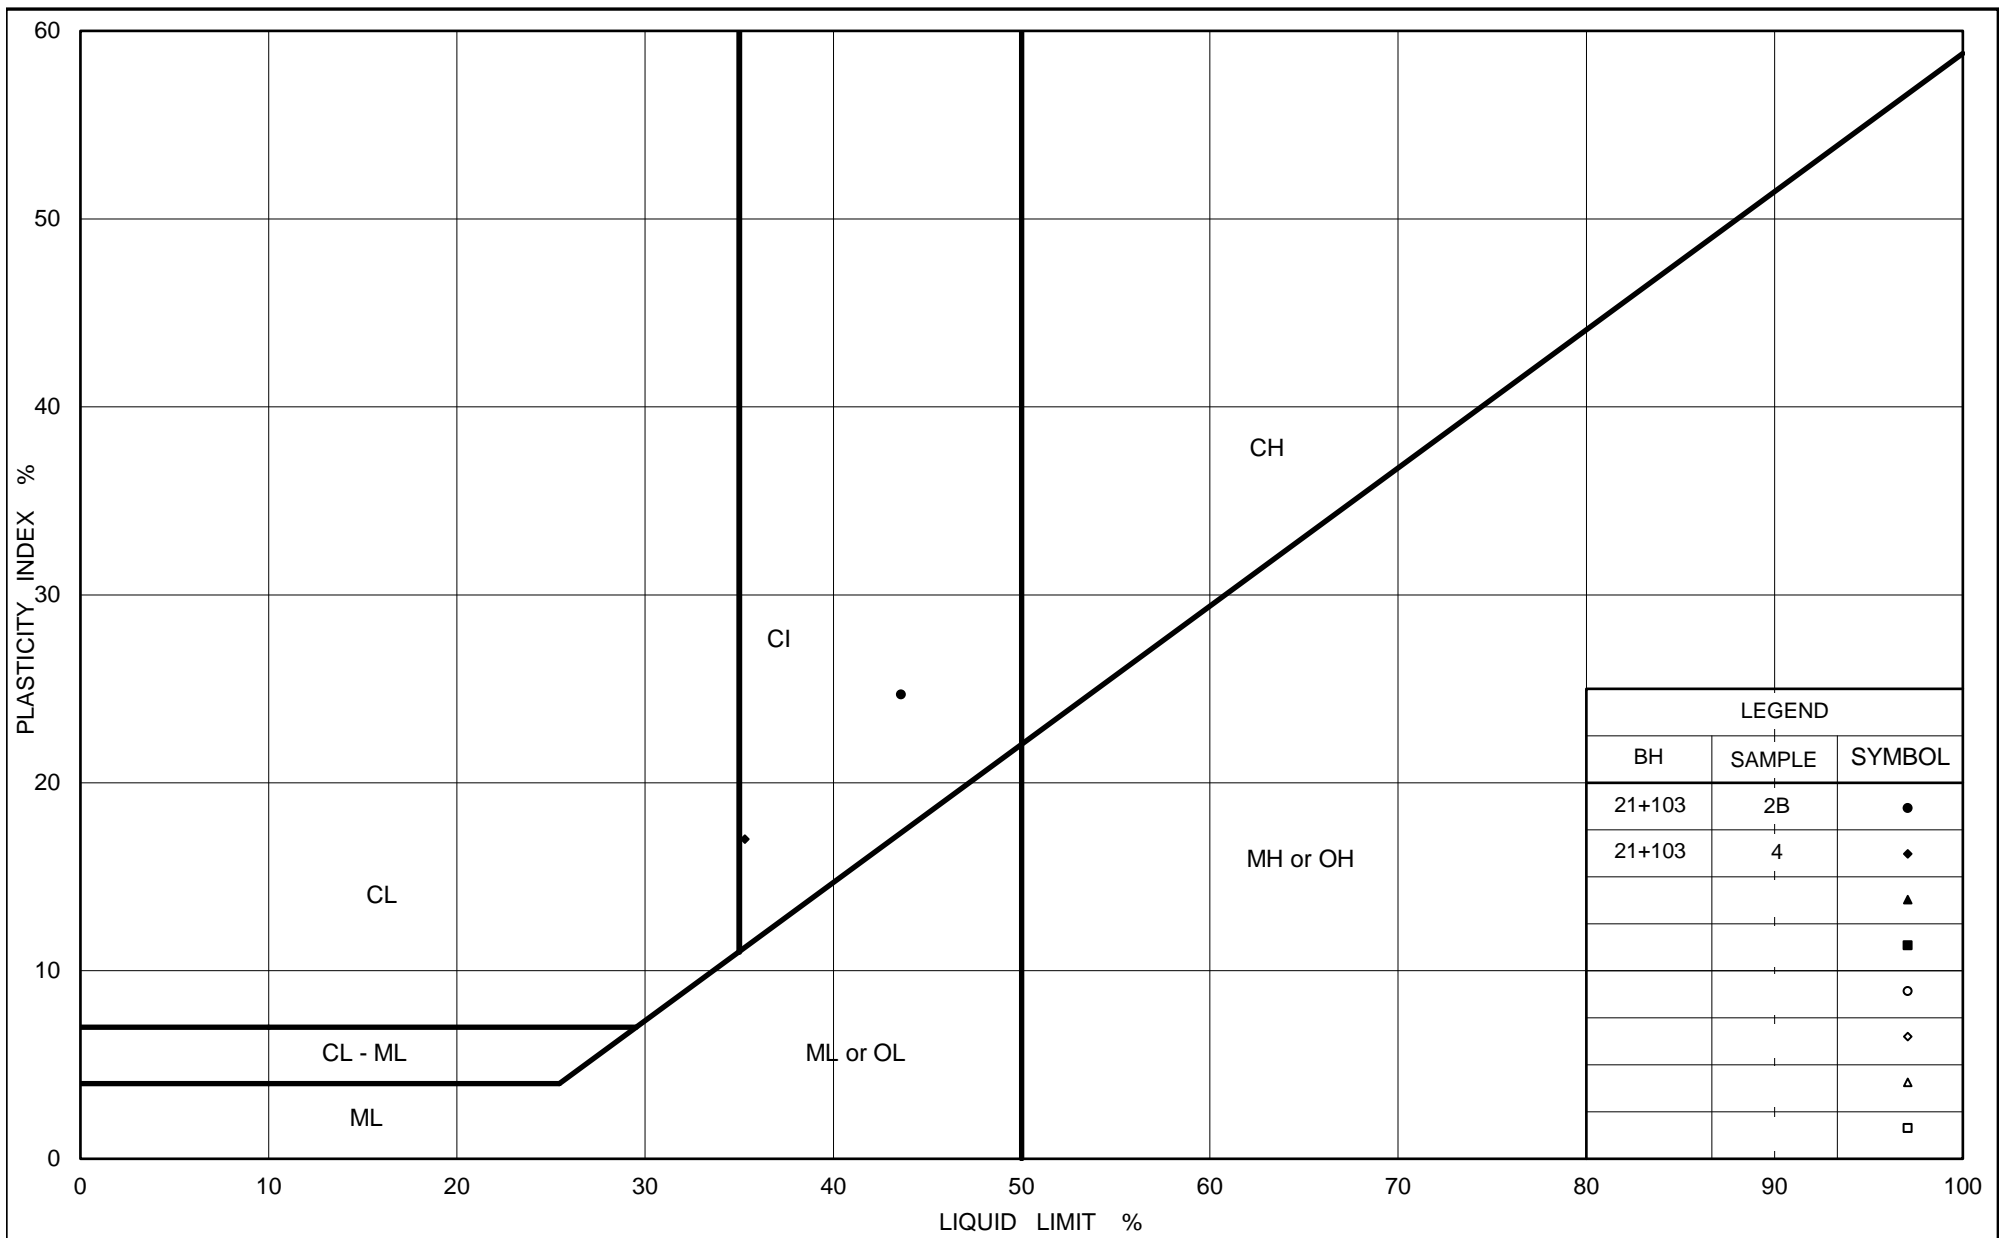
An Atterberg limit tests carried out a sample of this layer yielded a liquid limit of 63 per cent, a plastic limit of 26 per cent and a plasticity index of 37 per cent, indicating that the material is a clay of high plasticity as shown on Figure 5.

An Atterberg limit test carried out on a sample of the lower stratum yielded a liquid limit of about 46 per cent, a plastic limit of about 20 per cent and plasticity index of about 26 per cent, indicating that the material is a silty clay of intermediate plasticity as shown on Figure 5.
