**Foundation Investigation Report
Removal of CNR Overhead
Structures (Sites 5-49E and 5-49W)
Highway 401 – Southwold Township,
Ontario**

G.W.P. 3132-12-00
Geocres No. 40114-188

Prepared by:
Stantec Consulting Ltd.
400 – 1331 Clyde Avenue
Ottawa, ON K2C 3G4

October 2019

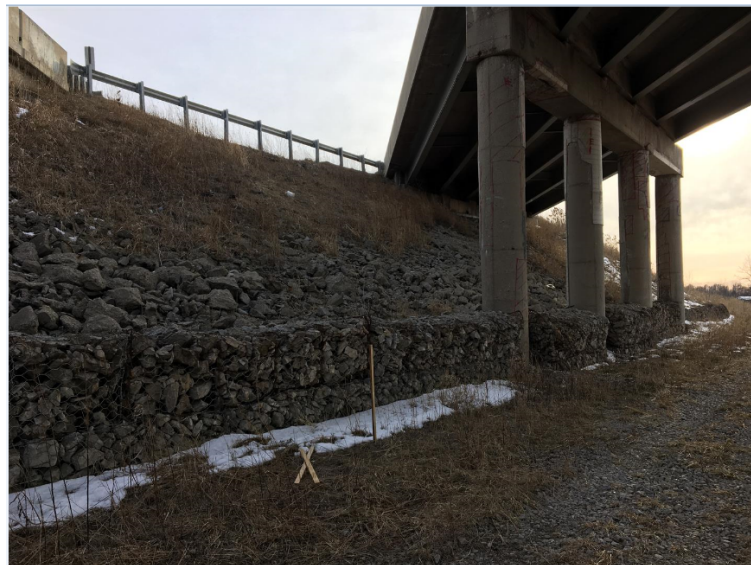
A low gabion basket wall has been constructed at the toe of the slope beneath the bridge abutments and rockfill materials have been placed on the slope as shown on Photograph 3.

Photograph 3 – Gabion Basket Wall and Rockfill on Slope Face Below Bridge Abutments
