Foundation Investigation Report

Rehabilitation of Highway 40 (Modeland Road) Overpasses at London Line

(Site Nos. 14X-0279/B1 and B2)
Highway 40, City of Sarnia, ON

March 18, 2022

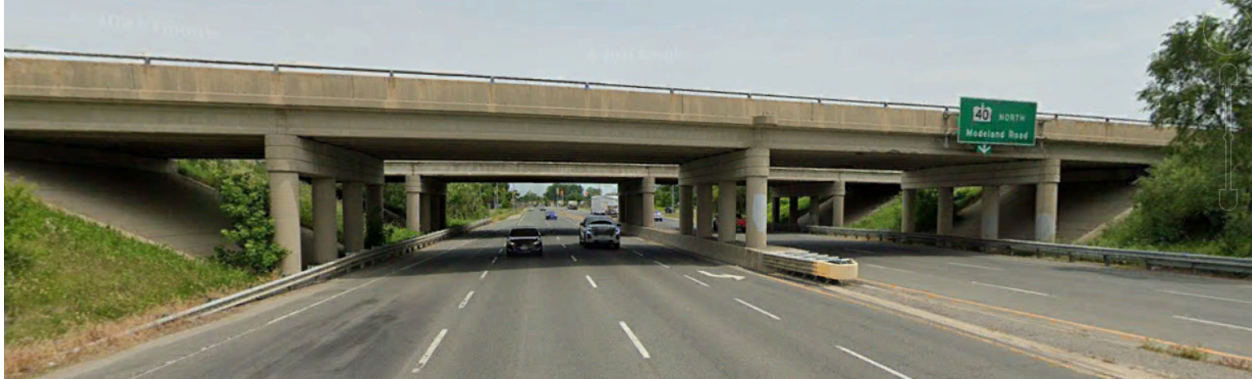
Photo 1: View of East Bridge (Looking West)

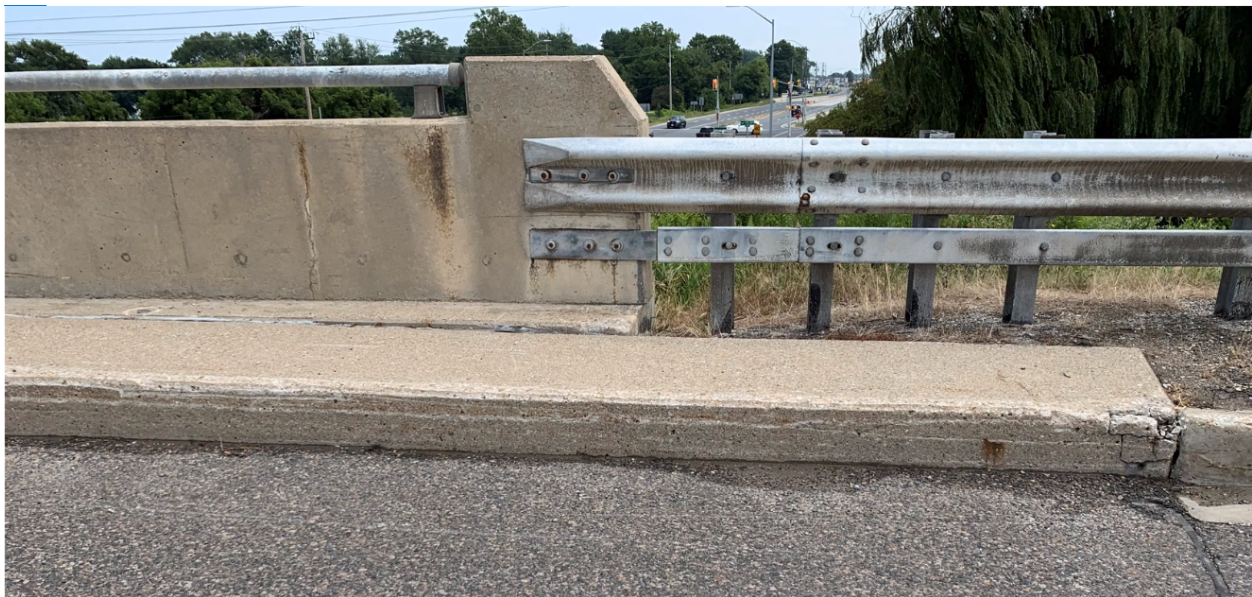
Photo 2: Settlement Between Approach Slab and Parapet Wall (East Bridge)

- There were signs of localized concrete spalling/delamination on the superstructures of both bridges.
- No indications of poor foundation performance were observed. Some differential settlement was noted between the approach slabs and the abutments/parapet walls on both bridges (see example of settlement in Photo 2 below).
- No indications of embankment instability were noted. The concrete protection present on the slopes below the abutments is typically in fair condition (see Photos 3 and 4 below).

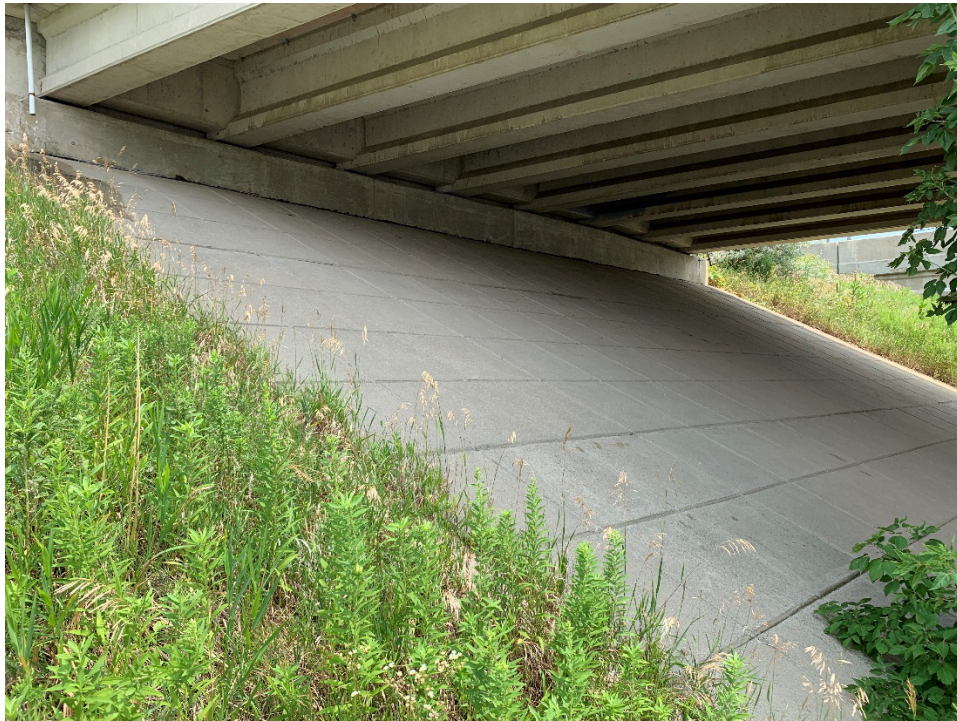
Photo 3: West bridge north abutment fore-slope (looking northeast)

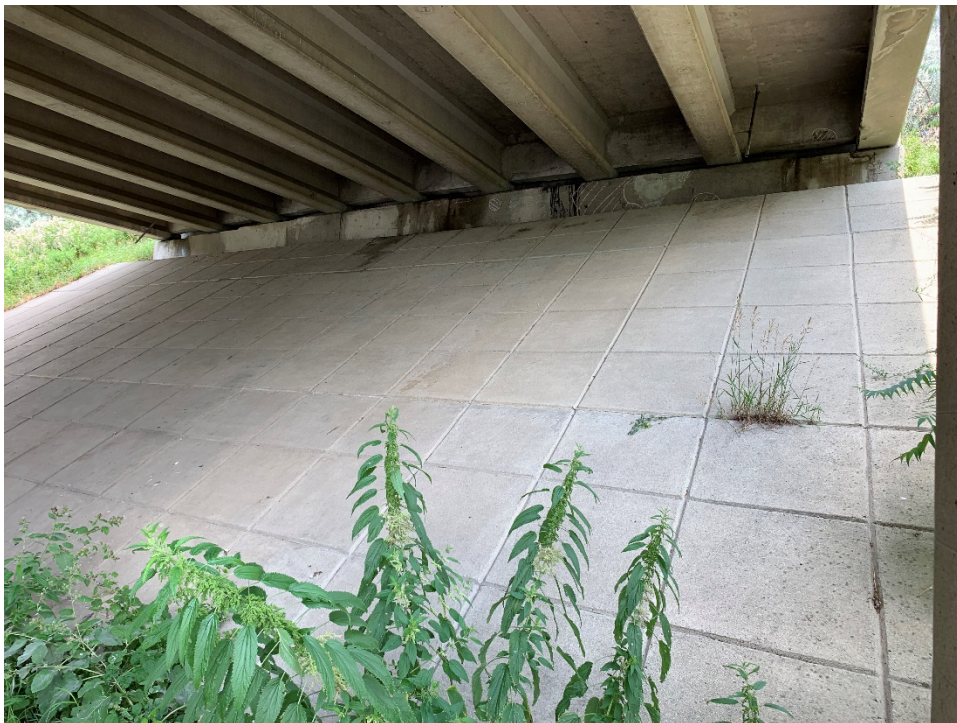
Photo 4: East bridge north abutment fore-slope (looking north)
