Foundation Investigation Report

*Sign Supports, High Mast Light and Closed Circuit Television (CCTV) Poles
Highway 410, Eglinton Avenue to Mayfield Road - Contract 2
Mississauga and Brampton, Ontario
Assignment No. 2016-E-0040, G.W.P. 2369-15-00*

GEOCRES No.: 30M12-445

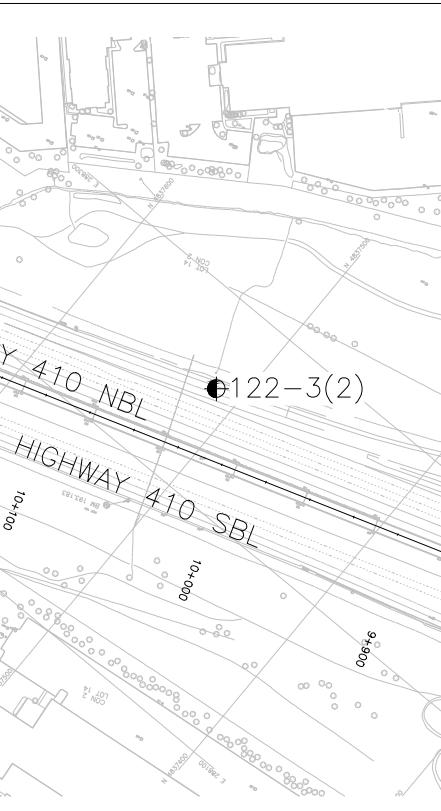
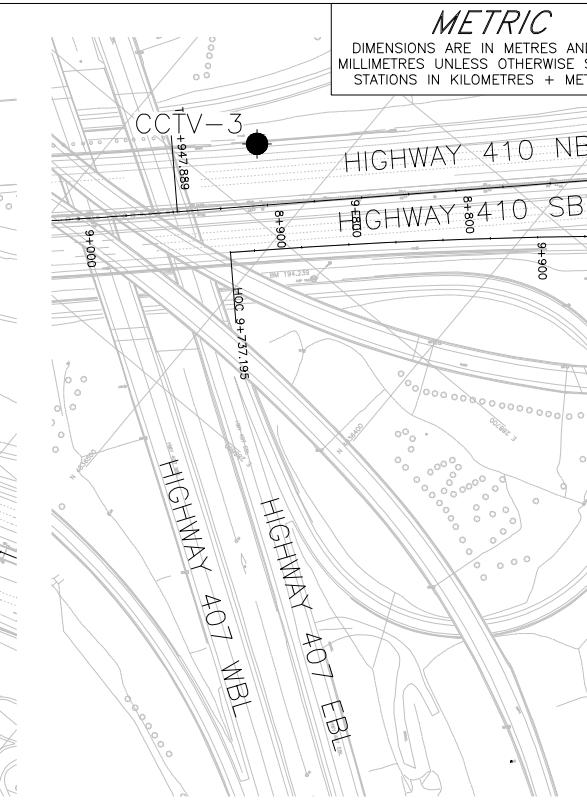
NO.	DATE	BY	REVISION
Geocres No. 30M12-445			
HWY. 410	PROJECT NO. 1669996	DIST. CENTRAL	
SUBM'D. NK	CHKD. NK	DATE: 05/09/2019	SITE: .
DRAWN: DD	CHKD. NK	APPD. LCC	DWG. 1

HIGHWAY 410
OHS, VMS, HML & CCTV POLES
BOREHOLE LOCATIONS

The 2019 foundation investigation for the sign supports, HML and CCTV poles was carried out between March 5 and March 25, 2019, during which time 14 boreholes (designated as Boreholes CCTV1, CCTV-3 to CCTV-6, HML-1, OH-1 to OH-6, VMS-1 and VMS-2) were advanced near the proposed foundation elements, as shown on Drawings 1 and 2. The borehole records are contained in Appendix B.
