FOUNDATION INVESTIGATION REPORT

OPEN CUT INSTALLATION OF NEW STORM SEWERS, HIGHWAY 11/ALGONQUIN AVE. GWP 5186-14-00, NORTH BAY, ONTARIO

Report Number: 1671122.2000 R2

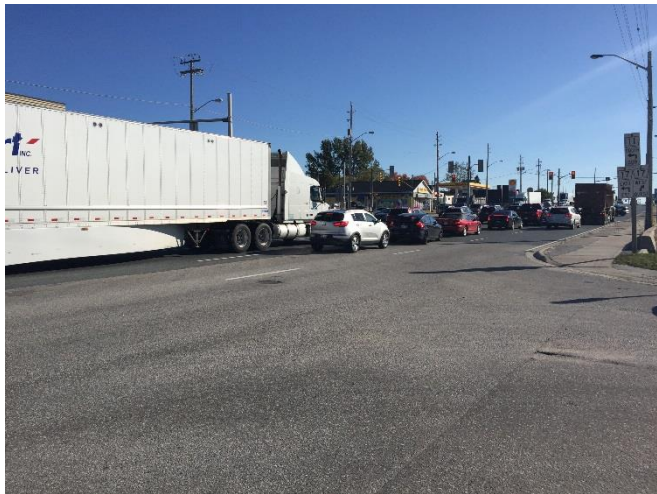
Figure 1: Heavy Traffic on Highway 11 looking from Champlain Ave. towards Shirreff Ave.

This portion of Highway 11 is used as a city thoroughway, and consists of an urban cross-section with sidewalks, businesses and parking lots on either side of the roadway. Street lights and traffic lights are present along this stretch of roadway. The land use is dense commercial within the project limits and the daily traffic volume is high (2016 Annual Average Daily Traffic ranges from 22,300 to 27,900 for this section of highway). The existing pavement is in fair condition and the main pavement distresses include extensive centreline, longitudinal and mid-lane cracking. Many utilities are also present within and crossing the roadway alignments. Site photographs are shown on Figures 1 to 5.

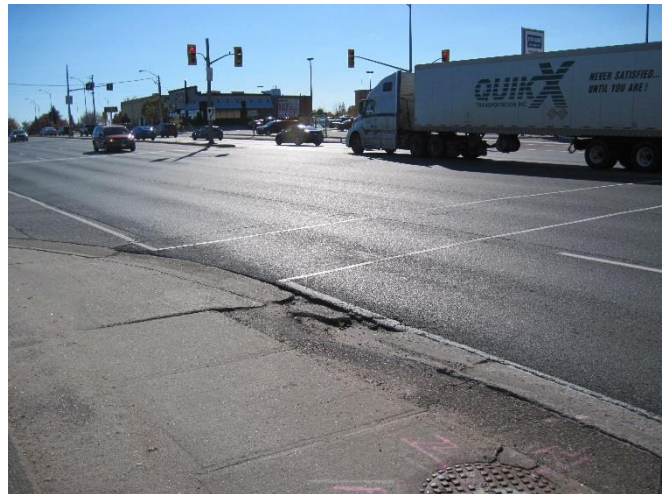
Figure 2: Traffic at Intersection of Highway 11 and Shirreff Ave., looking south from east side of the street

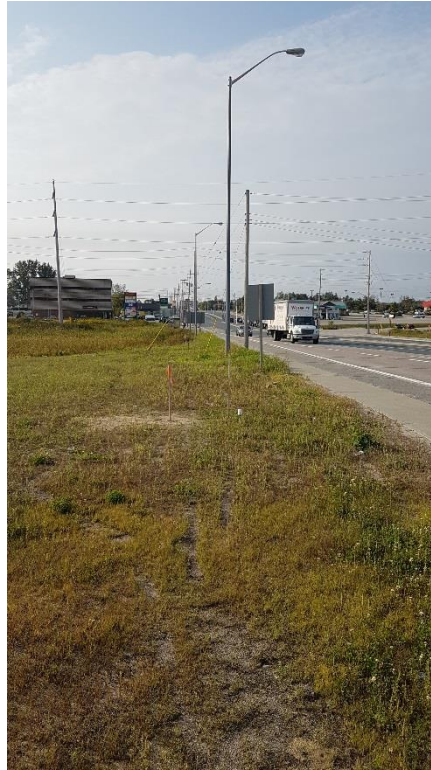
Figure 4: Looking south on grassed boulevard east of Highway 11 at approximate location of MH05

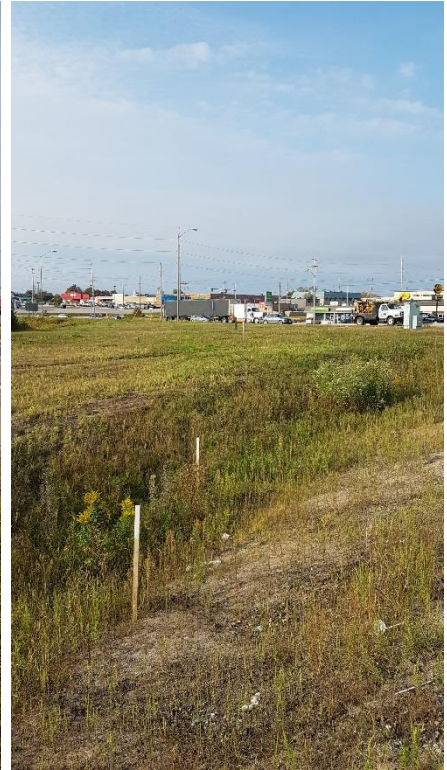
Figure 5: Looking southwest from grassed boulevard south of Airport Road at approximate location of MH06
