**Highway 560  
Six Mile Creek Culvert – Site No. 47-406/C  
Twp. of Mickle  
GWP 5242-11-00**

## **FINAL FOUNDATION INVESTIGATION REPORT**

Date: June 4, 2014  
Ref. N<sup>o</sup>: 13/05/13073-F4

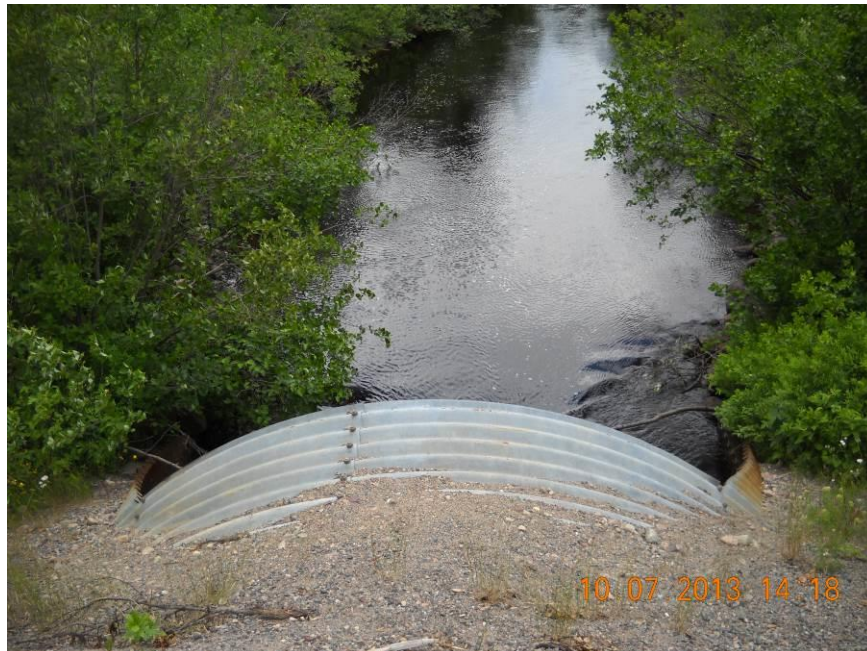
Photo: 1

Culvert Inlet – Looking North

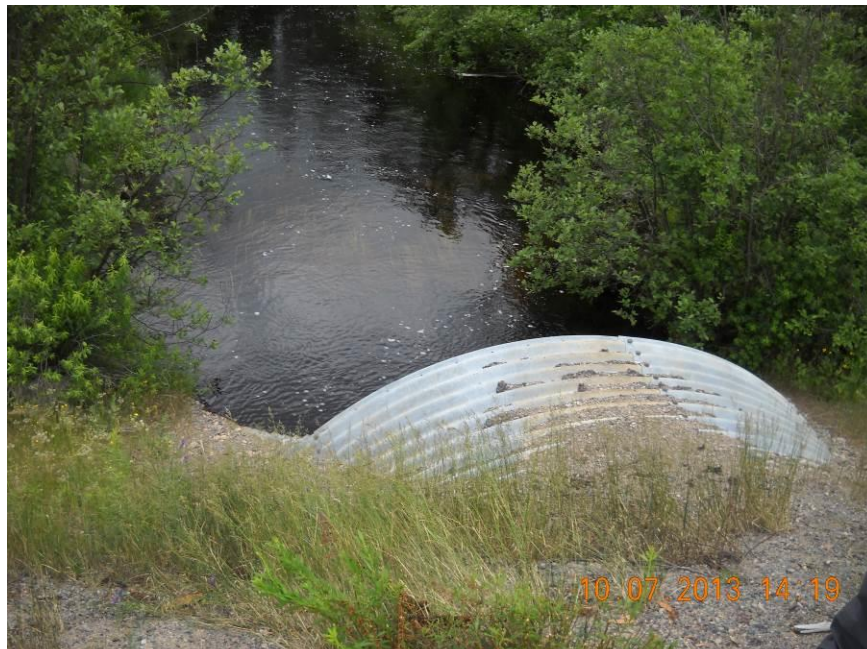
Photo: 2

Culvert Outlet – Looking South

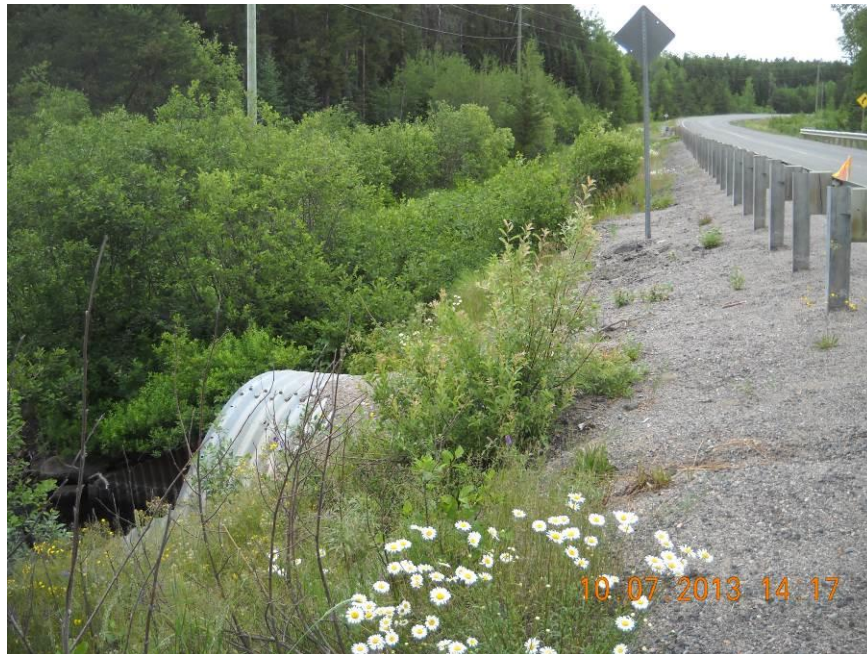
Photo: 3

Culvert Inlet – Looking East

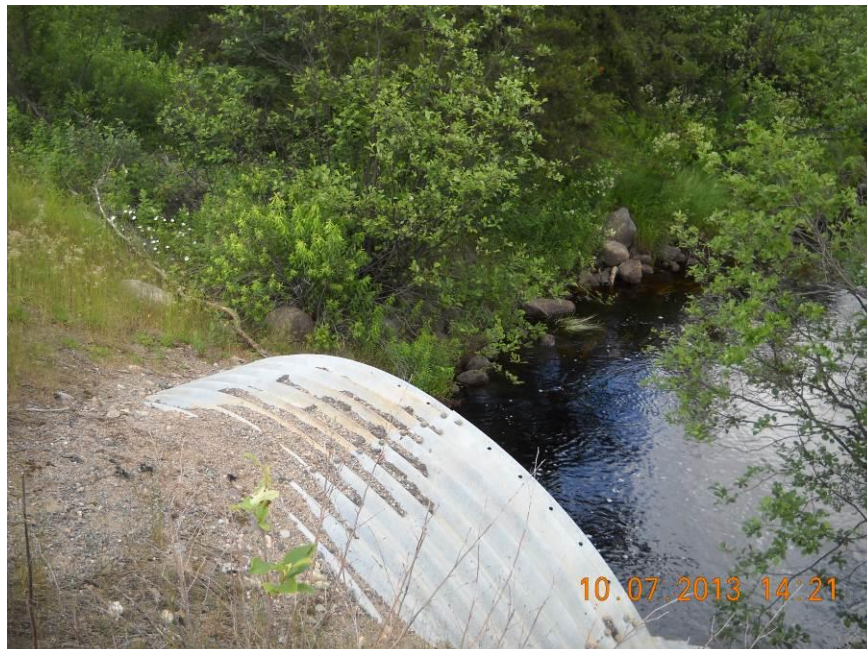
Photo: 4

Culvert Outlet – Note cobble/boulders in and around creek
