**Highway 560
Seven Mile Creek Culvert – Site No. 47-314/C
Twp. Of Mickle
GWP 5242-11-00**

FINAL FOUNDATION INVESTIGATION REPORT

Date: May 21, 2014
Ref. N^o: 13/05/13073-F5

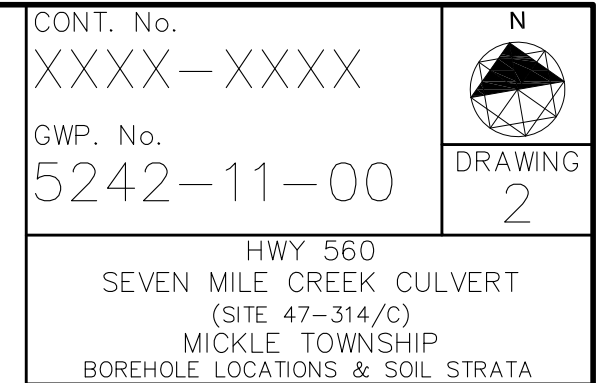
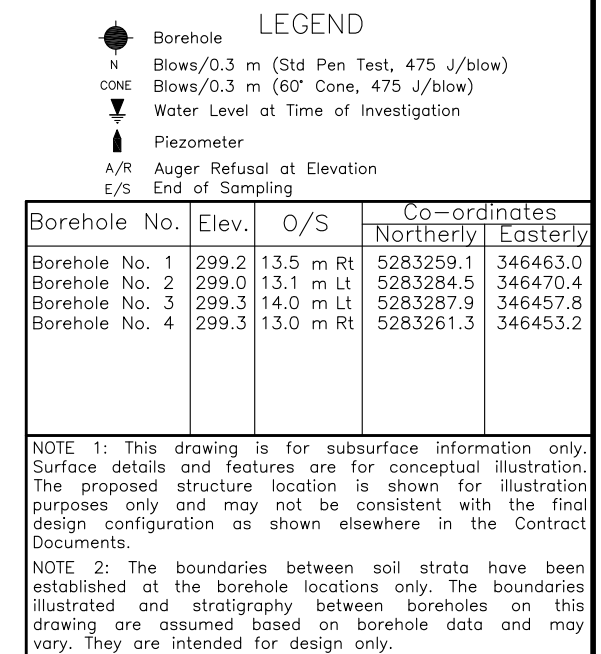
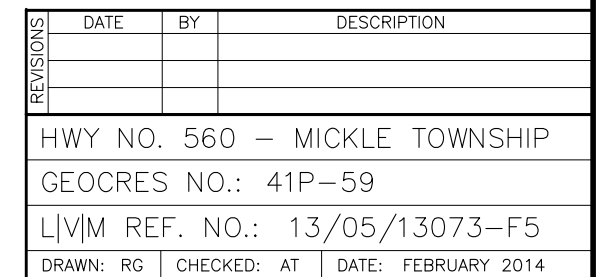
Drawing No. 2:	Borehole Location and Soil Strata
Figure No. L-1:	Grain Size Distribution Curves
Figure No. L-2:	Lab Test Summary Sheet

A plan and profile illustrating the borehole locations and stratigraphic sequences is shown on Drawing No. 2, Appendix 3. During the course of the exploration program, four (4) sampled boreholes were put down at this site, with Borehole Nos. 1 and 4 advanced at the culvert outlet (right/south) and Borehole Nos. 2 and 3 advanced at the culvert inlet (left/north). At the time of the subsurface investigation, the ground surface elevations at Boreholes Nos. 1 to 4 were recorded at 299.2, 299.0, 299.3, and 299.3 m, respectively.

Details of the subsurface conditions revealed by the investigation program are presented on the enclosed Record of Borehole Logs (Appendix 2) and on Drawing No. 2 (Appendix 3). Please

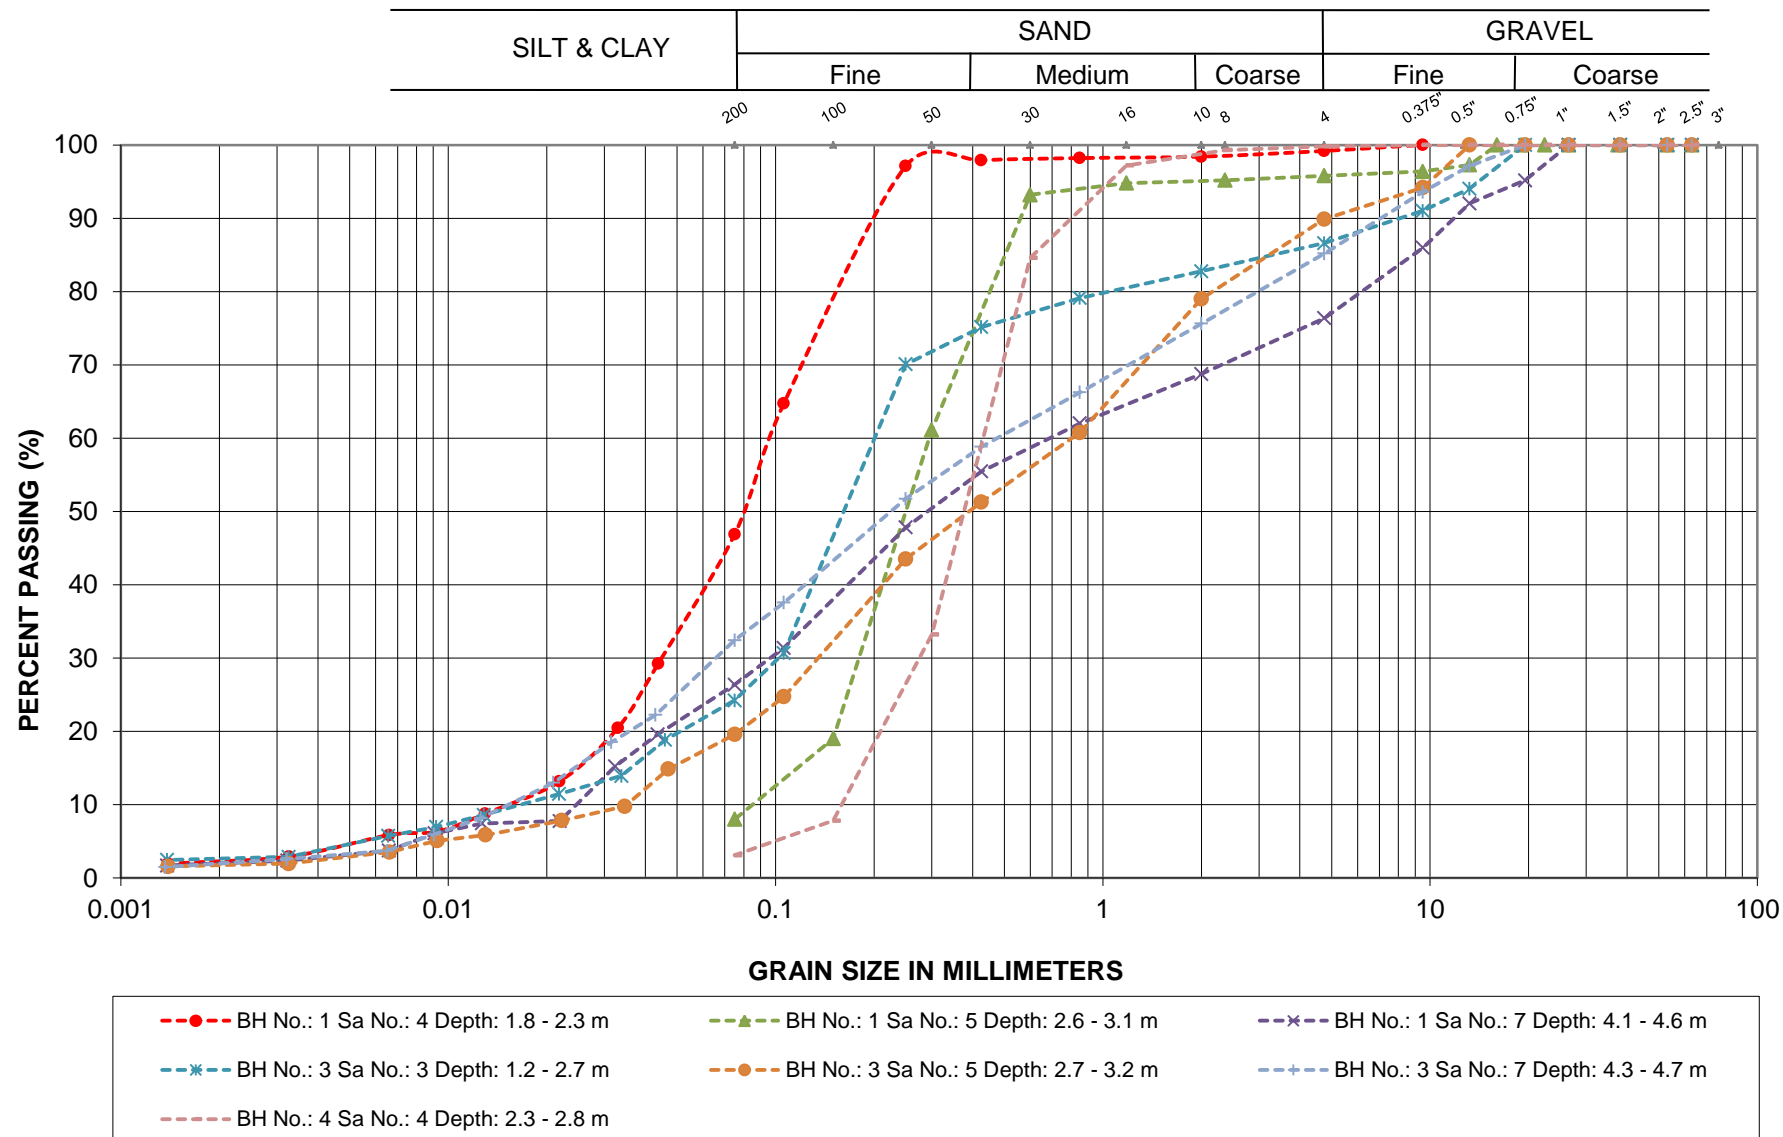
FIGURE L-1

GRAIN SIZE ANALYSIS

SANDS

The field work for this investigation was under the full time direction of a senior member of the LVM | Merlex engineering staff, who was responsible for locating the boreholes, clearing the borehole locations of underground services, in-situ sampling and testing operations, logging of the boreholes, labeling and preparation of samples for transport to our North Bay laboratory, plus overall drill supervision. All samples received a visual confirmatory inspection in our laboratory. Laboratory testing of select samples included routine testing for natural moisture content determination and particle size analysis. The results of the laboratory testing are presented on the individual Record of Borehole Sheets (Appendix 2), with a summary of results presented on the laboratory sheets in Appendix 3 (Figures Nos. L-1 and L-2).

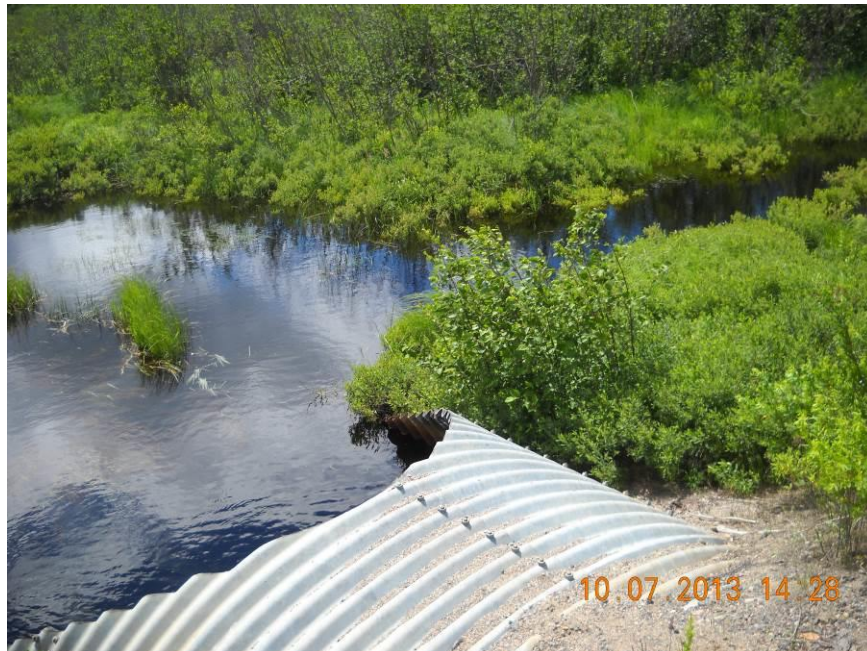
Photo: 1

Culvert Inlet – Looking North

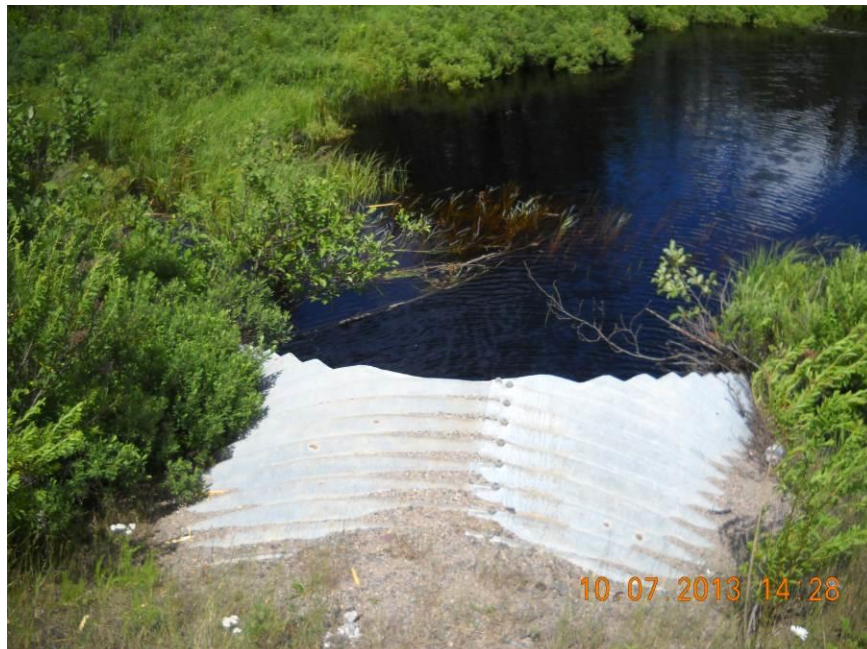
Photo: 2

Culvert Outlet – Looking South
