**FINAL
FOUNDATION INVESTIGATION REPORT
CULVERT STATION 18+688 – TWP. of Grenfell
GWP 162-98-00
MEL SITE C**

**Highway 11, From 0.3 km South of the Highway 11/66 Intersection
Northerly 11.7 km to 3.5 km South of Highway 570**

MEL Ref. No.: 09/10/09181C

November 15, 2010

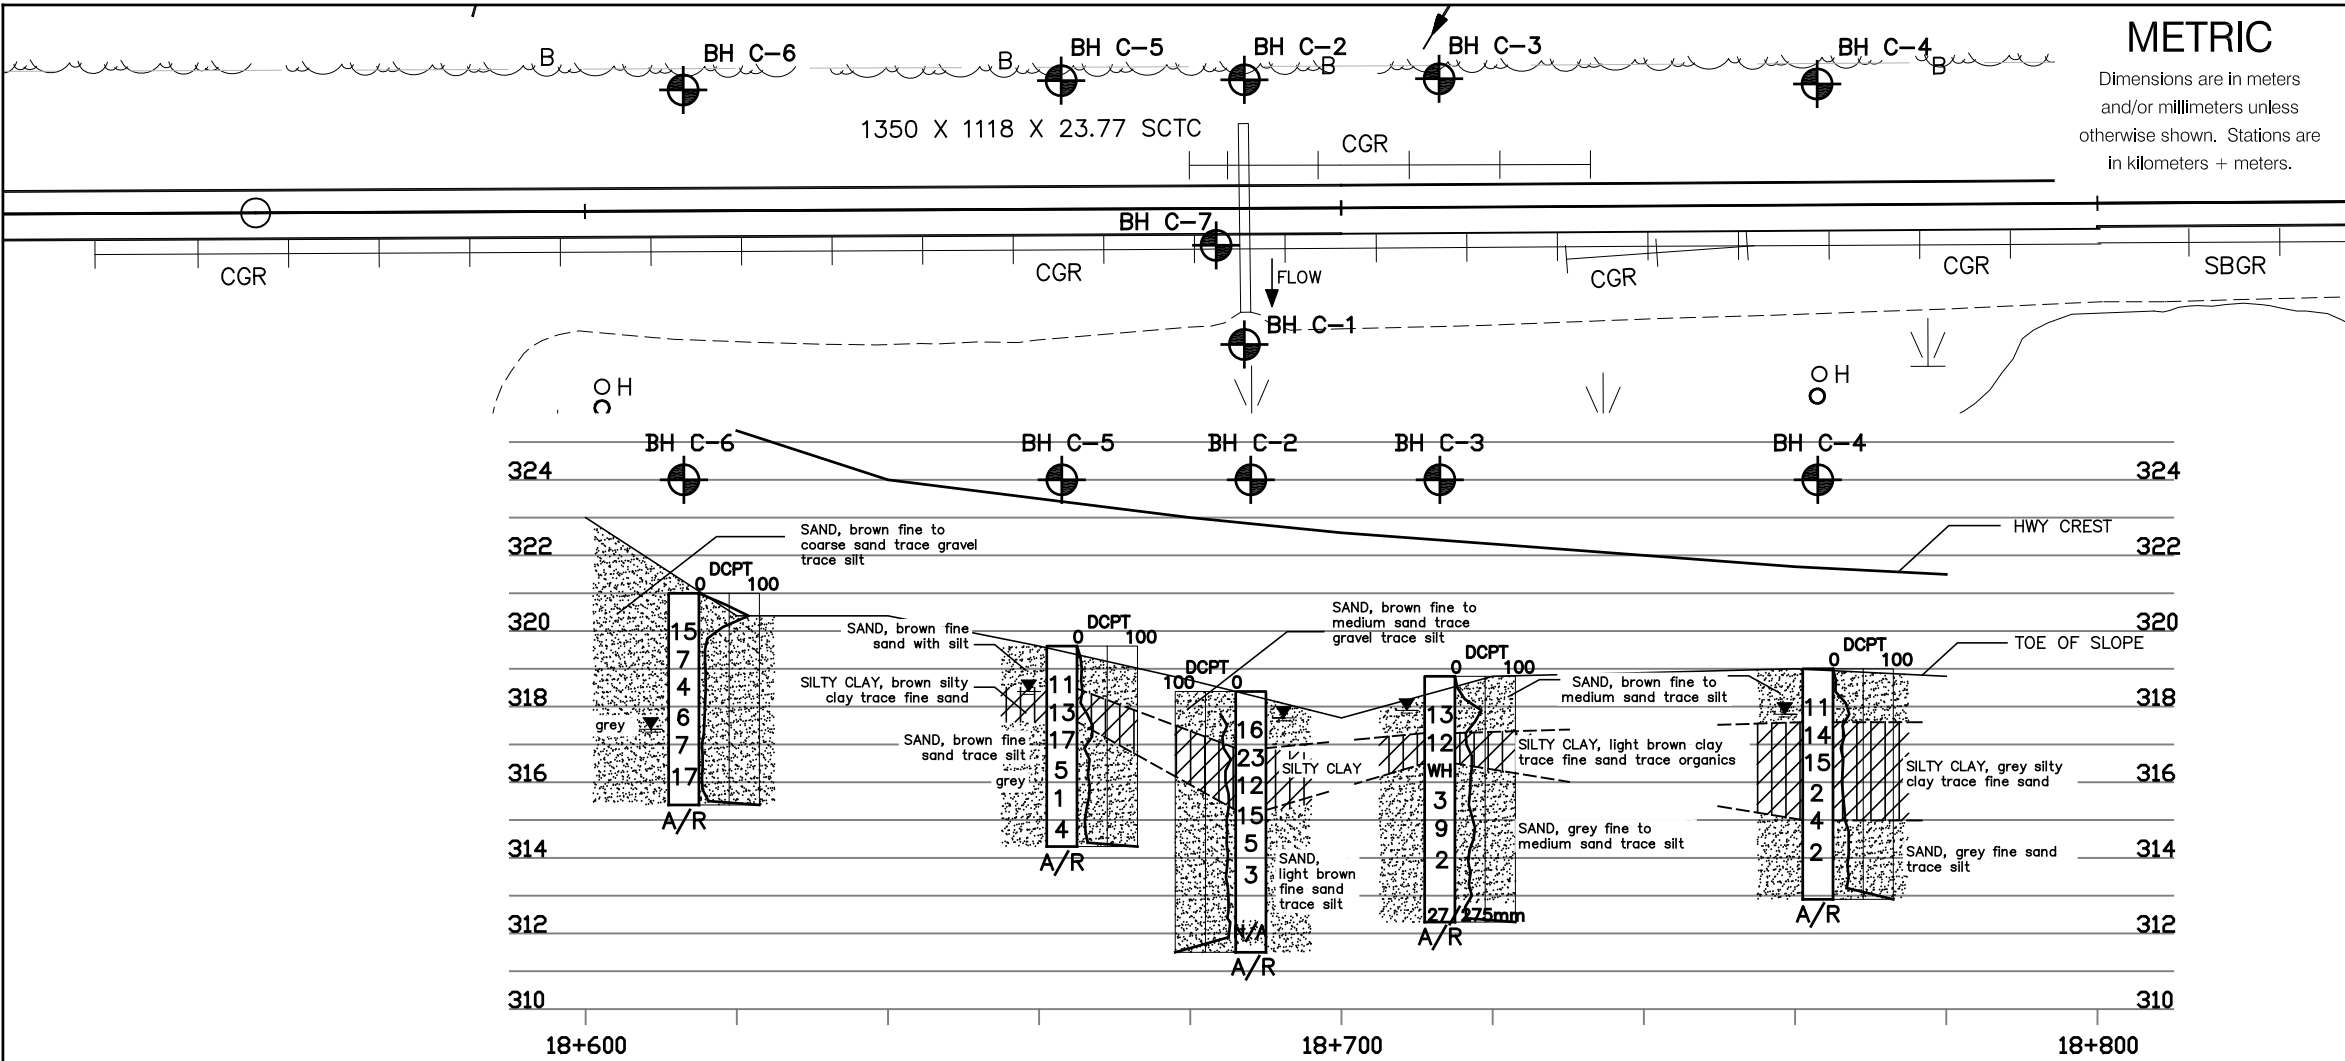
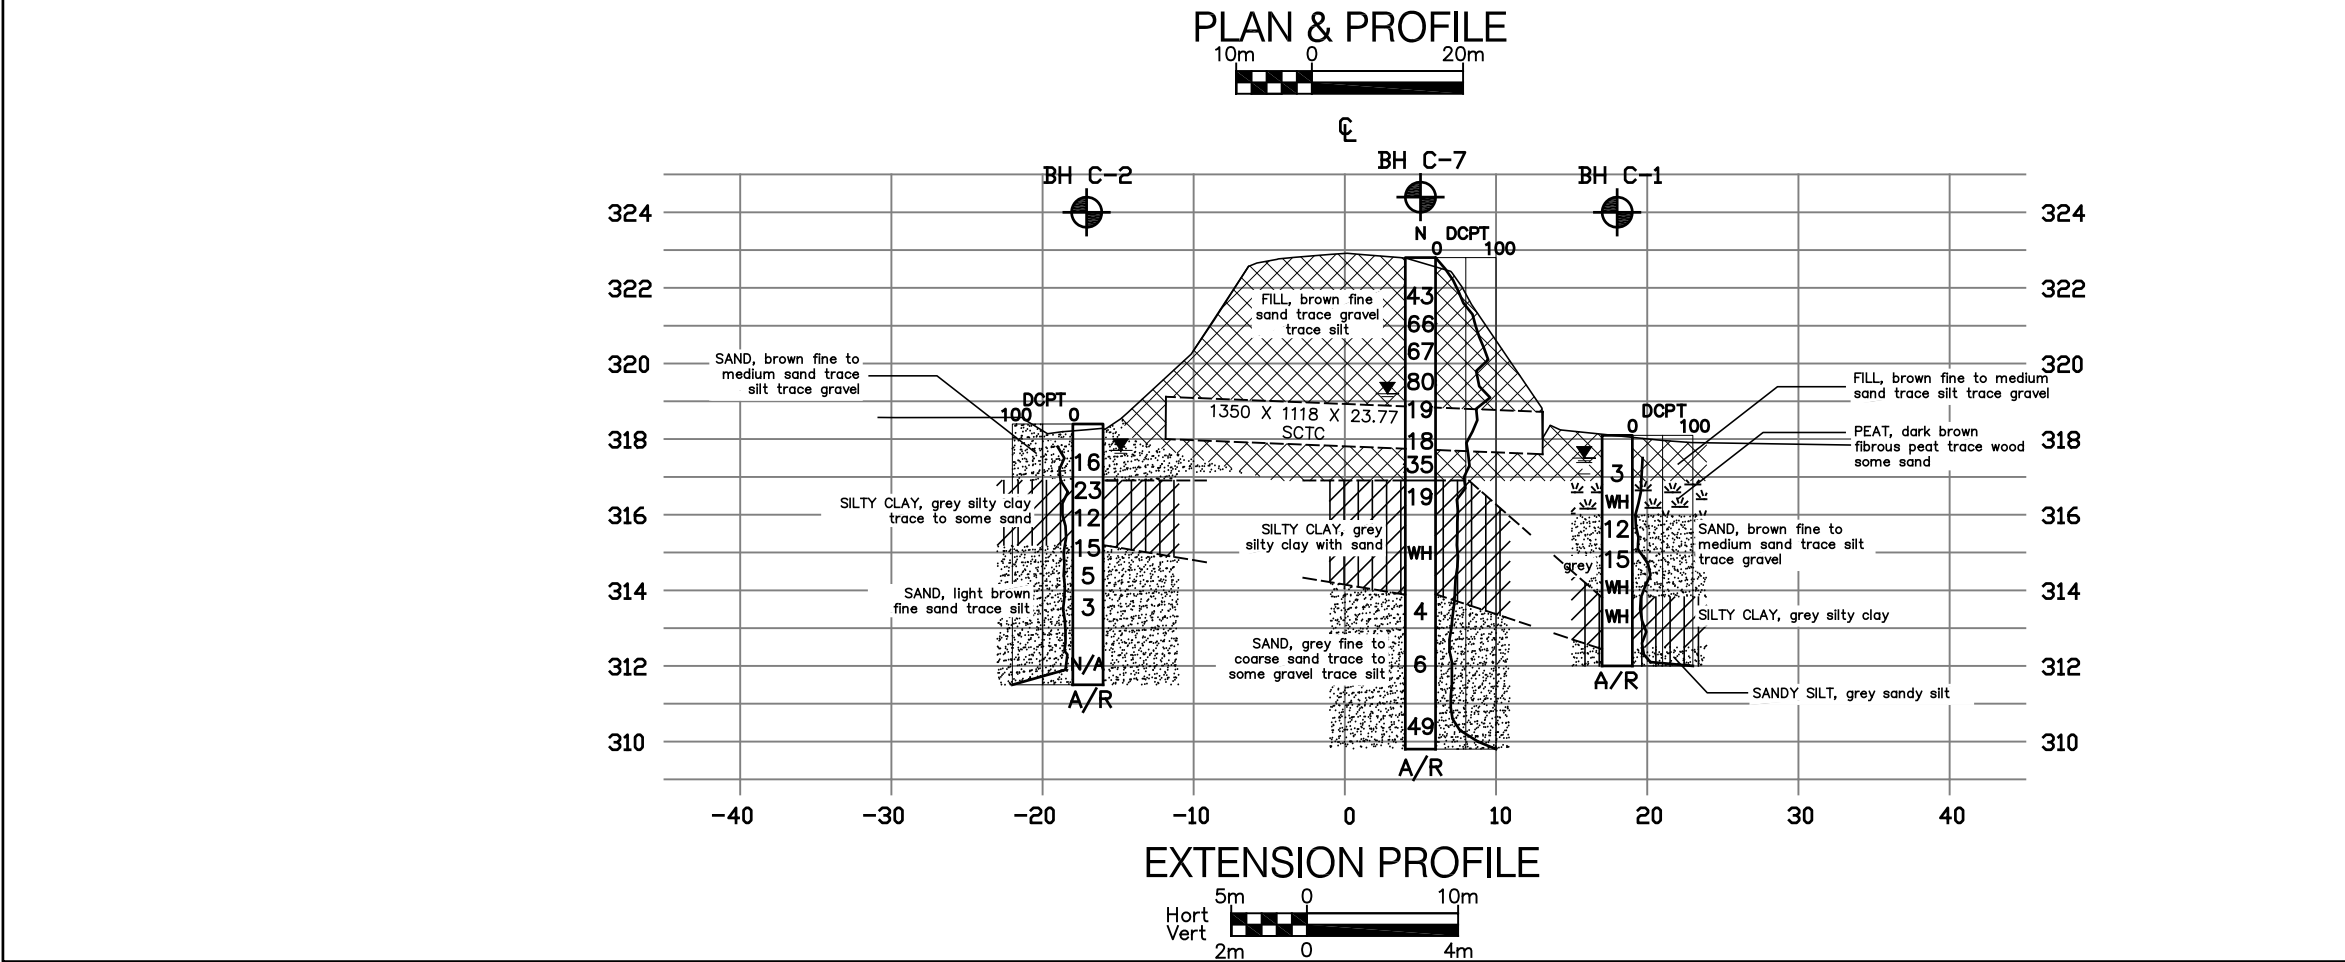
HWY No. 11 - CULVERT REPLACEMENT & POSS. DETOUR - 18+688			REF NO. 09181
SUBM'D			SITE C
DRAWN RG	CHK MAM	DATE SEPTEMBER 2010	FIG C-1

A plan and section showing the boring locations and stratigraphic sequences is shown on Figure No. C-1, Appendix C. During the course of the exploration program, seven (7) sampled boreholes were put down at this site, with Borehole Nos. C-1 and C-2, advanced at the east

HWY 11 - Township of Grenfell
Sta. 18+688 - MEL SITE C
Culvert Replacement and Possible Detour
BOREHOLE LOCATIONS & SOIL STRATA

Details of the subsurface conditions revealed by the investigation program are presented on the enclosed Record of Borehole Logs (Appendix B) and on Figure No. C-1 (Appendix C). Please note that stratigraphic delineation presented on the borehole logs and soil strata plot are the results of non-continuous sampling, response to drilling progress, the results of SPT and Dynamic Cone Penetration Test (DCPT) plus field observations. Typically such boundaries represent transitions from one zone to another and are not an exact demarcation of specific geological unit. Additional consideration should be given to the fact that subsurface conditions may vary markedly between adjacent boreholes and beyond any specific boring location, and are shown on the drawings for design purposes only. At the time of the subsurface investigation, the ground surface elevations at Boreholes Nos. C-1 to C-7, inclusive, were recorded at 318.1, 318.4, 318.8, 319.0, 319.6, 321.0, and 322.8 m, respectively.

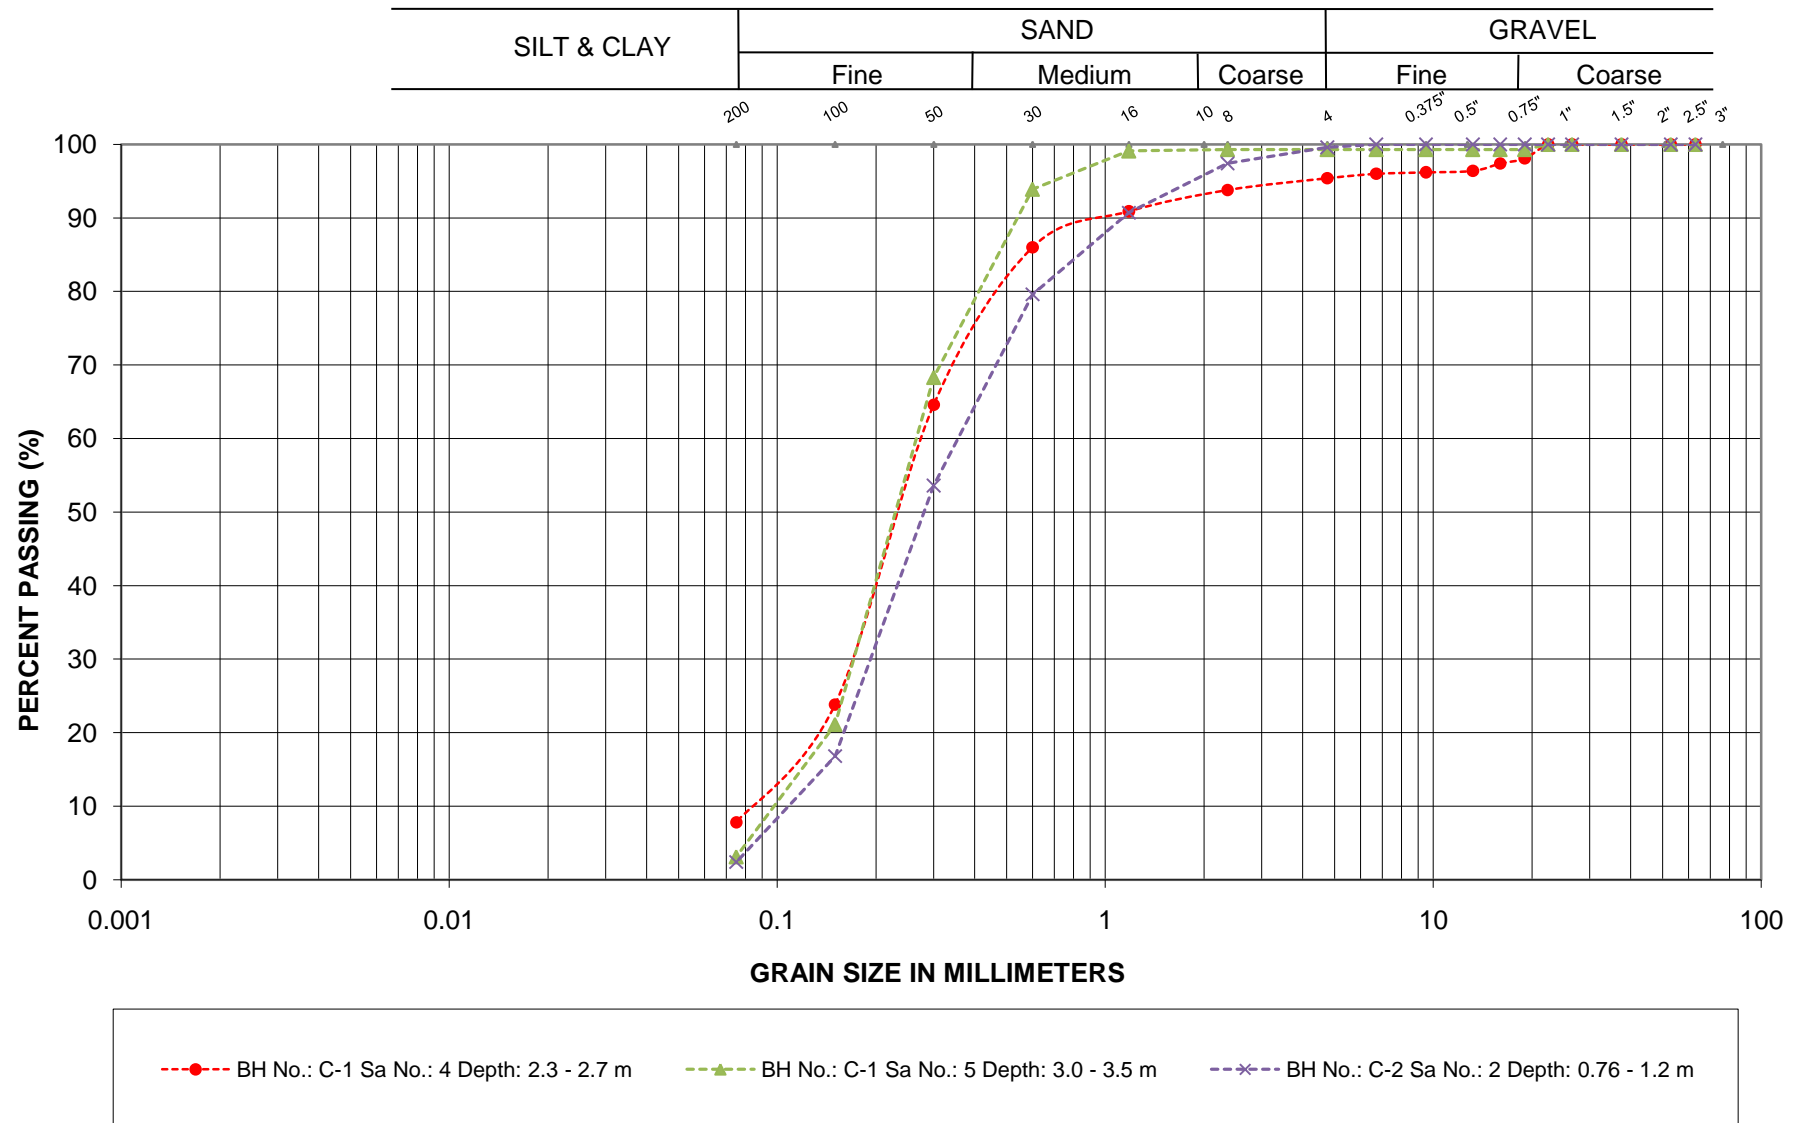
GRAIN SIZE ANALYSIS

SANDS - Sand, Trace Gravel, Trace Silt

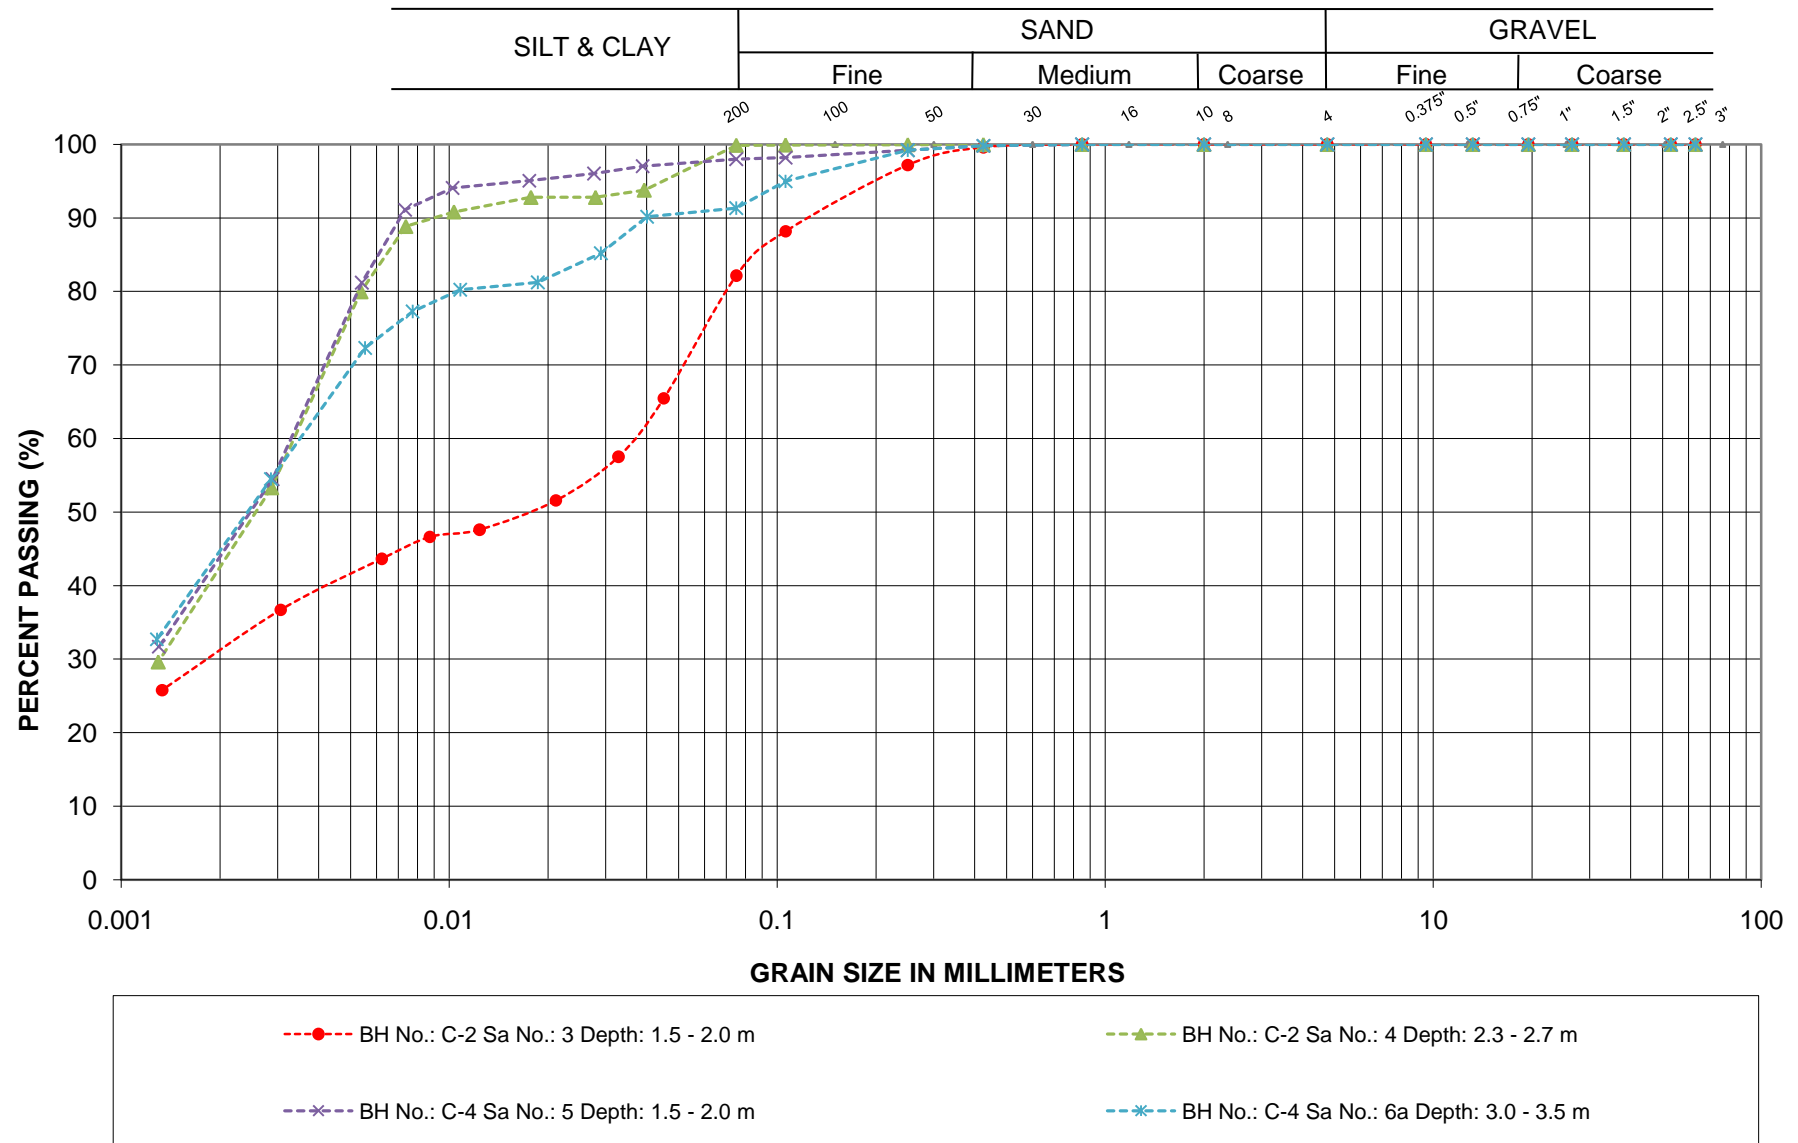
GRAIN SIZE ANALYSIS

SILTY CLAY - Silty Clay, Trace to Some Sand

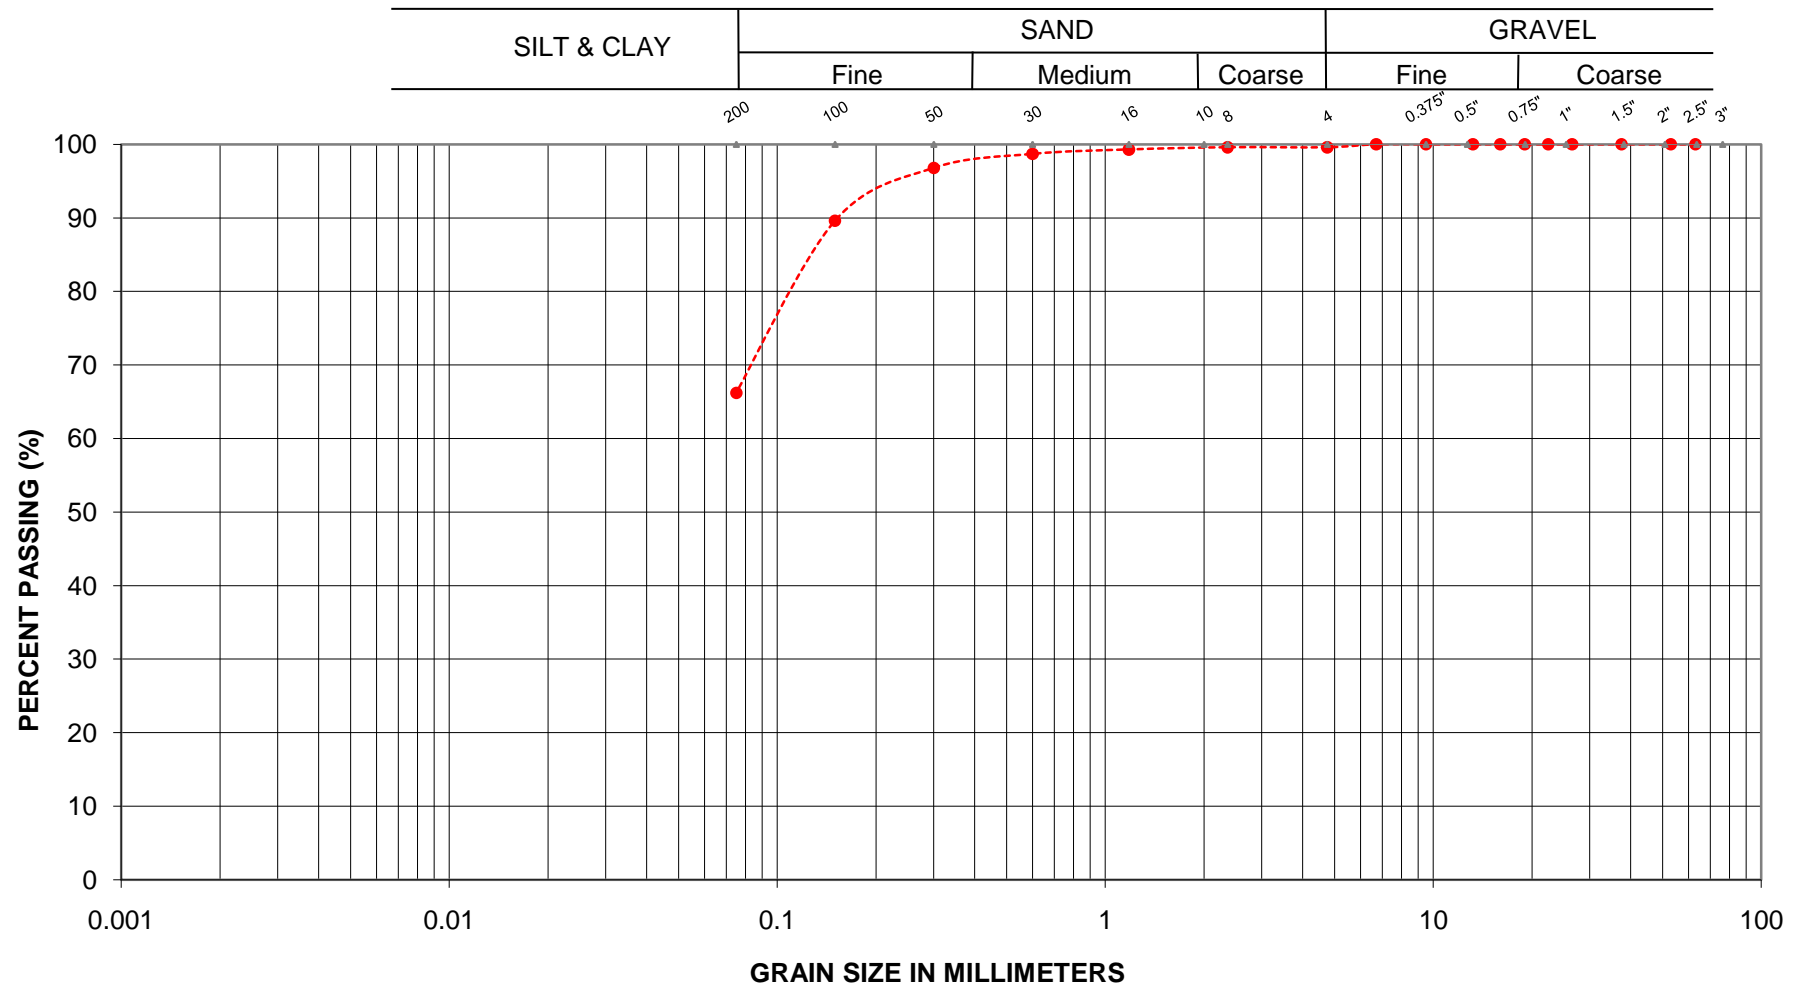
GRAIN SIZE ANALYSIS

---●--- BH No.: C-1 Sa No.: 8 Depth: 6.1 - 6.2 m

Underlying the silty clay at Borehole No. C-1, a thin deposit of grey sandy silt was penetrated. The natural moisture content from a sample of this deposit was in the order of 22%. Gradation analysis was carried out on a single sample of this deposit, the results of which indicated 0% gravel size particles, 34% sand size particles, and 66% silt and clay size particles (see Figure No. L-3, Appendix C). Auger refusal was encountered in this deposit at depth of 6.1 m below ground surface (elevation 312.0 m).

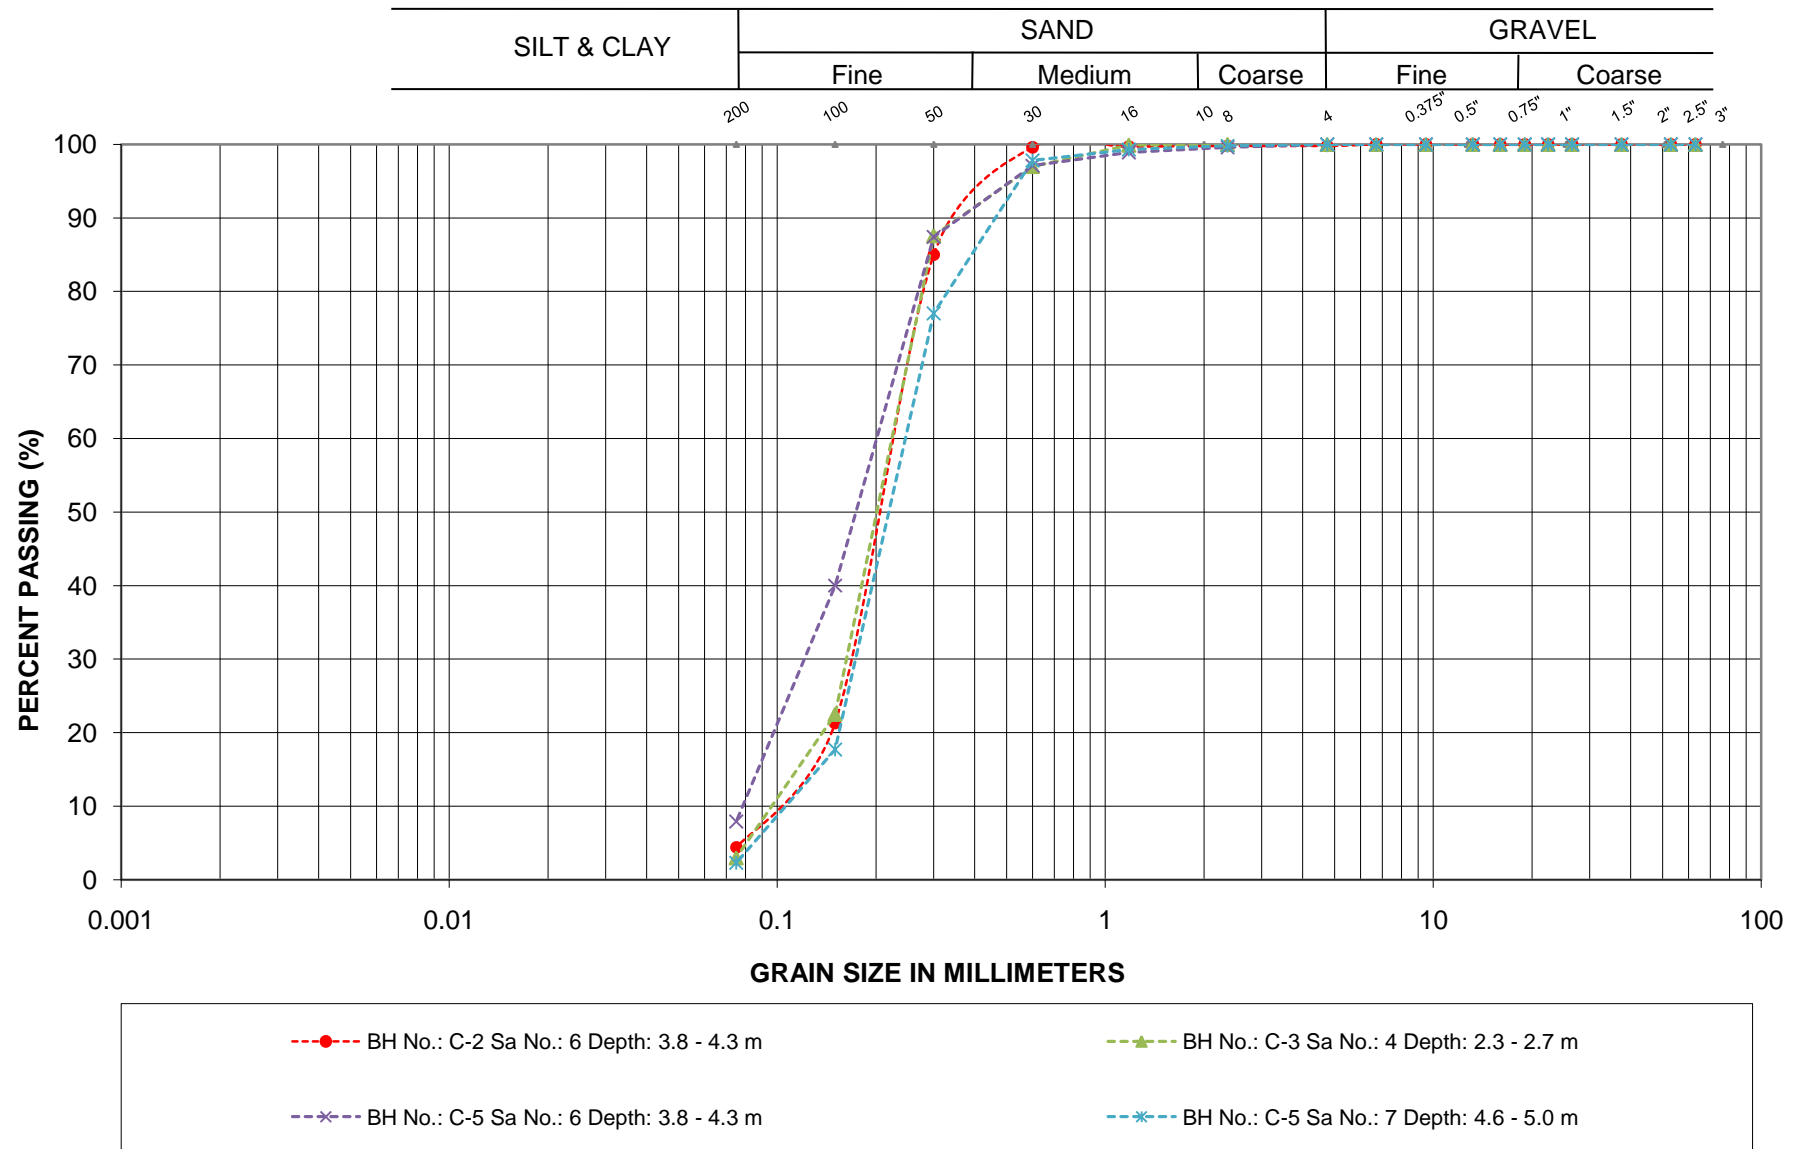
GRAIN SIZE ANALYSIS

SANDS - Sand, Trace Silt

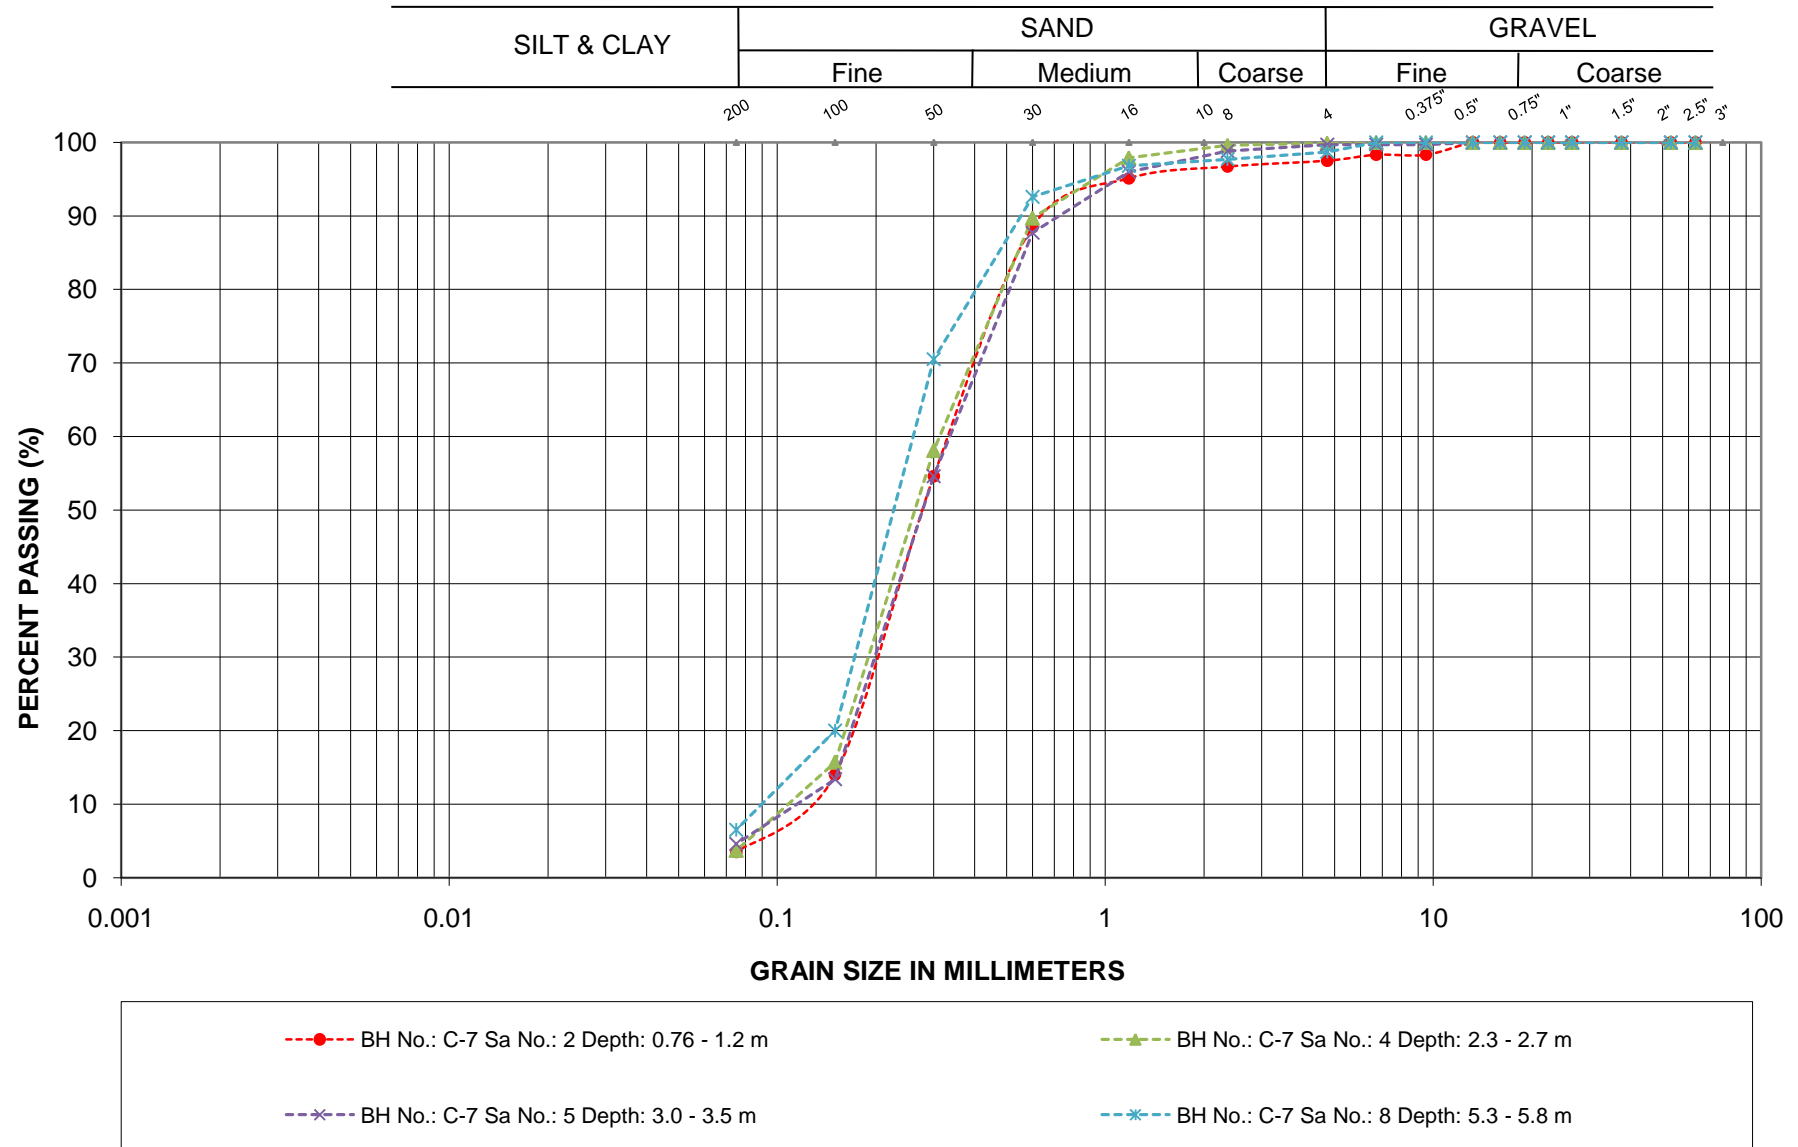
GRAIN SIZE ANALYSIS

FILL - Sand, Trace Gravel, Trace Silt

moisture content from samples of this granular fill deposit was in the order of 3 to 20%. Gradation analyses were carried out on four (4) samples of this deposit which was retained in the spilt spoon sampler (37 mm inside diameter), the results of which indicated 0 to 2% gravel size particles, 92 to 96% sand size particles, and 4 to 7% silt and clay size particles (see Figure No. L-5, Appendix C). Based on the SPT values of 18 to 80 the compactness of this deposit was described as compact to very dense, generally very dense. This deposit was encountered to a depth of 5.8 m (elevation 317.0 m).

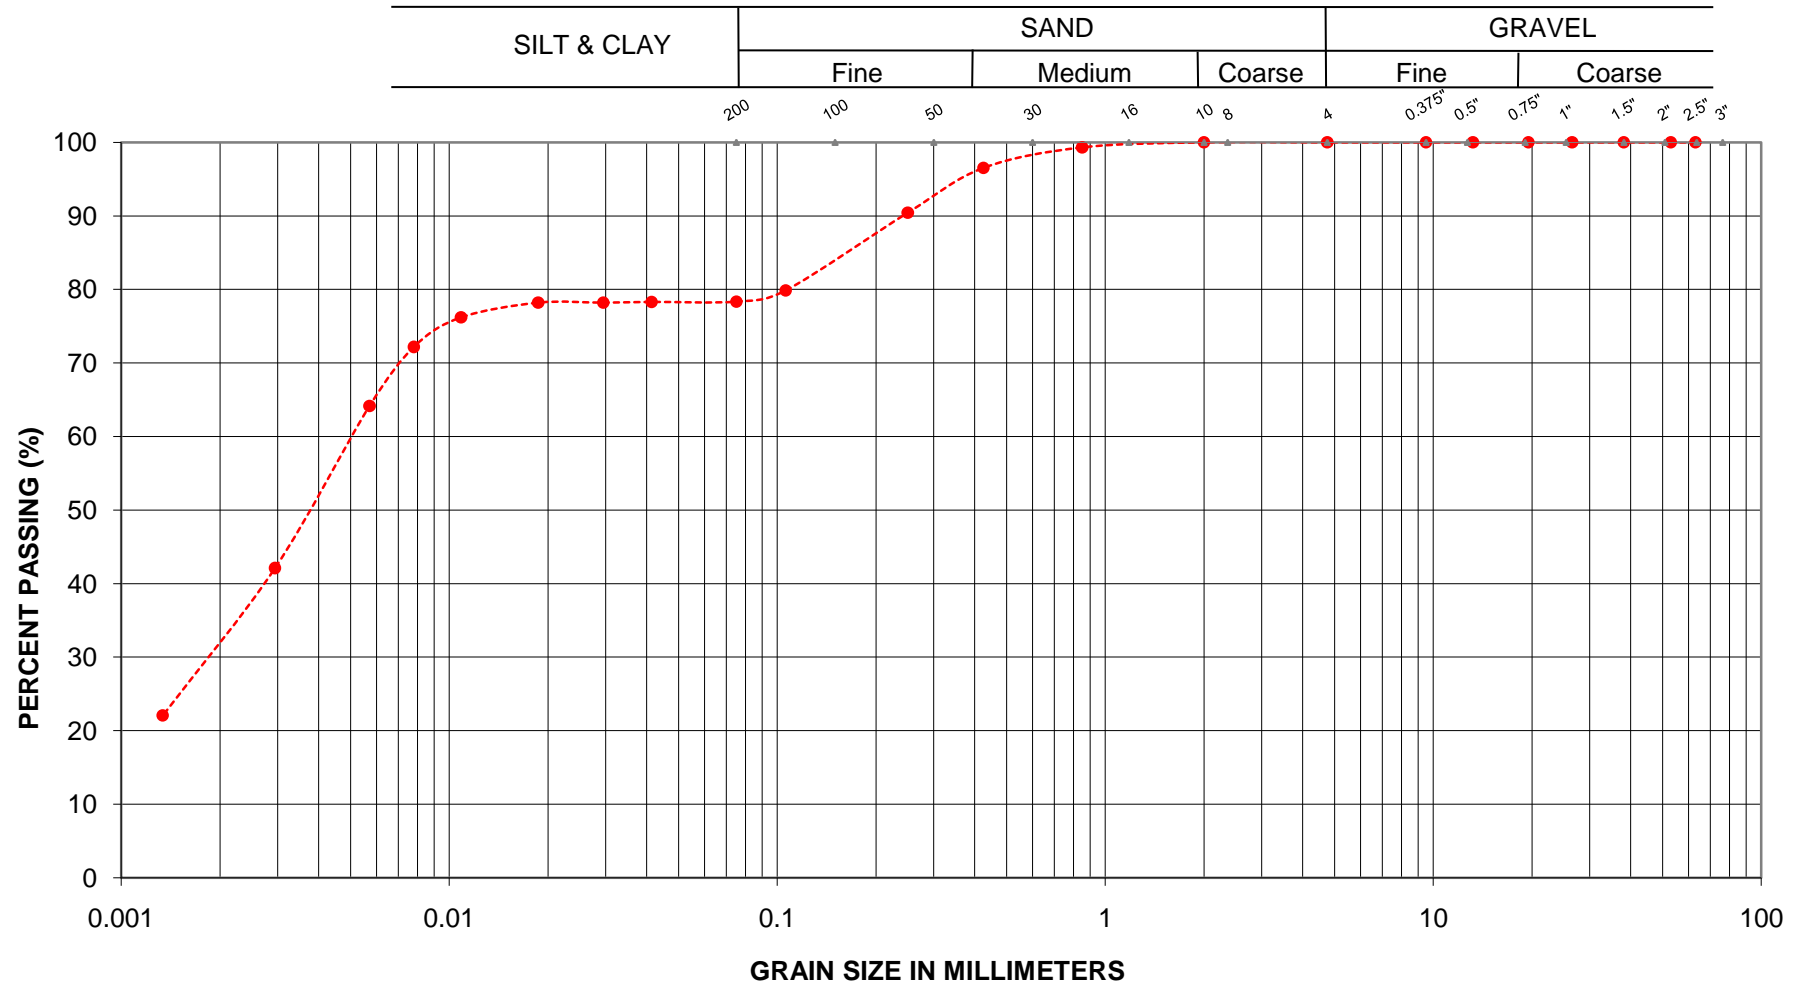
**GRAIN SIZE ANALYSIS**

---●--- BH No.: C-7 Sa No.: 10 Depth: 7.6 - 8.1 m

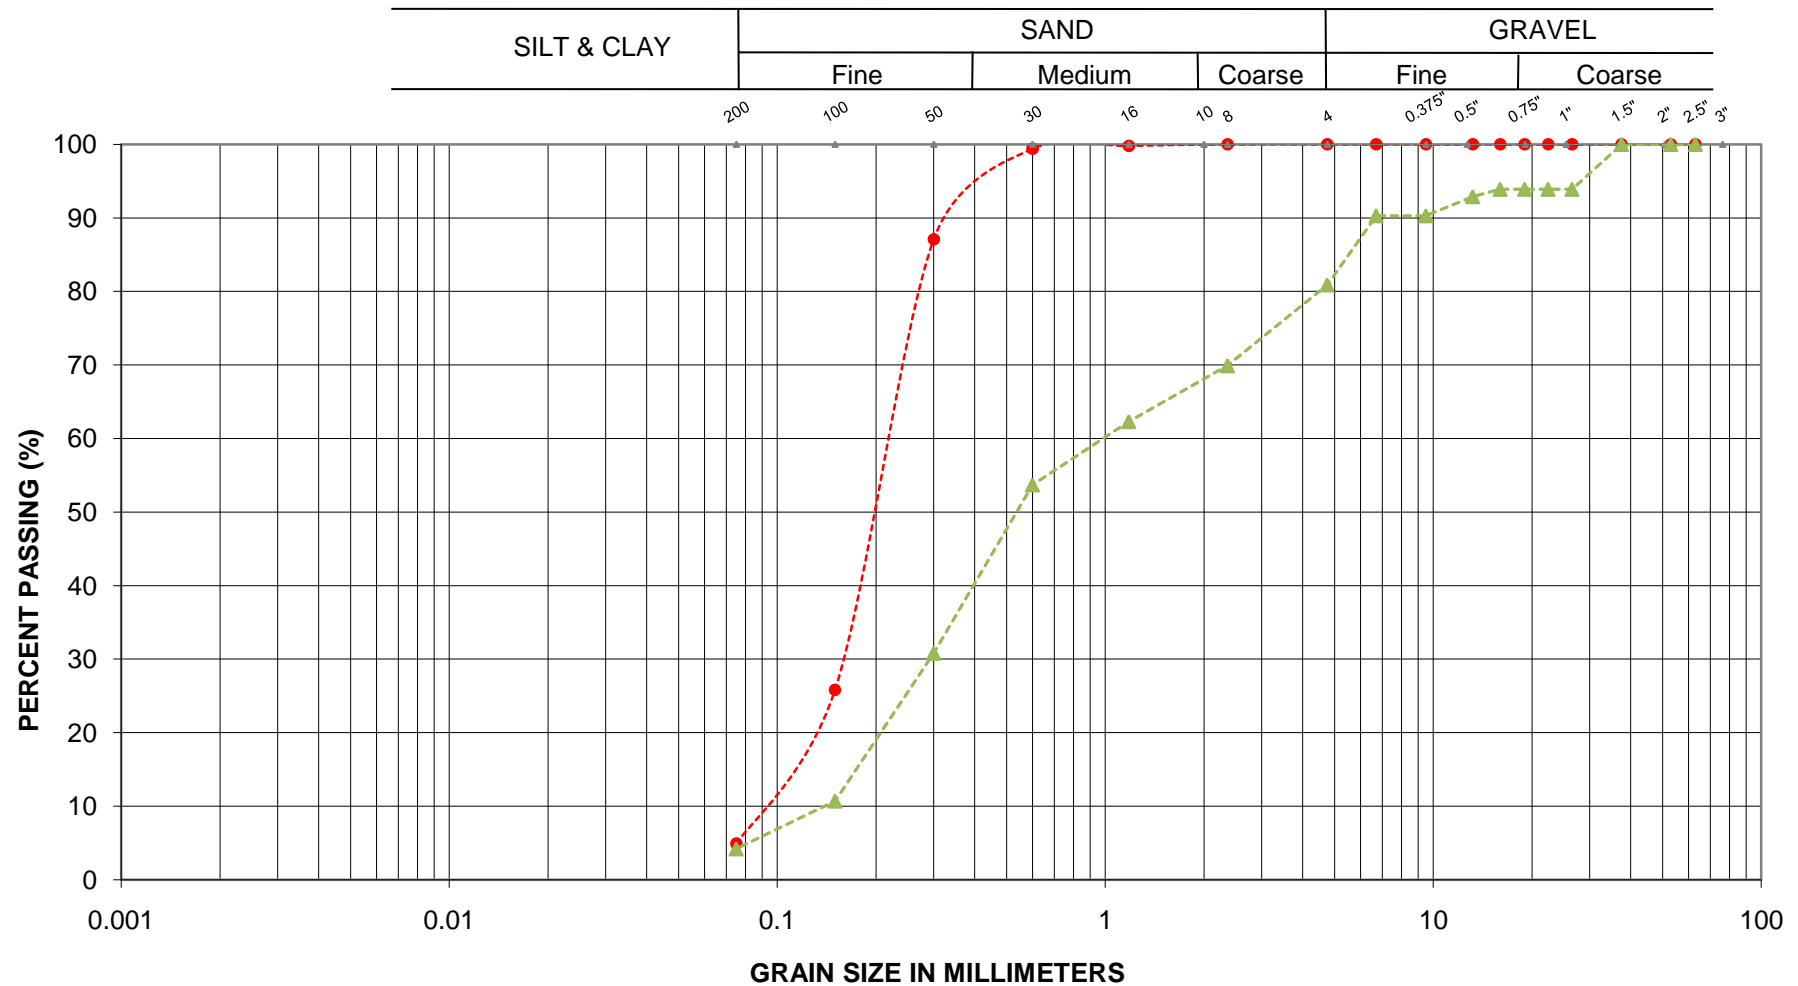
GRAIN SIZE ANALYSIS

---●--- BH No.: C-7 Sa No.: 12 Depth: 10.7 - 11.1 m

---▲--- BH No.: C-7 Sa No.: 13 Depth: 12.2 - 12.7 m

Underlying the silty clay at Borehole No. C-7, a deposit of grey fine to coarse sand trace to some gravel trace silt was penetrated. The natural moisture content from samples of this deposit was in the order of 13 to 26%. Gradation analyses were carried out on two (2) samples of this deposit, the results of which indicated 0 to 19% gravel size particles, 77 to 95% sand size particles, and 4 to 5% silt and clay size particles (see Figure No. L-7, Appendix C). Based on

the SPT values of 4 to 49 blows per 300 mm penetration, the compactness of this deposit was described as loose becoming dense with depth. Auger refusal was encountered in this deposit at depth of 13.0 m below ground surface (elevation 309.8 m).

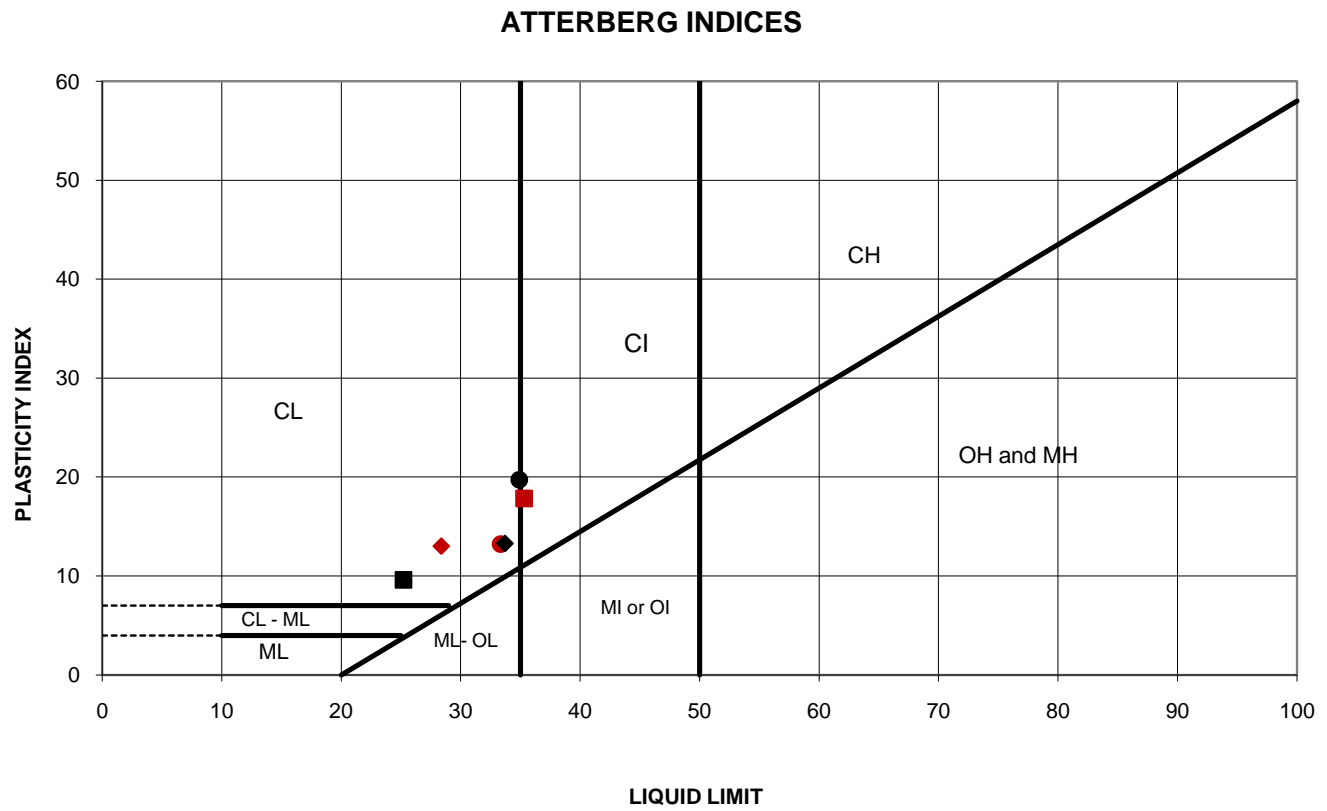
FIGURE L- 8

ATTERBERG LIMITS TEST RESULTS

SYMBOL	BH	Sa. No.	Depth(m)	Elev.(m)	Plasticity Index	Plastic Limit	Liquid Limit	NMC %
●	C-1	7	4.6	313.5	19.7	15.2	34.9	31.3
■	C-2	3	1.5	316.7	9.6	15.6	25.2	23.2
◆	C-2	4	2.3	315.9	13.3	20.4	33.7	27.2
●	C-4	5	3.0	315.0	13.2	20.1	33.4	29.9
■	C-4	6a	3.8	314.2	17.8	17.5	35.3	42.2
◆	C-7	10	7.6	315.2	13.0	15.4	28.4	25.7

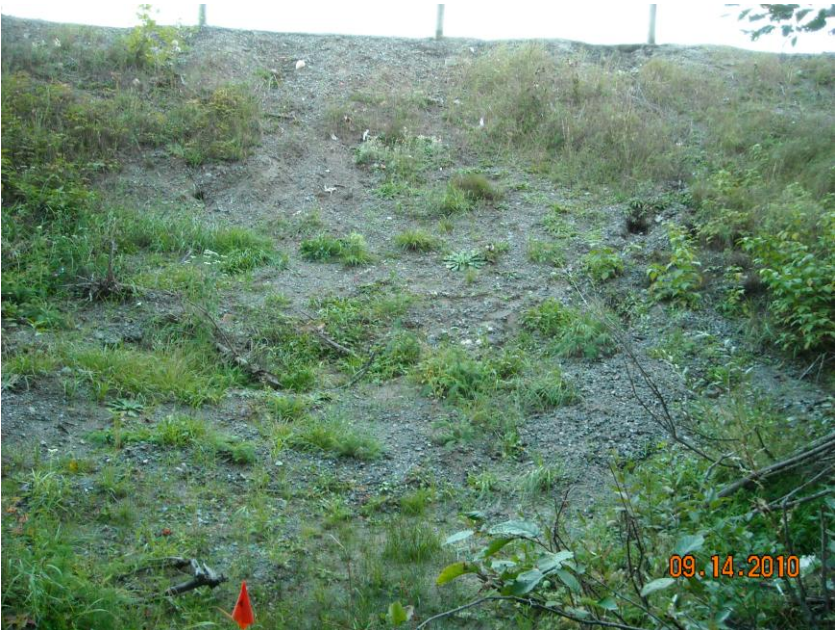
Location of Culvert Inlet – West Embankment, location of buried culvert end	Photo: 1

embankment instability except for surface slippage above the culvert due to insufficient culvert length on the left. There were no obvious signs of settlement of the pavement structure at the culvert location. The culvert was reported to be in good condition, however the left end was buried due to slope raveling.

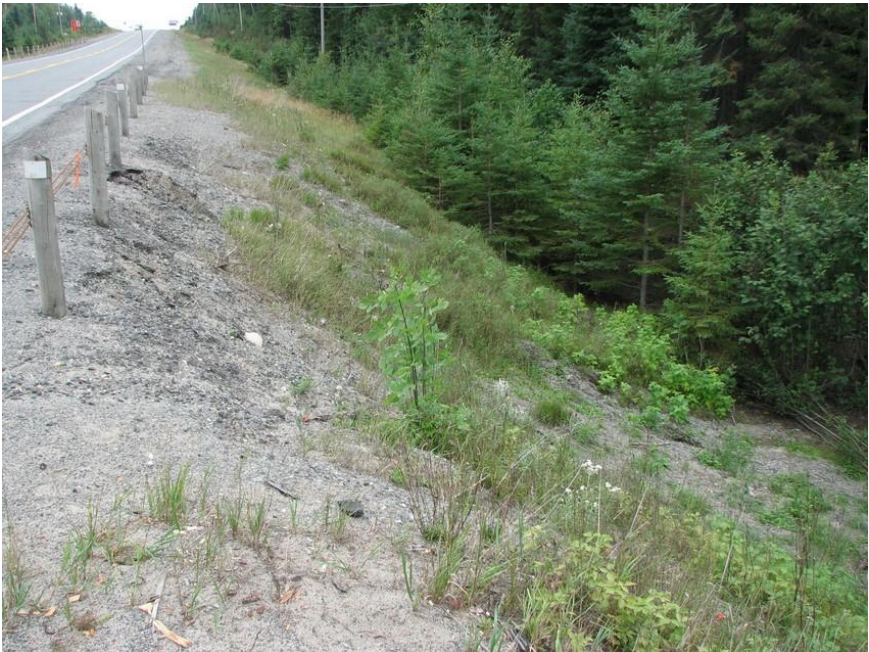
A photograph showing a grassy, sloping embankment. The ground is covered with green grass and some small plants. A red flag is visible in the lower left corner. The date '09.14.2010' is printed in orange in the lower right corner.	
West Side of Embankment – Slope instability at culvert inlet, looking south	Photo: 2
