FOUNDATION INVESTIGATION REPORT

**NOISE BARRIER WALL, SOUTHEAST OF CUBERT STREET
AND HIGHWAY 401 OVERPASS
CITY OF OSHAWA, ONTARIO
G.W.P. 2555-17-00
GEOCRES No. 30M15-352**

Client Name: Egis Canada Ltd.

Date: July 26, 2024

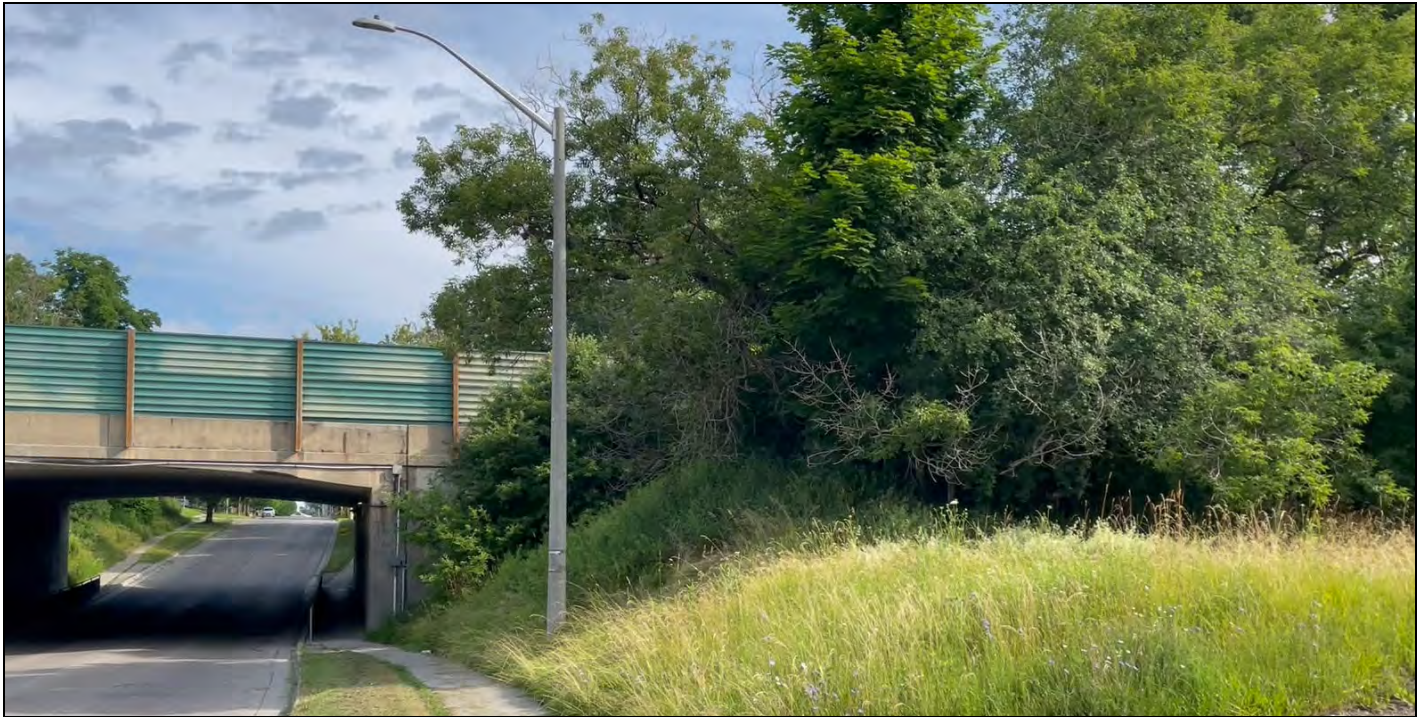
Photo 2- South Side of Highway 401 and Cubert St. Overpass
East abutment, south side (looking east)
Date: July 2023

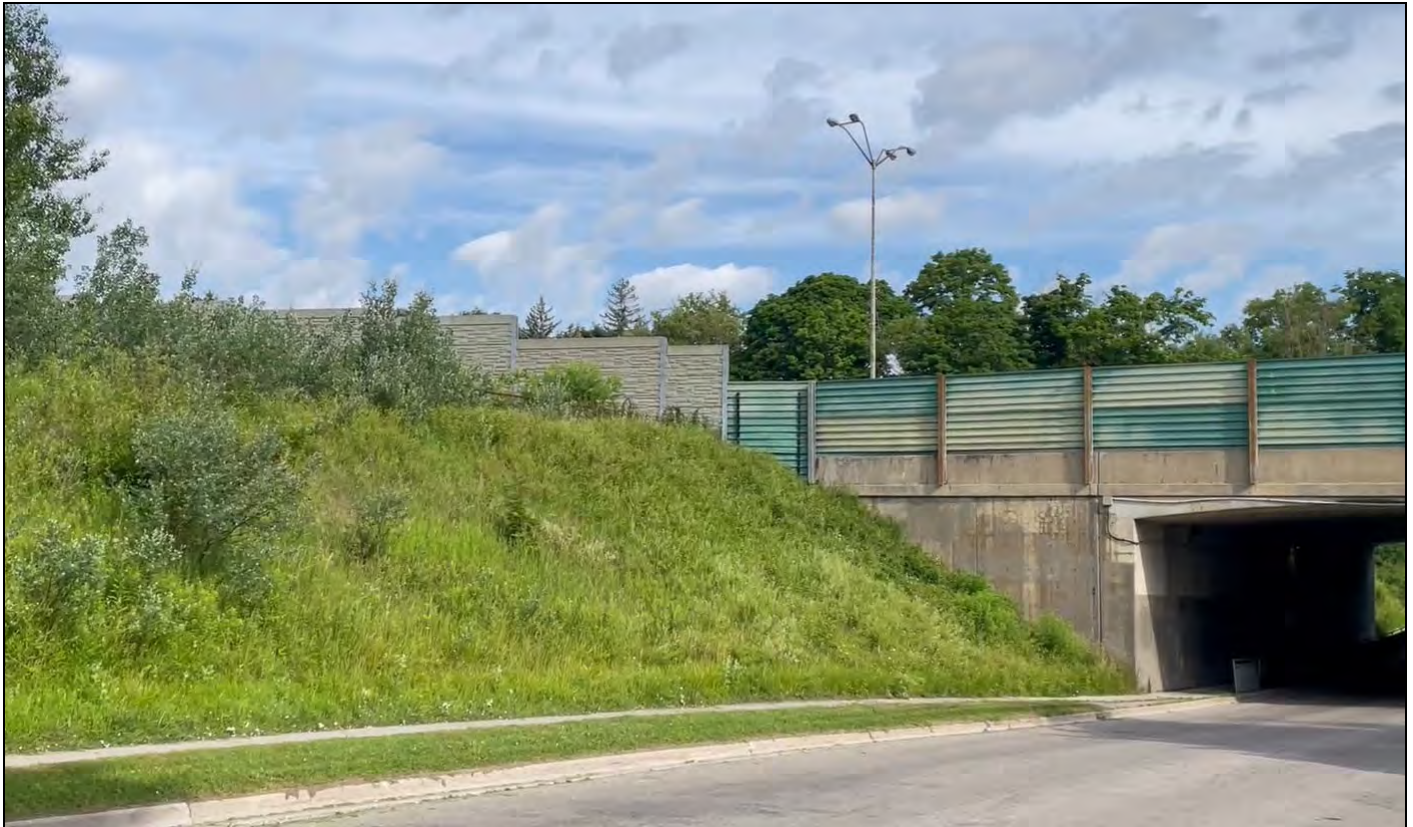
Photo 3- South Side of Highway 401 and Cubert St. Overpass
West abutment, south side (looking west)
Date: July 2023
