REPORT
ON THE
FOUNDATION INVESTIGATION
AT THE
PROPOSED STRUCTURE FW #6
AT STATION 84+60 ON THE
TORONTO TO NIAGARA FALLS LANE
AT THE HIGH SPEED INTERCHANGE
NEAR BURLINGTON

Project F 55-43

Plan DM 44 05

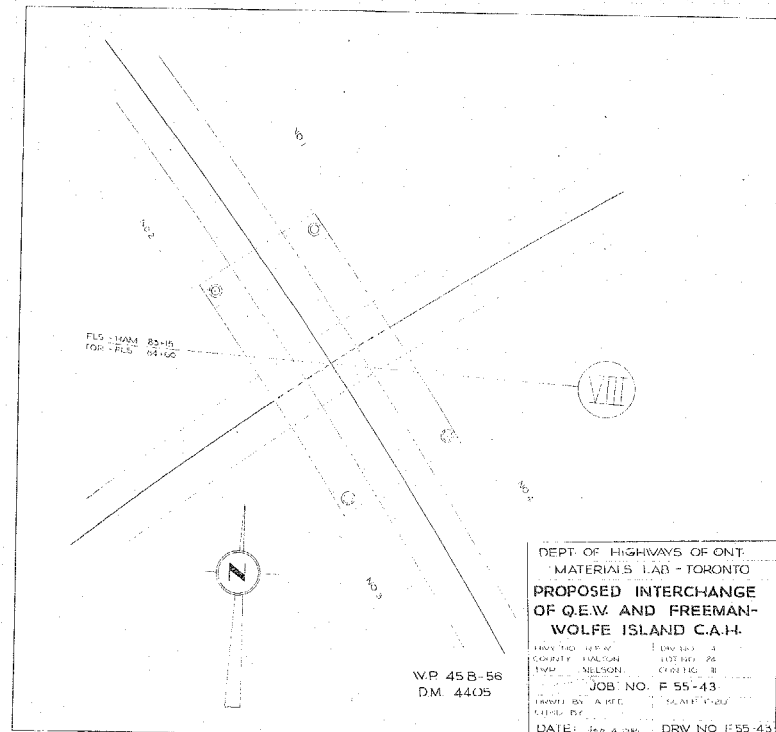
MATERIALS LABORATORY-DEPARTMENT OF HIGHWAYS - ONTARIO
OFFICE REPORT ON SOIL EXPLORATION

SOIL PROFILE
