THURBER ENGINEERING LTD.

**FOUNDATION INVESTIGATION REPORT
HIGHWAY 101 GHOST RIVER BRIDGE REHABILITATION
SITE NO. 39E-0154/B0**

**DISTRICT OF COCHRANE, ONTARIO
MTO ASSIGNMENT NO. 5021-E-0027
G.W.P. 5185-16-00, W.P. 5343-19-01**

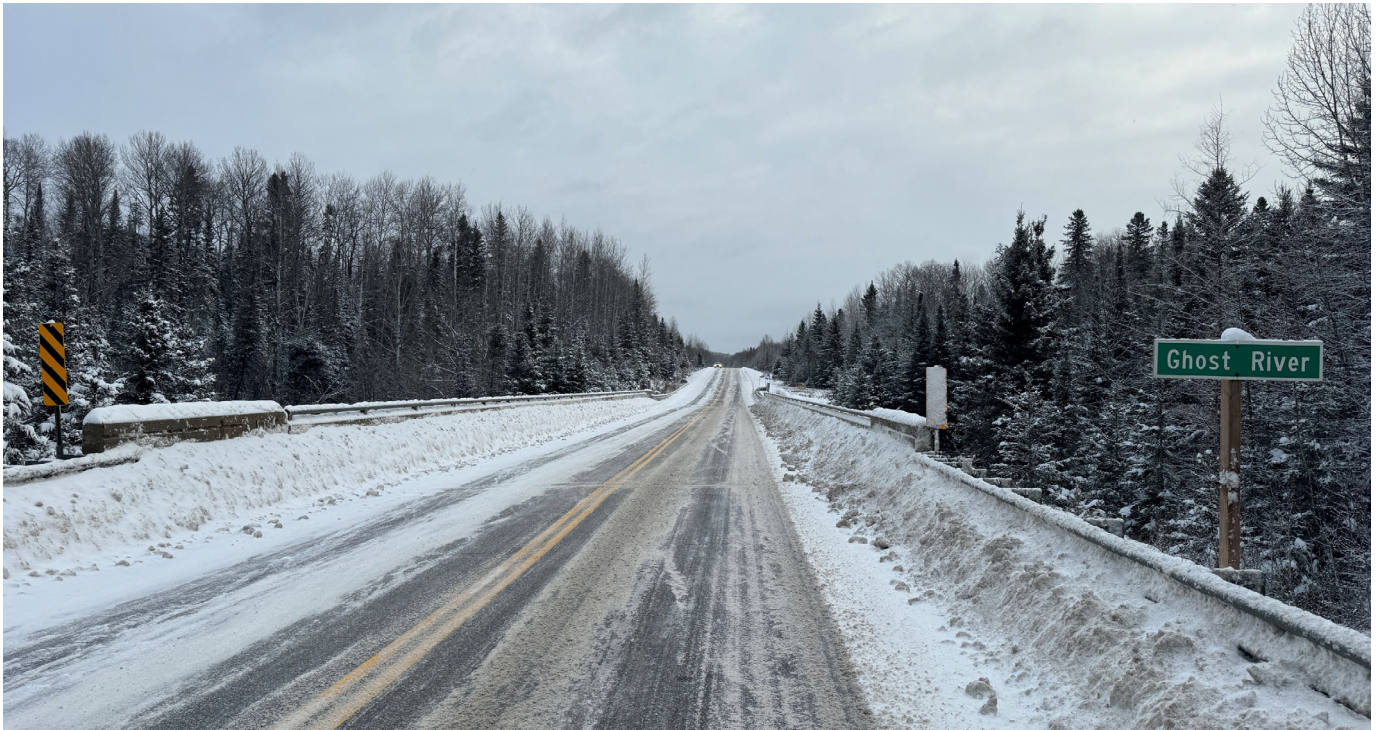
Photograph #1 – Highway 11 Ghost River bridge looking east. (November 2023)

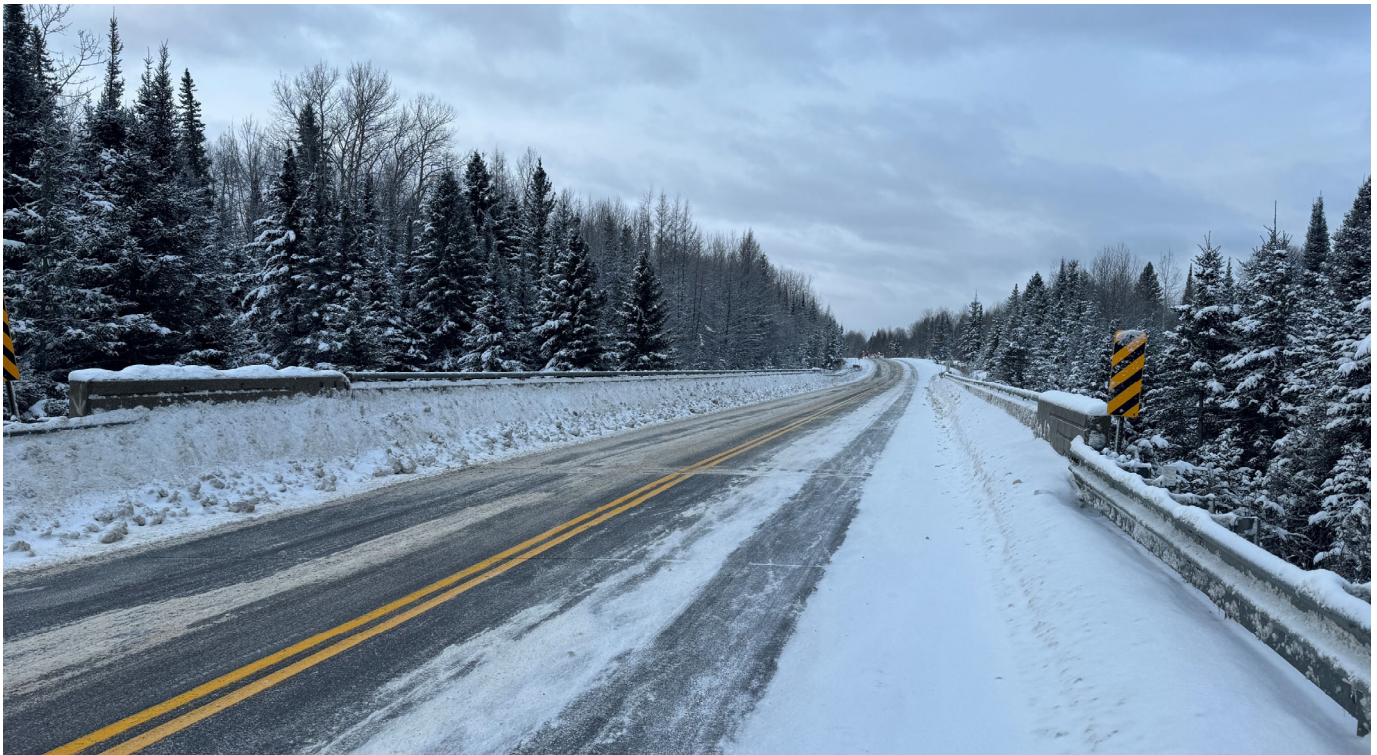
Photograph #2 – Highway 11 Ghost River bridge look west. (November 2023)

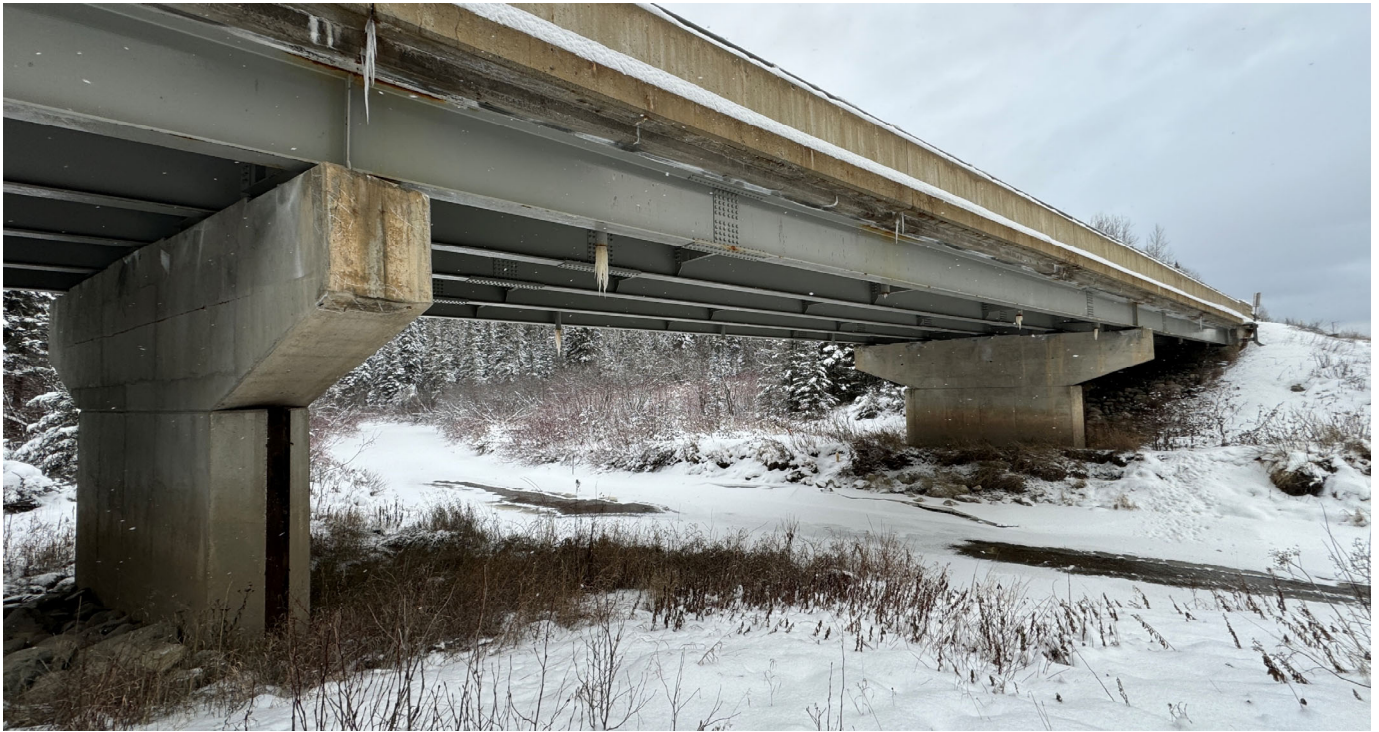
Photograph #3 – Underside of Highway 11 Ghost River bridge, looking northeast. (November 2023)
