THURBER ENGINEERING LTD.

Foundation Investigation Report

Sign Support for Proposed Pole-Mounted Variable Message Signs

**Queen Elizabeth Way / Garden City Skyway
St. Catharines / Niagara-On-The-Lake, Ontario
Agreement No. 2019-E-0052**

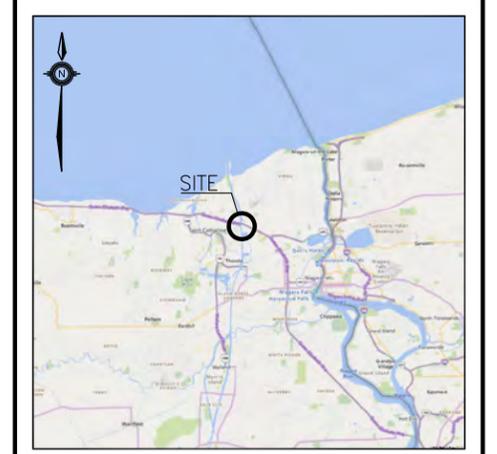
CONT No	SHEET
WP No	
QEW-GARDEN CITY SKYWAY VARIABLE MESSAGE SIGN NIAGARA-BOUND BOREHOLE LOCATIONS PLAN

The as-drilled borehole locations and elevations were measured relative to identifiable site features and superimposed on the base plan/contour plan. In accordance with the requirements for surveying of foundation boreholes, the survey readings have a vertical and horizontal accuracy of 0.1 m and 0.5 m, respectively. The locations of the boreholes as presented on the record of boreholes, and as shown on Drawings 1 and 2 are positioned relative to coordinate system MTM NAD 83, Zone 10. The borehole locations, geographic coordinates, ground surface elevations and depths of borehole prior to termination is summarized in summarized in Table 3.1.
