FOUNDATION INVESTIGATION AND DESIGN REPORT

**Kawawia Creek Culvert Replacement, Highway 502, Site No. 41S-244/C, District
of Kenora**

Agreement No. 6014-E-0017

exp Services Inc.
December 10, 2015

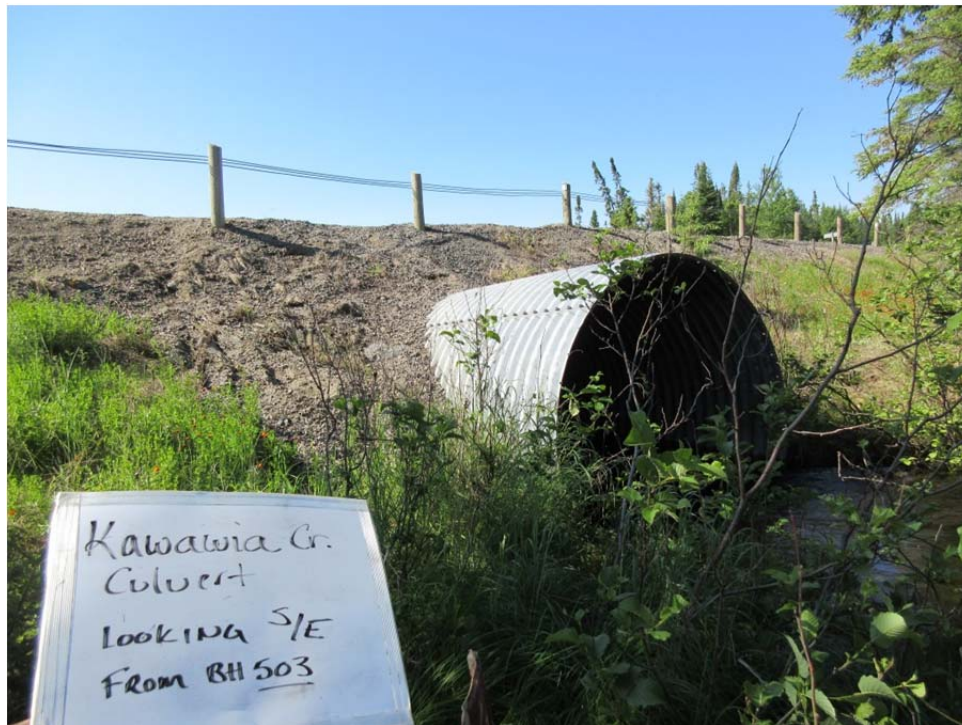
Photo 1. Existing culvert inlet on west side of highway

At the vicinity of the inlet and outlet of the culvert some minor vegetation was noted at both culvert ends. The surrounding area of the culvert at the west side of Hwy 502 was generally forested and at the east side was generally a low lying area with tall grass. The inlet and outlet appeared to be generally clear of debris and excess vegetation, and as such the flow does not appear to be restricted.

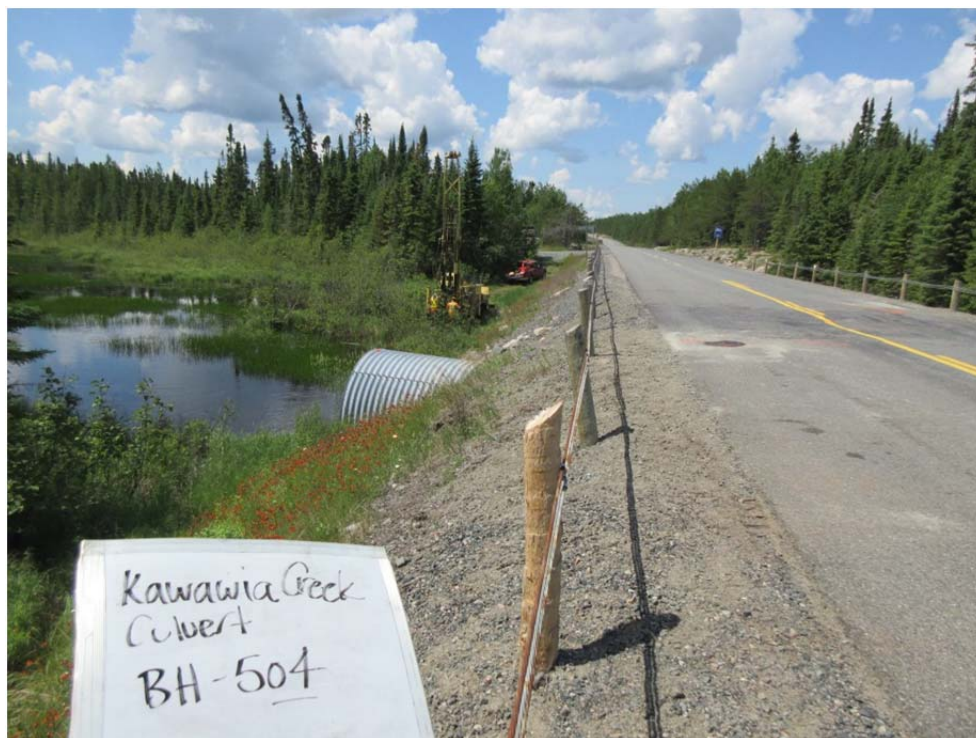
Photo 2. Existing culvert outlet on east side of highway facing south

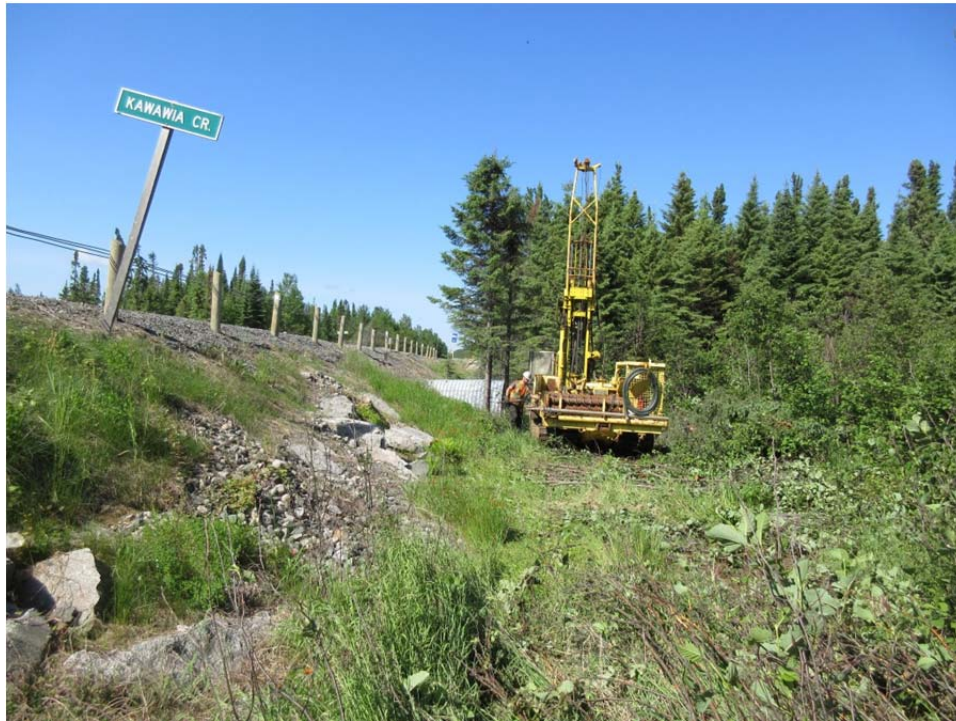
Photo 5. Embankment slope on west side facing south

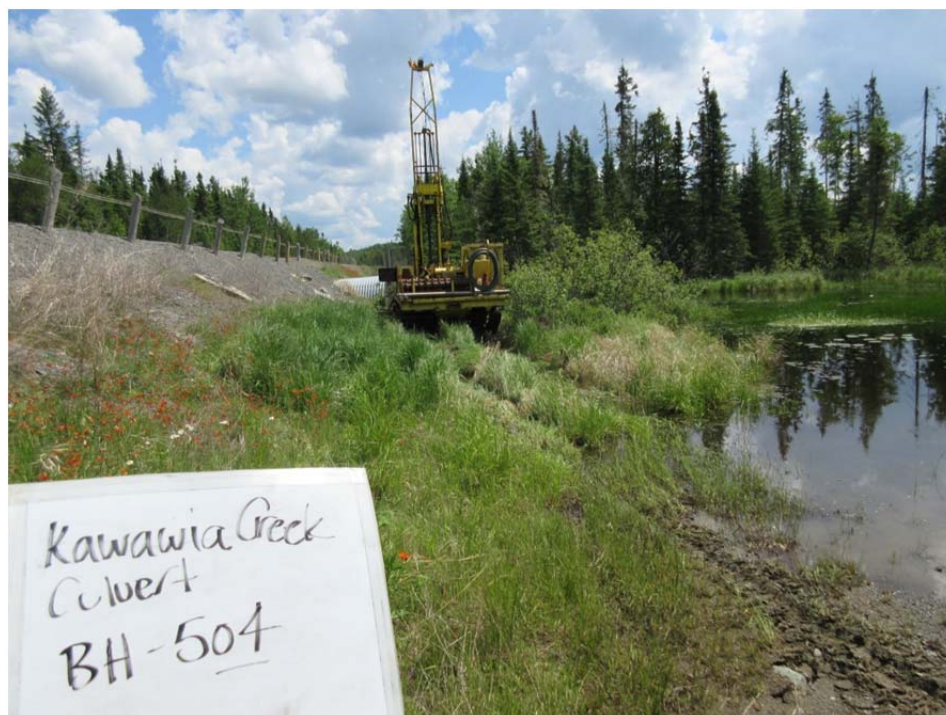
Photo 6. Embankment slope on east side facing north

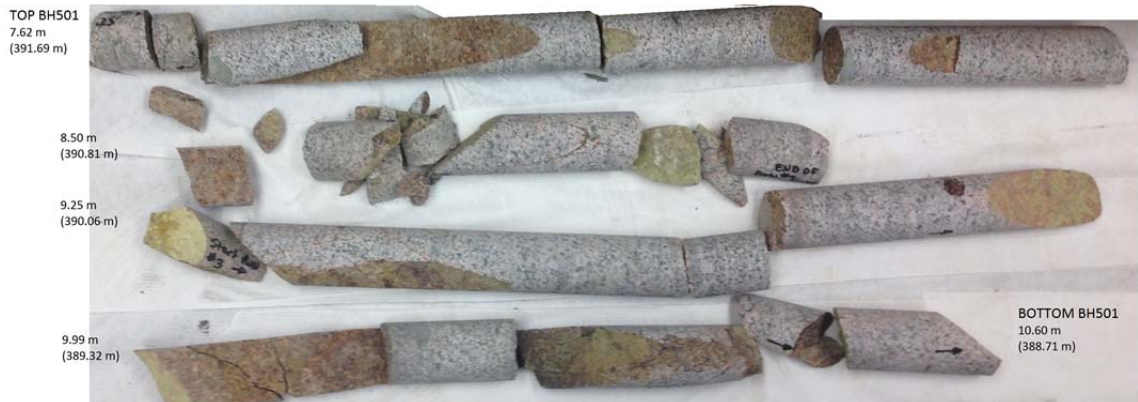
BH501 - Bedrock Core Samples with Depths and Elevations

Bedrock was encountered underlying the silty sand with gravel, and the cobbles and boulders at BH501 and BH502, at depths of about 7.6 m (391.7 m elevation) and 6.5 m (392.8 m elevation), respectively. The bedrock was generally described as a medium strong (25 MPa to 50 MPa compressive strength), very severely fractured, pink to white, and medium to coarse grained. The boreholes were extended by rock coring about 3.0 m into bedrock, and to depths ranging about 9.5 m and 10.6 m below ground surface. The boreholes were terminated at elevations ranging between about 388.7 m and 389.8 m. Photographs of the bedrock core samples are presented in Appendix C, after the Borehole Logs.

Gross recoveries ranged between about 97% and 100%. The Rock Quality Designation (RQD), which is a modified core recovery, was 0% for all core run samples (very severely fractured).

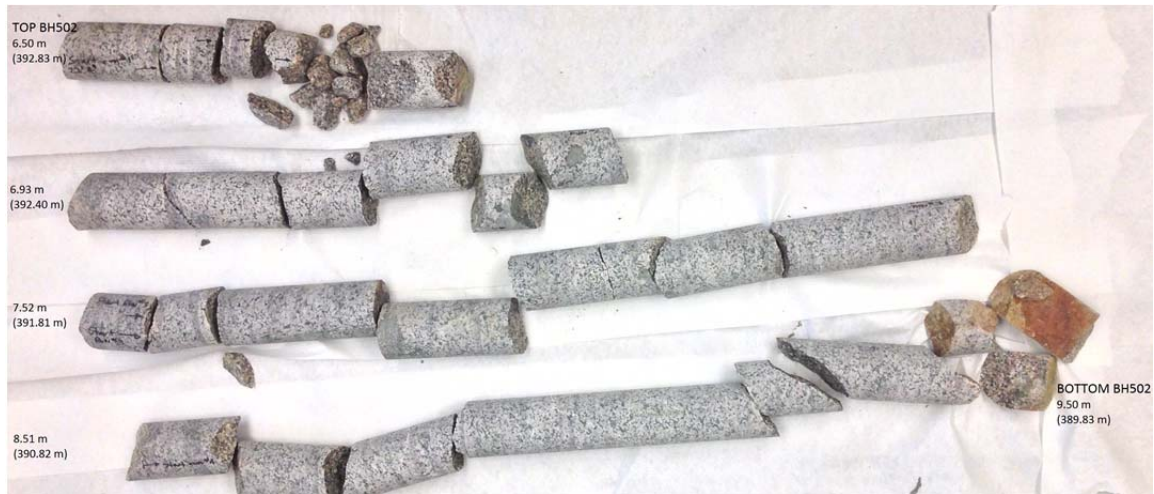
BH502 - Bedrock Core Samples with Depths and Elevations
