FOUNDATION INVESTIGATION REPORT

**Temporary Cofferdam at Structural Culvert (44.553470, -81.510180), MTO Site No.
39E-313/C, Highway 634, Township of Adanac, Ontario**

January 12, 2017

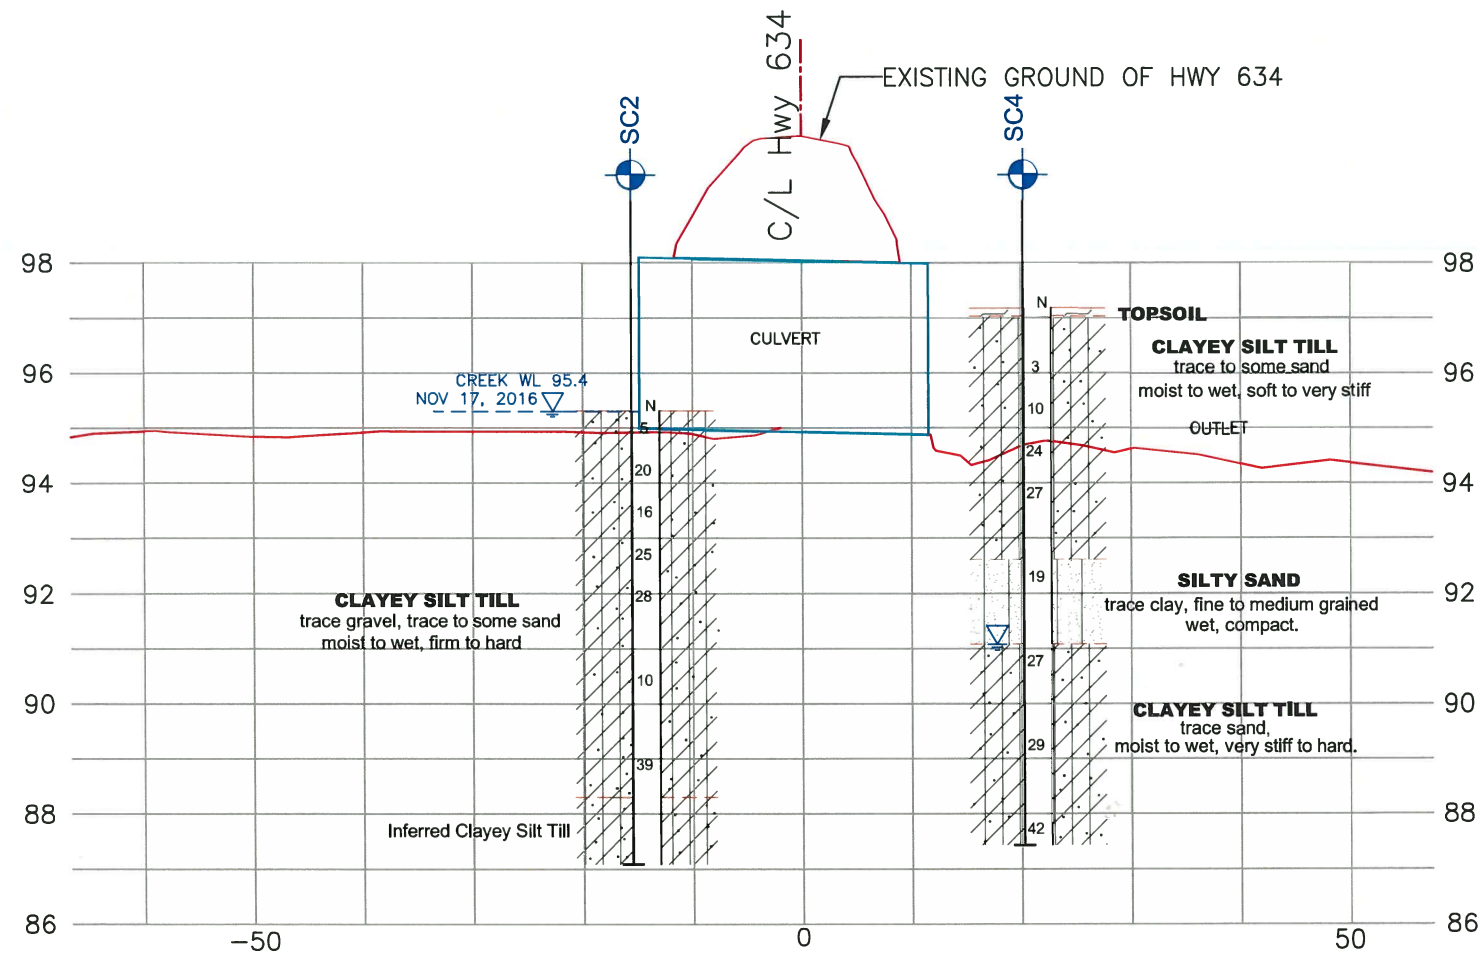
PLAN

SECTION ALONG C/L CULVRT

The Structural Culvert is located along Hwy 634, at the approximate Station of 30+292.8 (based on the GA drawing provided by the MTO). Hwy 634 is a two lane, north/south roadway with approximately 1 m wide granular shoulders and a wooden guardrail system at the culvert location. The highway crosses above the Structural Culvert with approximately 2.2 m of embankment fill above the culvert crown, and 2.5H:1V sideslopes. The existing Structural Culvert consists of a 3.0 m diameter SPCSP having a total length of approximately 27 m (based on the drawing provided by the MTO). Photographs of the site are included in Appendix A of this report. The culvert location and cross sectional profiles are shown on Drawings 1 and 2 in Appendix B.

The drilled boreholes were advanced to depths of approximately 8.2 to 9.8 m below ground surface. Drawings 1 and 2 in Appendix B show the locations of all four boreholes and cross-sections of stratigraphy along the existing culvert alignment and the proximity of culvert inlet and outlet location.

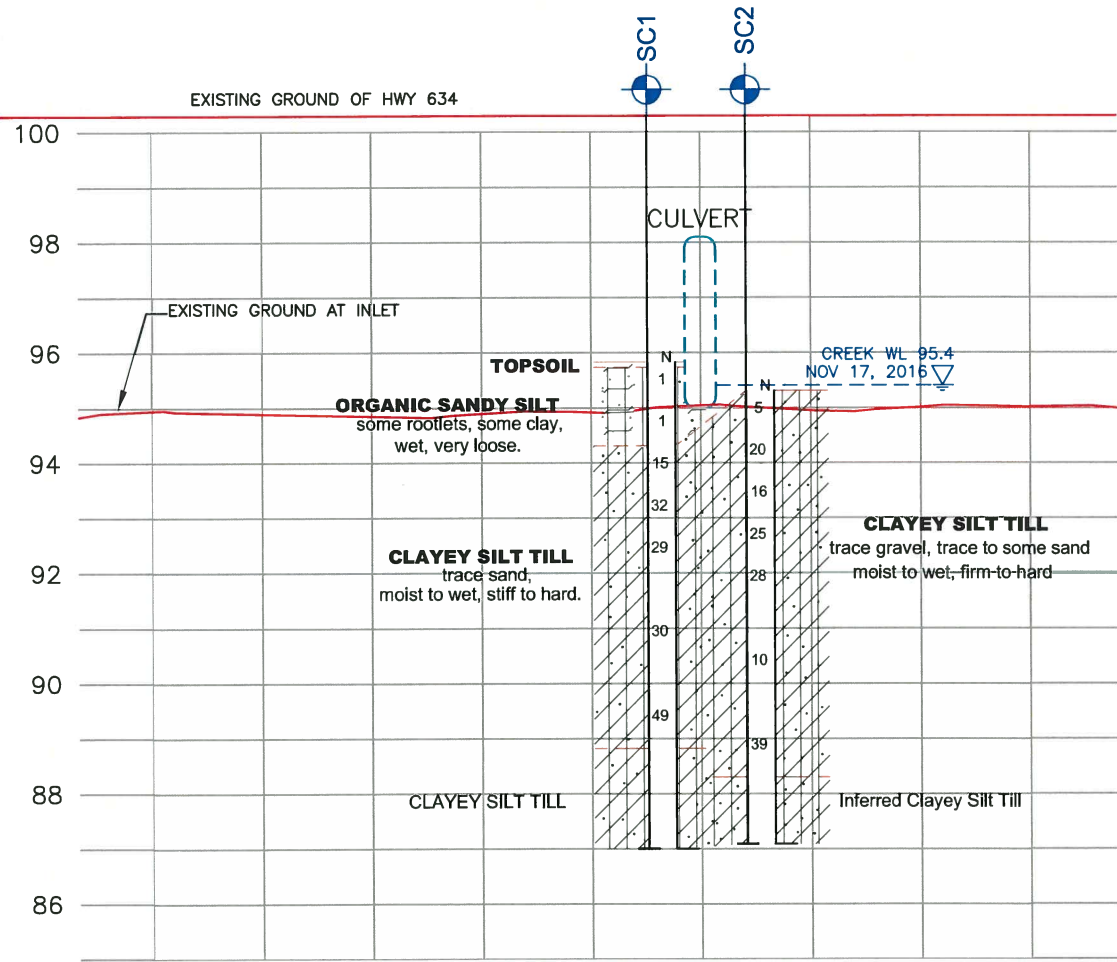
SECTION A-A'

TEMPORARY COFFERDAM AT STRUCTURAL
CULVERT/ HWY 634 (39E-313/C)
SECTIONS A-A' AND B-B'

A borehole location plan and cross section subsurface profiles are provided in Appendix B. It should be noted that the stratigraphic boundaries indicated on the borehole log and cross section stratigraphic profiles are inferred from semi-continuous sampling, observations of drilling progress and results of Standard Penetration Tests. These boundaries typically represent transitions from one soil type to another and should not be regarded as exact planes of geological change. Furthermore, subsurface conditions may vary between and beyond the borehole locations.

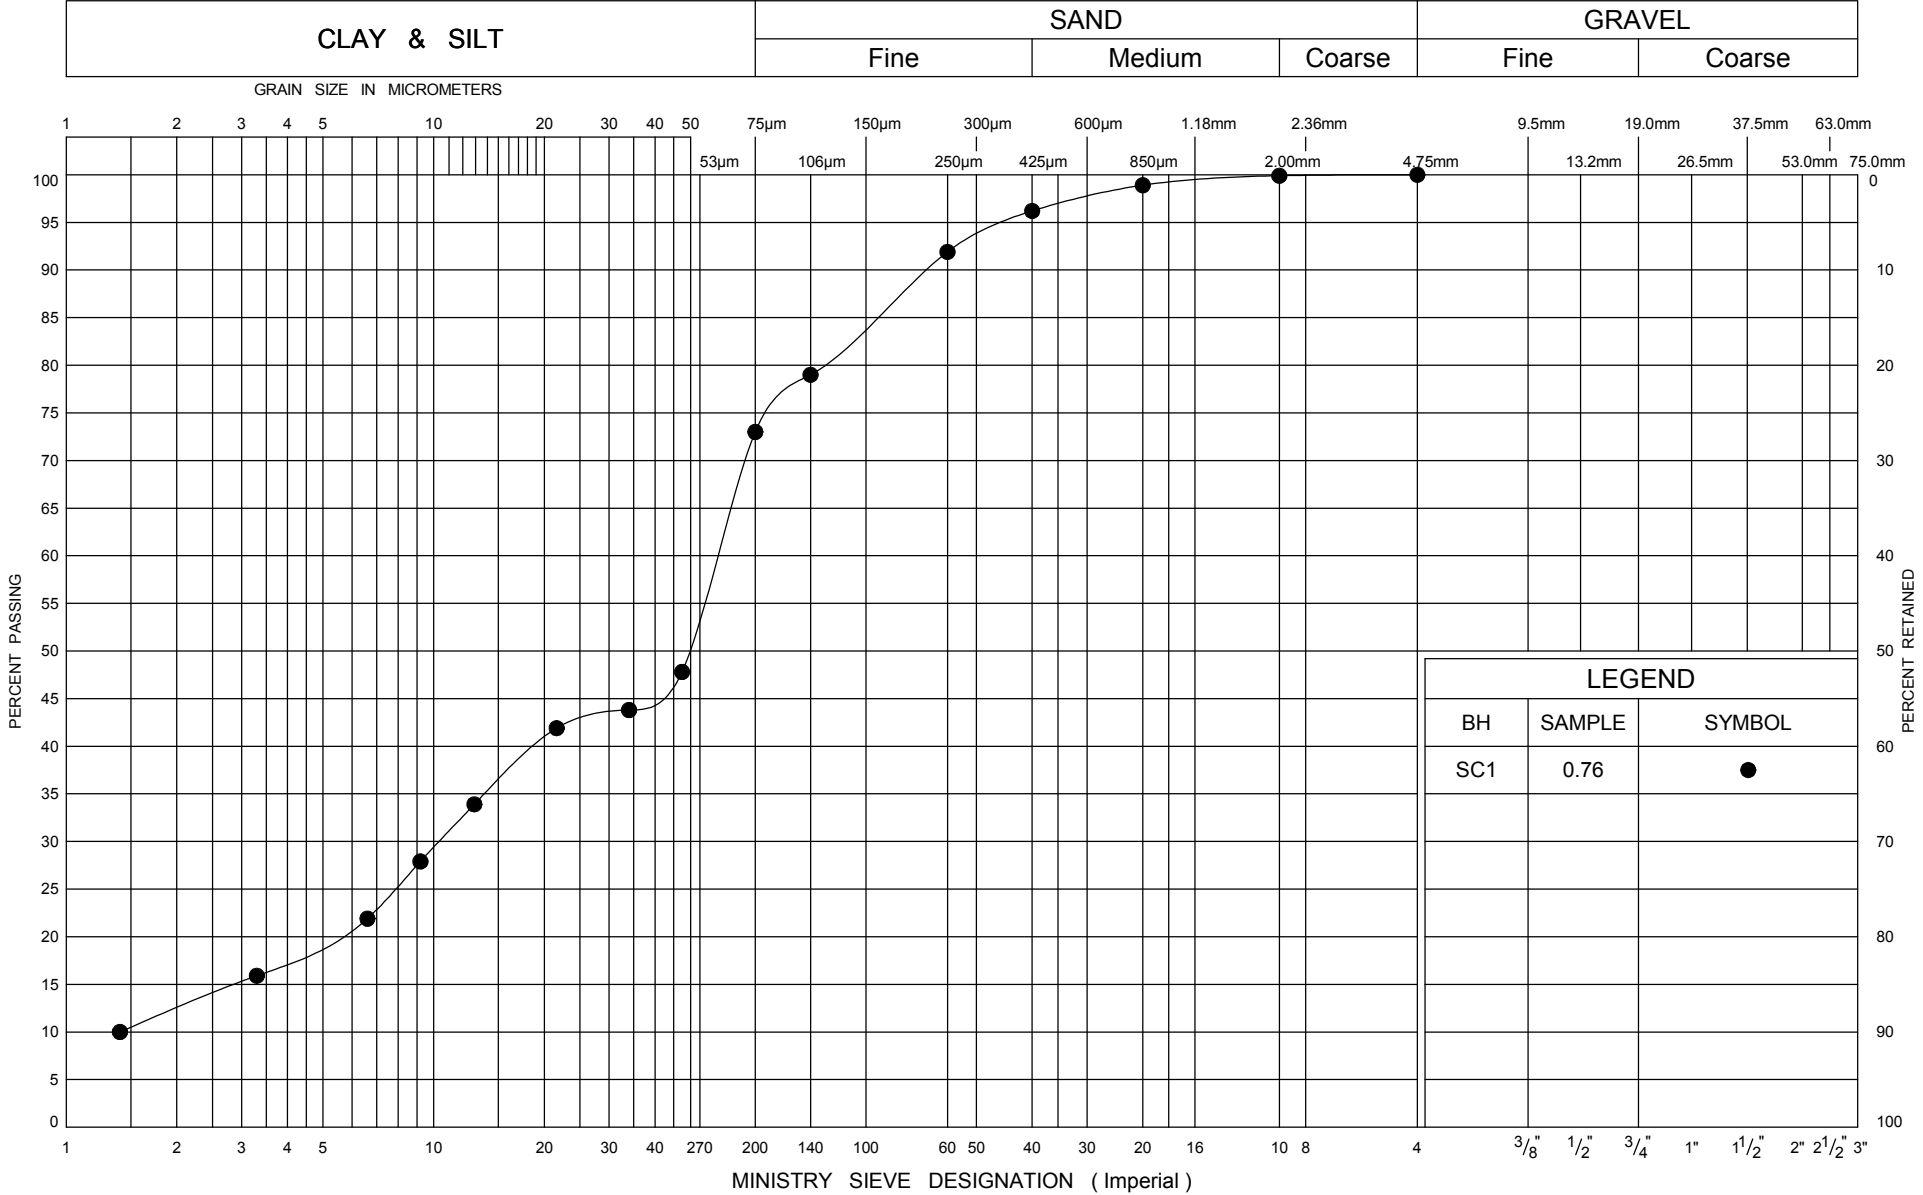
The results of the moisture content and grain size distribution tests are provided on the record of borehole sheets in Appendix C. The results of the grain size distribution test are also provided on Figure 1 in Appendix D.

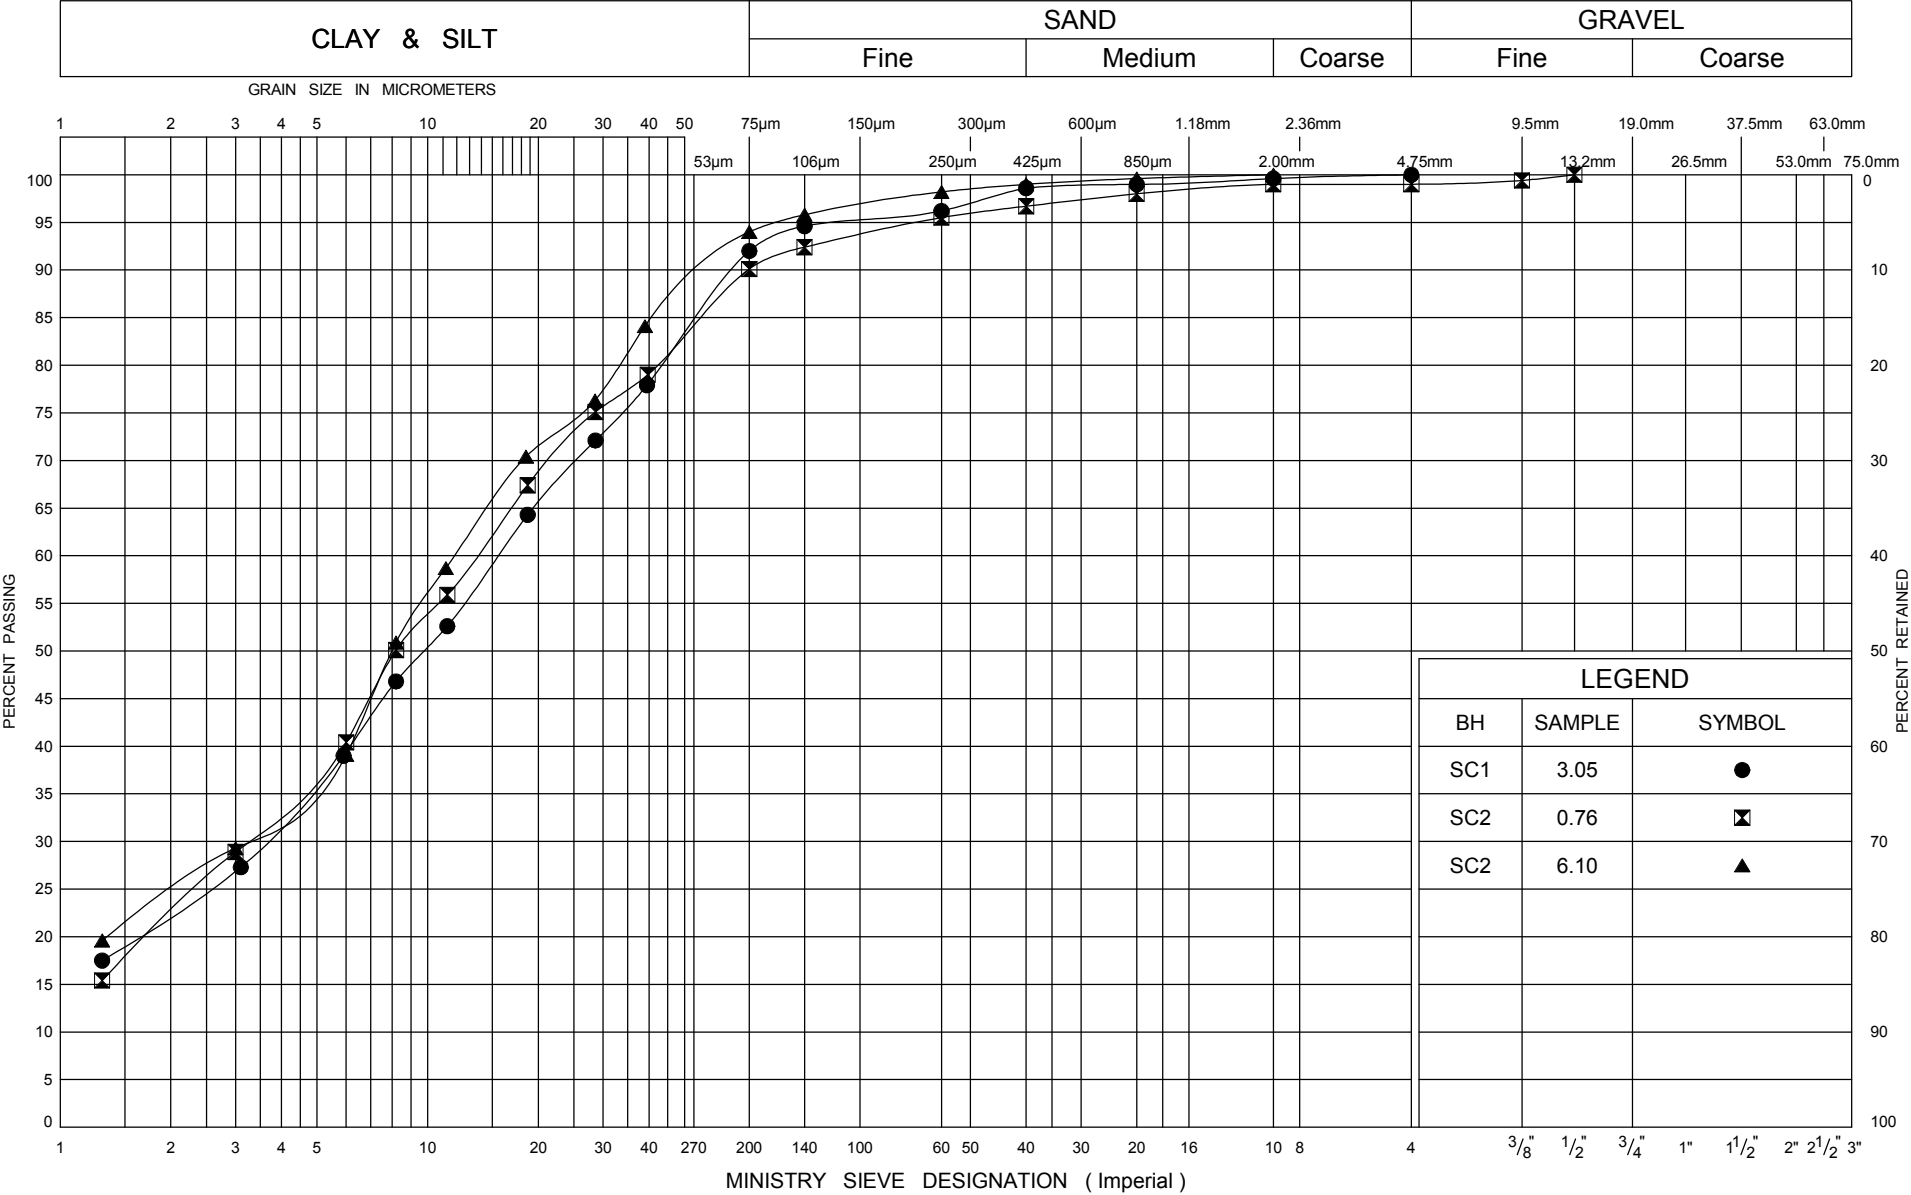
The results of the moisture content, grain size distribution and Atterberg limit tests are provided on the record of borehole sheets in Appendix C. The results of the grain size distribution test are also provided on Figures 2 in Appendix D. The results of the Atterberg Limits tests are provided on Figure 5 in Appendix D.

The results of the moisture content, grain size distribution and Atterberg limit tests are provided on the record of borehole sheets in Appendix C. The results of the grain size distribution test and Atterberg limit test are also provided on Figures 2 and 5 in Appendix D.

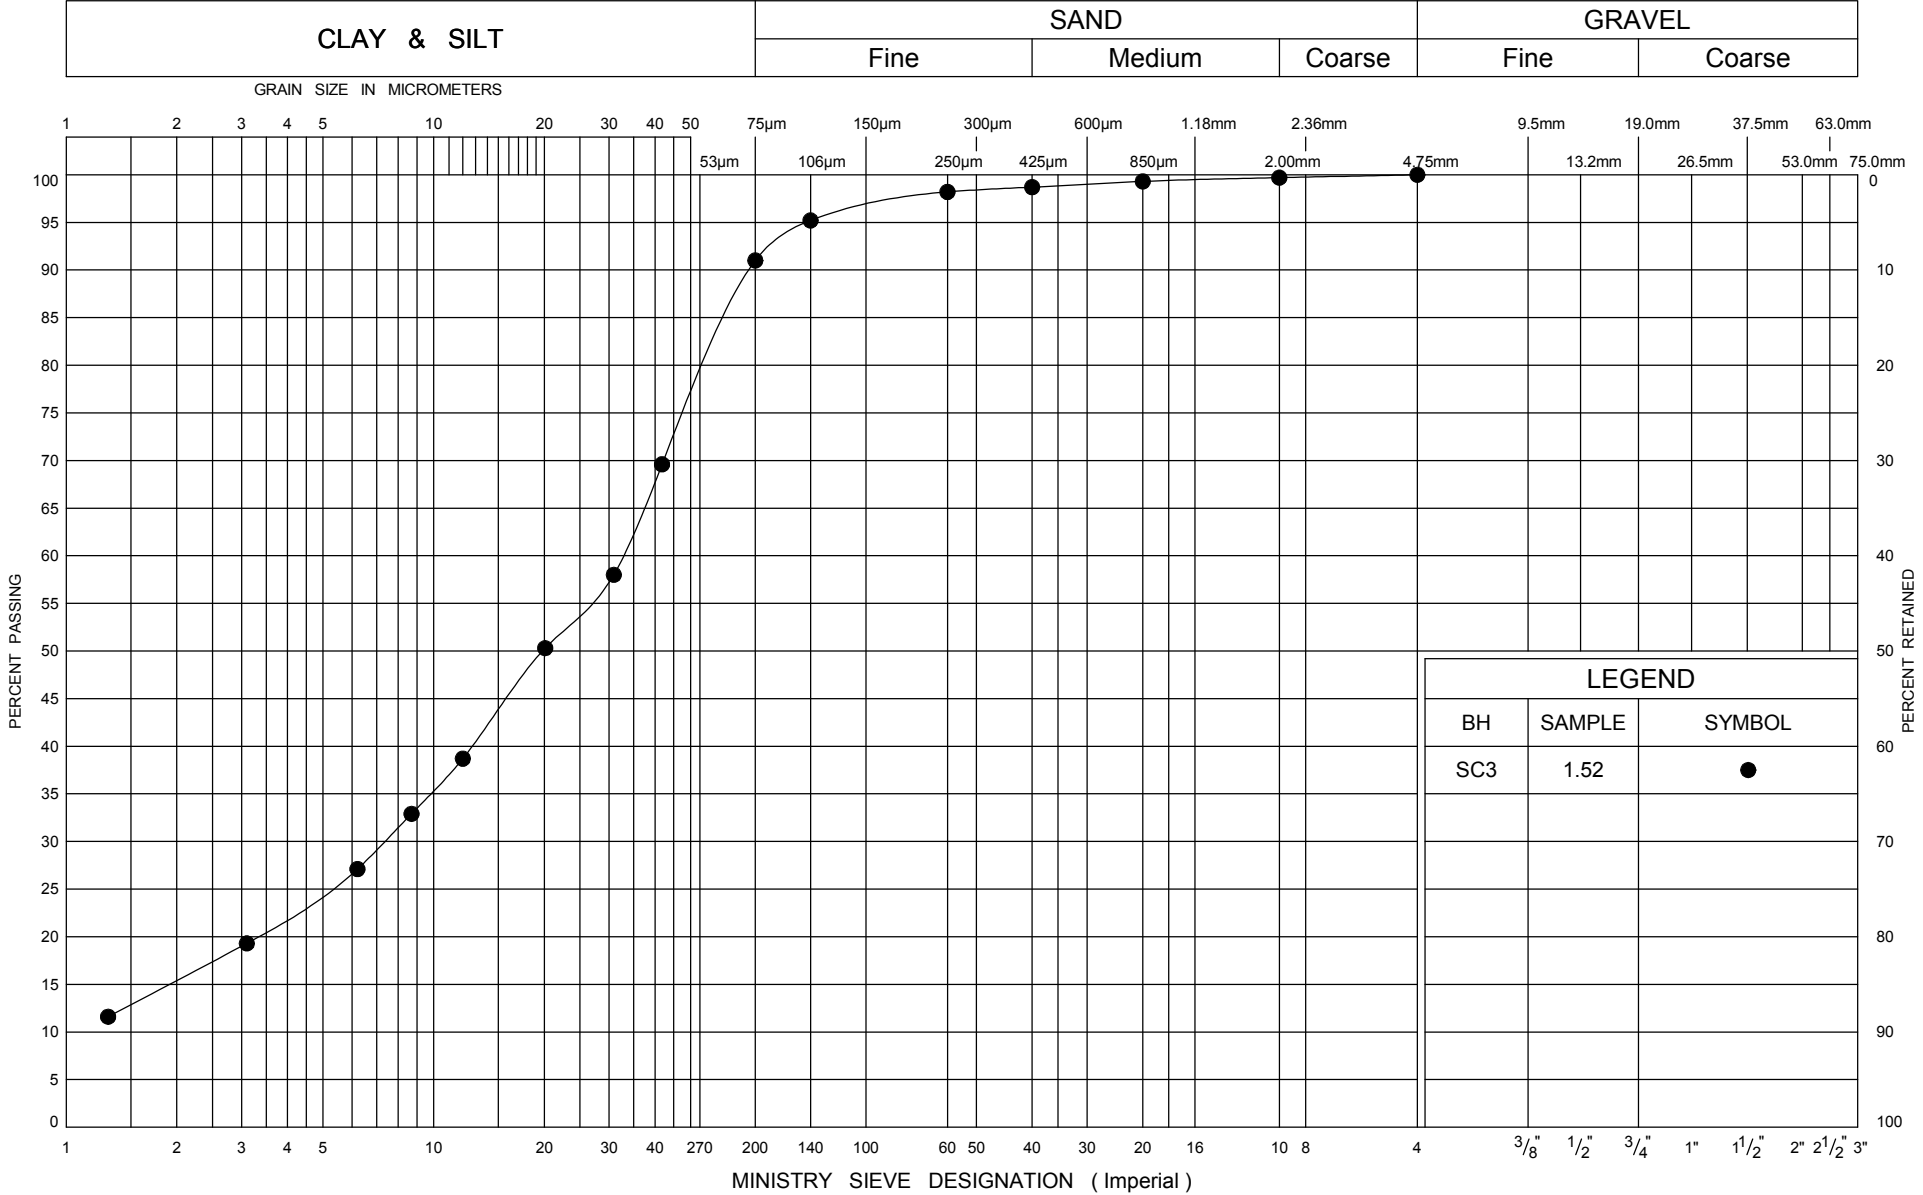
The results of the moisture content, grain size distribution and Atterberg limit tests are provided on the record of borehole sheets in Appendix C. The results of the grain size distribution and Atterberg limit tests are also provided on Figure 3 and 6, respectively in Appendix D.
