**REPORT ON
GEOTECHNICAL INVESTIGATION AND FOUNDATION DESIGN
PROPOSED PEDESTRIAN BRIDGES AT HIGHWAY 410
WILLIAMS PARKWAY WIDENING
BRAMPTON, ONTARIO**

GEOCREs No. 30M12-179

SPL CONSULTANTS LIMITED

Project: 1122-110B
November 10, 2015

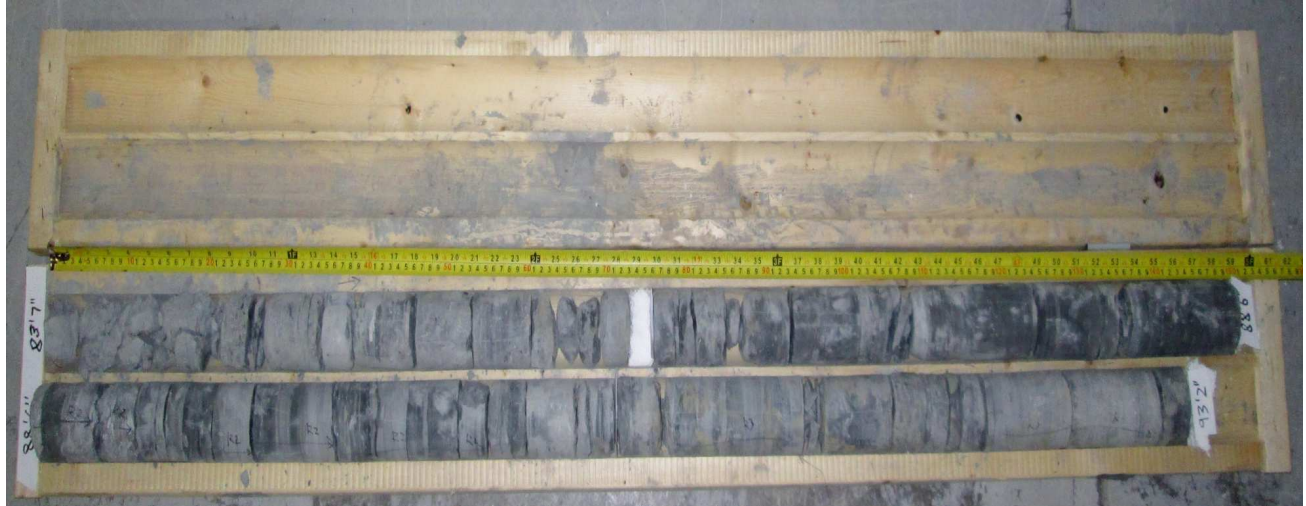
Run 2 86' 1" ~ 91' 1"

Run 3 91' 1" ~ 93' 7"

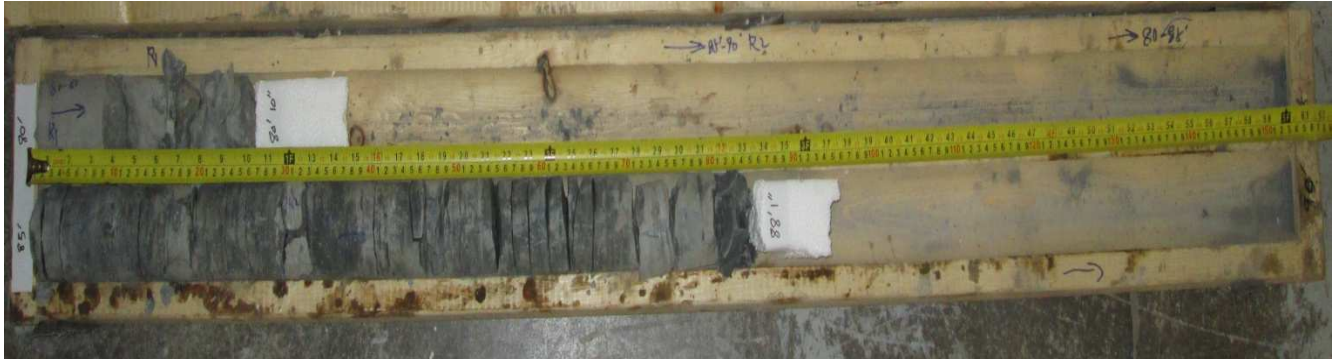
Photo A2: BH12-2 Bedrock Core

Run 1: 80' – 85'

Run 2: 85' – 90'

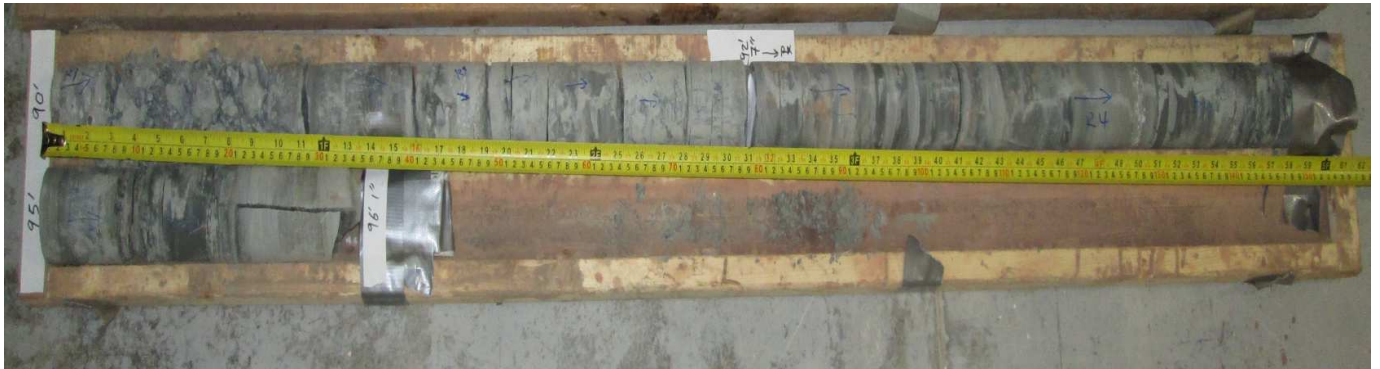
Photo A3: BH12-2 Bedrock Core

Run 3: 90' – 92'7\"

Run 4: 92'7\" – 96'1\"

Fracture Index: When logging the rock cores, the fracture Index (i.e. the number of fractures for each 0.3m length of core) was also recorded. The recorded values range between nil and greater than 25. In BH12-2, broken zone was encountered to a depth of 25.9 m. It was observed that the planes of weaknesses along which the cores tended to break, included planes of fissility and bedding, the contact surfaces between shale and siltstone or limestone bands and some oblique and subvertical joints.

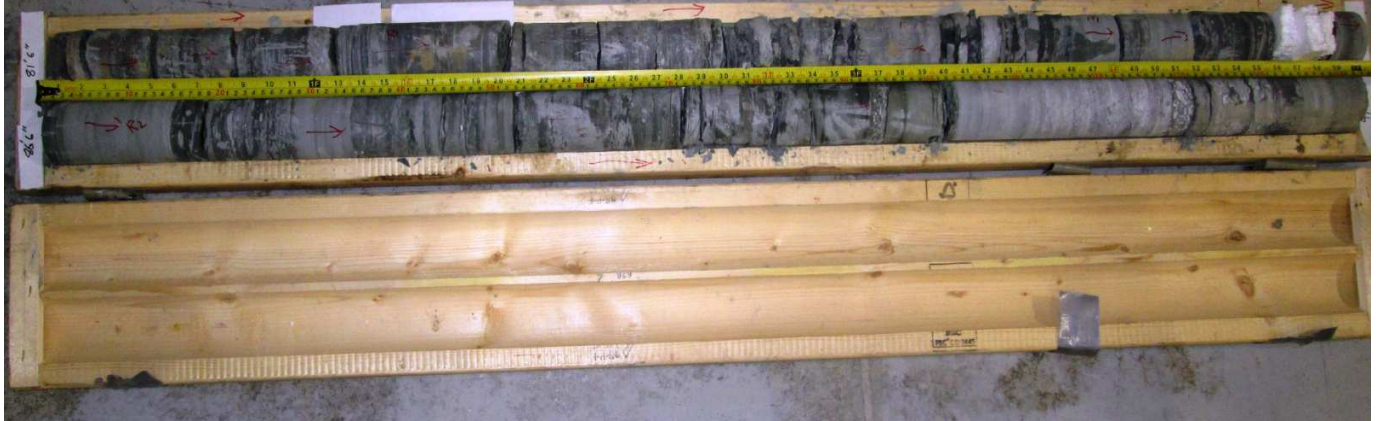
Photo A4: BH12-5 Bedrock Core

Run 1: 81'6" – 86'6"

Run 2: 86'6" – 91'6"

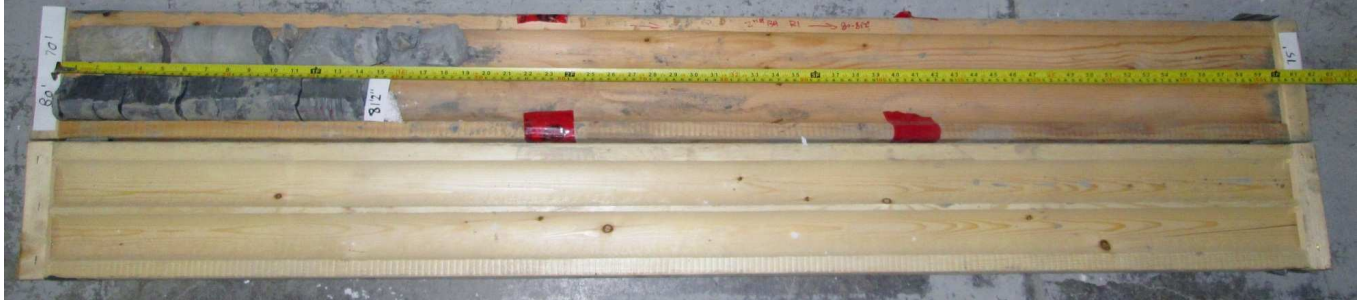
Photo A5: BH12-6 Boulder / Bedrock Core

Run 1: 70' – 75' (Boulder)

Run 2: 80' – 81'2" (Shale Bedrock)
