**FINAL  
FOUNDATION INVESTIGATION AND DESIGN REPORT  
COUNTY ROAD 28 - HWY 401 N/S-W RAMP RETAINING WALL  
NORTHUMBERLAND COUNTY – PORT HOPE, ONTARIO  
ASSIGNMENT NO.: 4019-E-0021  
GWP 4068-14-00**

**SITE NO. 21X-0232/B0  
GEOCRES NO.: 30M16-076**

**Report  
to  
MCINTOSH PERRY | LEA JOINT VENTURE**

August 2023  
Thurber File No.: 33099

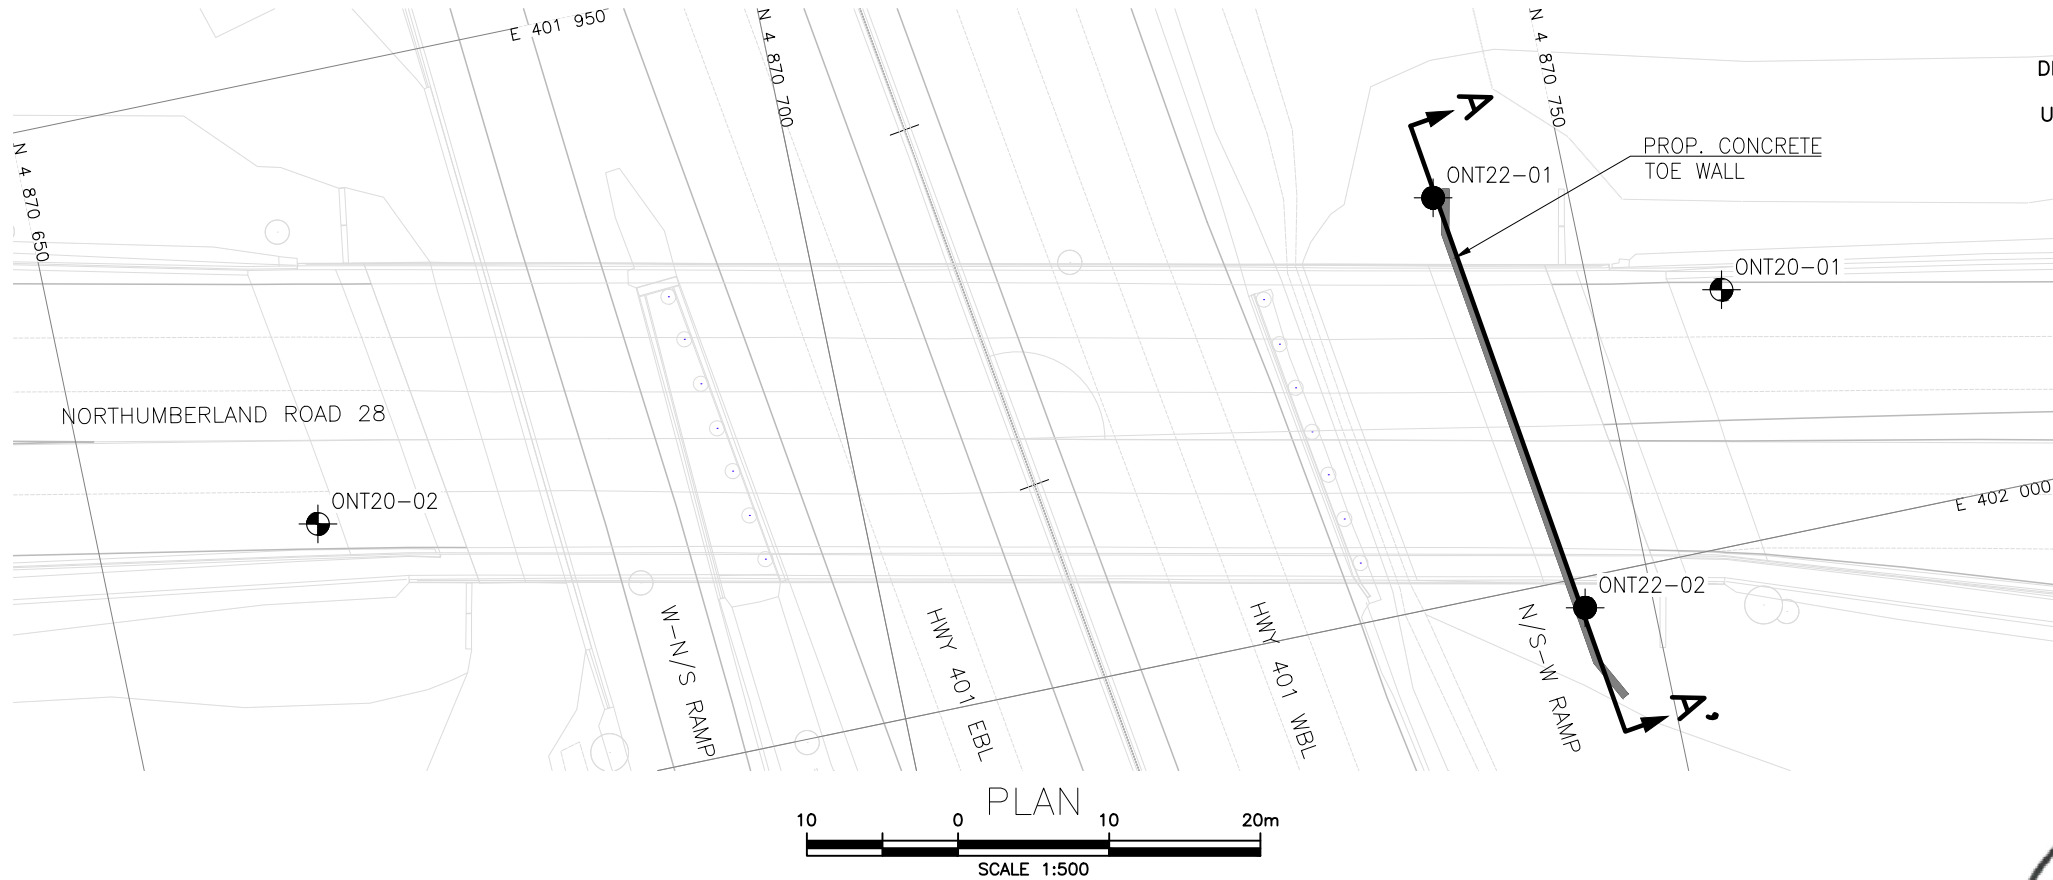
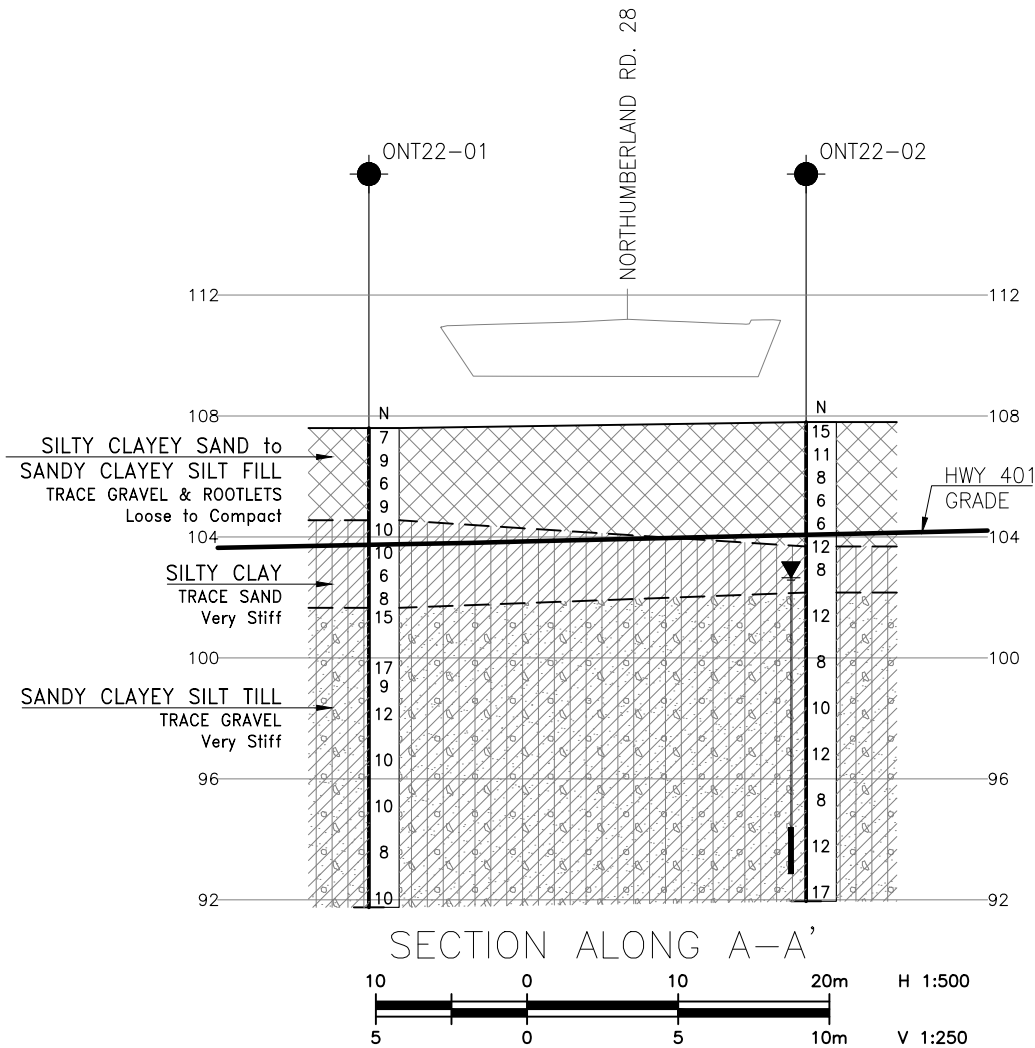
HIGHWAY 401  
NORTHUMBERLAND ROAD 28  
BRIDGE REPLACEMENT  
BOREHOLE LOCATIONS AND SOIL STRATA

# PROFILE ALONG NORTHUMBERLAND RD. 28

Details of the encountered soil stratigraphy are presented on the Record of Borehole sheets included in Appendix B and on the Borehole Location and Soil Strata Drawing included in Appendix A. Soil classification is in accordance with ASTM D2487 with cohesive soils described as per current MTO Guidelines for Foundation Engineering Services. A general description of the stratigraphy, based on the conditions encountered in the boreholes, is given in the following paragraphs. However, the factual data presented on the Record of Borehole sheets takes precedence over this general description for interpretation of the site conditions. It must be recognized that the soil and groundwater conditions will vary between and beyond borehole locations.

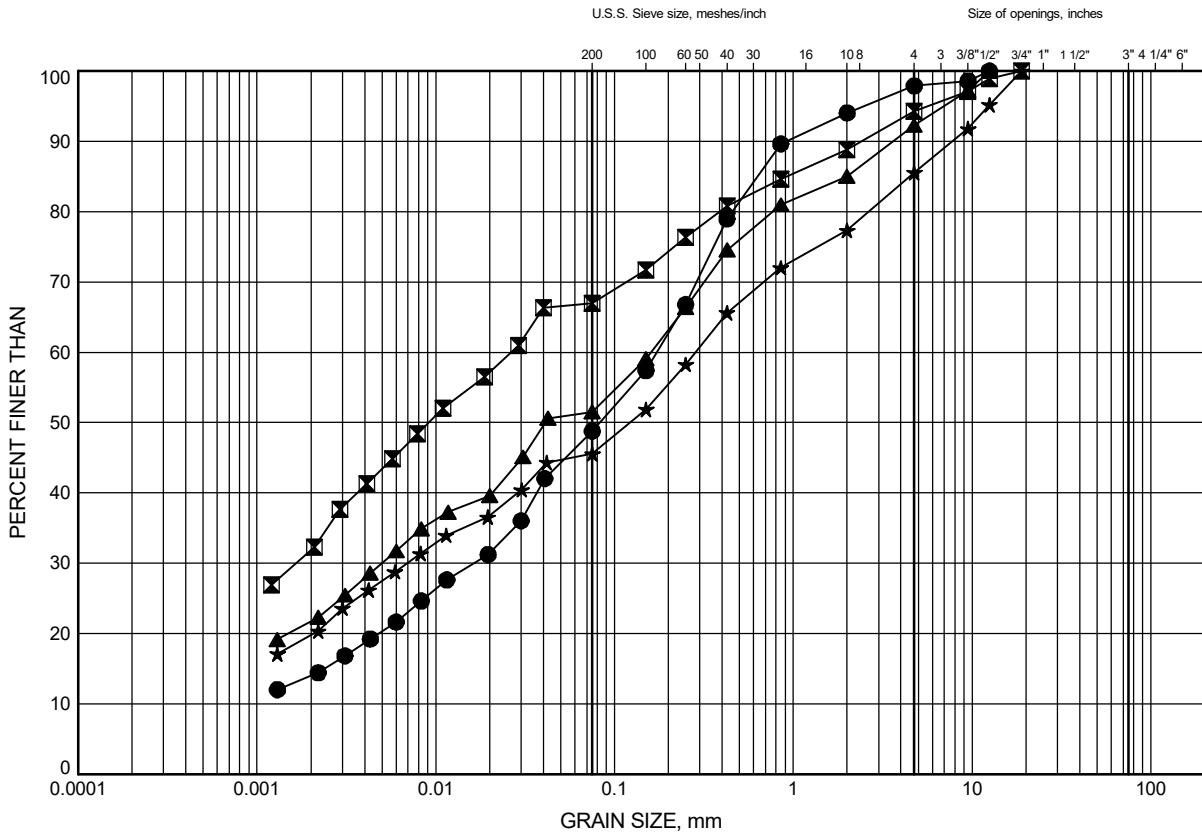
## Embankment Fill

Recorded moisture contents in the fill ranged from 6 to 19%. The results of gradation analyses completed on four samples of the embankment fill are illustrated on Figure C1 of Appendix C. The results of the tests are summarized in Table 6-1 and are presented on the Record of Borehole sheets in Appendix B.

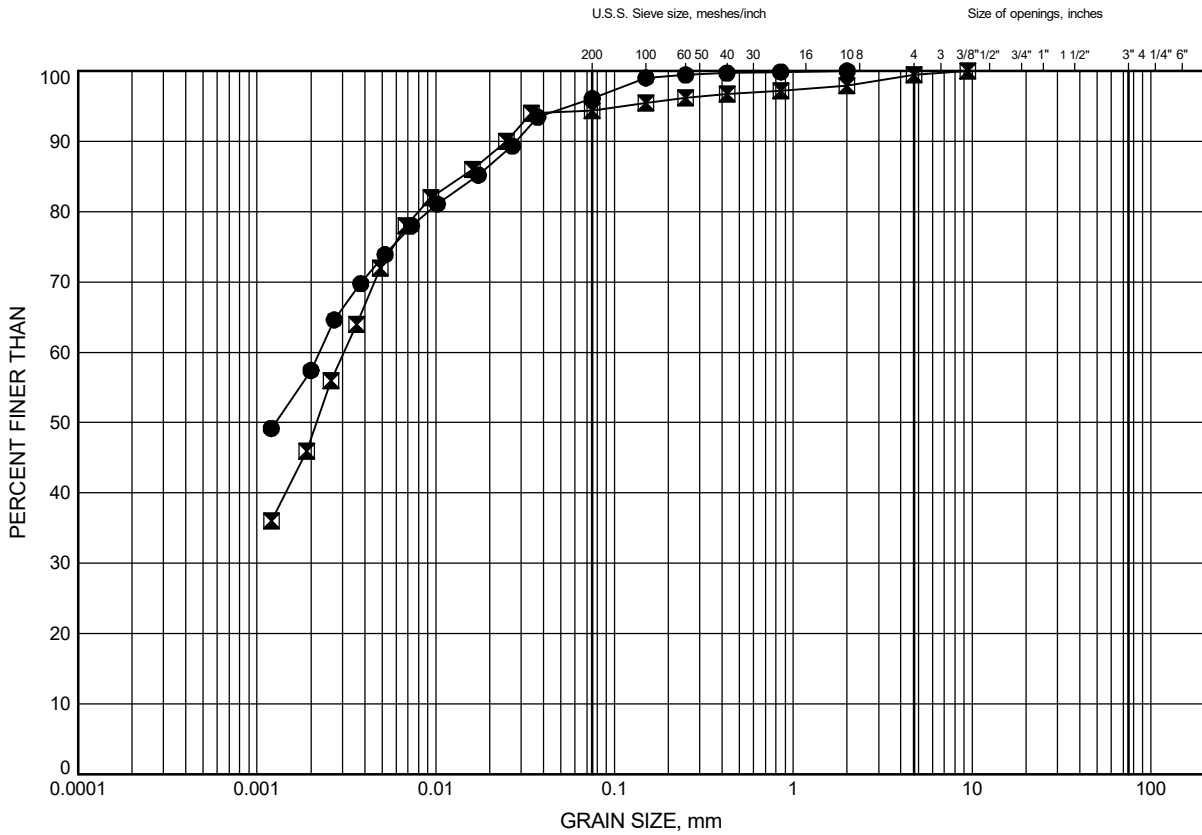
## Silty Clay (CI)

Recorded moisture contents ranged from 23 to 38%. The results of gradation analyses completed on two samples of the silty clay layer are summarized in Table 6-3 and are illustrated on Figure C2 of Appendix C.

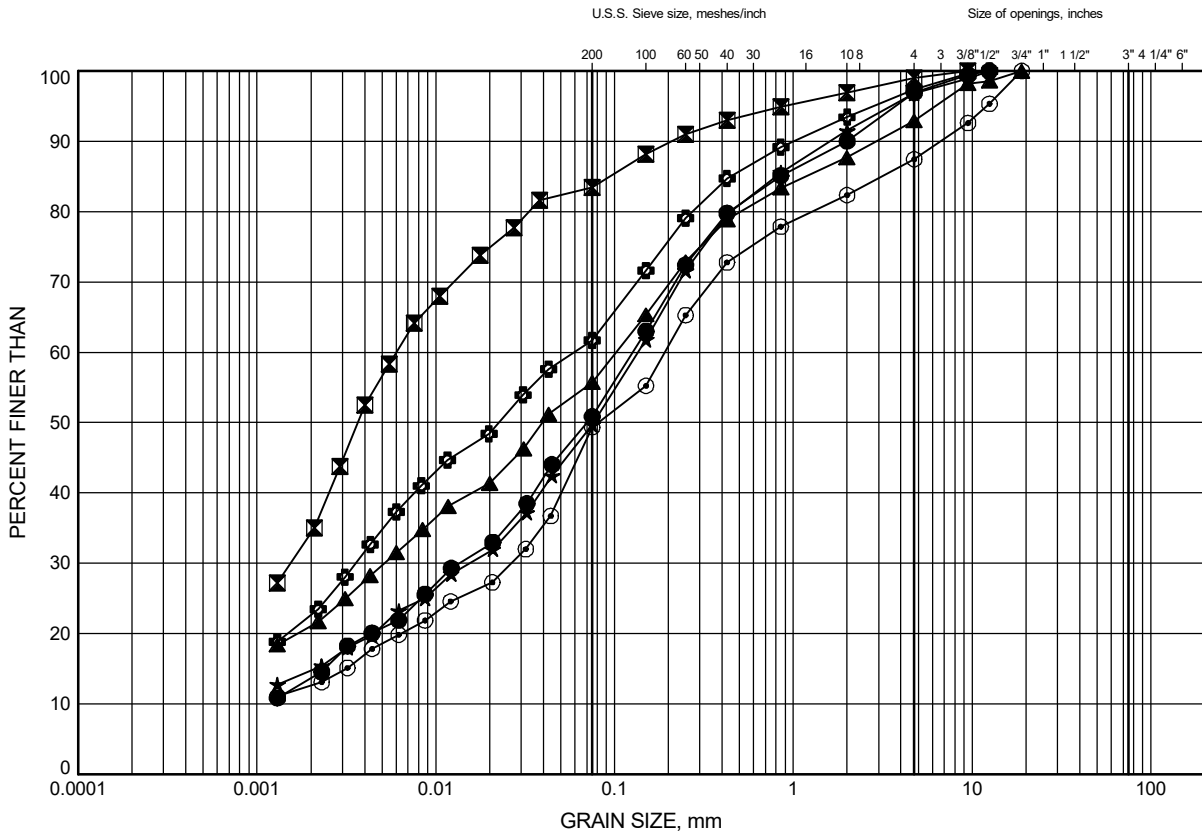
## Glacial Till

The moisture content of the sample tested ranged from 9% to 28%. The results of gradation analyses completed on seven samples of the glacial till layer are summarized in Table 6-5 and illustrated on Figures C3 and C4 of Appendix C.

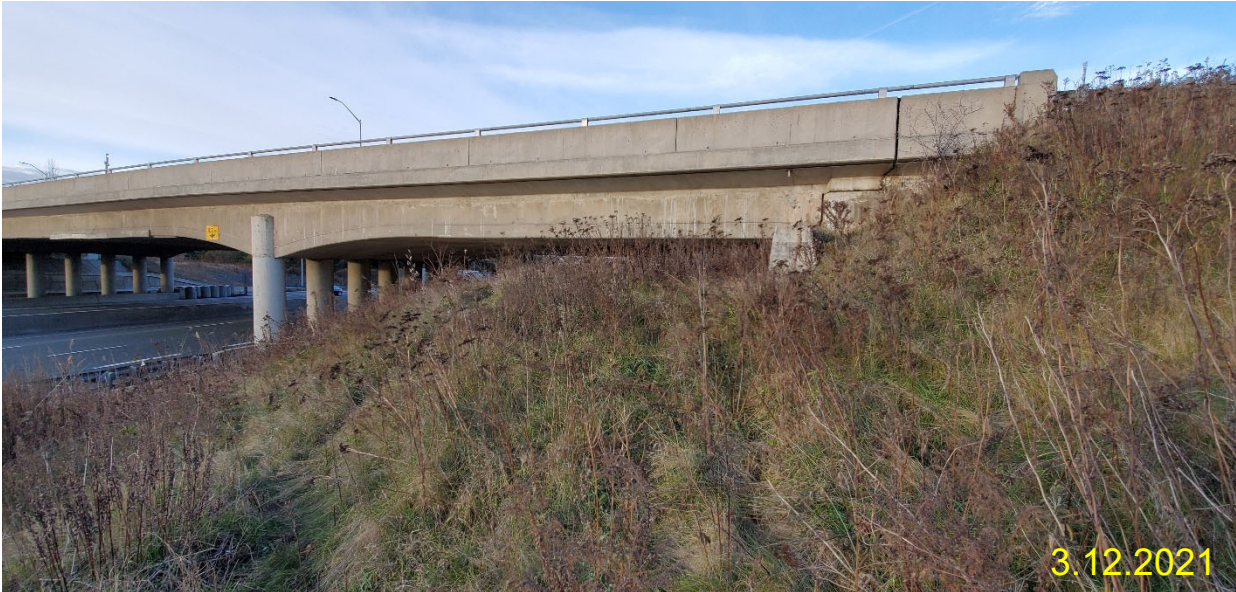
Photo 1: Looking west towards the crest of the existing north foreslope of the Highway 401 underpass of County Road 28

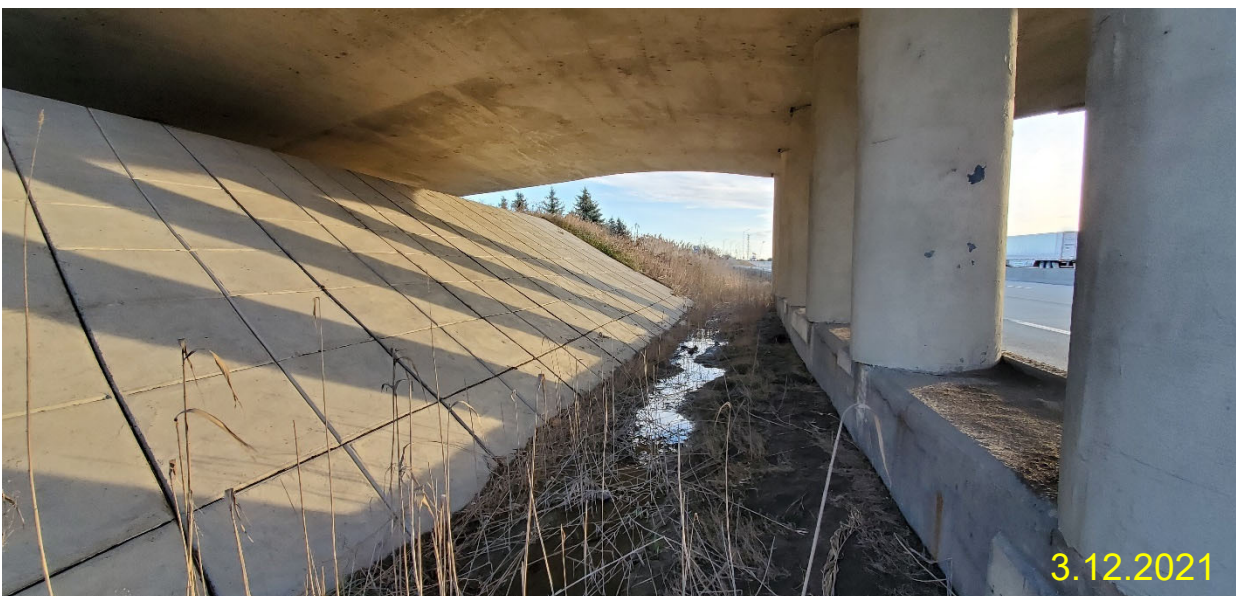
Photo 2: Looking east along the toe of the existing north foreslope of the Highway 401 underpass of County Road 28
