FOUNDATION INVESTIGATION REPORT
PROPOSED RECONSTRUCTION OF
STRUCTURAL CULVERT - SITE 2-476-C
HIGHWAY 21 FROM KINCARDINE TO TIVERTON
G.W.P. 408-94-00
Agreement # 3005-E-0038

FOUNDATION INVESTIGATION REPORT
PROPOSED RECONSTRUCTION OF
STRUCTURAL CULVERT - SITE 2-476-C
HIGHWAY 21 FROM KINCARDINE TO TIVERTON

G.W.P. 408-94-00
Agreement # 3005-E-0038

September 28, 2007
06-8-IEG2-476

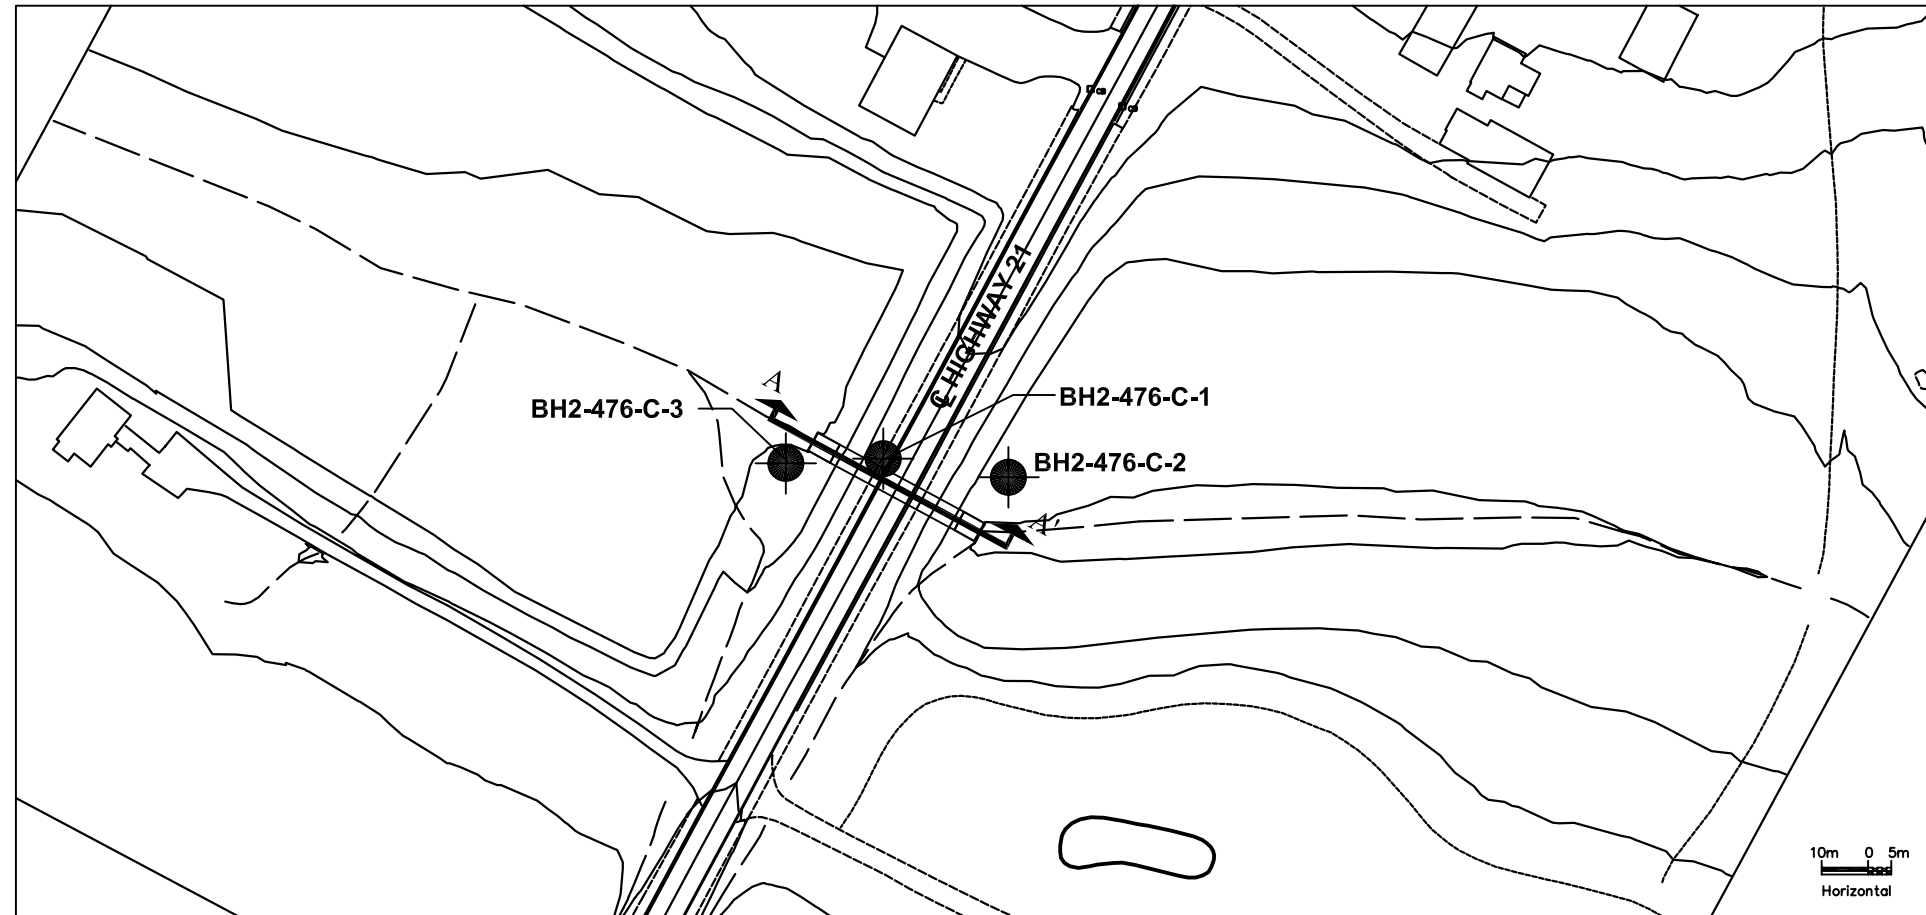
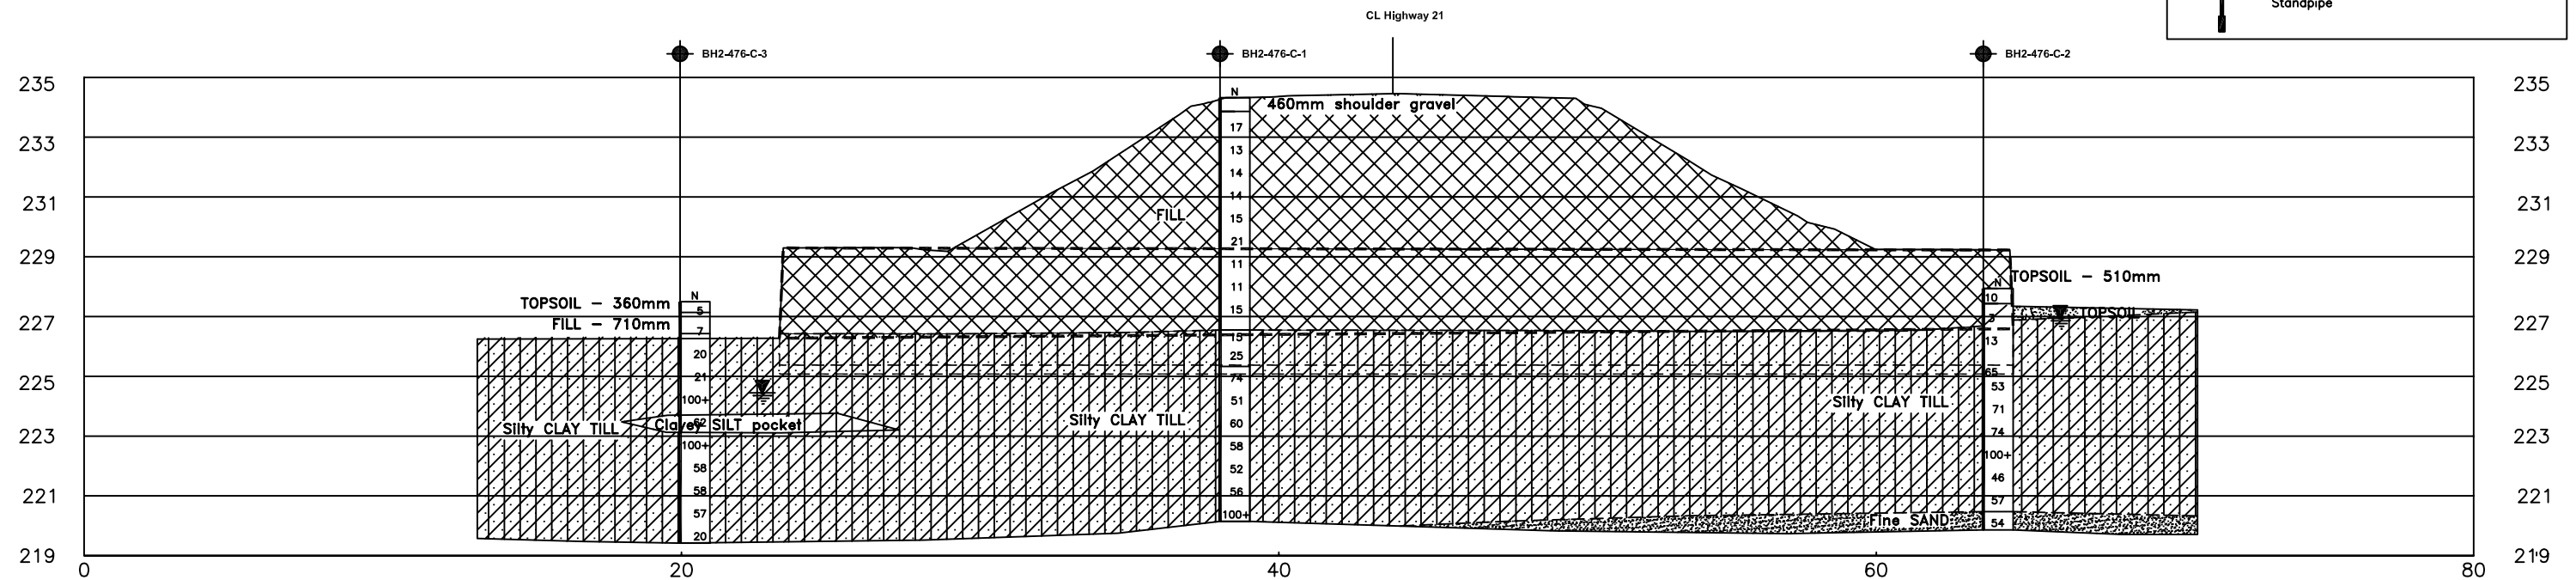
Drawing 1
Borehole Locations
And
Soil Strata

BOREHOLE LOCATION PLAN

SECTION A-A'
CENTERLINE OF CULVERT

On September 25 to 27, 2006, a CME 55 drill rig was supplied by London Soil Test Limited and used on site for drilling and Standard Penetration Testing (SPT, following the procedures of ASTM D 1586). Three (3) boreholes were drilled and sampled to obtain data for foundation design of the proposed replacement culvert. The locations of the boreholes are shown on Drawing 1.

Reference is made to the Record of Borehole sheets (Appendix "A") and Laboratory Test Results (Appendix "B") for detailed subsurface soil and groundwater conditions encountered in the boreholes. The stratigraphic boundaries shown on the Record of Borehole sheets are inferred from non-continuous sampling and, consequently, represent transitions between soil types rather than exact planes of geological change. The soil profiles depicting the subsurface conditions on Drawing 1 will vary between and beyond the borehole locations.

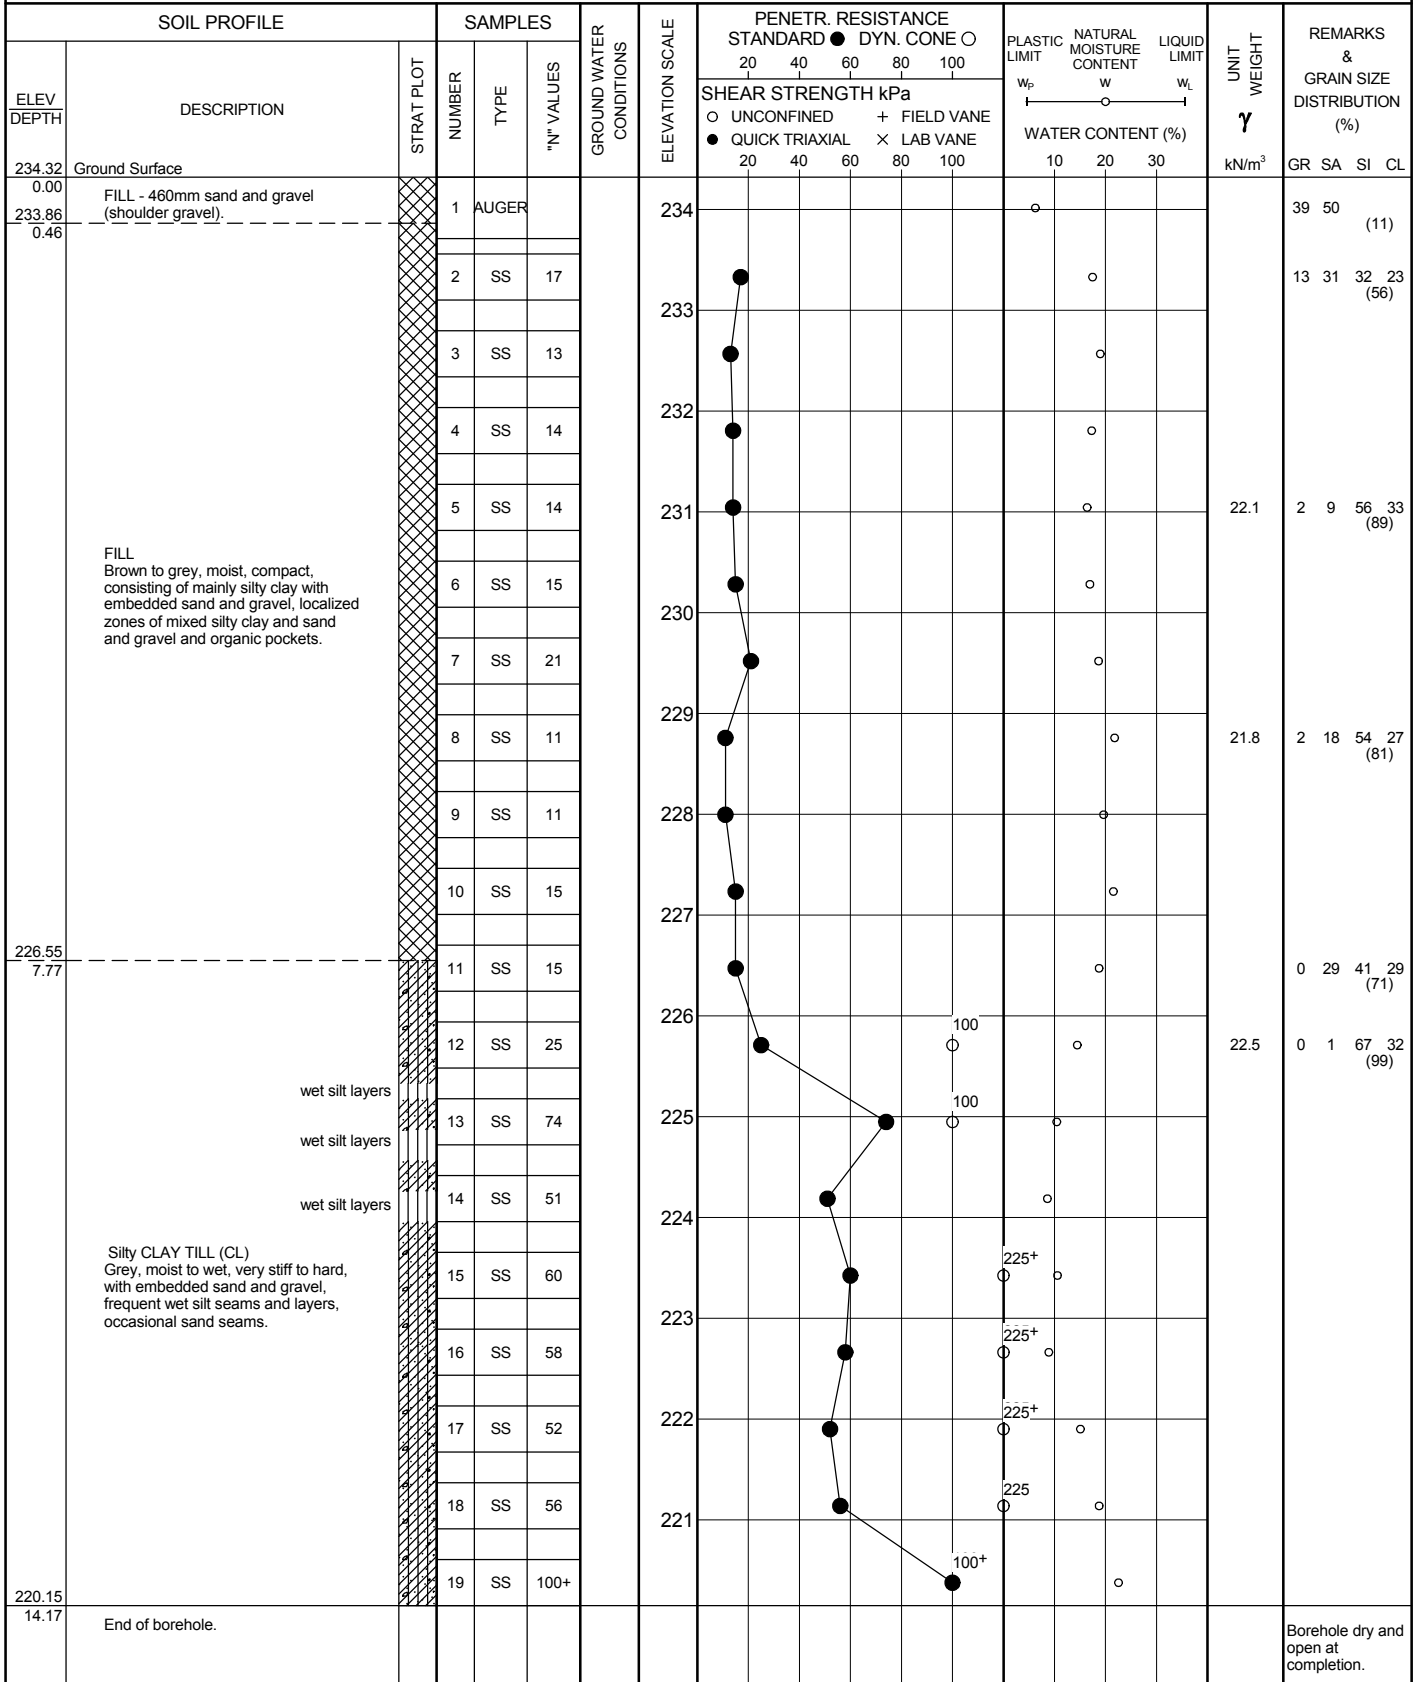
RECORD OF BOREHOLE No 2-476-C-1

W.P. GWP 408-94-00 LOCATION Site No. 2-476-C Northing - 4902864, Easting - 380805 ORIGINATED BY RB
 DIST Owen Sound HWY 21 BOREHOLE TYPE 100mm SST Auger COMPILED BY JL
 DATUM Geodetic DATE 09.25.06 - 09.25.06 CHECKED BY EC

Borehole 2-476-C-1, which was located at the west edge of existing pavement in the shoulder area, encountered 460 mm shoulder gravel. Underlying the shoulder gravel is the embankment fill material that extended to a depth of 7.77 m (elevation 226.55 m). The fill beneath the shoulder gravel typically consists of silty clay with sand and gravel and with sand and gravel pockets and occasional organic inclusions.

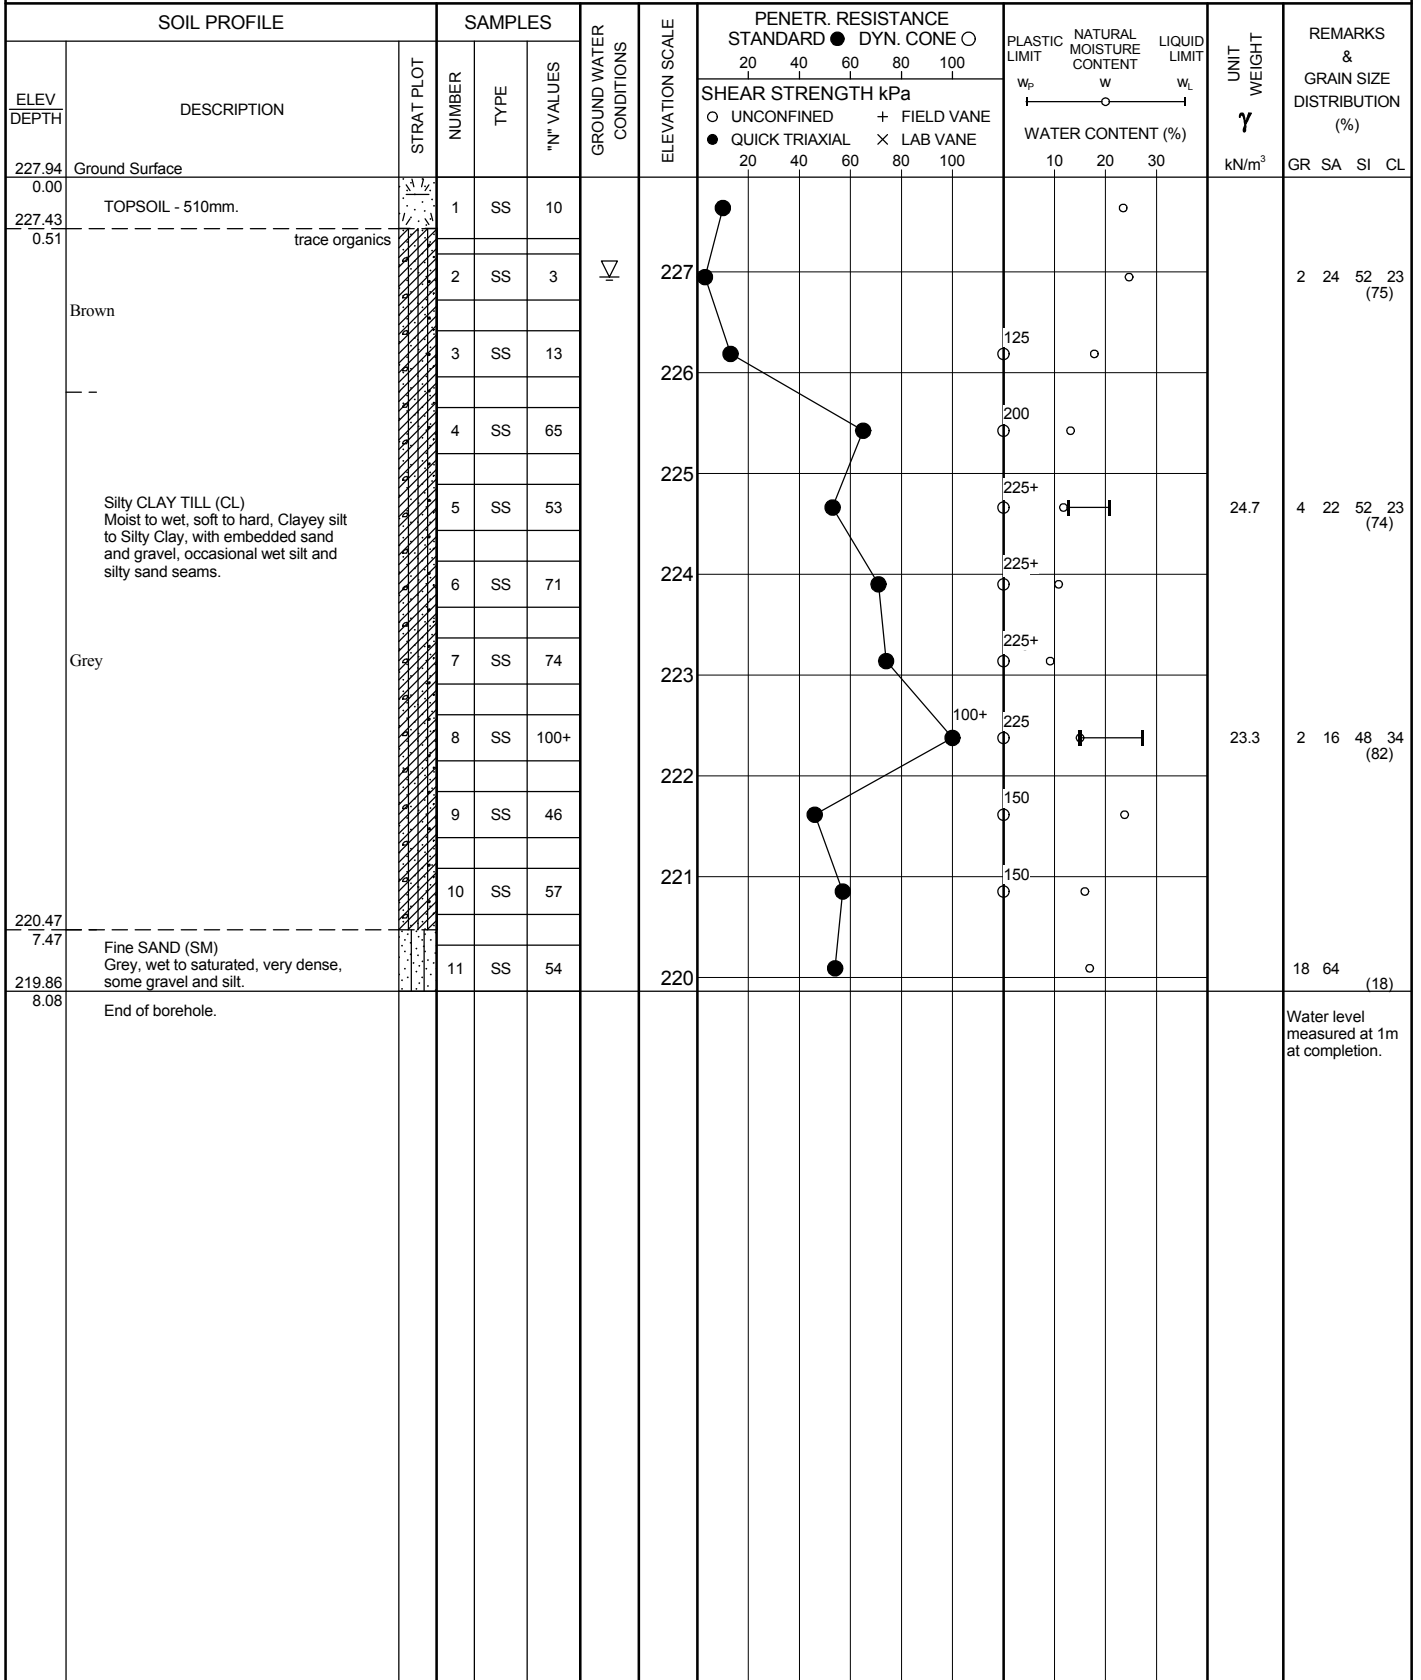
RECORD OF BOREHOLE No 2-476-C-2

W.P. GWP 408-94-00 LOCATION Site No. 2-476-C Northing - 4902860, Easting - 380832 ORIGINATED BY RB
 DIST Owen Sound HWY 21 BOREHOLE TYPE 100mm SST Auger COMPILED BY JL
 DATUM Geodetic DATE 09.26.06 - 09.26.06 CHECKED BY EC

At Boreholes 2-476-C-2 and 2-476-C-3, topsoil and silt to silty sand fill were contacted to depths of 0.51 m (elevation 227.43 m) and 1.07 m (elevation 226.43 m) respectively.

A grey fine sand layer, containing some gravel and silt, was contacted at a depth of 7.47 m (elevation 220.47 m) below the silty clay till at Borehole 2-476-C-2. A grain size distribution of the sand is shown on Figure 4 of Appendix "B". A single standard penetration test yielded an "N"-value of 54 blows per 0.3 m. The measured natural moisture content is 16%. Based on the above field and laboratory test results, the sand exhibited very dense compactness condition.

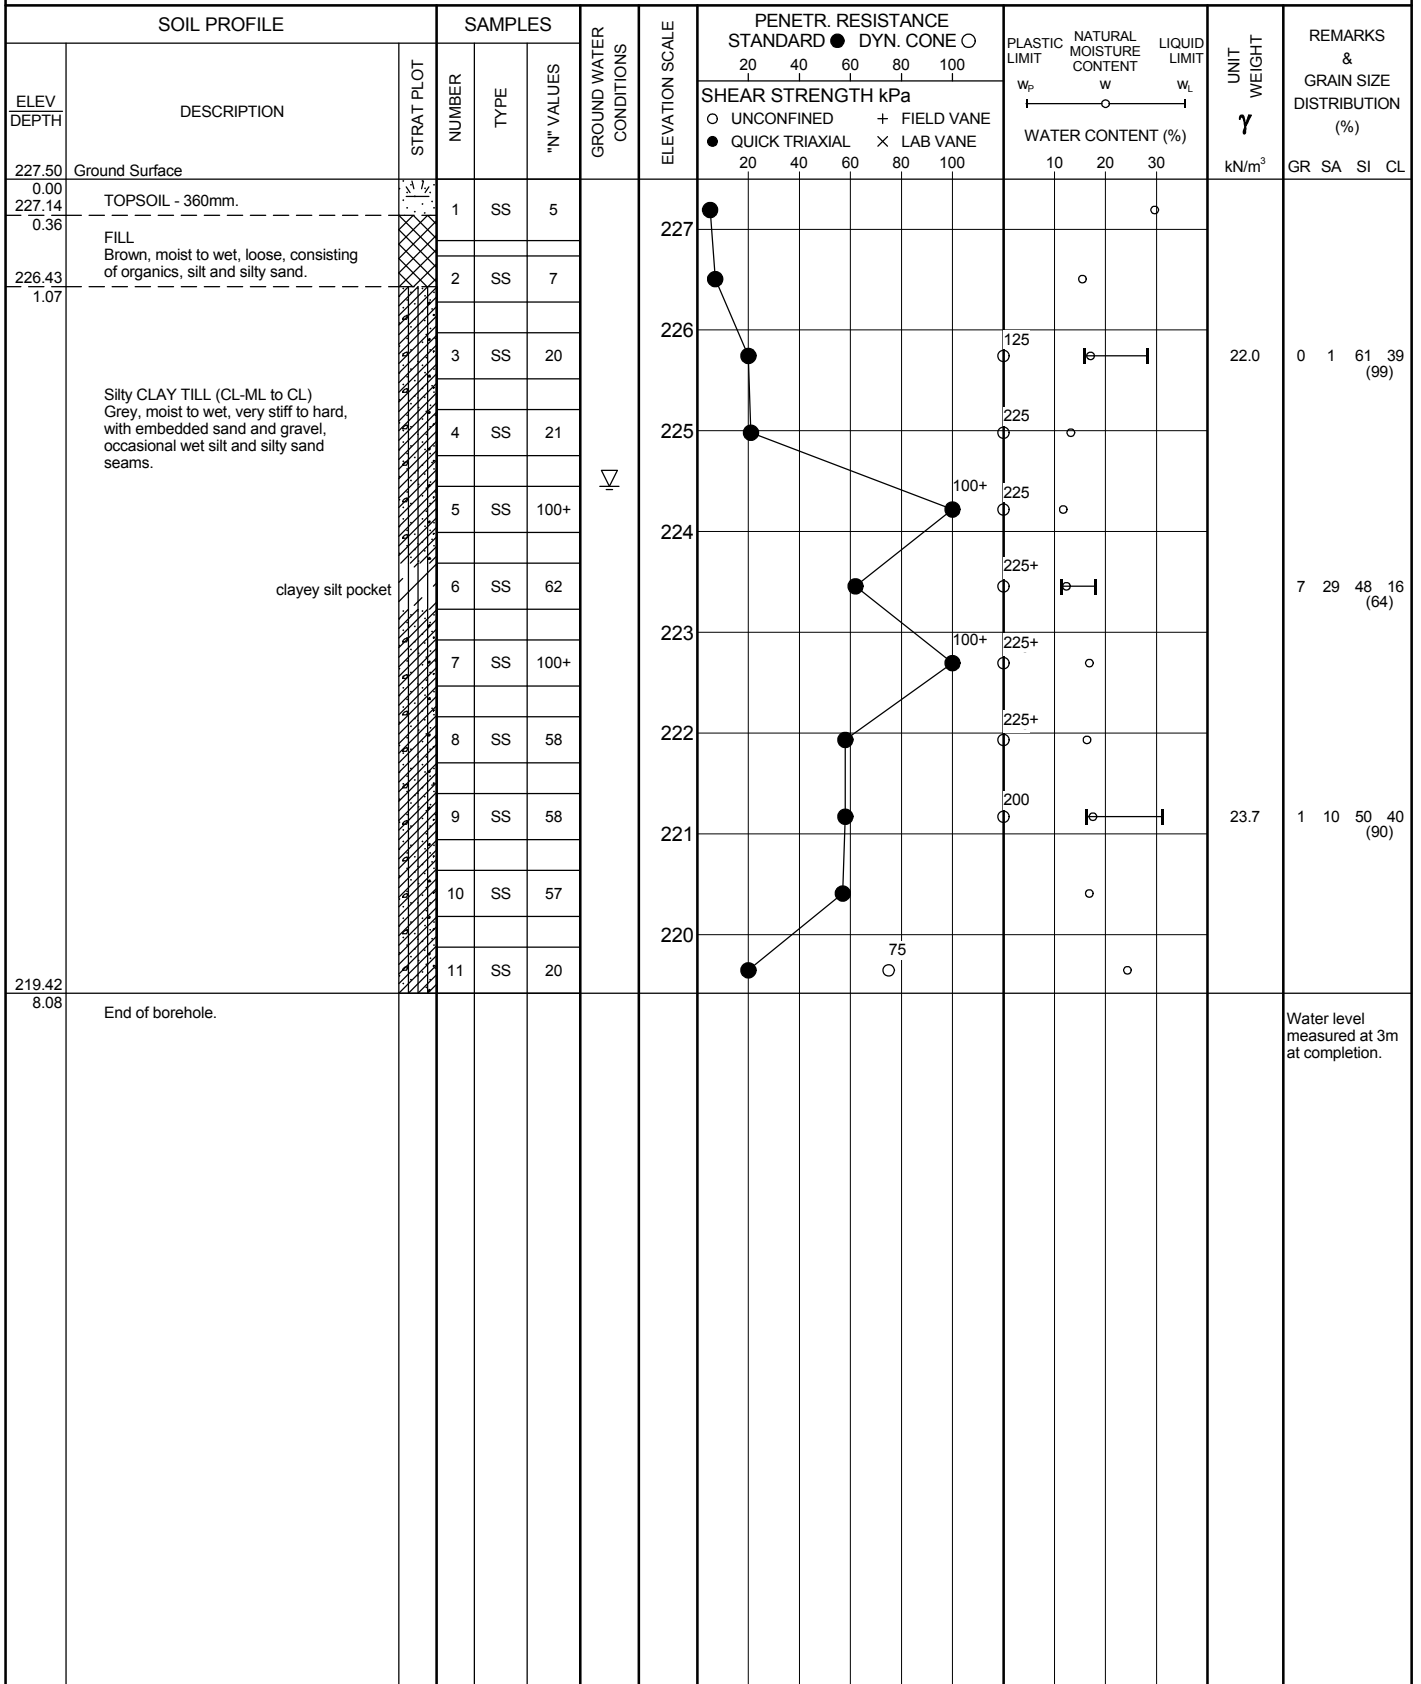
RECORD OF BOREHOLE No 2-476-C-3

W.P. GWP 408-94-00 LOCATION Site No. 2-476-C Northing - 4902863, Easting - 380784 ORIGINATED BY RB
 DIST Owen Sound HWY 21 BOREHOLE TYPE 100mm SST Auger COMPILED BY JL
 DATUM Geodetic DATE 09.27.06 - 09.27.06 CHECKED BY EC

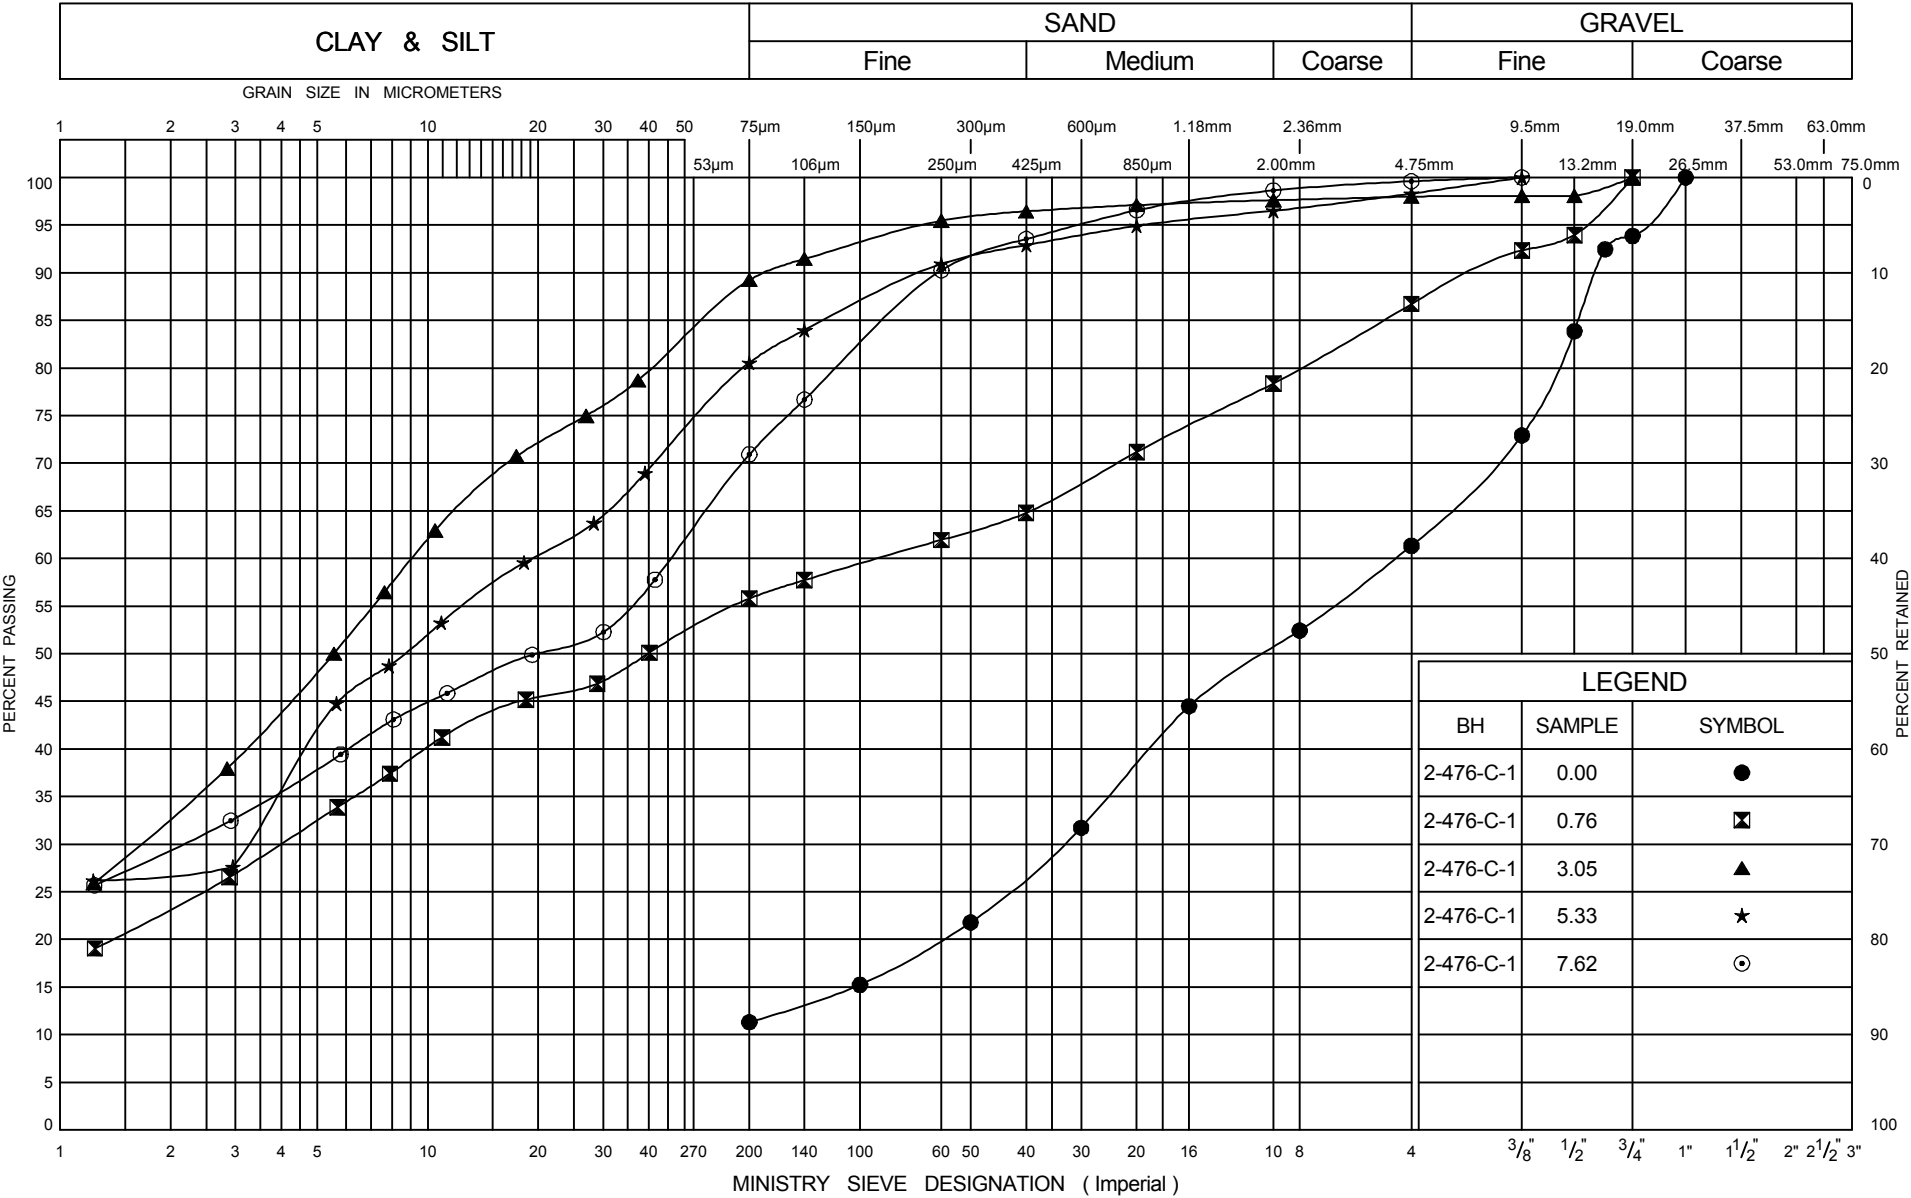
FIG No 1
GWP 408-94-00
Highway 21-Kincardine to Tiverton

GRAIN SIZE DISTRIBUTION
FILL

Four (4) grain size distributions of the embankment fill and one (1) grain size distribution of the shoulder gravel are shown on Figure 1 of Appendix “B”. Standard penetration tests yielded “N”-values from 5 to 21 blows per 0.3 m. The unit weight of the embankment fill was measured to be in the range of 21.8 to 22.1 kN/m³. The embankment fill is brown to grey in colour and the measured natural moisture contents range from 6 to 22%.

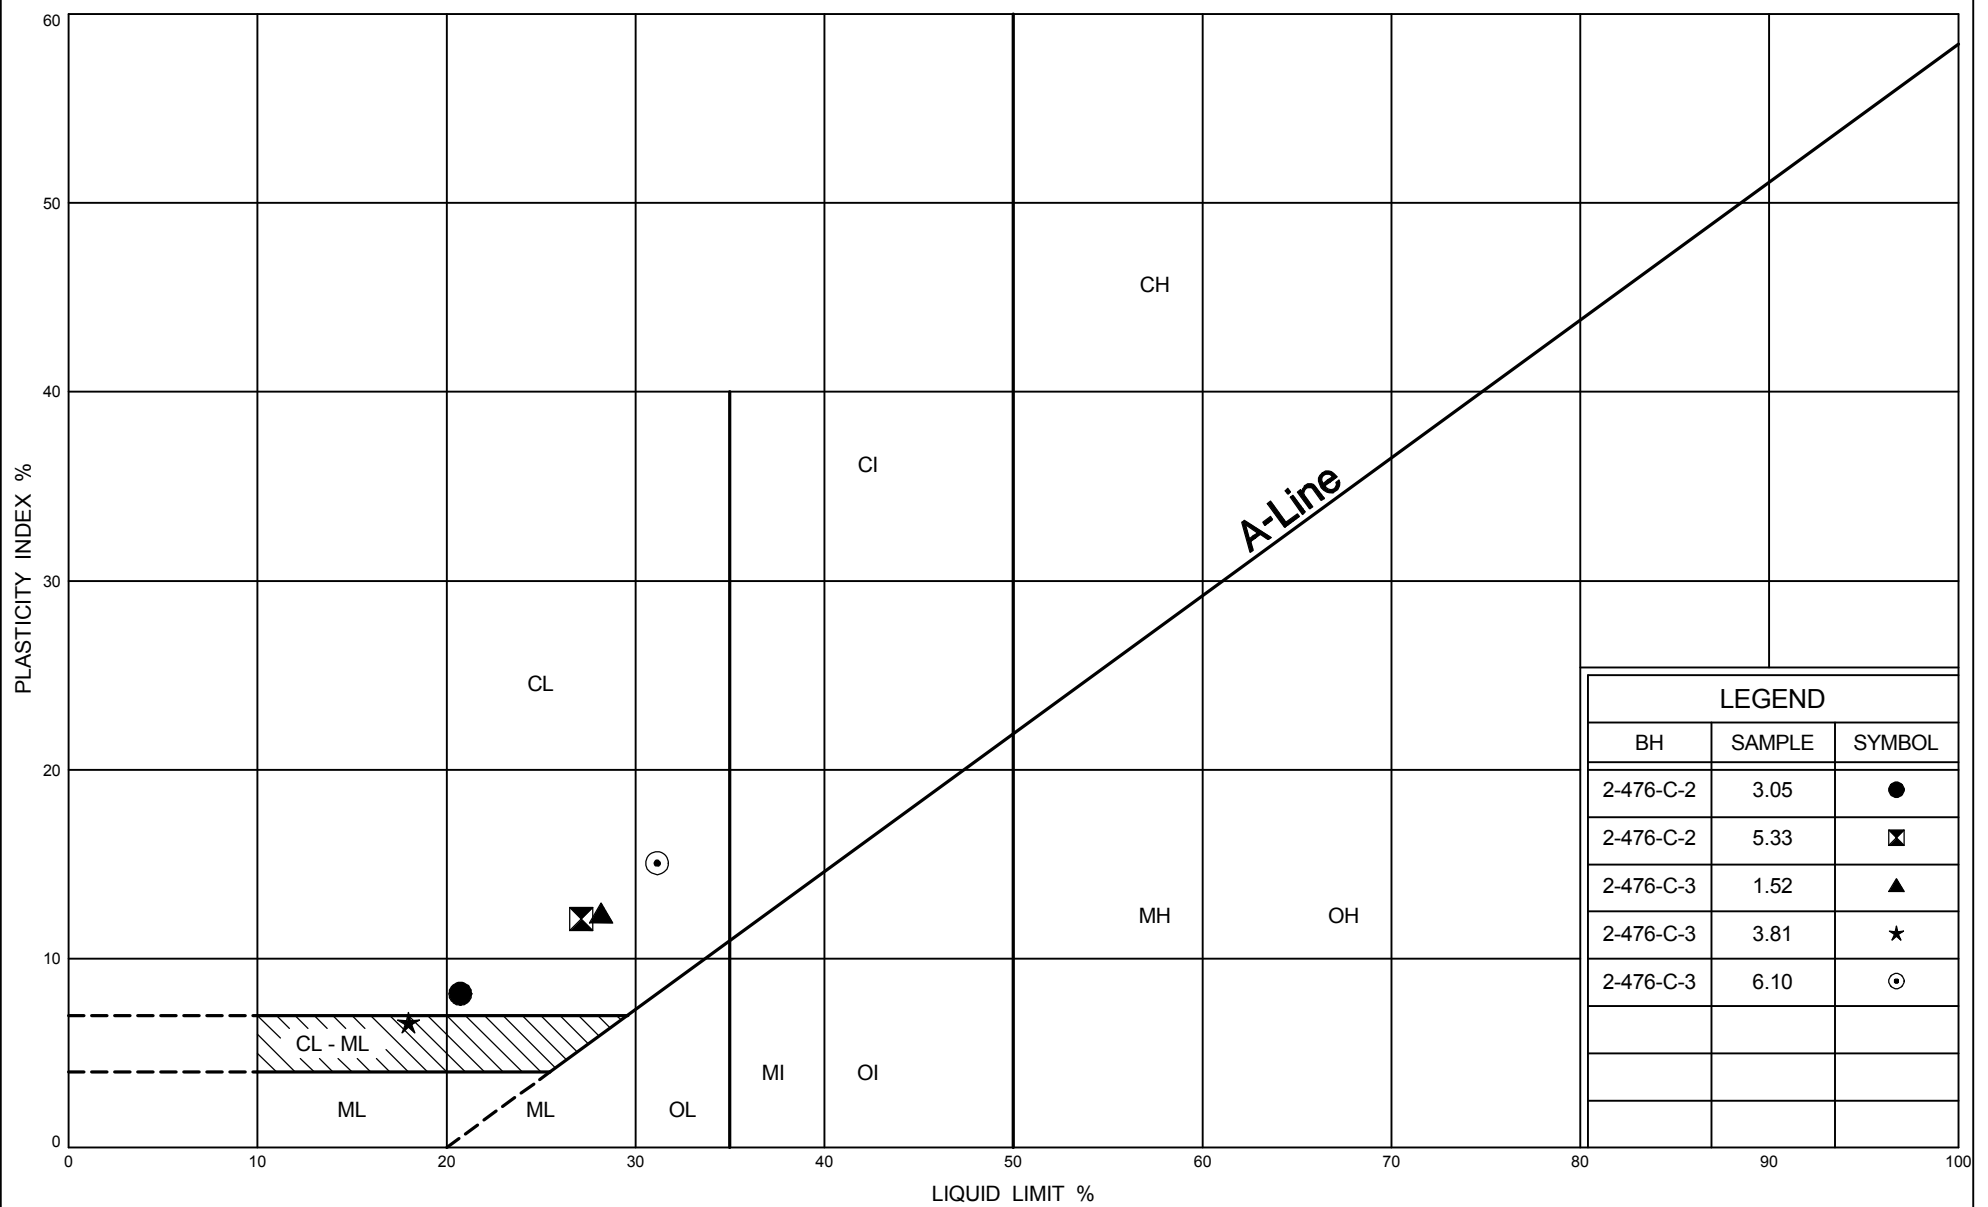
FIG No 3

PLASTICITY CHART SILTY CLAY TILL (CL)

Five (5) samples were tested and exhibited the following Atterberg Limits. These results are shown in Figure 3 of Appendix “B” and summarized below:

Silty Clay Till (four samples)

Liquid Limit (W_L)	21 to 31%, average at 26.8%
Plastic Limit (W_P)	13 to 16%, average at 15.0%
Plasticity Index (I_p)	8 to 15%, average at 11.8%

Clayey Silt Layer within Silty Clay Till (one sample)

Liquid Limit (W_L)	18%
Plastic Limit (W_P)	11%
Plasticity Index (I_p)	7%

The natural moisture contents were in the range of 9 to 25%. These results are characteristic of clayey soils of low plasticity (CL). The measured natural moisture contents are generally near or below the measured plastic limits and indicate that the deposit is pre-consolidated.

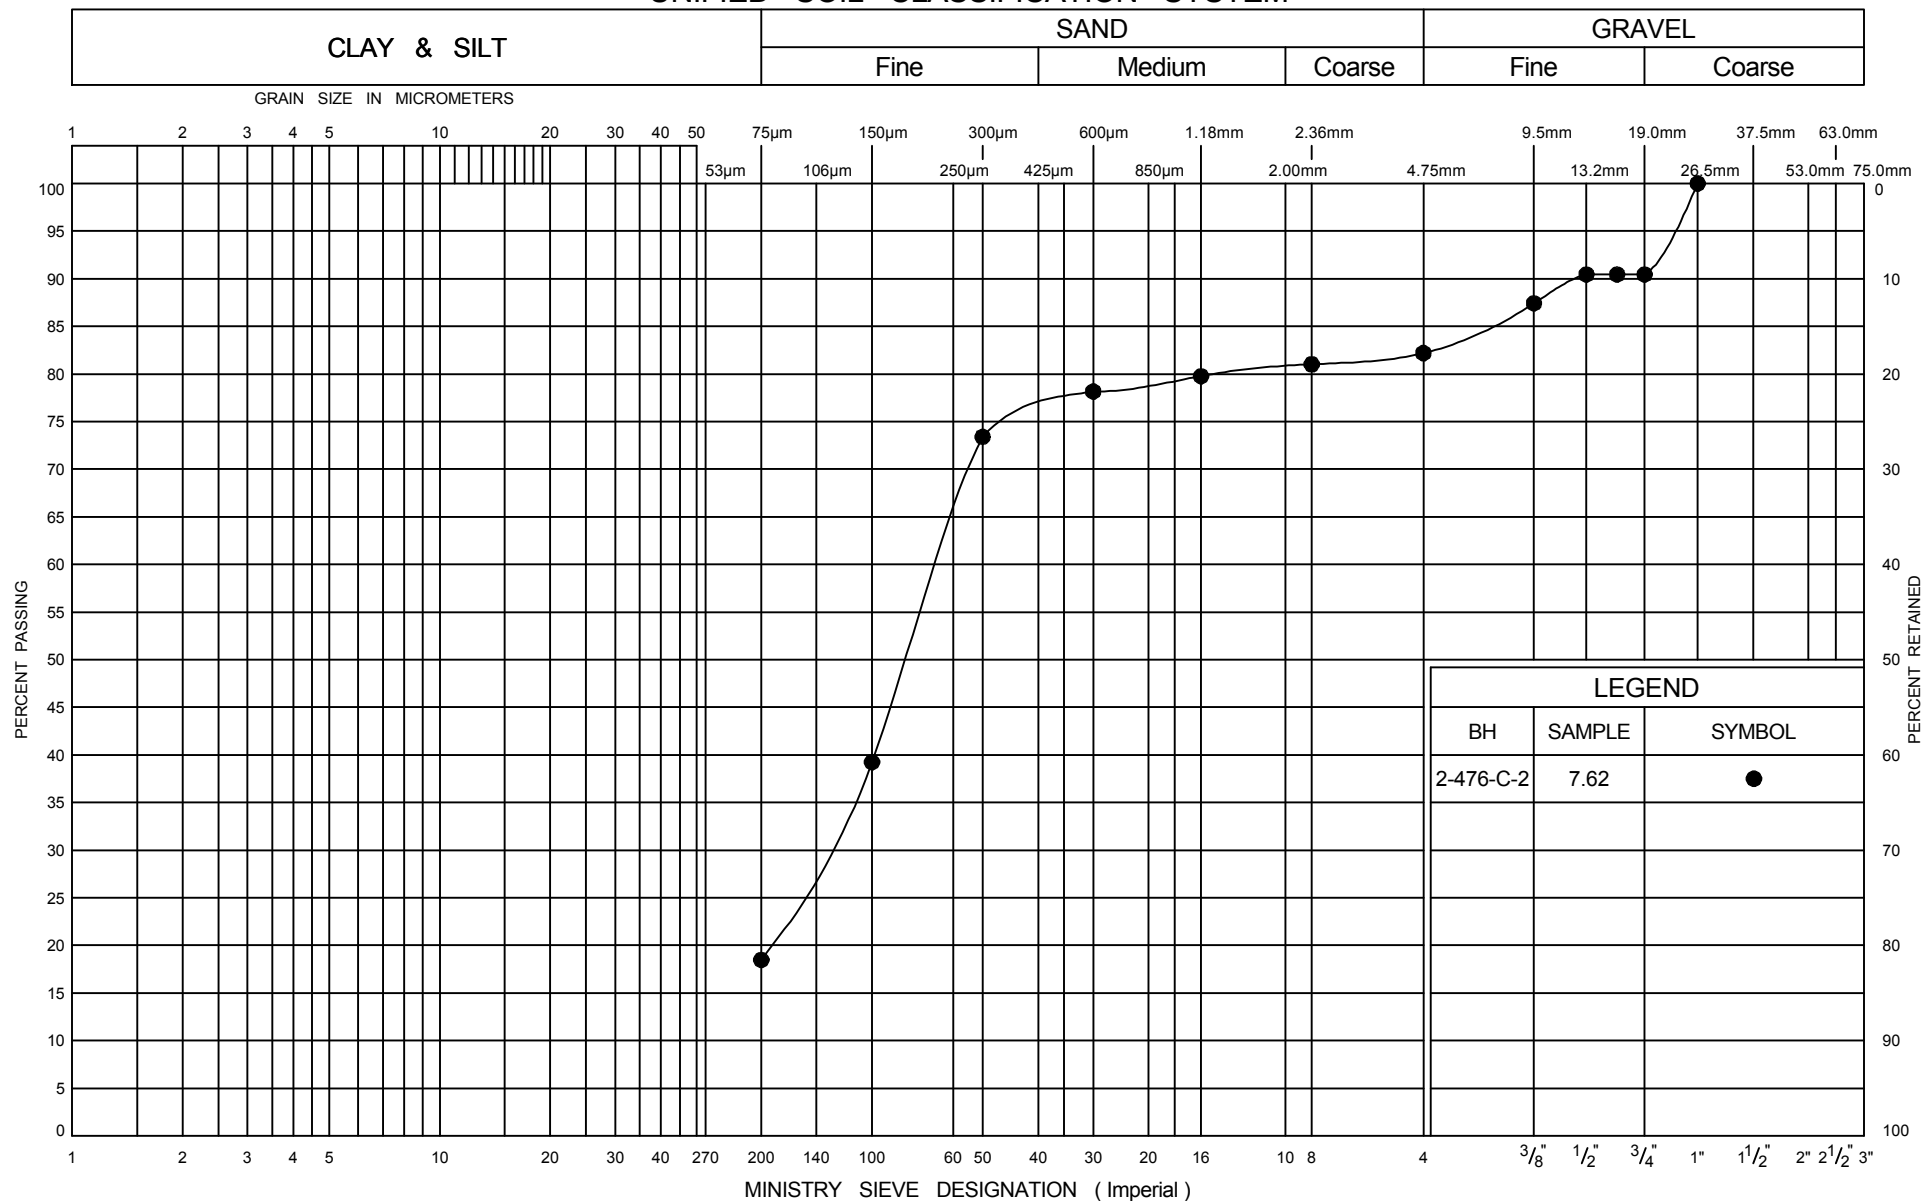
FIG No 4

GRAIN SIZE DISTRIBUTION

Fine SAND, some silt (SP)

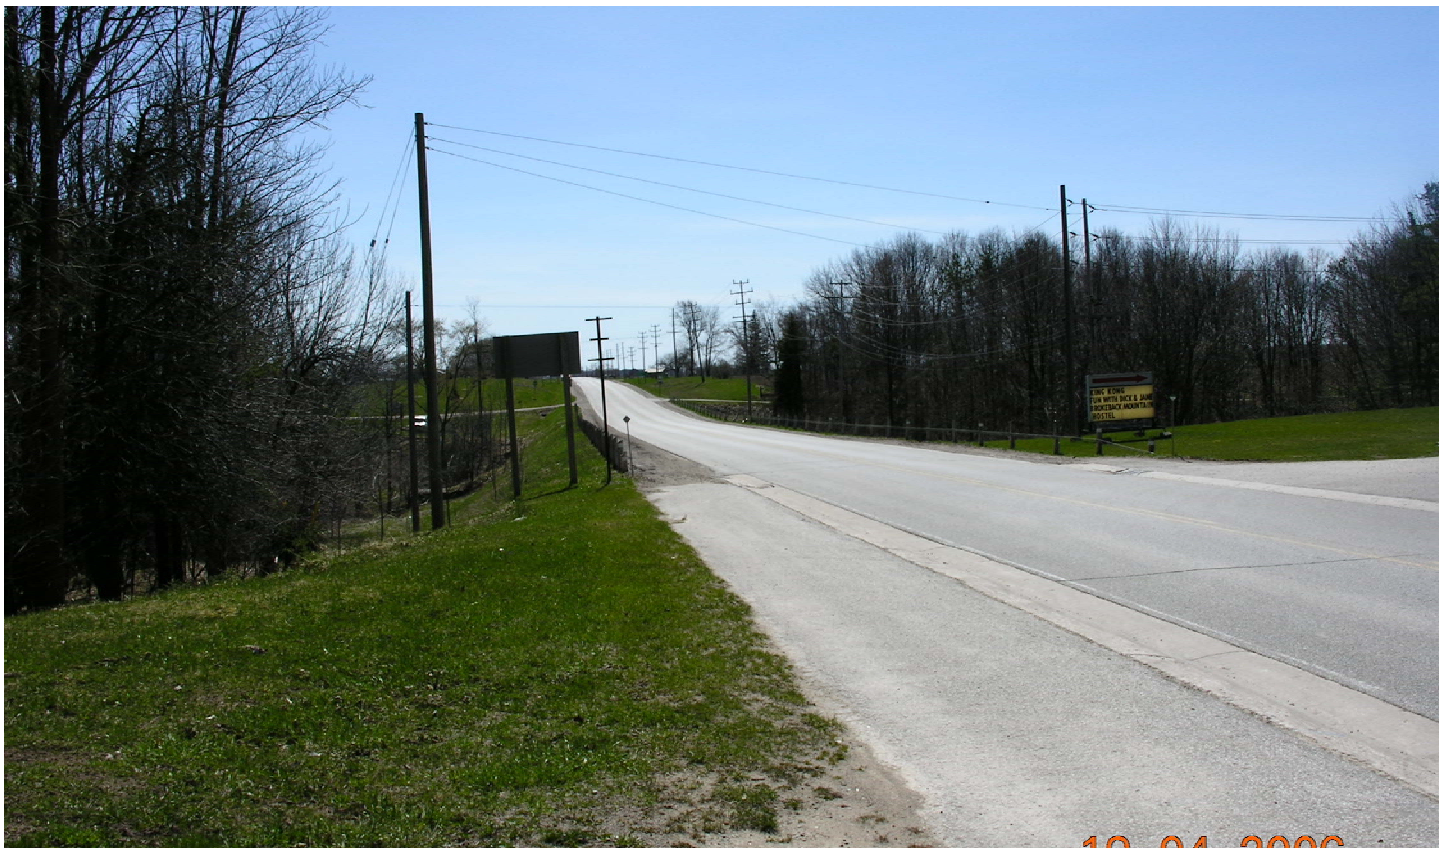
Culvert 2-476-C, general view

Structure 2-476-C is located on Highway 21, approximately 11.2 km north of Highway 9, located at station 24+856. Photographs of this culvert site are presented in Appendix D. The existing structure is a reinforced concrete, rigid frame open footing culvert having dimensions of 3.60 m wide by 2.40 m high by 41.15 m long, with an overfill height of 5.2 m. The culvert opening dimensions were provided by AGM. A brown silty clay deposit was noted at the streambed.

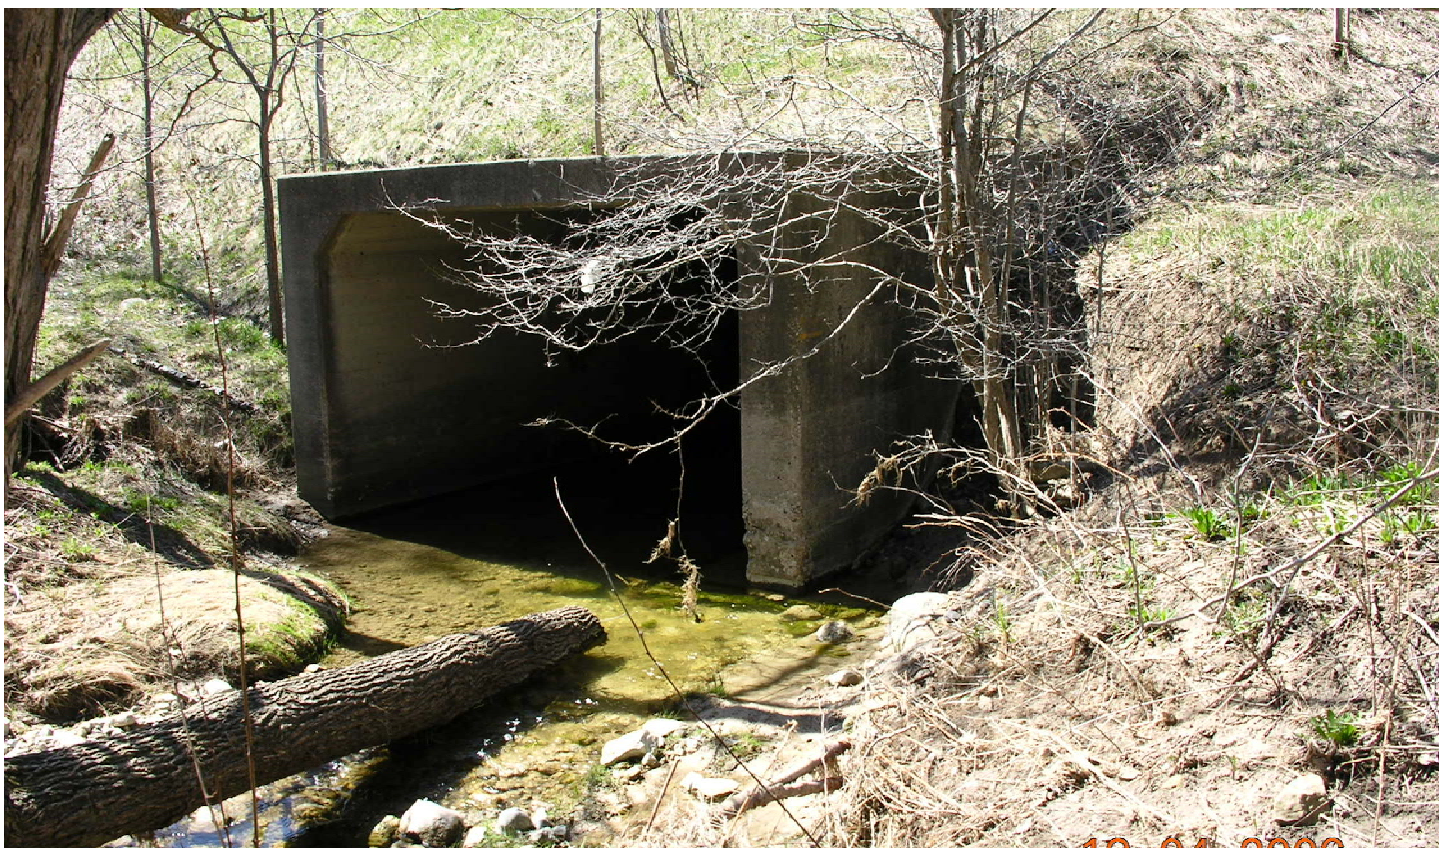
Culvert 2-476-C, inlet

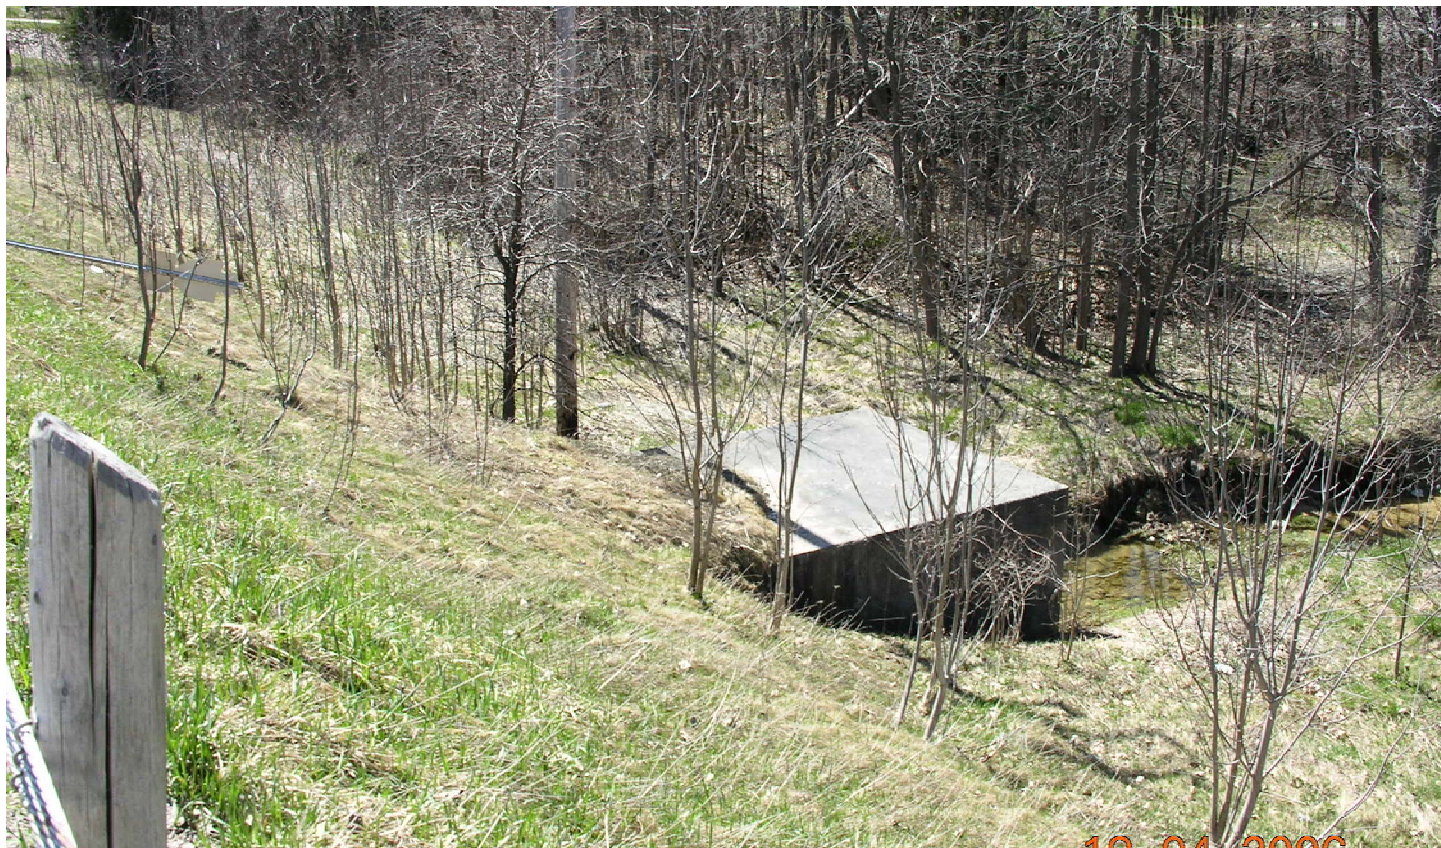
Culvert 2-476-C, outlet
