FOUNDATION INVESTIGATION REPORT

**REHABILITATION OF HIGHWAY 21
FROM BAYFIELD TO GODERICH, ONTARIO**

CULVERT REPLACEMENT AT STATION 11+873

MTO GEOCRES NO. 40P12-22

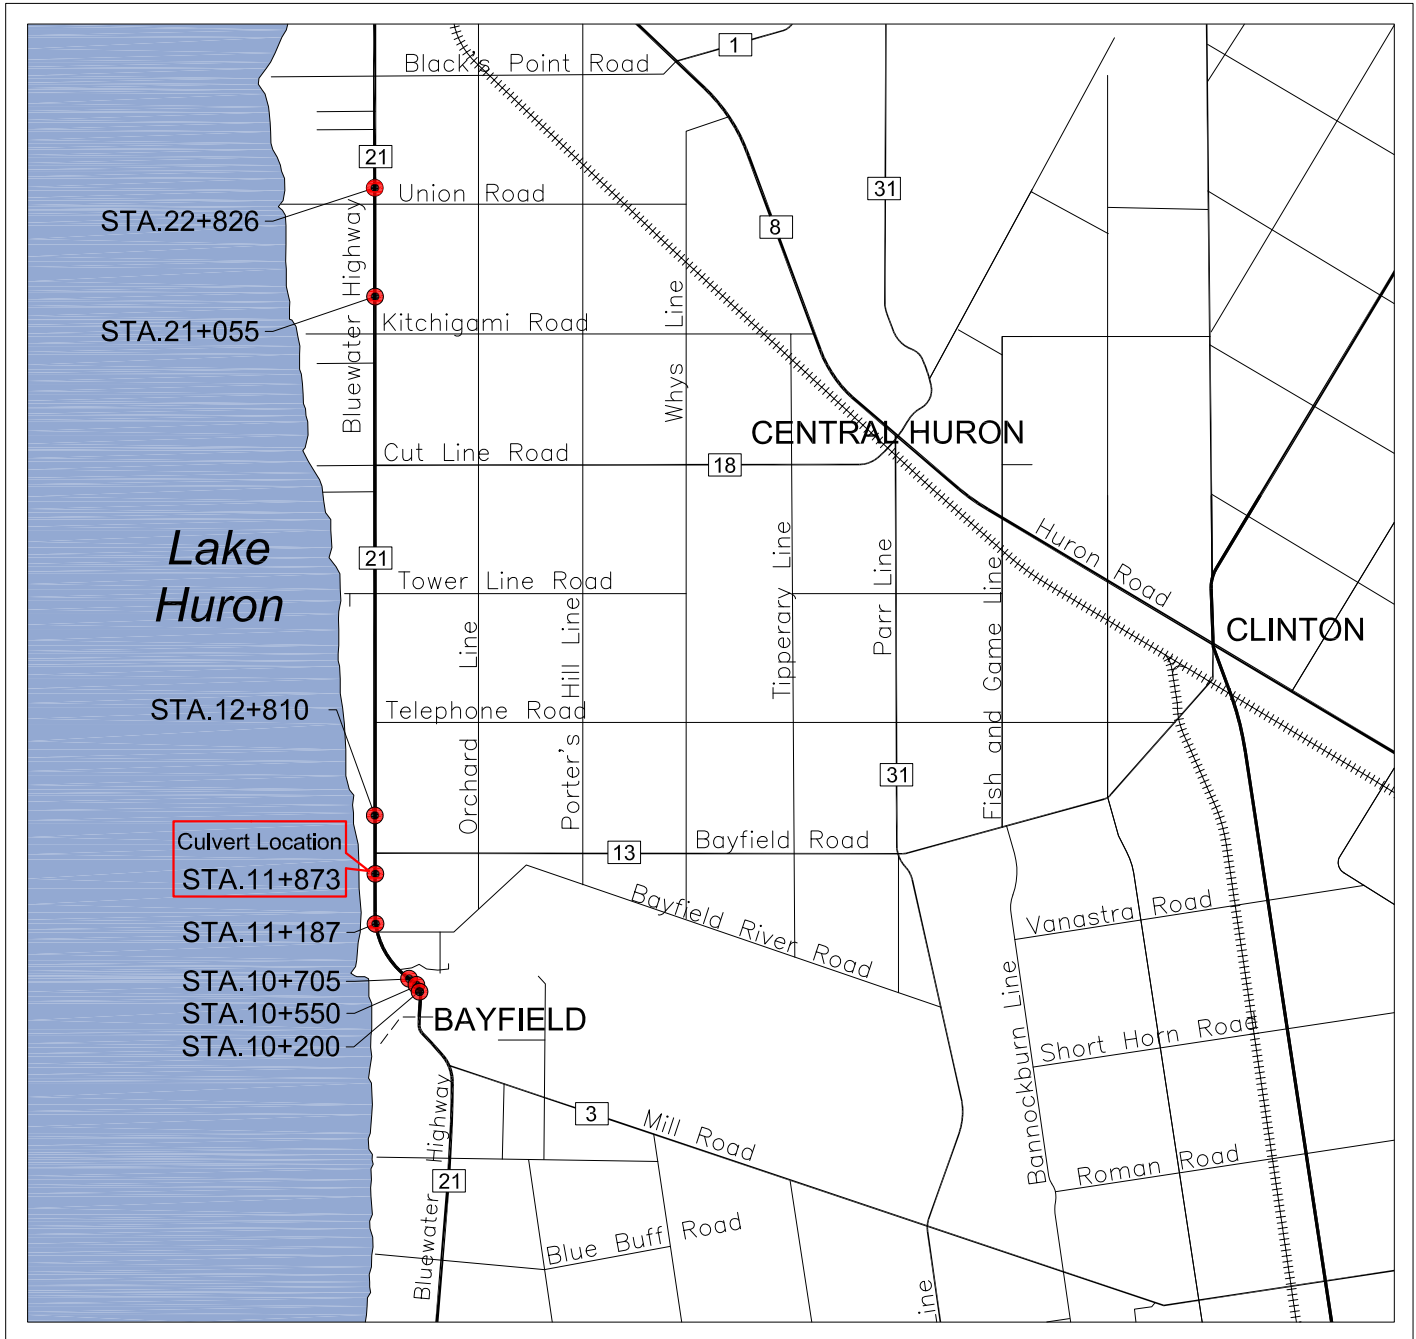
DRAWING No.
1

TITLE
CULVERT LOCATION PLAN

The investigated culvert site (at Station 11+873) is located about 330 m south of Bayfield Road (County Road 13), north of Bayfield, Ontario (Drawing No. 1).

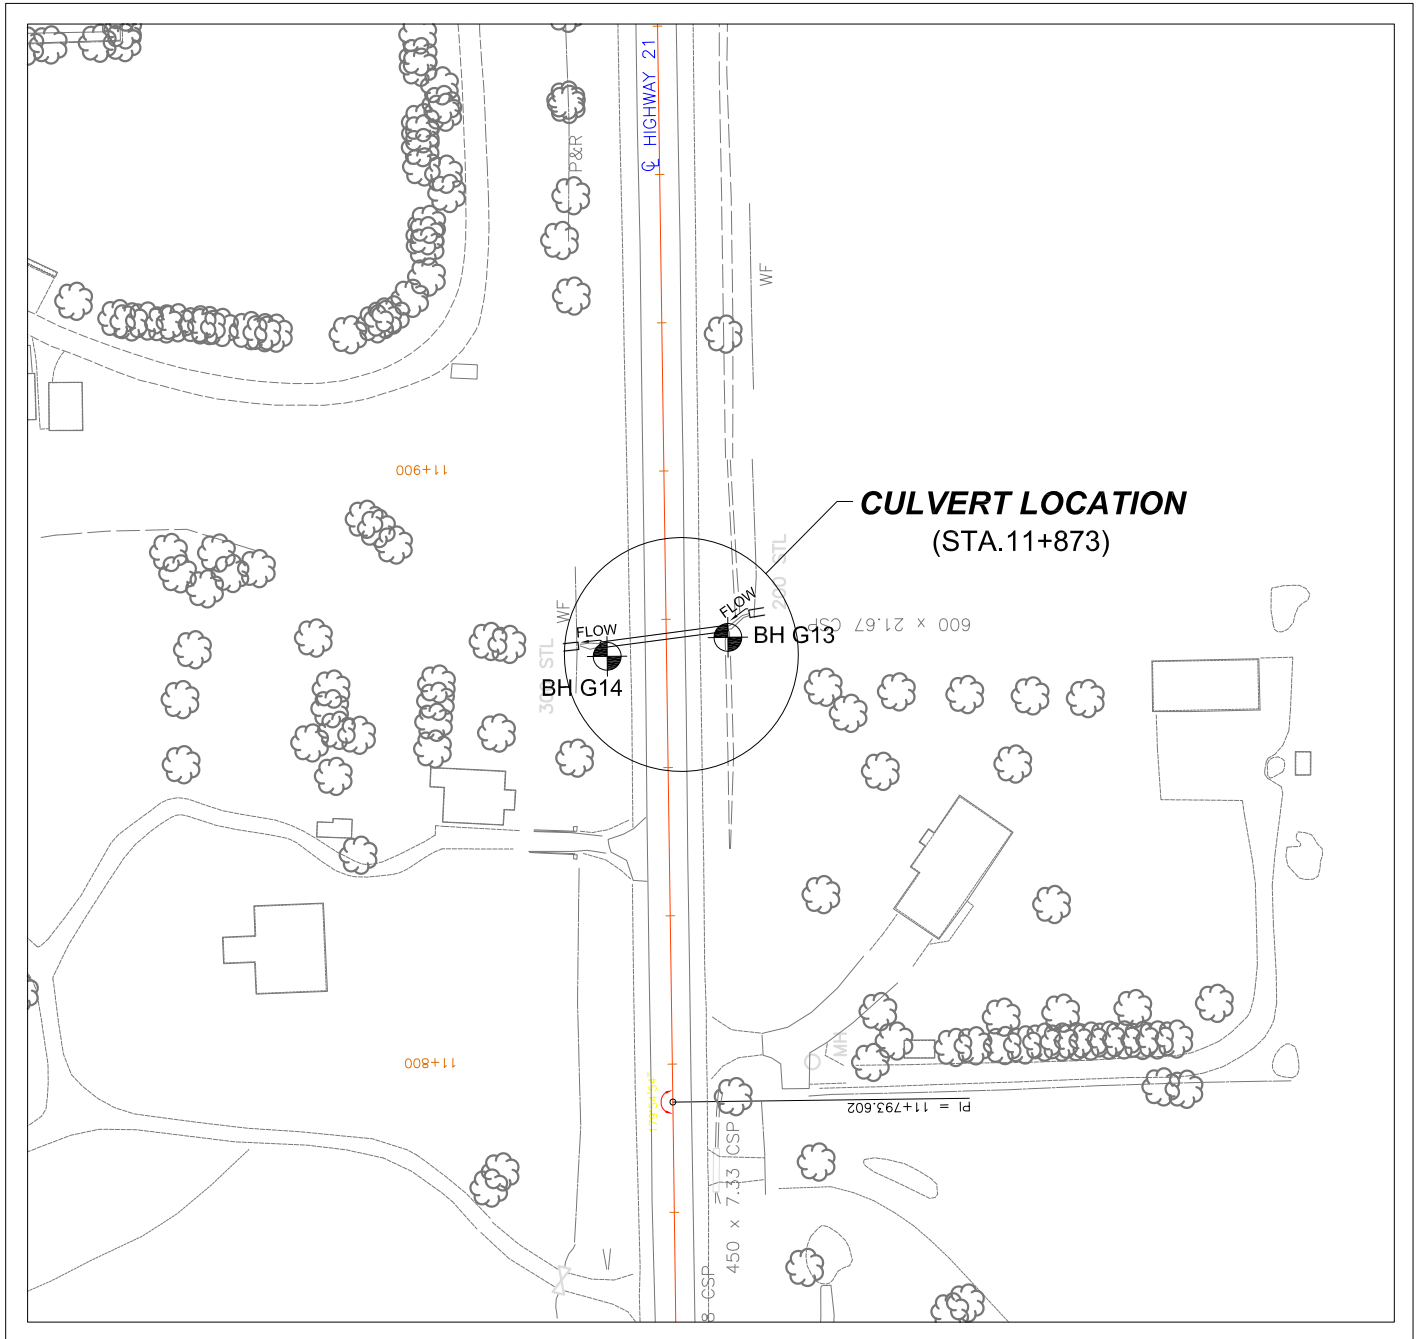
2

BOREHOLE LOCATION PLAN

In accordance with the Terms of Reference for this investigation, two (2) boreholes were advanced - one on each side of the existing culvert. Borehole BH G13 was drilled near the culvert inlet, while Borehole BH G14 was advanced near the culvert outlet and adjacent to the west shoulder. The borehole locations are presented on Drawing No. 2.

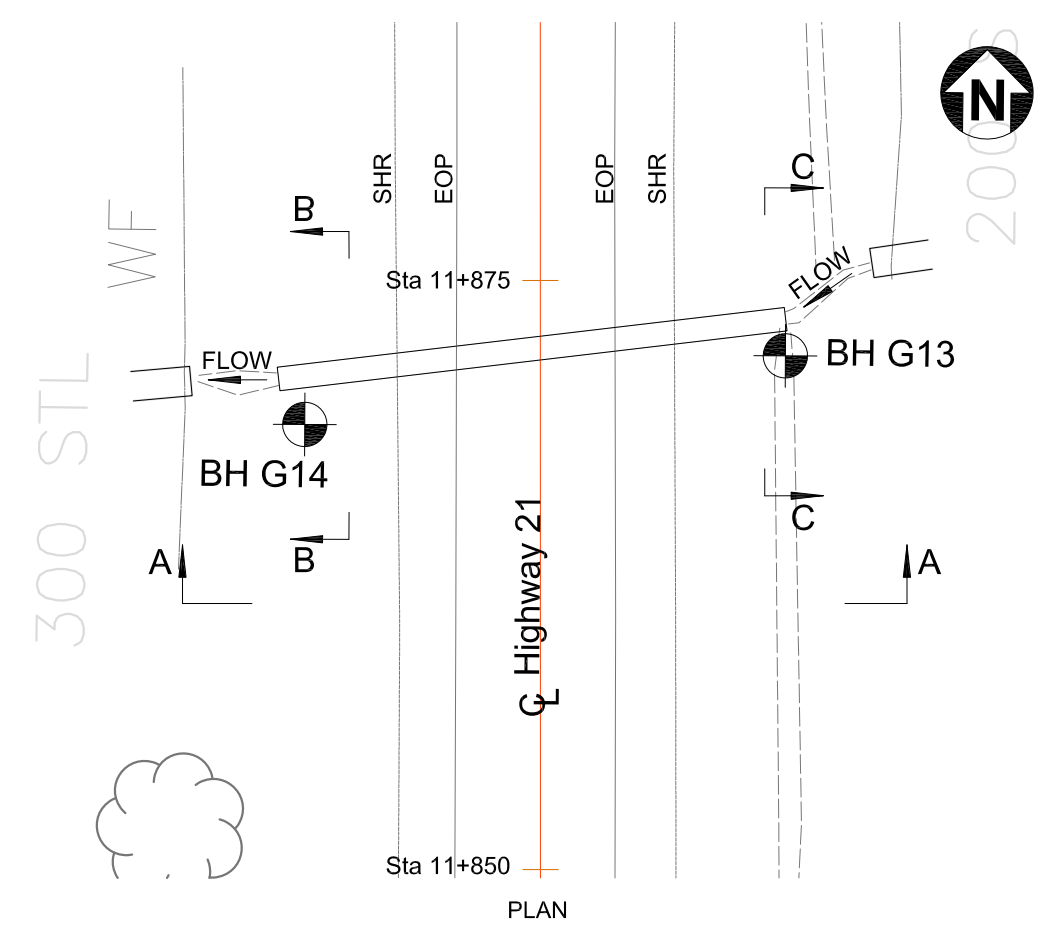
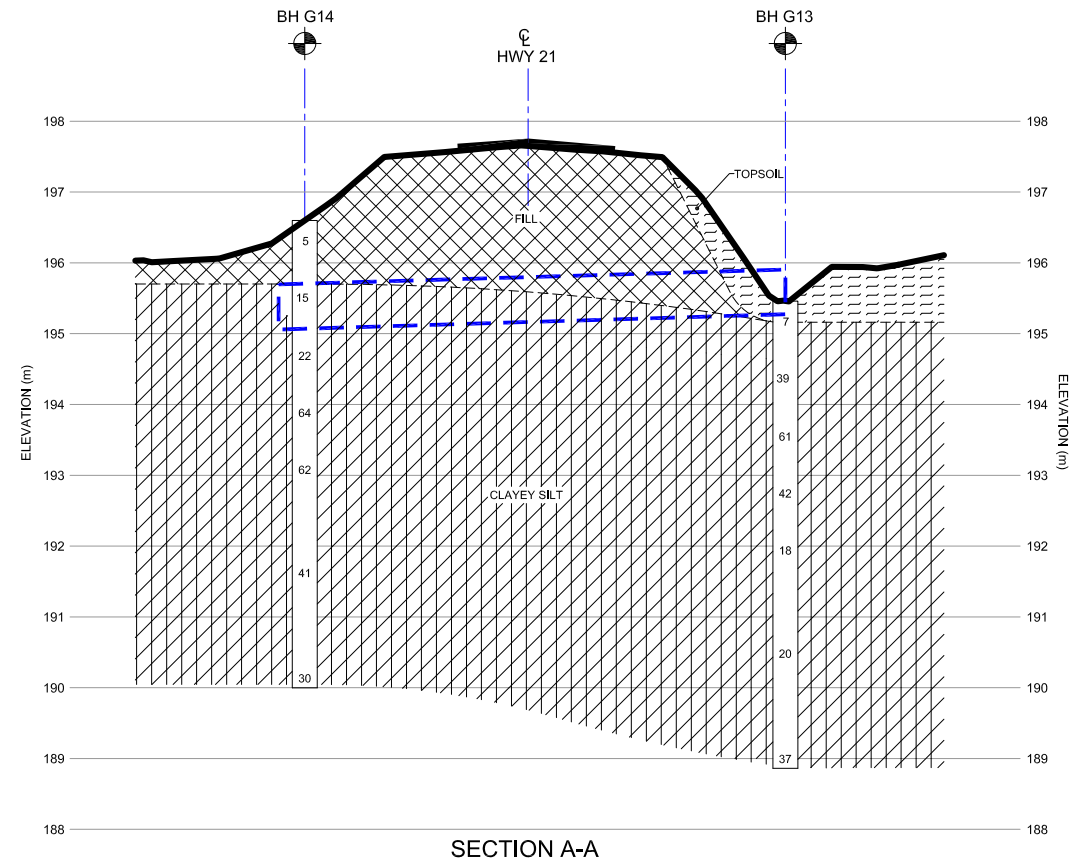
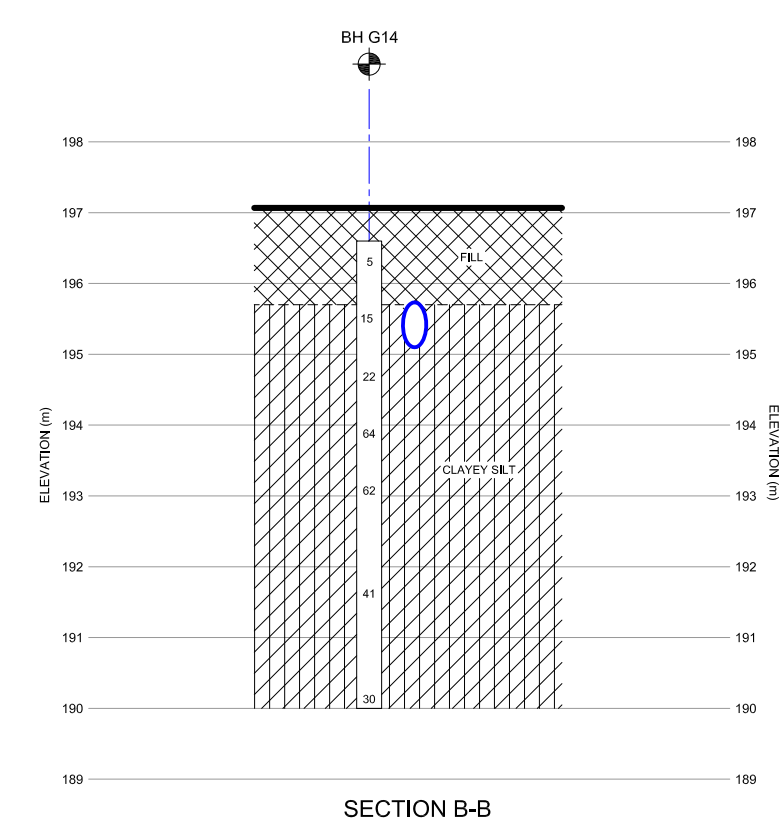
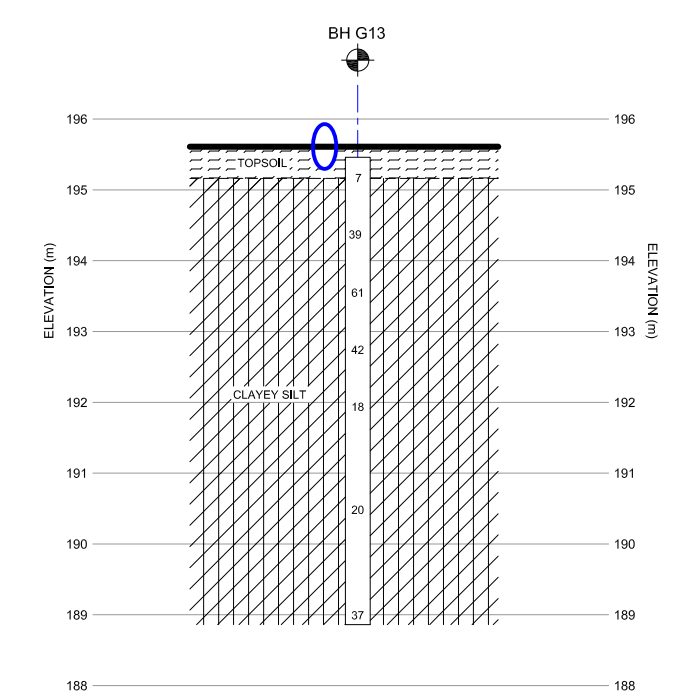
REHABILITATION OF HWY 21 FROM BAYFIELD TO GODERICH
GEOCRE No.40P12-22
CULVERT AT STA 11+873
STRATIGRAPHIC CROSS SECTION

The stratigraphic units and groundwater conditions at the borehole locations are discussed in the following sections. Detailed information is provided in the Record of Boreholes (Appendix A). Interpolated stratigraphical cross sections showing the existing culvert are presented on Drawing No. 3.

Based on the investigation results, the soil profile consisted predominantly of topsoil or silty clay fill underlain by native clayey silt deposit extending to the termination depths of the boreholes (elevations 188.9 in BH G13 and 190.0 m ± in BH G14).

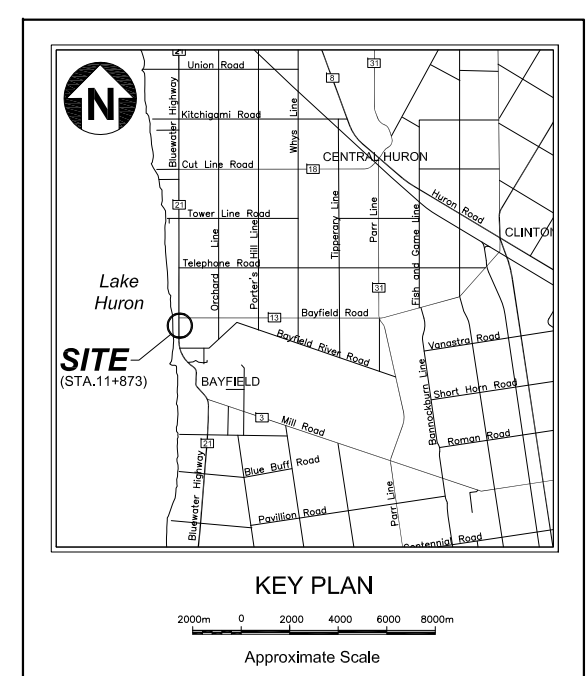
SHEET
1 OF 1

LEGEND			
	BOREHOLE LOCATION		
	GROUNDWATER LEVEL AT TIME OF INVESTIGATION		
EOP	EDGE OF PAVEMENT		
SHR	SHOULDER ROUND		
DESCRIPTION	UTM COORDINATES		ELEVATION (m)
	NORTHING	EASTING	
BH G13	4825907	443045	195.46
BH G14	4825907	443026	196.60

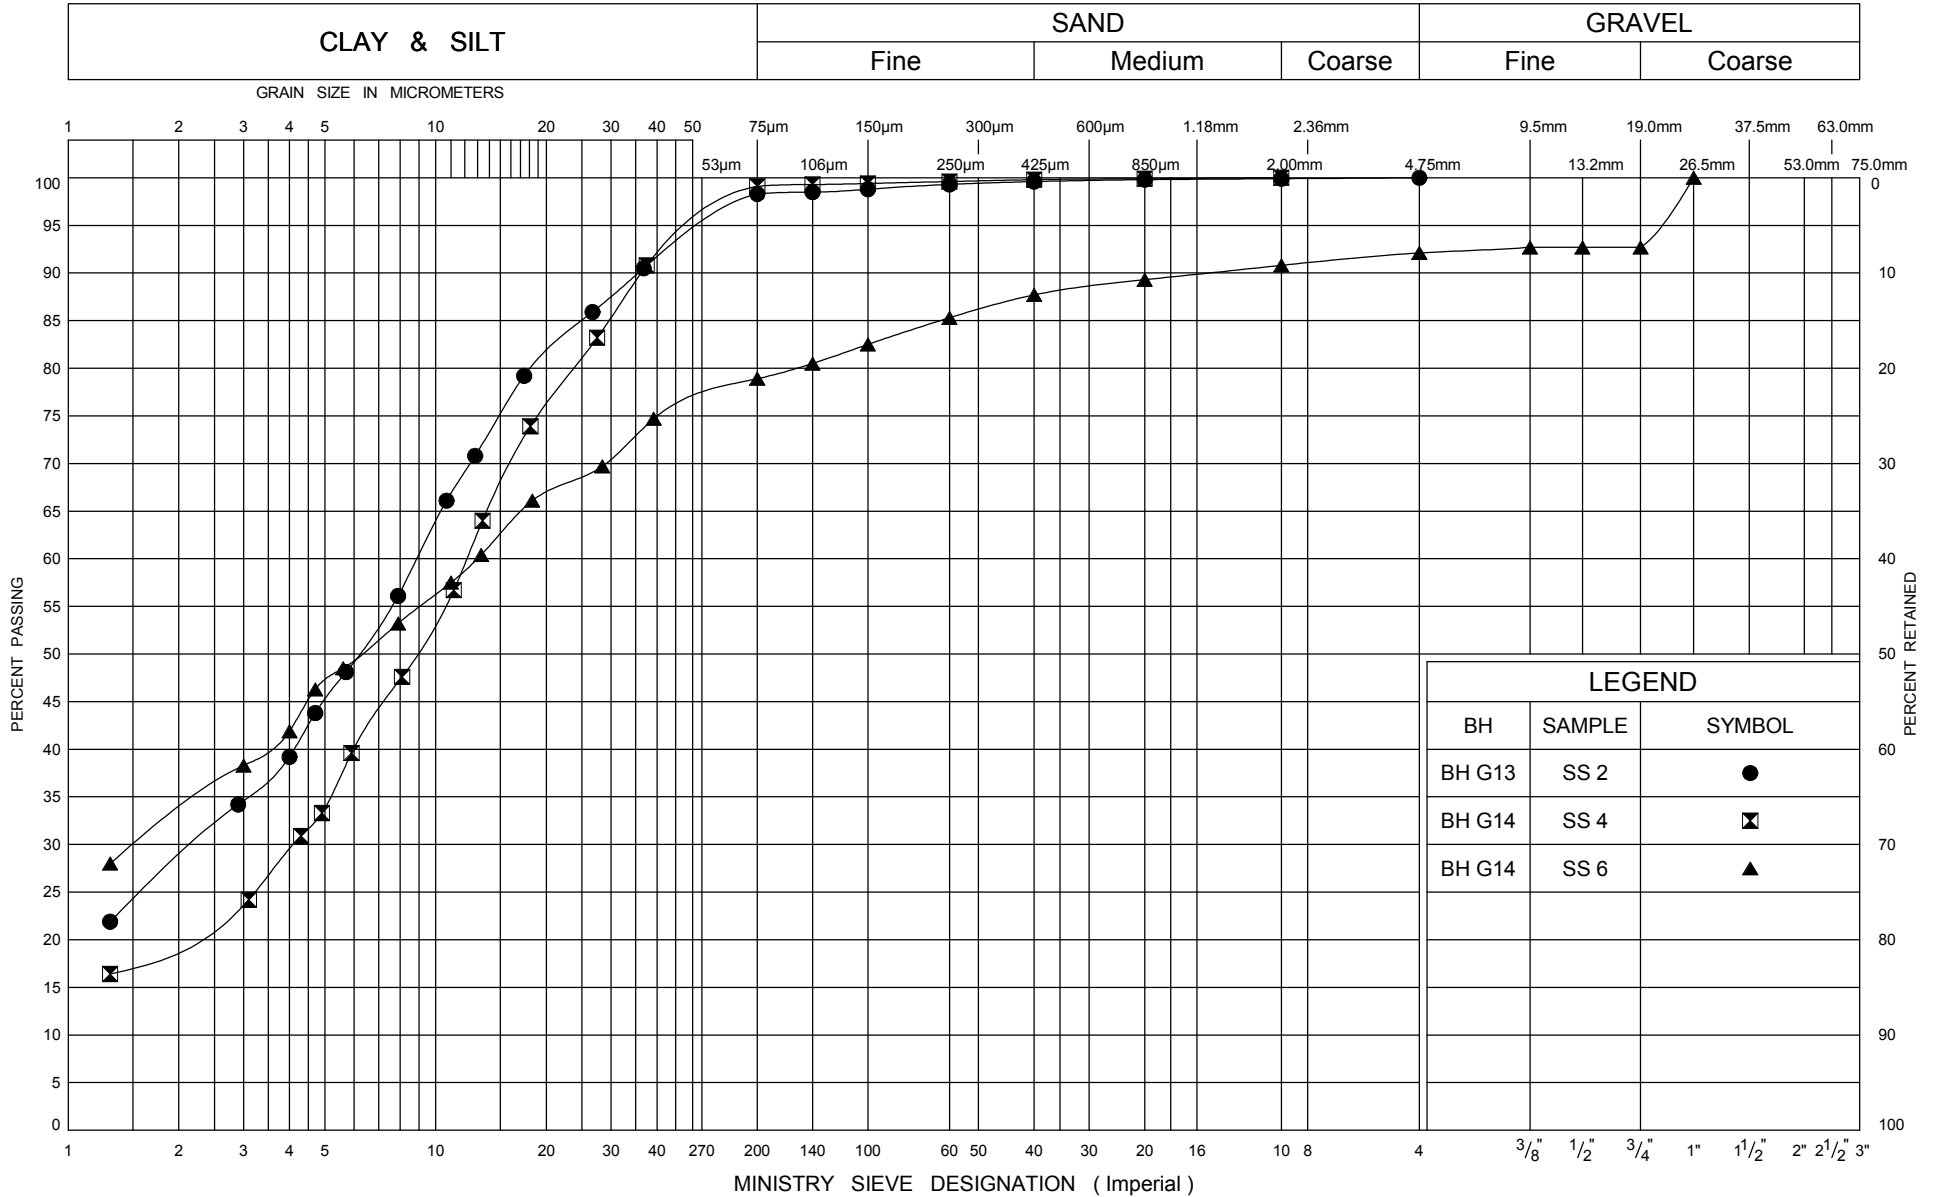
The grain size distribution curves are presented in Figure No. B 1 and the plasticity chart is presented in Figure No. B2, in Appendix B.

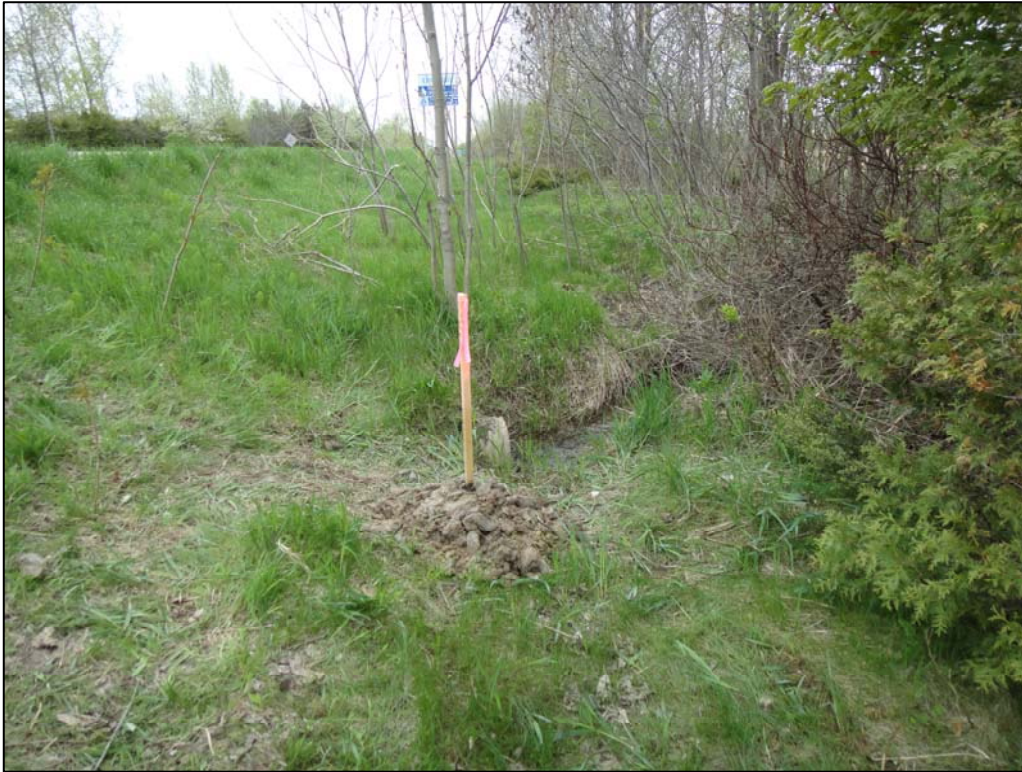
Photograph No. 1: View of culvert at inlet.

Site photographs showing the culvert location are presented in Appendix C (Photographs 1 and 2).

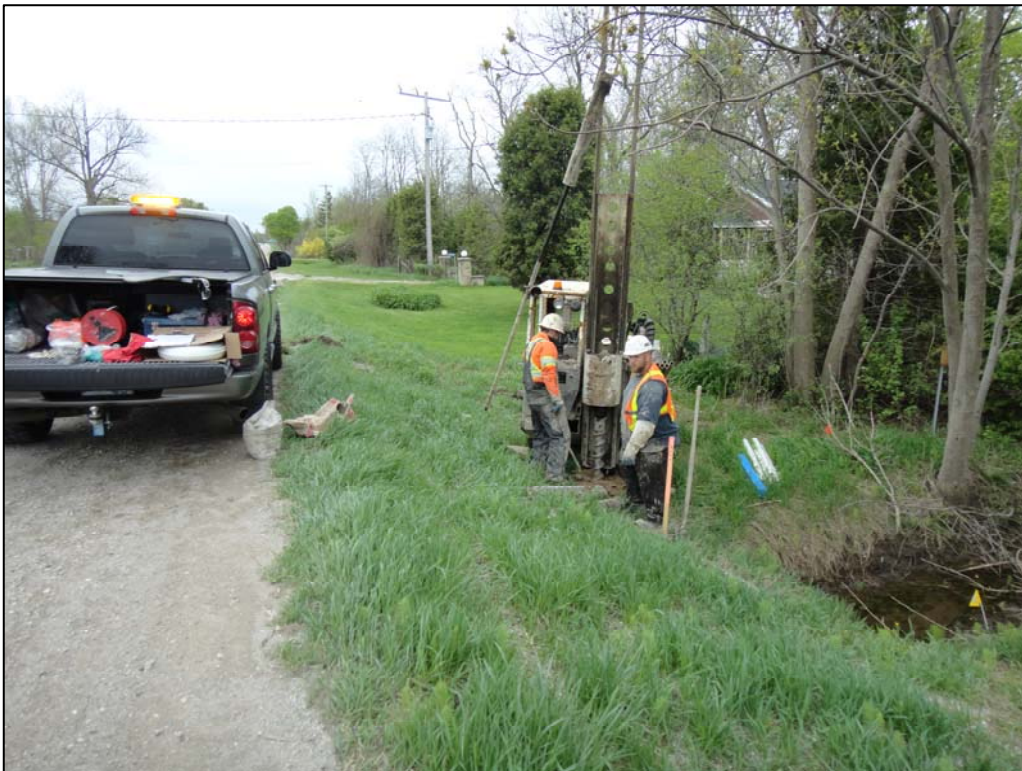
Photograph No. 2: View of culvert at outlet.
