FOUNDATION INVESTIGATION REPORT
REHABILITATION OF HIGHWAY 21
FROM BAYFIELD TO GODERICH, ONTARIO

CULVERT AT STATION 10+267

MTO GEOCRES NO. 40P12-17

This report presents the results of foundation investigation for culvert extension at Station 10+267.

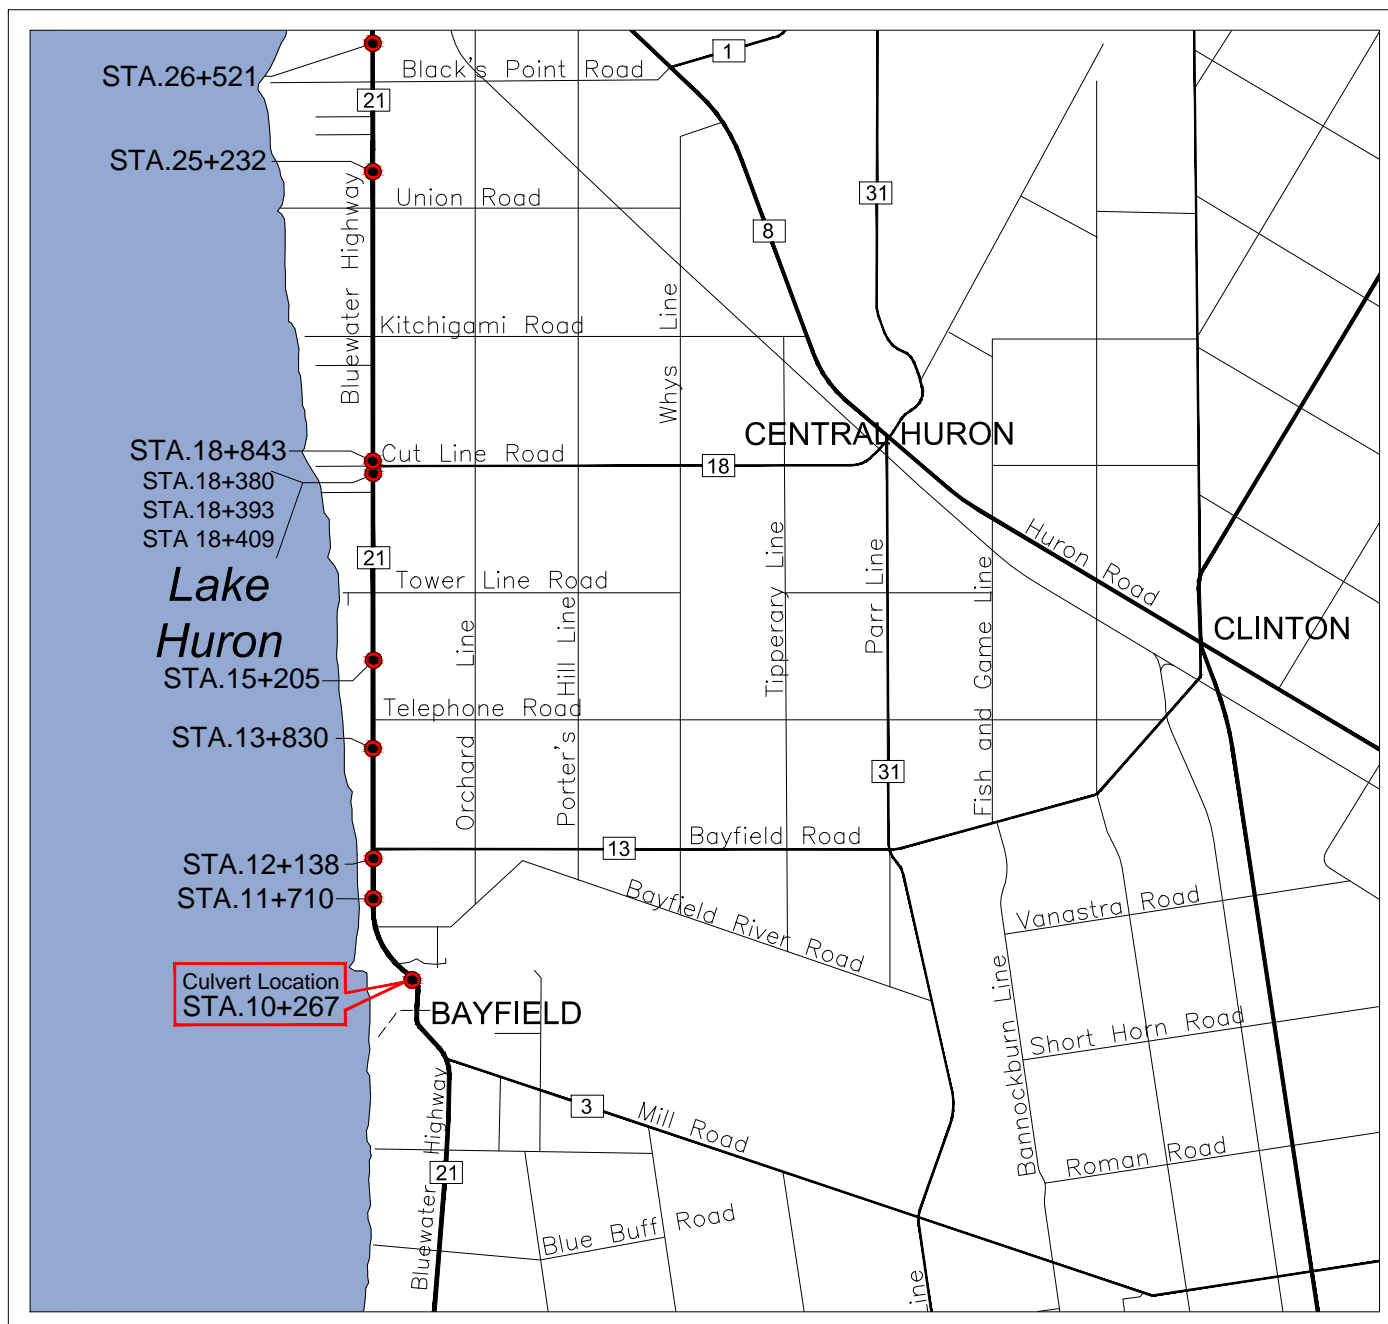
CULVERT LOCATION PLAN

The investigated culvert site (at Station 10+267) is located about 680 m south of Bayfield River Road, near Bayfield, Ontario (Drawing No. 1).

AMEC Environment & Infrastructure, a Division of AMEC Americas Limited (“AMEC”), was retained by the Ministry of Transportation Ontario - West Region (“MTO”) to provide Detail Design Services for the Rehabilitation of Highway 21, Ontario. The project highway is about 20 km long stretching northerly from about 1.85 km south of Bayfield River Bridge (Bayfield) to about 0.17 km north of Huckins Street (Goderich), Ontario, as shown in Drawing No. 1.

In March 2012, AMEC conducted additional foundation investigations at the locations of 11 additional existing culverts, as shown on Drawing No. 1. The number of boreholes and locations of the boreholes were based on the Highway 21 Culvert Recommendations Table (dated 18 January 2012). The details of the additional culverts investigated, and the boreholes advanced at each location, are summarized in Table 1.1.

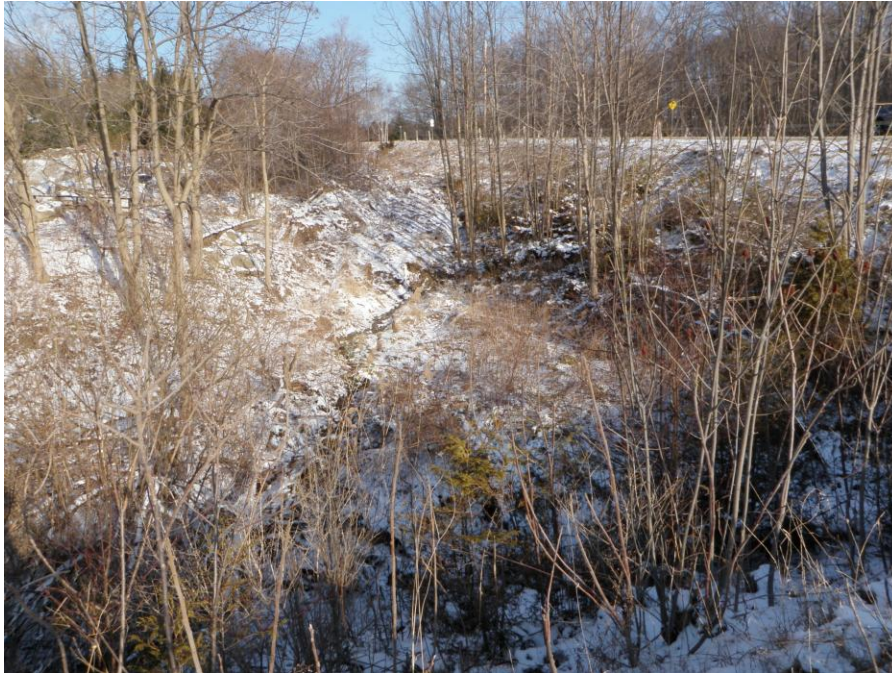
PHOTOGRAPH NO. 1

Looking towards the existing culvert outlet area.

Overall view of the slope over the culvert.

At the time of field work, the investigated area was covered with vegetation. Site photographs showing the culvert are presented in Appendix C (Photographs 1 and 2).

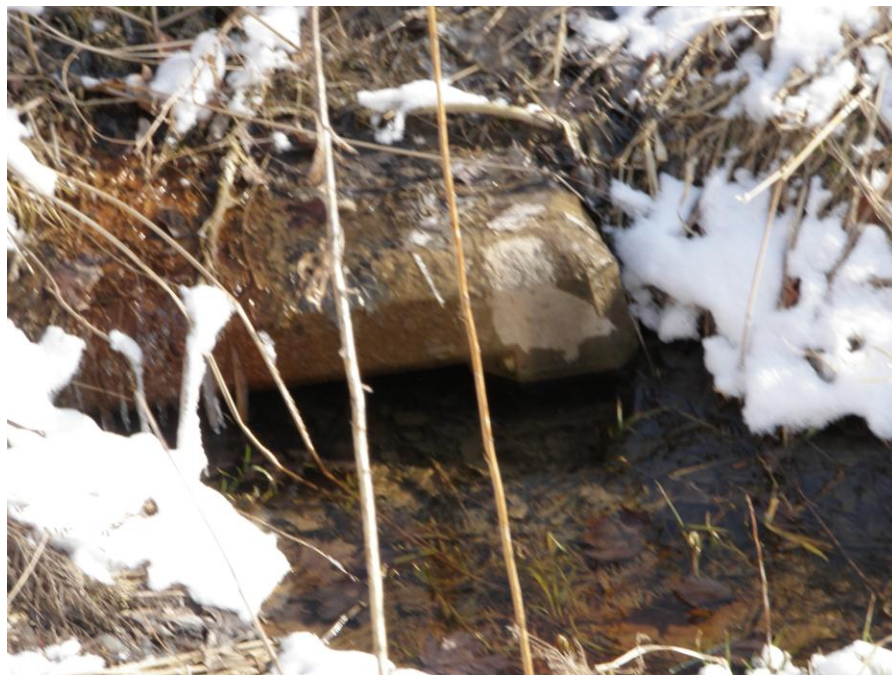
PHOTOGRAPH NO. 2

Looking towards the existing culvert outlet area.
