FOUNDATION INVESTIGATION REPORT

**REHABILITATION OF HIGHWAY 21
FROM BAYFIELD TO GODERICH, ONTARIO**

CULVERT No. 56 AT STATION 25+232

**MINISTRY OF TRANSPORTATION ONTARIO (MTO) - WEST REGION
PURCHASE ORDER NUMBER 3009-E-0022
GWP 834-93-00**

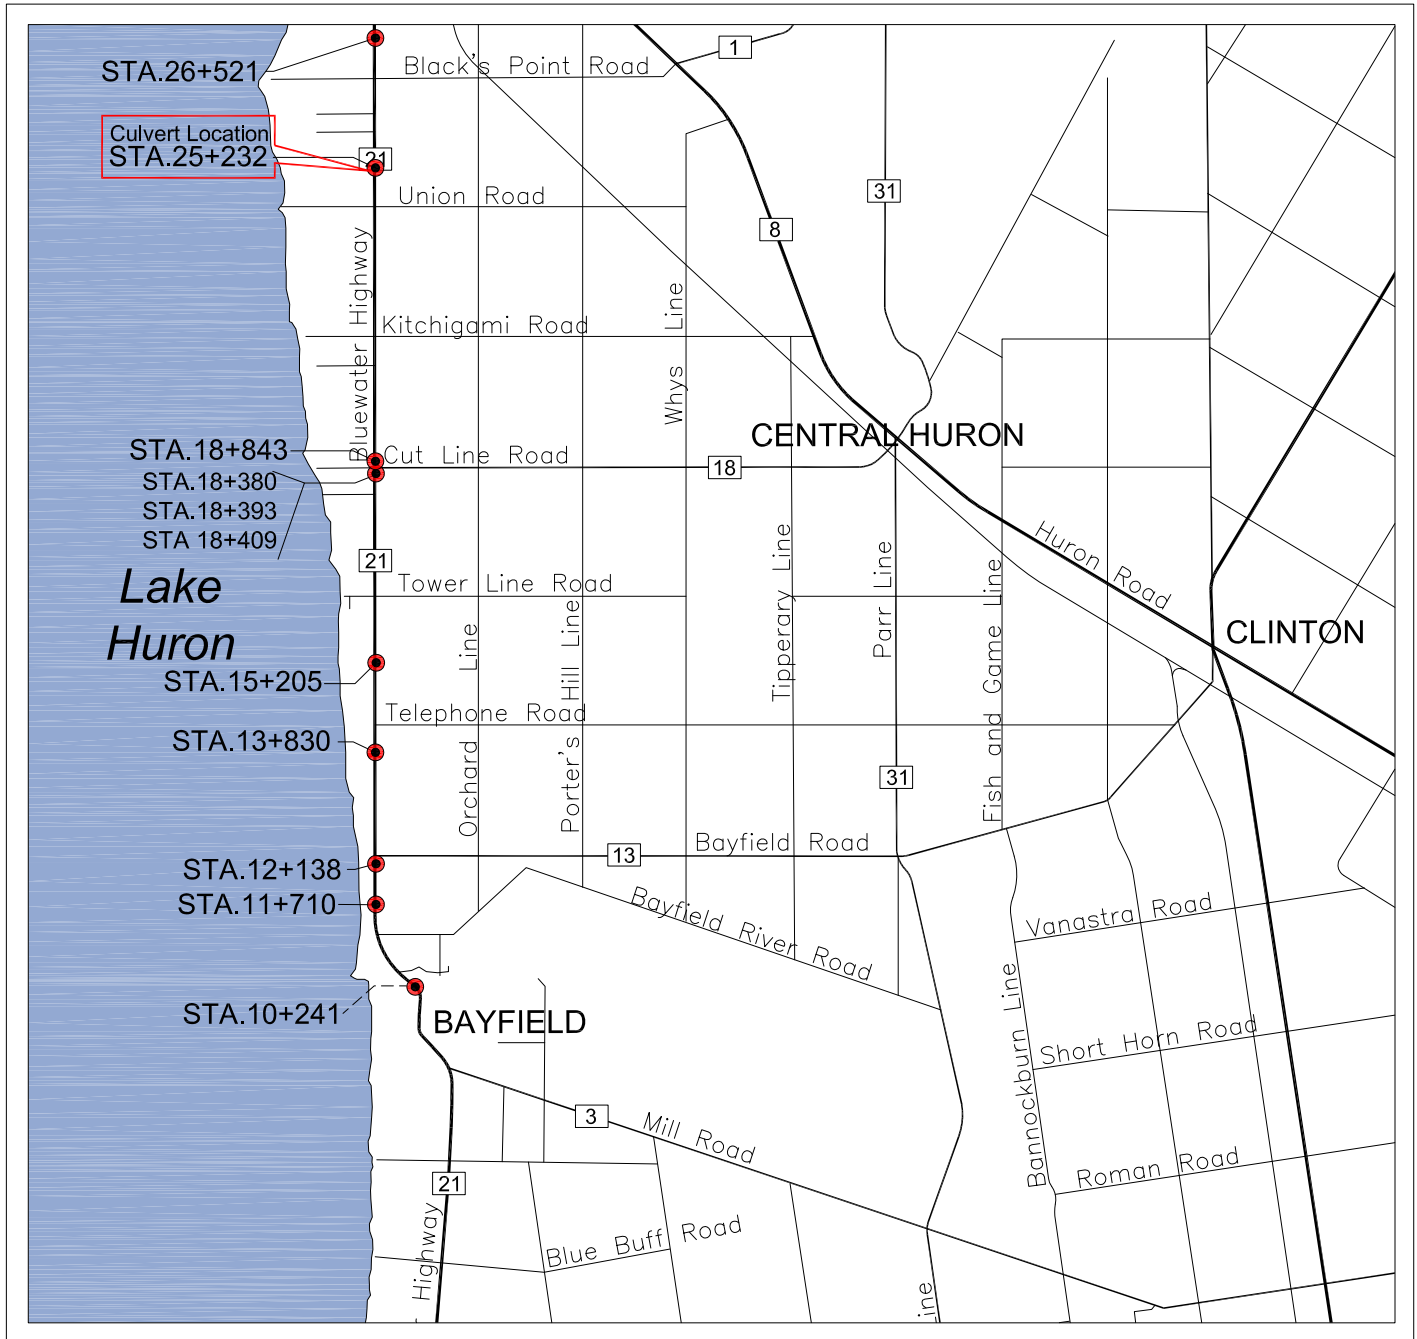
DRAWING No.

TITLE
CULVERT LOCATION PLAN

CULVERT LOCATION
(STA.25+232)

AMEC Environment & Infrastructure, a Division of AMEC Americas Limited ("AMEC"), was retained by the Ministry of Transportation Ontario - West Region ("MTO") to provide Detail Design Services for the Rehabilitation of Highway 21, Ontario. The project highway is about 20 km long stretching northerly from about 1.85 km south of Bayfield River Bridge (Bayfield) to about 0.17 km north of Huckins Street (Goderich), Ontario, as shown in Drawing No. 1.

The investigated culvert site (Station 25+232) is located about 2.75 km north of Union Road, between Bayfield and Goderich, Ontario (Drawing No. 1).

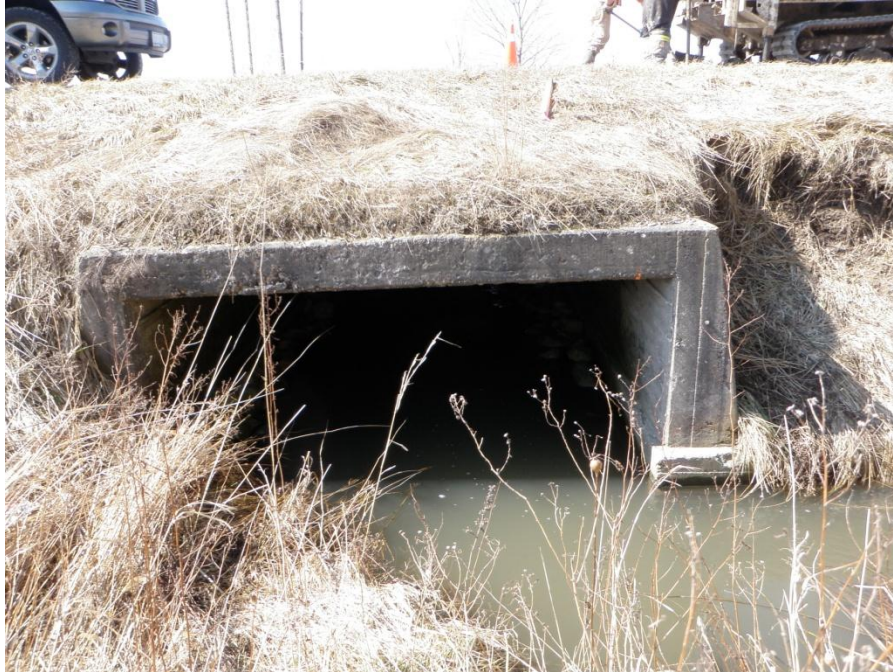
PHOTOGRAPH NO. 1

Looking towards the existing
culvert inlet area.

At this location, Highway 21 is a two-lane asphaltic concrete paved road with gravel shoulders on both sides, and runs on top of an embankment built up above the surrounding grades. The surrounding area is primarily rural in nature, with active agricultural operations and/or farm houses / vacant lands / wood lots. The embankment slopes were covered with vegetation at the time of the fieldwork. Site photographs showing the culvert are presented in Appendix C (Photographs 1 and 2).

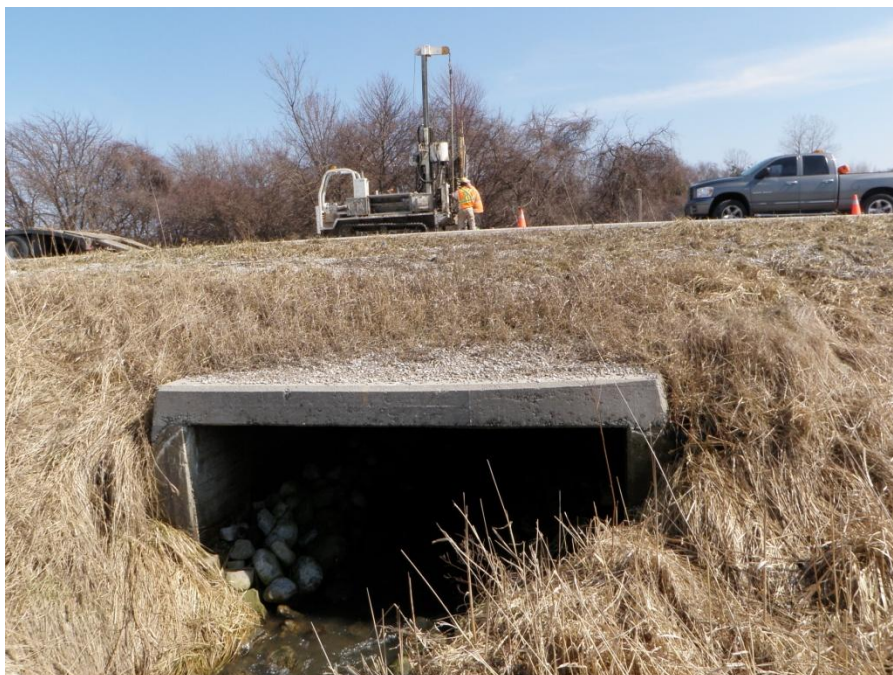
PHOTOGRAPH NO. 2

Looking towards the existing
culvert outlet area.
