**FOUNDATION INVESTIGATION REPORT**

**REHABILITATION OF HIGHWAY 21  
FROM BAYFIELD TO GODERICH, ONTARIO**

**CULVERT NO. 34 AT STATION 18+843**

**MTO GEOCRES NO. 40P12-19**

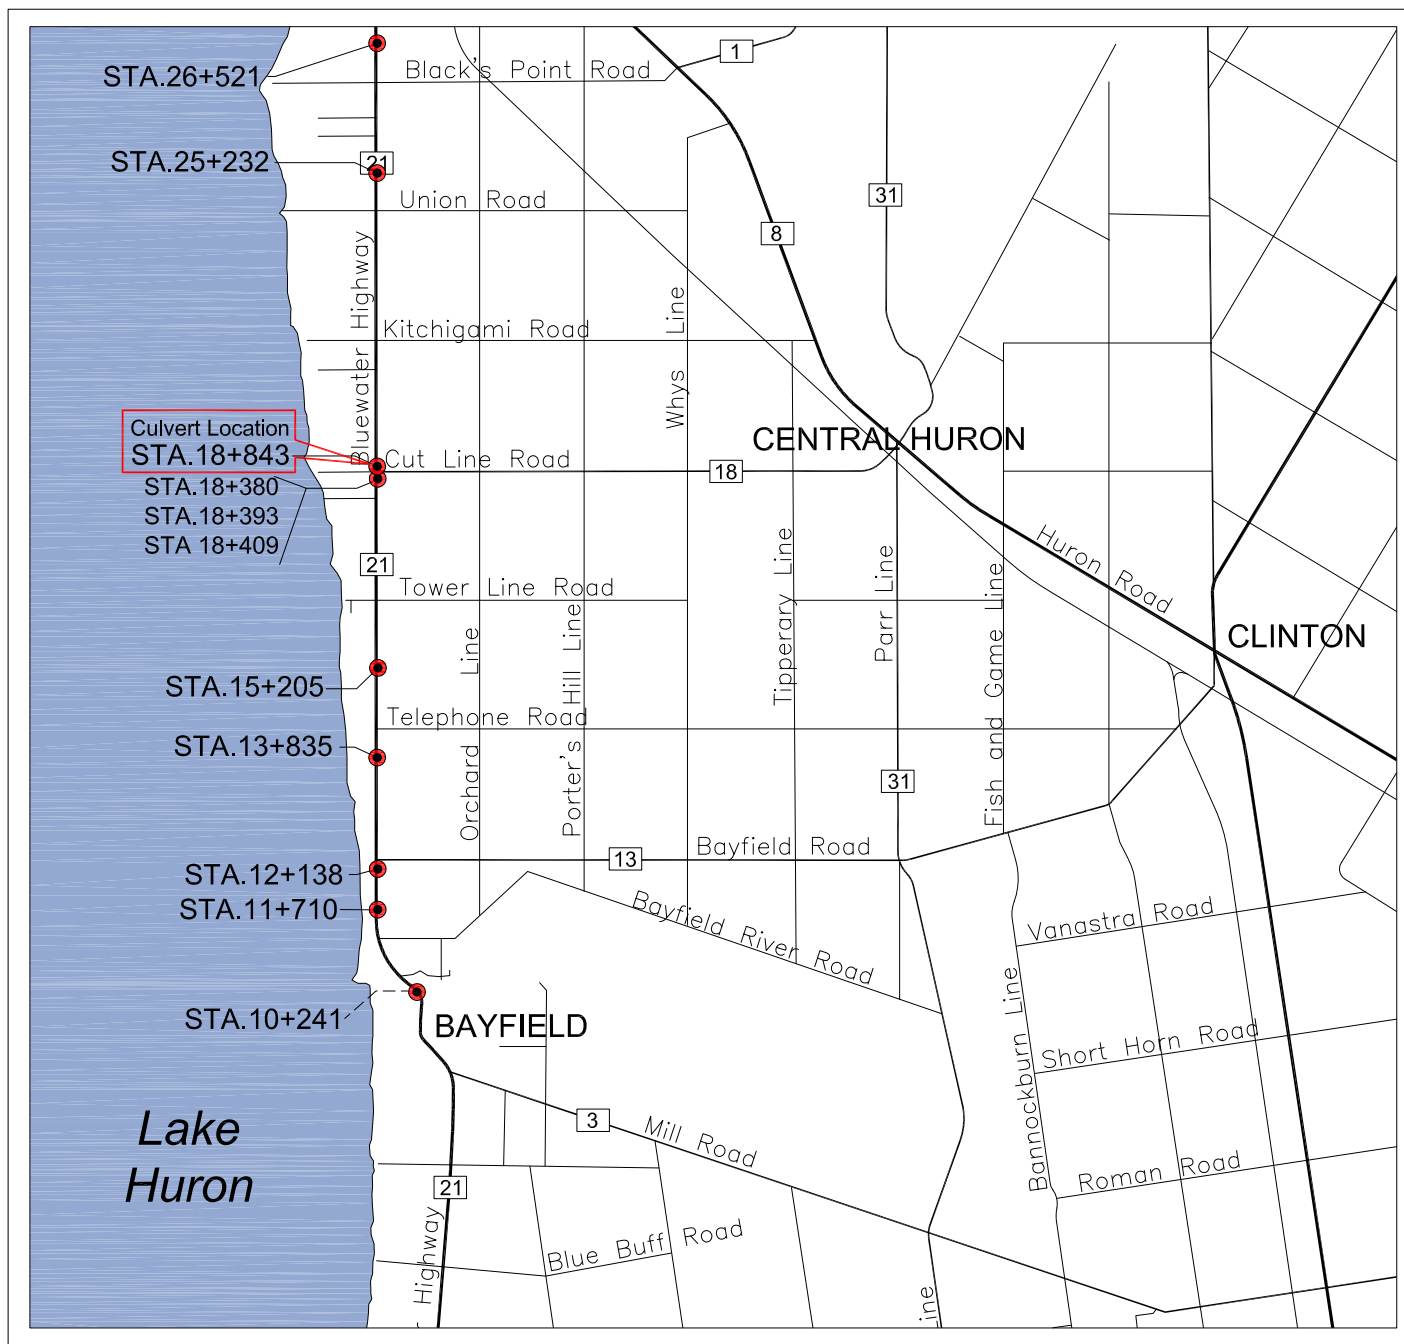
**CULVERT LOCATION PLAN**

The investigated culvert site (at Station 18+843) is located about 7 m north of Cut Line Road, north of Bayfield, Ontario (Drawing No. 1).

AMEC Environment & Infrastructure, a Division of AMEC Americas Limited ("AMEC"), was retained by the Ministry of Transportation Ontario - West Region ("MTO") to provide Detail Design Services for the Rehabilitation of Highway 21, Ontario. The project highway is about 20 km long stretching northerly from about 1.85 km south of Bayfield River Bridge (Bayfield) to about 0.17 km north of Huckins Street (Goderich), Ontario, as shown in Drawing No. 1.

In March 2012, AMEC conducted additional foundation investigations at the locations of 11 additional existing culverts, as shown on Drawing No. 1. The number of boreholes and locations of the boreholes were based on the Highway 21 Culvert Recommendations Table (dated 18 January 2012). The details of the additional culverts investigated, and the boreholes advanced at each location, are summarized in Table 1.1.

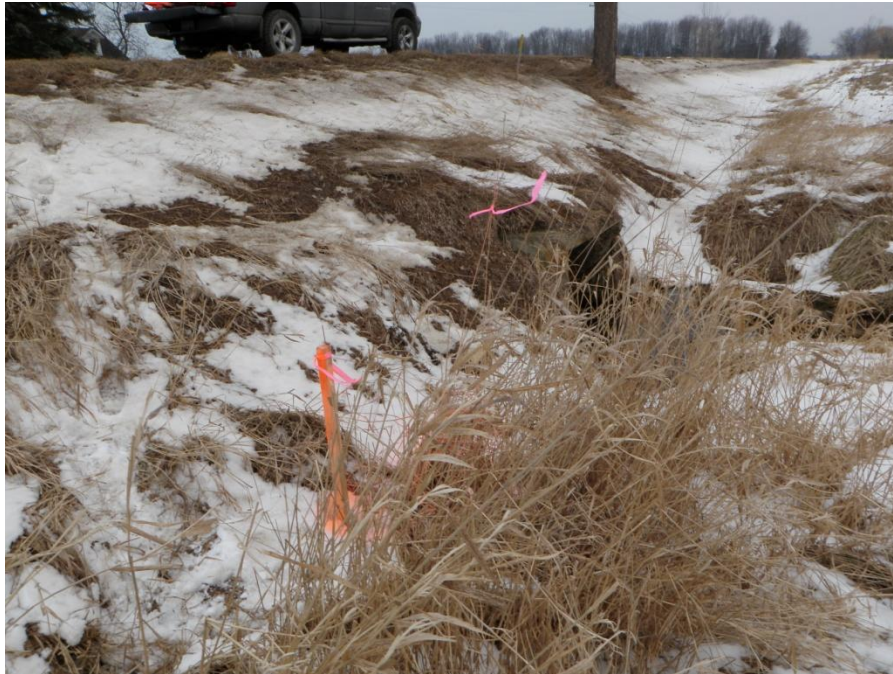
PHOTOGRAPH NO. 1

Looking towards the existing  
culvert inlet area.

At this location, Highway 21 is a two-lane asphaltic concrete paved road with gravel shoulders on both sides, and runs on top of an embankment built up above the surrounding grade. The surrounding area is primarily rural in nature, with active agricultural operations and farm houses / vacant lands / wood lots. The embankment slopes were covered with vegetation at the time of the fieldwork. Site photographs showing the culvert are presented in Appendix C (Photographs 1 and 2).

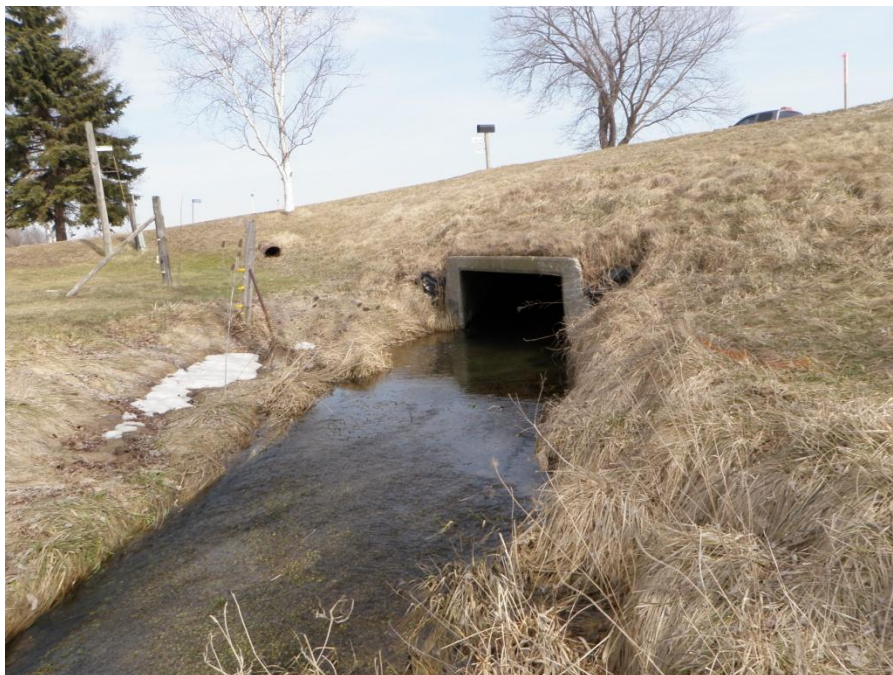
PHOTOGRAPH NO. 2

Looking towards the existing  
culvert outlet area.
