FOUNDATION INVESTIGATION REPORT

**REHABILITATION OF HIGHWAY 21
FROM BAYFIELD TO GODERICH, ONTARIO**

CULVERT NO. 61 AT STATION 26+521

**MINISTRY OF TRANSPORTATION ONTARIO (MTO) - WEST REGION
PURCHASE ORDER NUMBER 3009-E-0022
GWP 834-93-00**

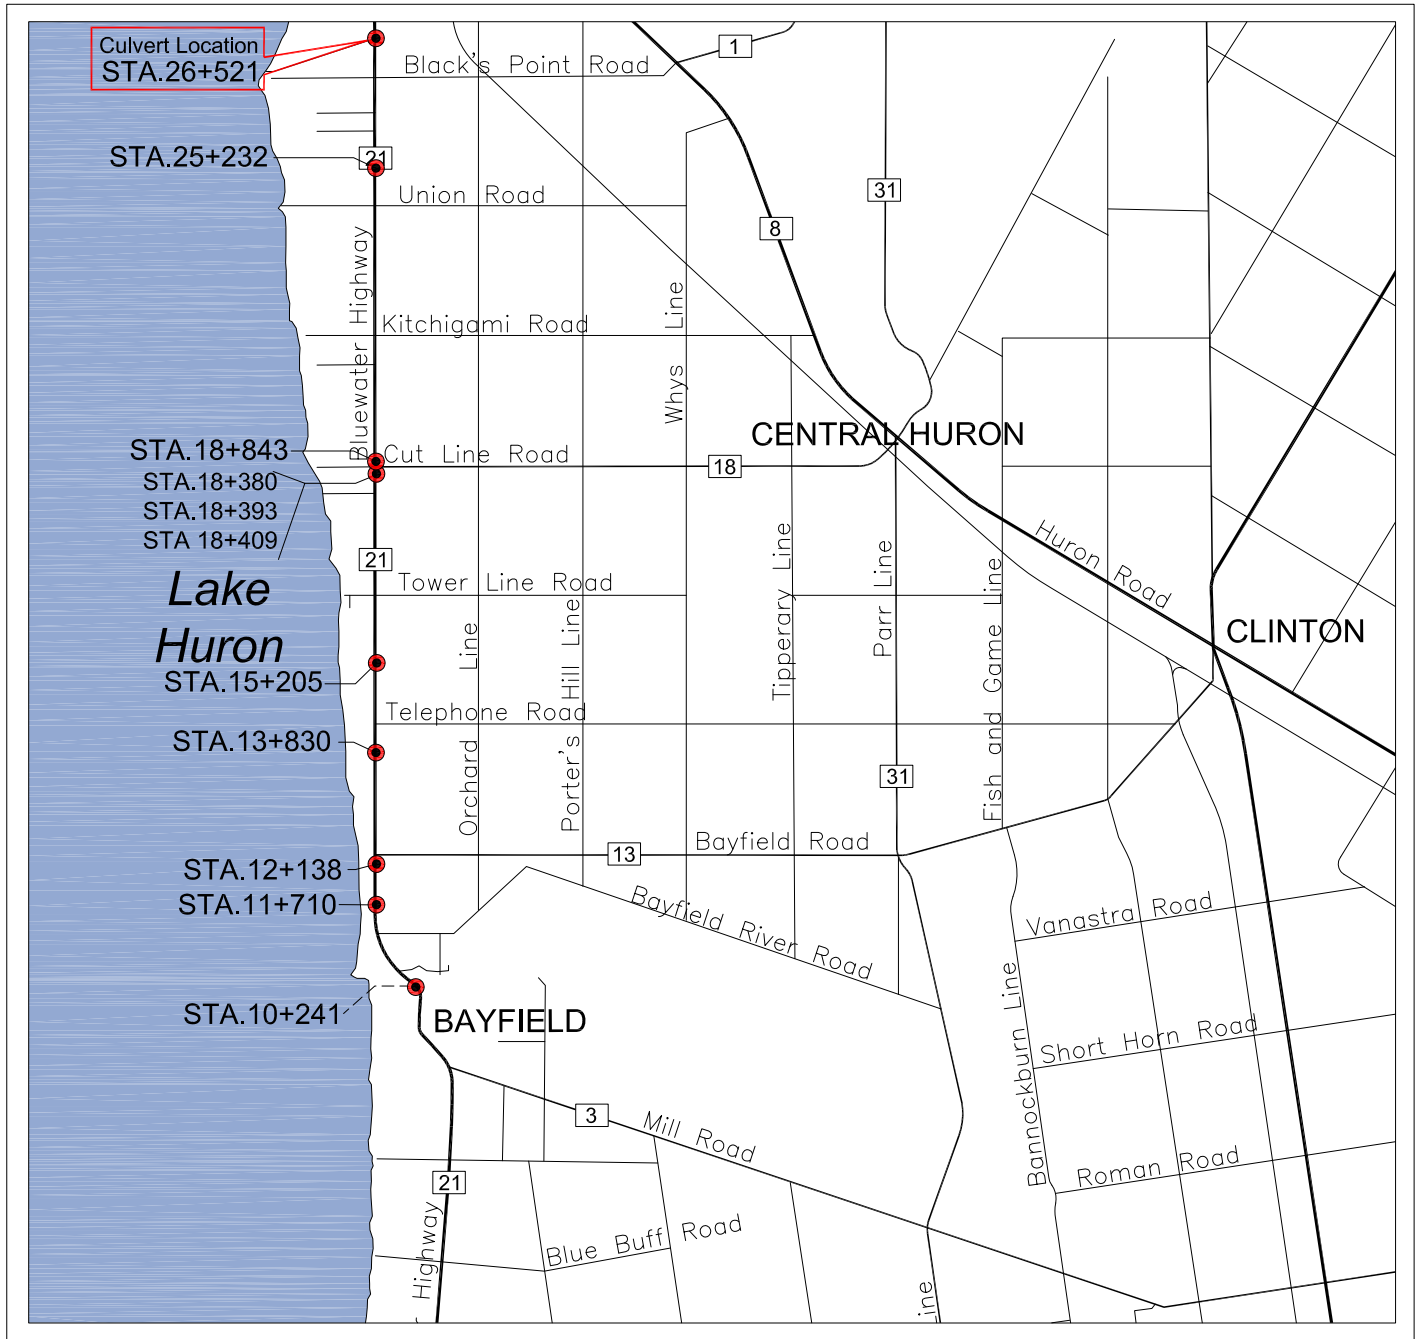
DRAWING No.
1

TITLE
CULVERT LOCATION PLAN

AMEC Environment & Infrastructure, a Division of AMEC Americas Limited (“AMEC”), was retained by the Ministry of Transportation Ontario - West Region (“MTO”) to provide Detail Design Services for the Rehabilitation of Highway 21, Ontario. The project highway is about 20 km long stretching northerly from about 1.85 km south of Bayfield River Bridge (Bayfield) to about 0.17 km north of Huckins Street (Goderich), Ontario, as shown in Drawing No. 1.

The investigated culvert site (at Station 26+521) is located about 4 km north of Union Road, south of Goderich, Ontario (Drawing No. 1).

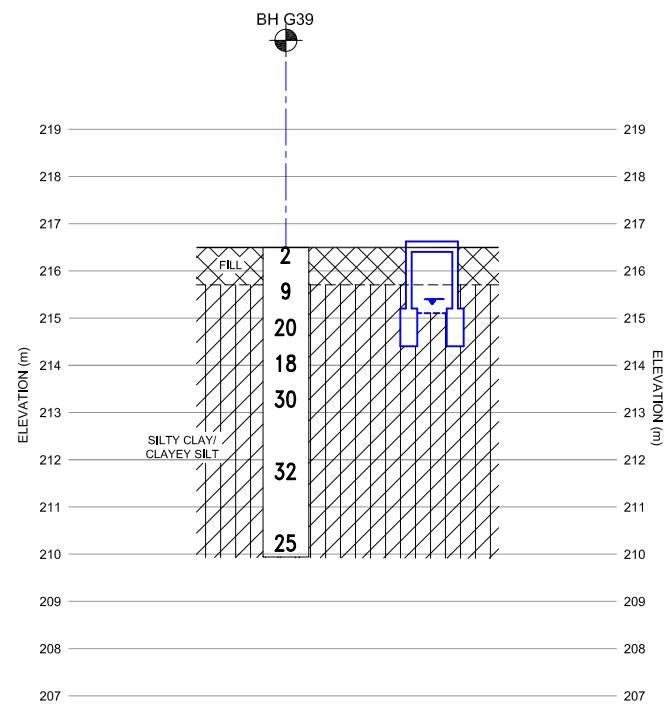
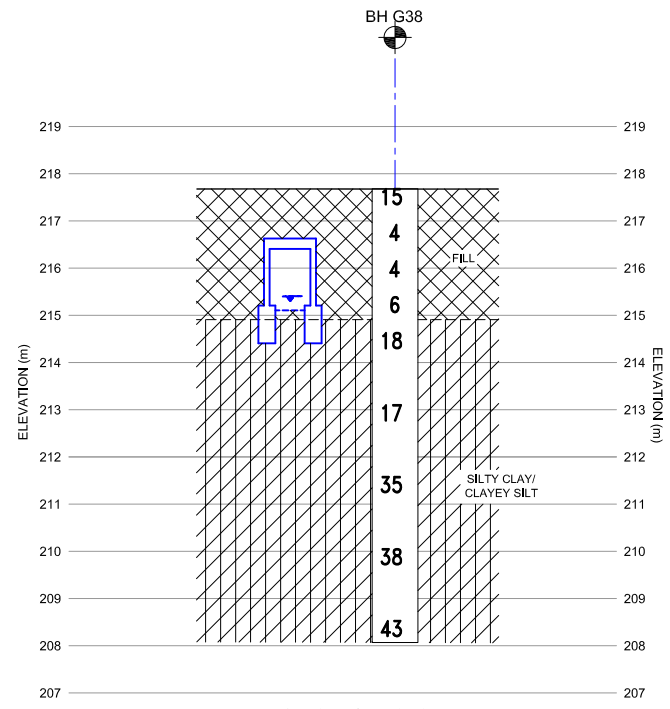
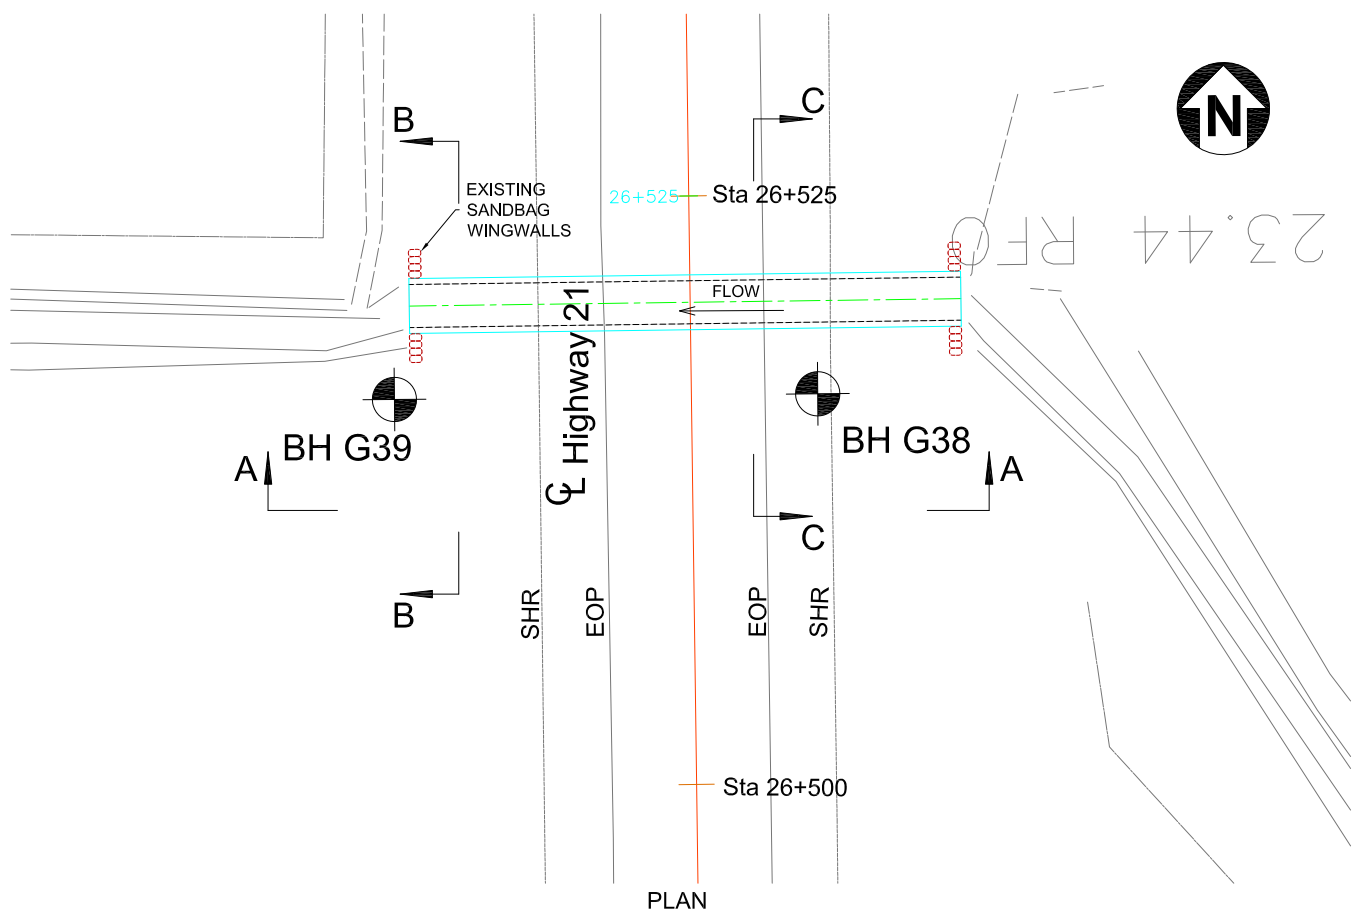
**SHEET
1 OF 1**

SECTION A-A

SECTION B-B

SECTION C-C

REHABILITATION OF HWY 21 FROM BAYFIELD TO GODERICH
GEOCRES No.40P12-32
CULVERT AT STA 26+521
STRATIGRAPHIC CROSS SECTION

The stratigraphic units and groundwater conditions at the borehole locations are discussed in the following sections. Detailed information is provided in the Record of Boreholes in Appendix A. Interpolated stratigraphical cross sections through the existing culvert are provided in Drawing No. 3.

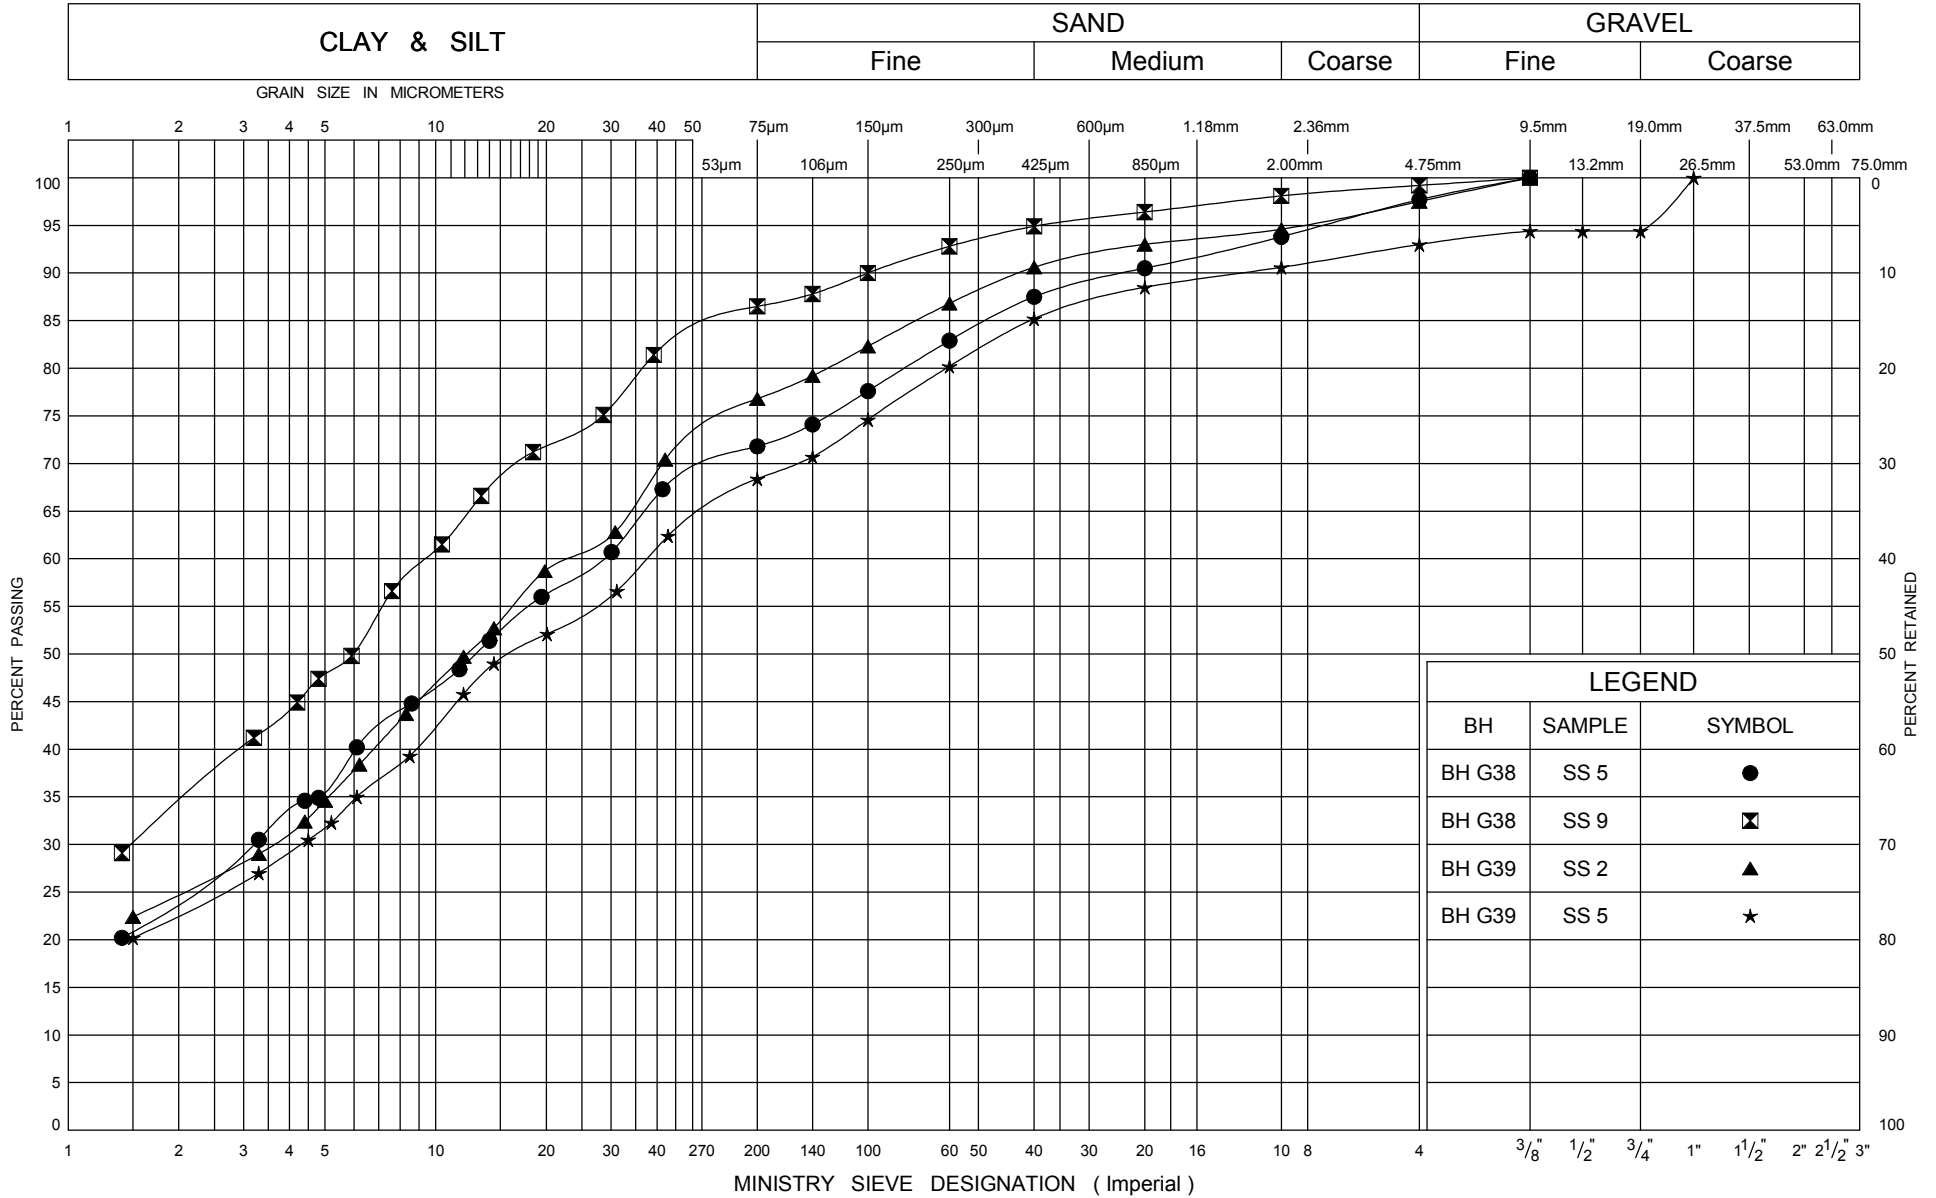
The grain size distribution curves are presented in Figure No. B 1, and the plasticity chart is presented in Figure No. B 2, in Appendix B.

Grain size analyses and Atterberg Limit tests were completed on 4 samples of the clayey silt / silty clay, and the results are presented in Table 5.1.

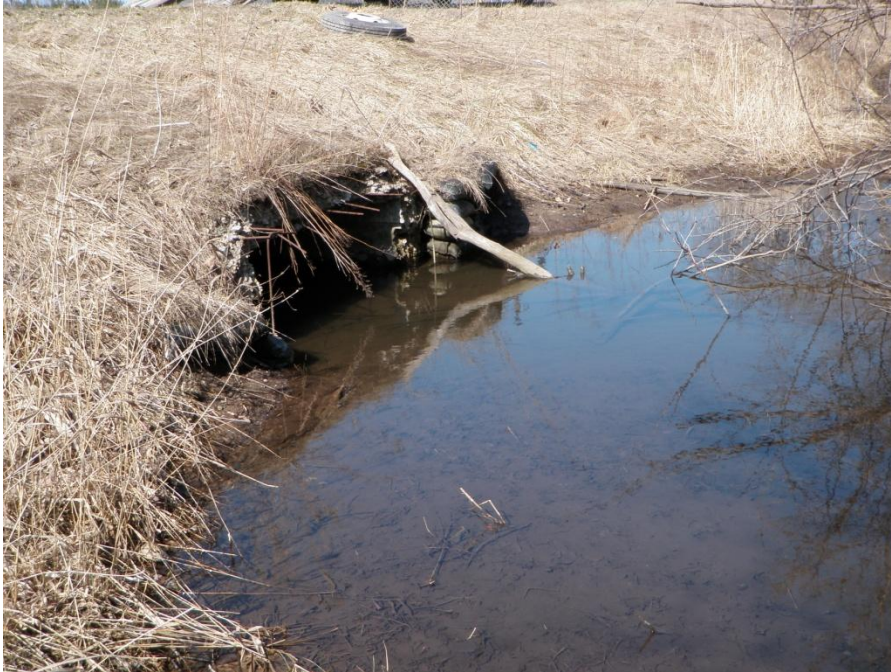
PHOTOGRAPH NO. 1

Looking towards the existing
culvert inlet area.

At the time of field work, the investigated areas at the ends of the existing culvert were covered with vegetation. Site photographs showing the culvert are presented in Appendix C (Photographs 1 and 2).

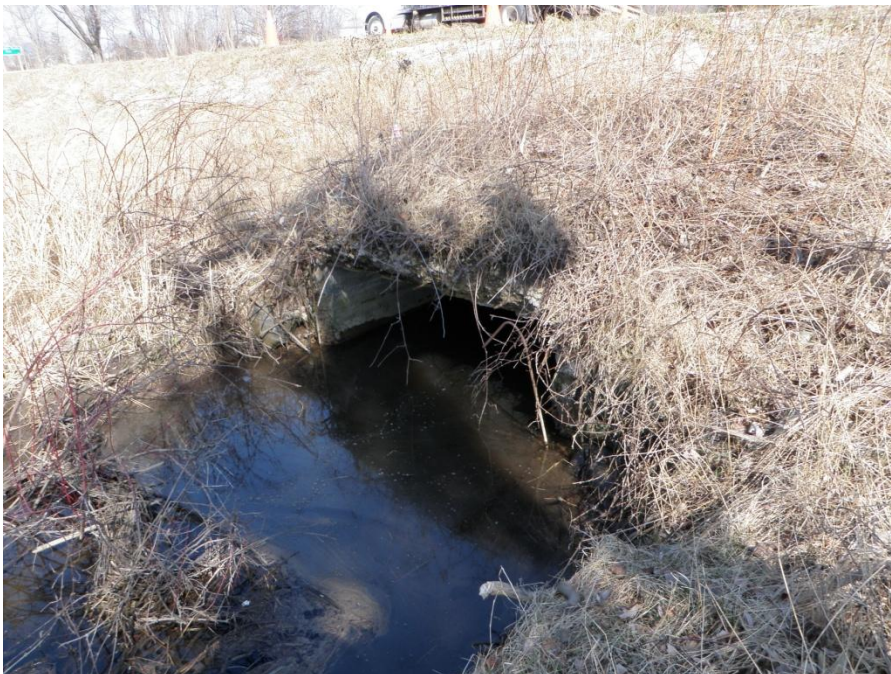
PHOTOGRAPH NO. 2

Looking towards the existing
culvert outlet area.
