Final Foundation Investigation Report

Highway 24 Resurfacing and
Replacement of Culvert at
Station 16+453 (Site No. 17)
Township of South Dumfries, ON

G.W.P. 3065-11-00

Geocres No. 40P08-239

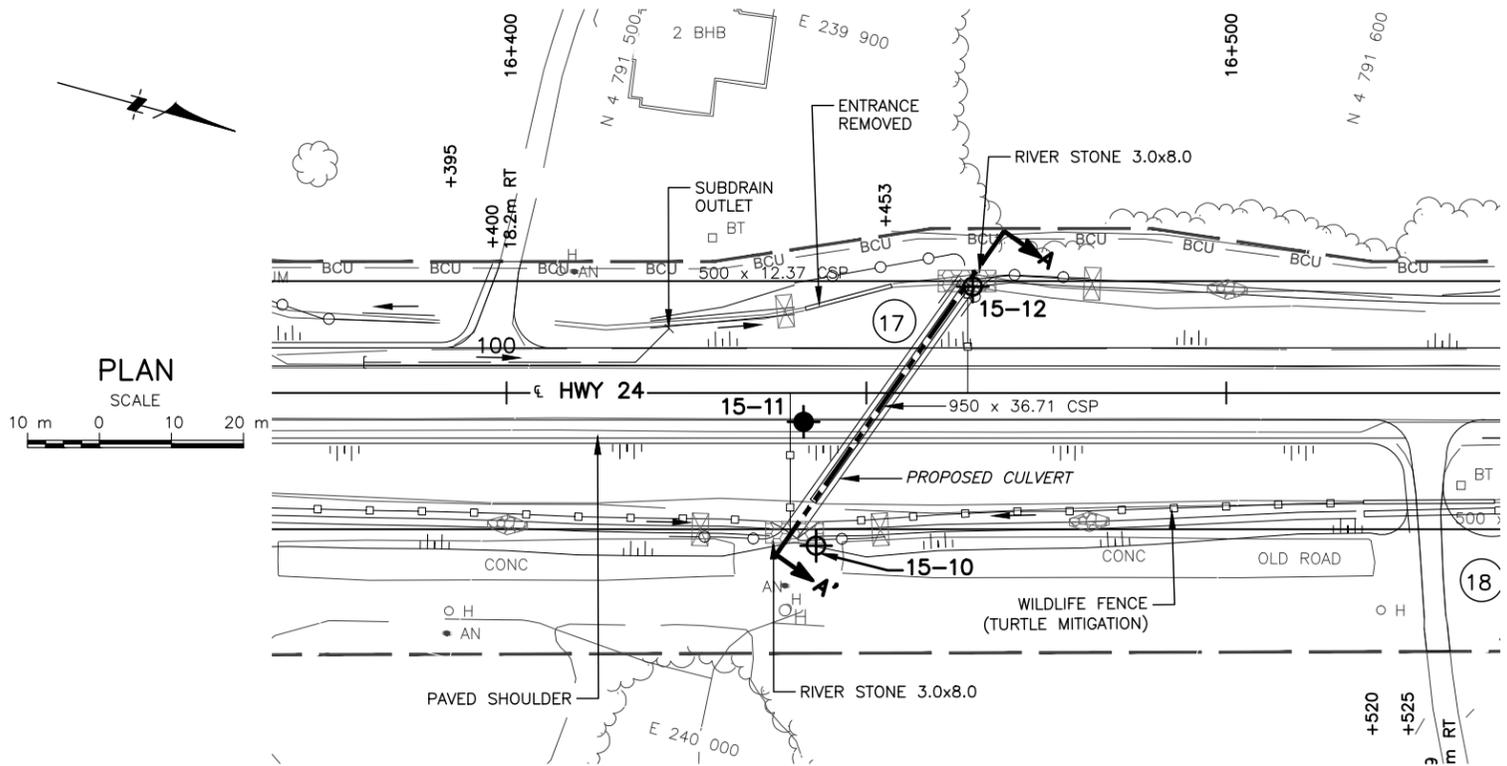
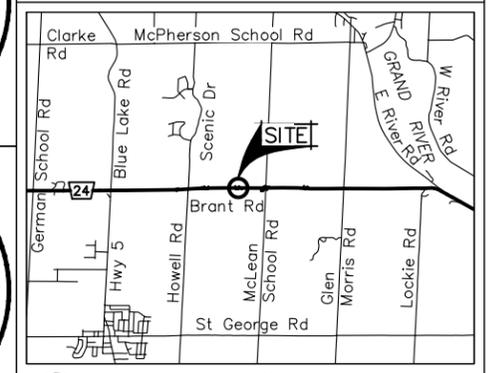
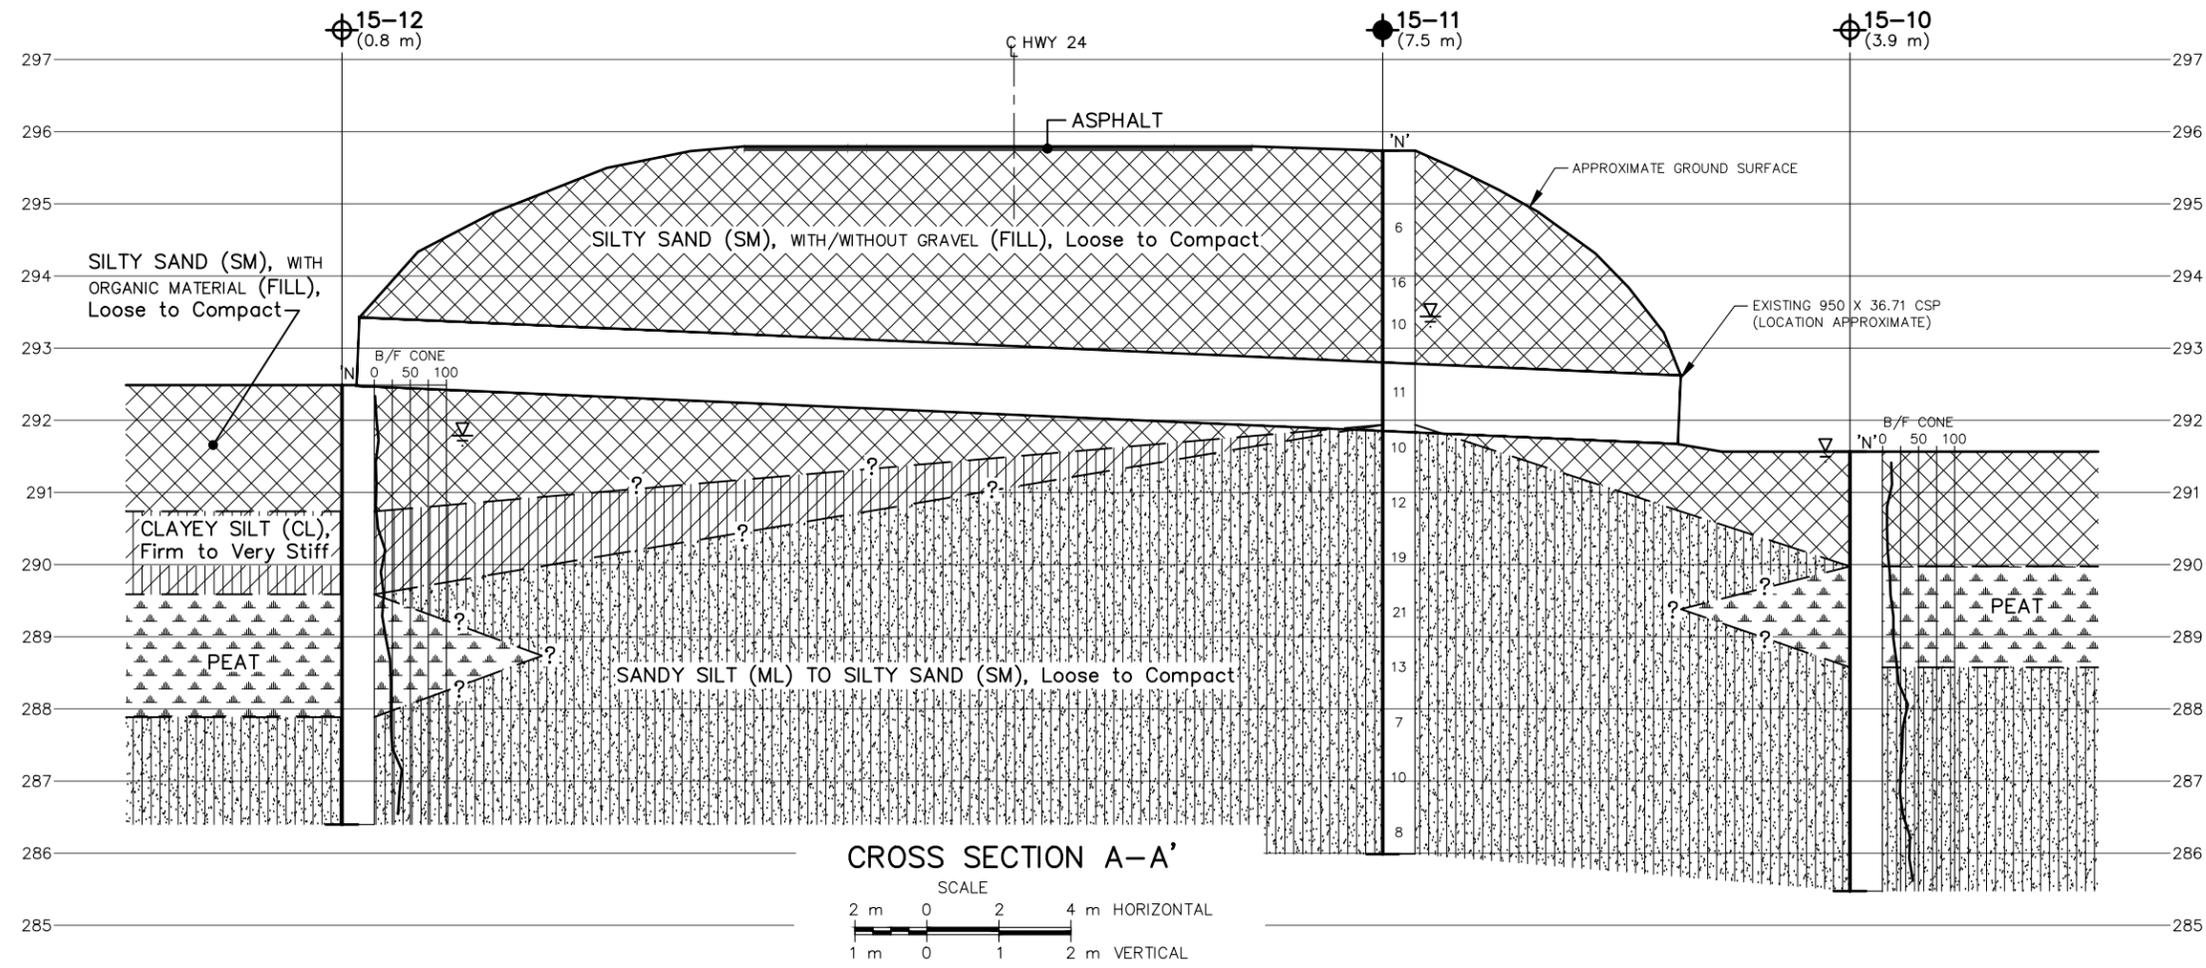
Drawing No. 1 – Borehole Location Plan and Soil Strata Plot

Borehole location plans and stratigraphic section of the soils encountered within the boreholes are provided on Drawing No. 1 in Appendix A.

HWY 24, TWP OF S DUMFRIES, ON
CULVERT AT STA 16+453 (SITE 17)
BOREHOLE LOCATIONS & SOIL STRATA

The site location is shown on the Key Plan inset to Drawing No. 1, provided in Appendix A. The existing Culvert crosses beneath Highway 24 near Station 16+453, approximately 572 m south of the intersection of Highway 24 and McLean School Road.

The terms of reference indicate the existing culvert type is a Corrugated Steel Pipe (CSP). The culvert has a diameter of 950 mm and a length of 36.71 m. The culvert is covered with approximately 3 m of fill. The approximate alignment of the existing culvert is shown on Drawing No. 1 in Appendix A.

A field investigation consisting of three boreholes was carried out at the culvert site. The boreholes were designated BH15-10, BH15-11, and BH15-12 and their locations are shown on the Borehole Location Plan, Drawing No.1 in Appendix A.

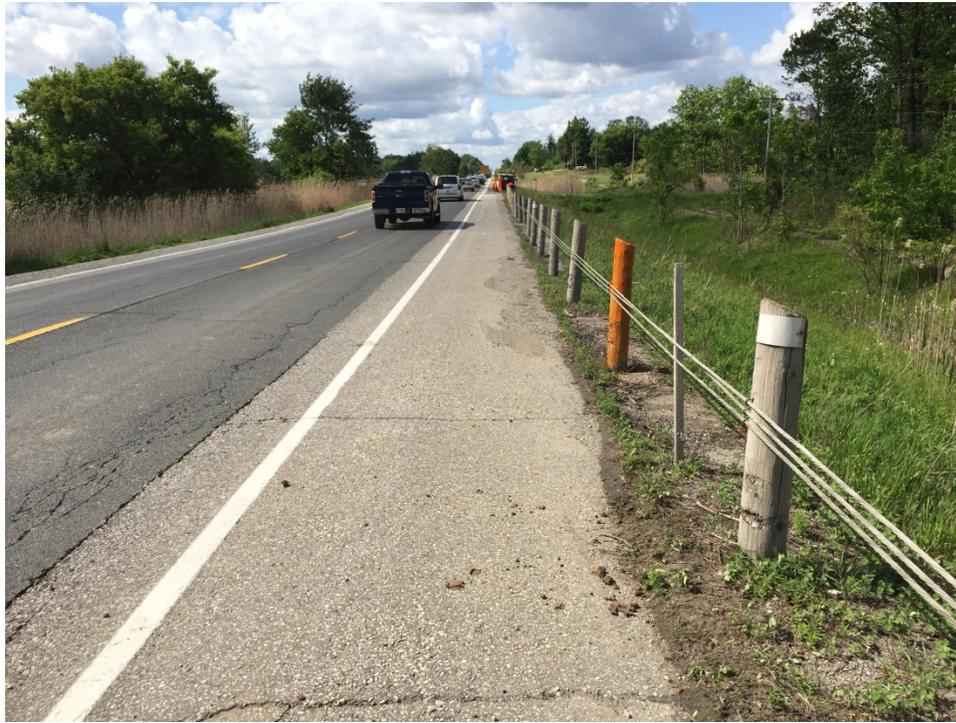
Site Photo No.: 1

Looking north on BH15-11

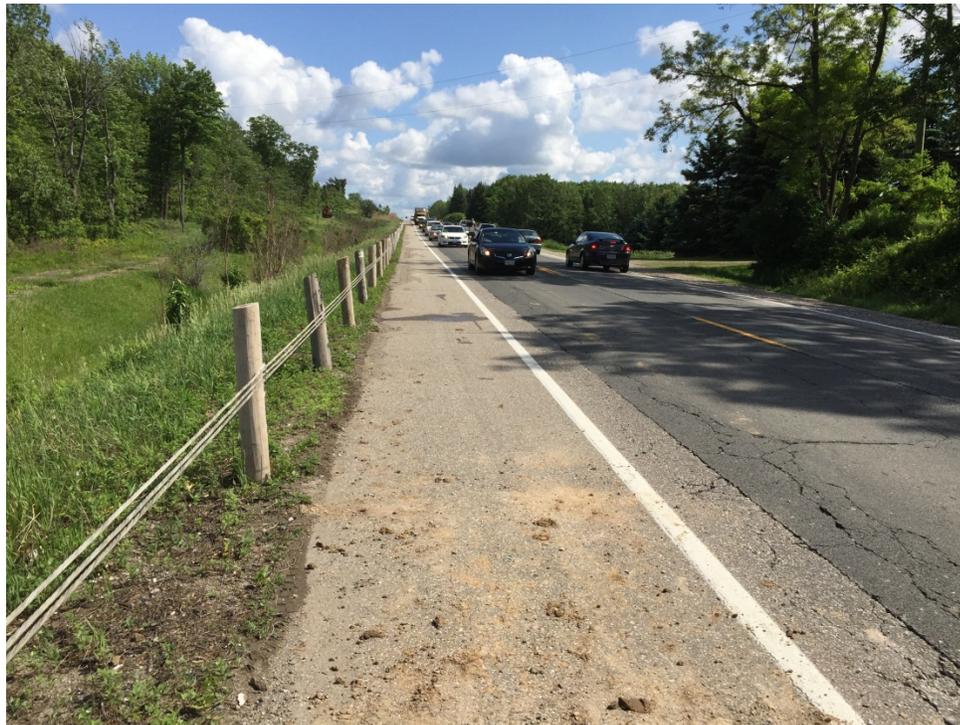
Site Photo No.: 2

Looking south on BH15-11

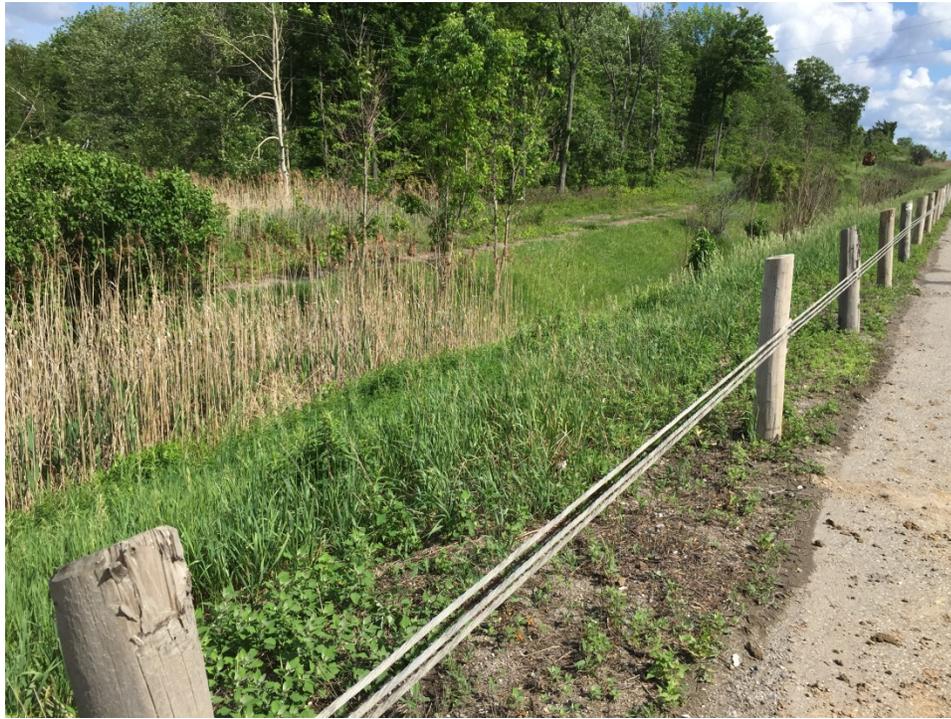
Site Photo No.: 3

Looking southeast toward BH15-10 on BH15-11

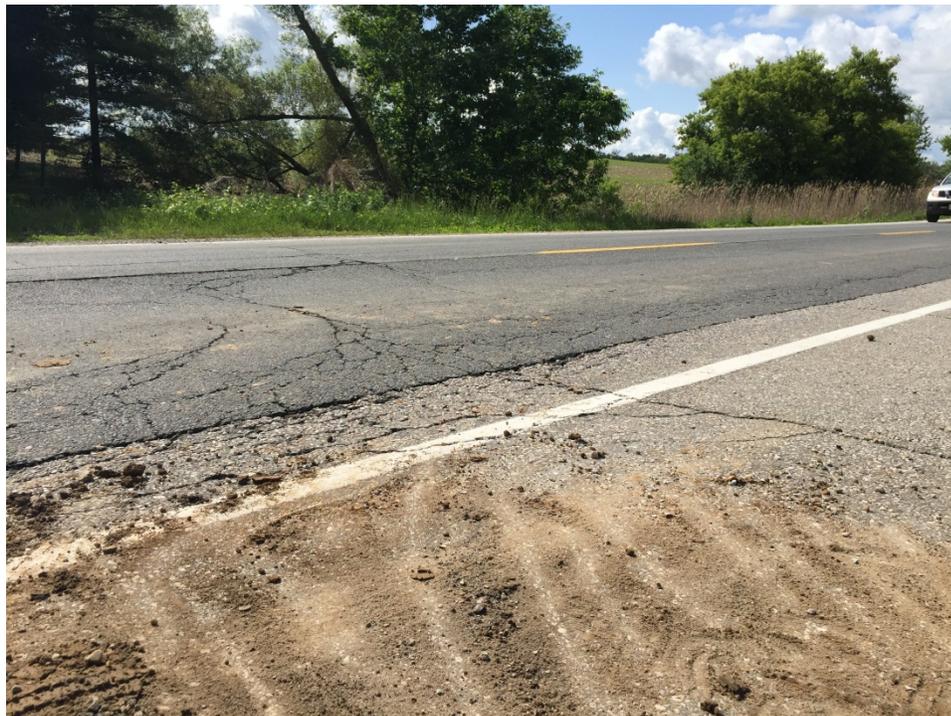
Site Photo No.: 4

Looking northwest toward BH15-12 on BH15-11

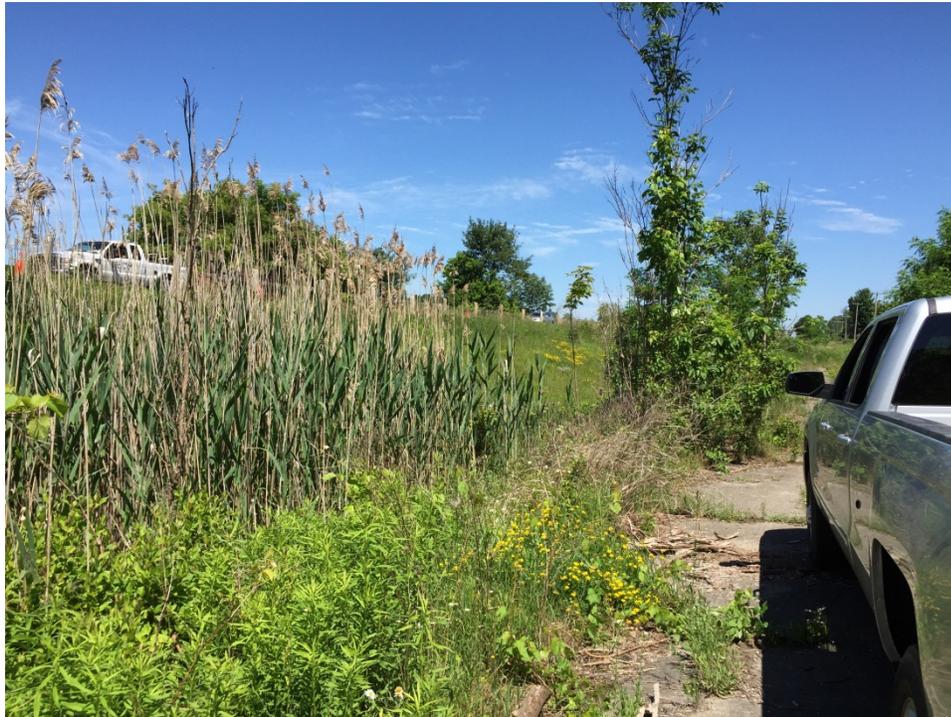
Site Photo No.: 5

Looking northwest near BH15-10

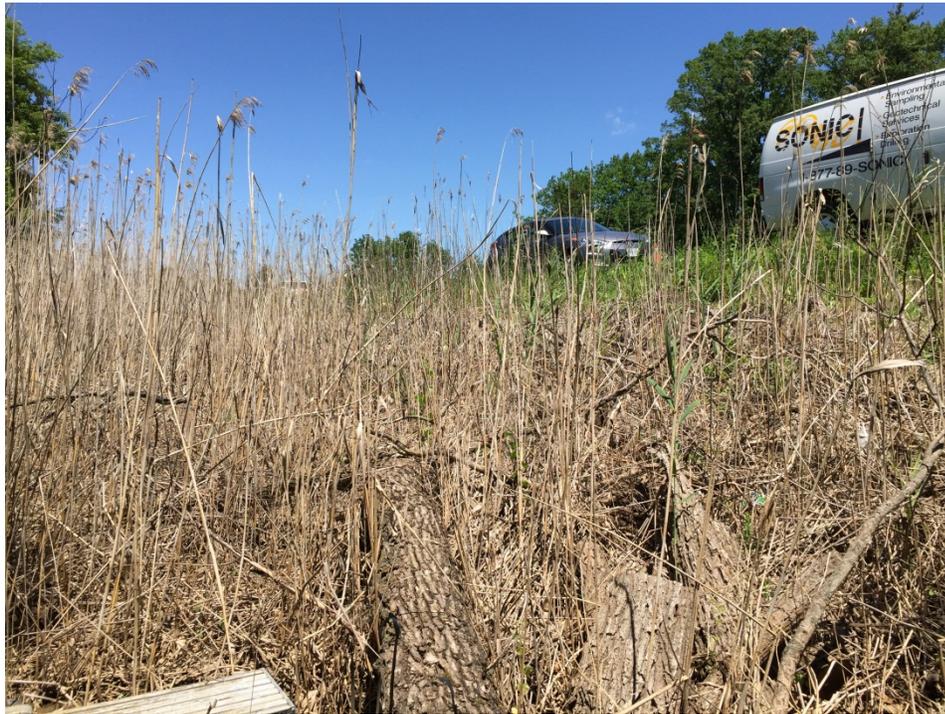
Site Photo No.: 6

Looking northeast on BH15-12

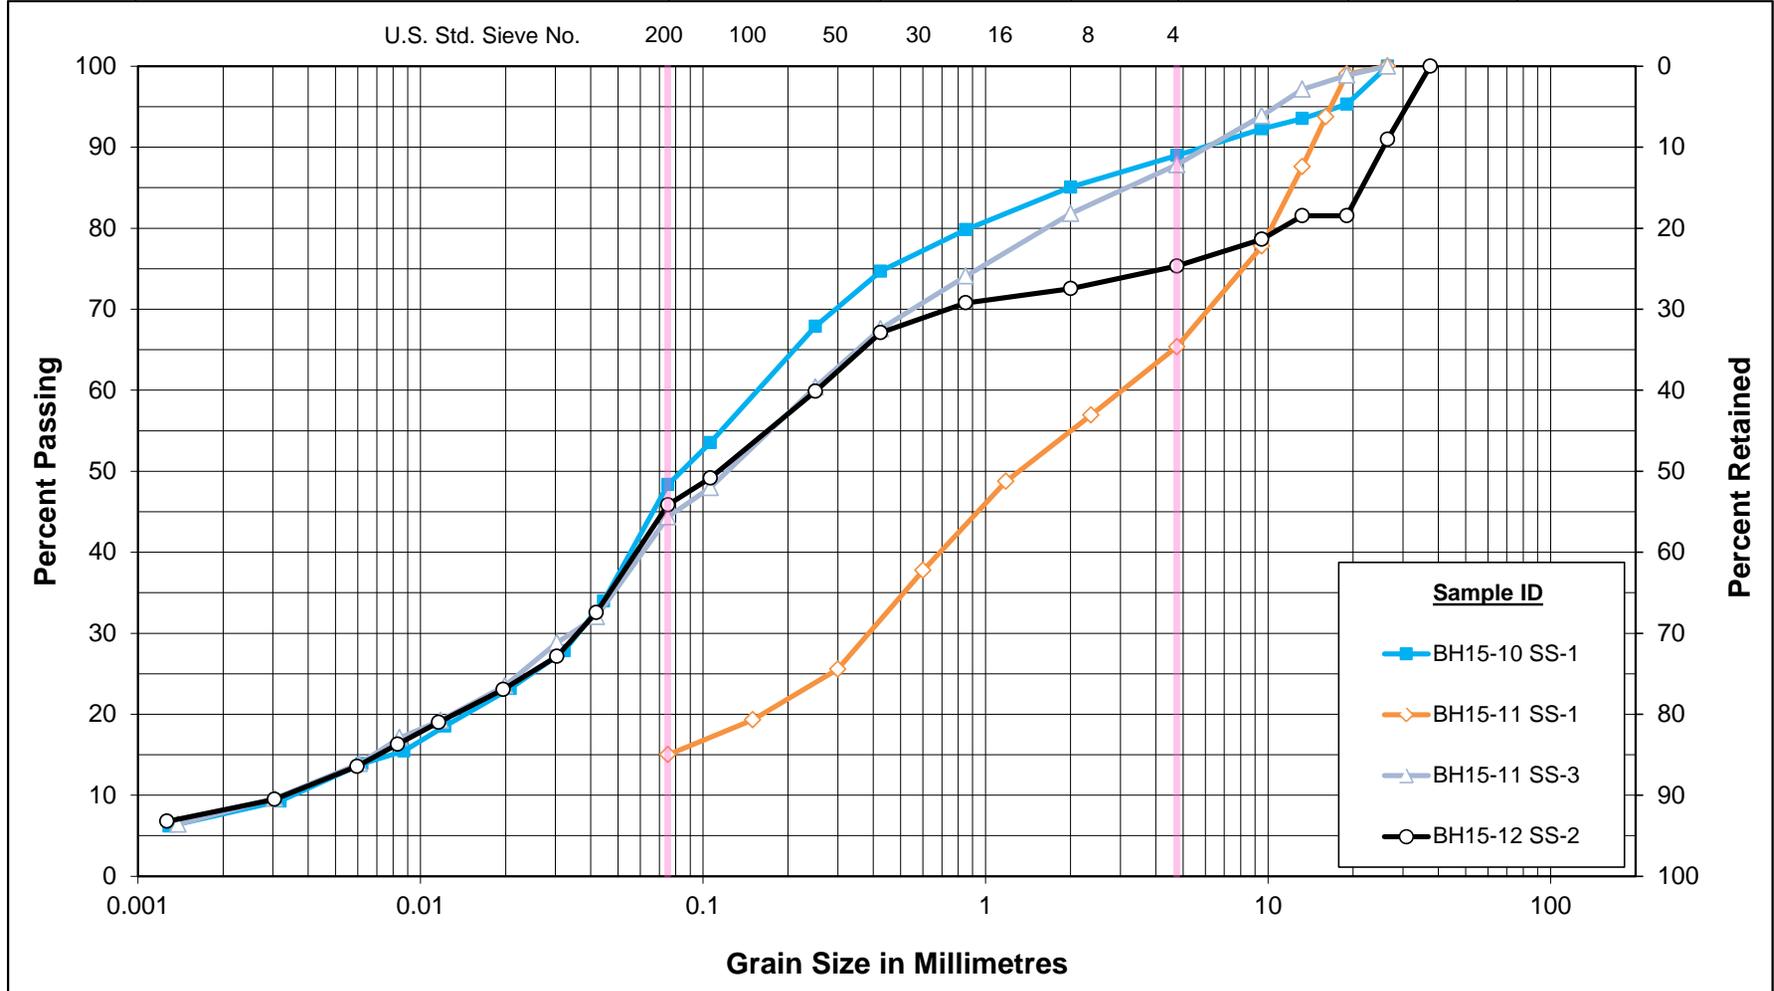
GRAIN SIZE DISTRIBUTION
FILL: Silty SAND (SM)
with/without Gravel

Gravel:	11 and 35%
Sand:	29 and 50%
Silt:	15 to 41%
Clay:	7 to 8%
Moisture Content:	4 to 19%

Moisture content of the organic fill in BH15-12 ranged from 48 to 97%. The grain size distribution curve for the fill material is provided in Figure No. 1 of Appendix C.

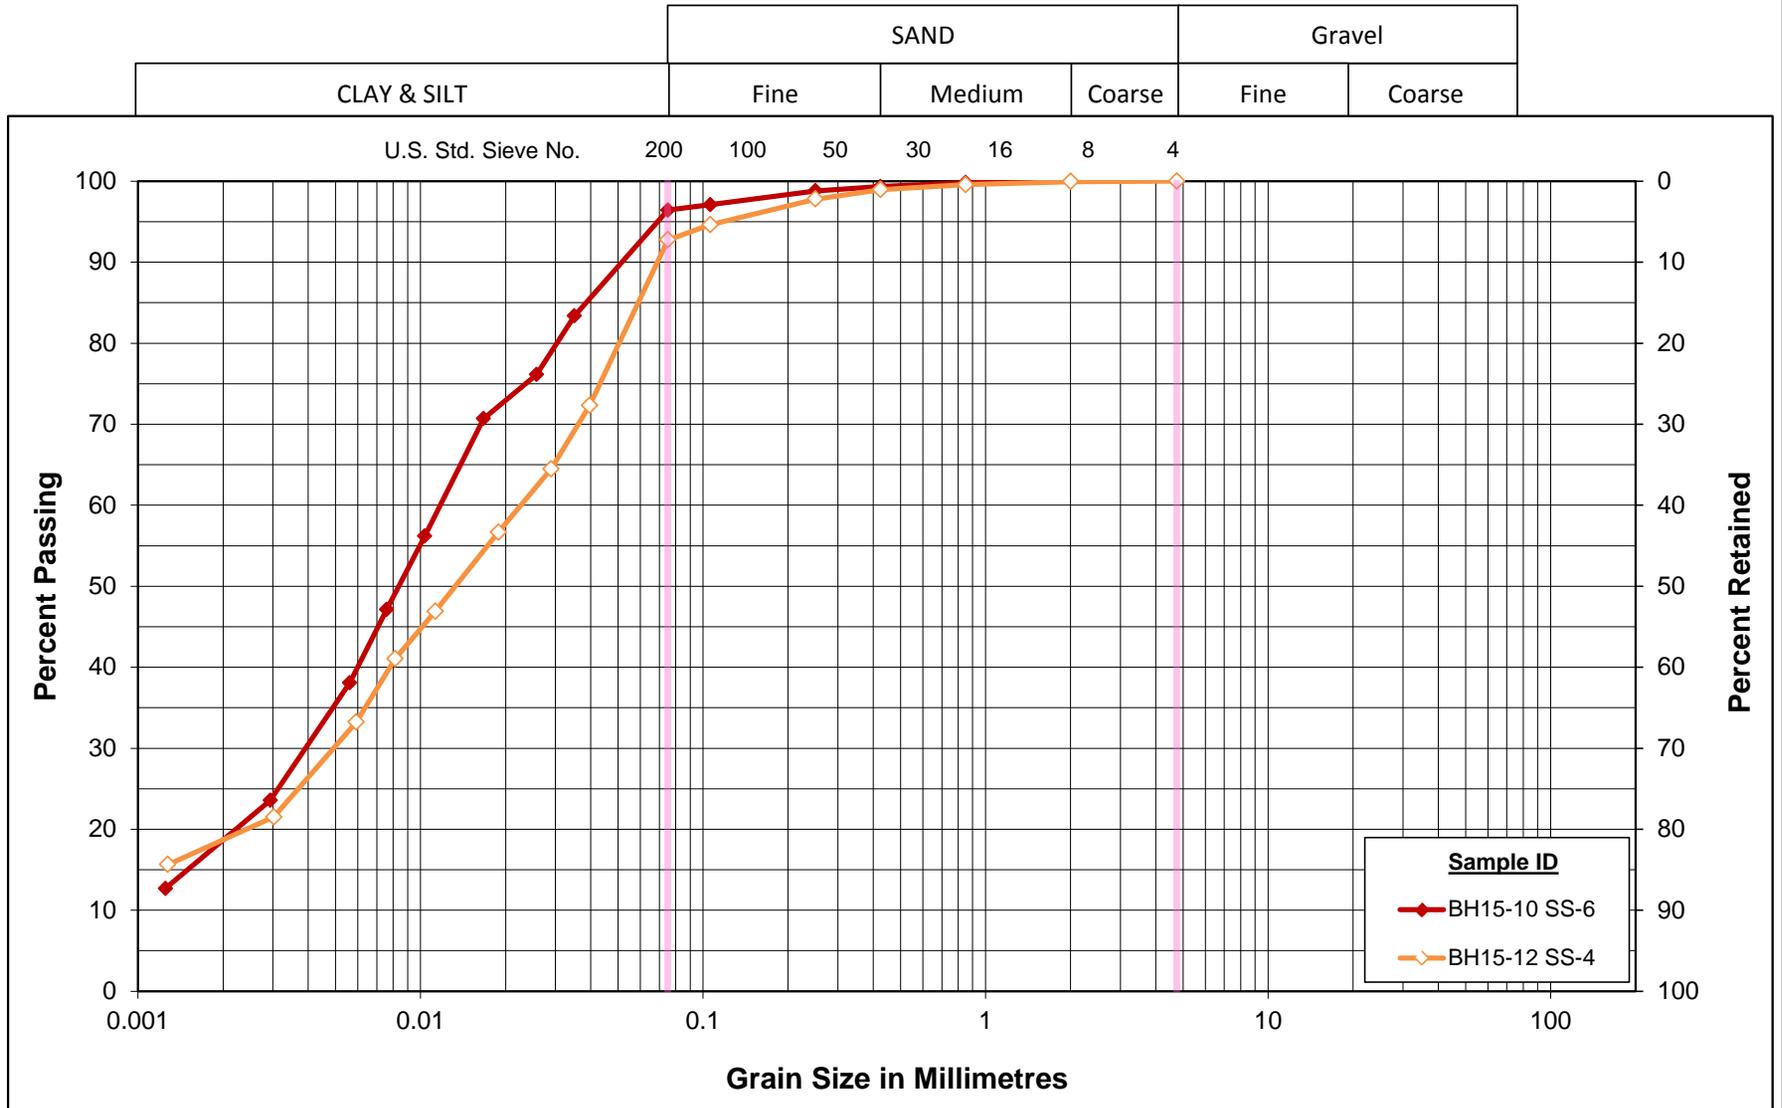
GRAIN SIZE DISTRIBUTION Clayey SILT (CL)

Gravel:	0%
Sand:	4 to 7%
Silt:	75 to 79%
Clay:	17 to 18%
Moisture Content:	22 to 42%

The grain size distribution curve for the clayey silt is provided in Figure No. 2 of Appendix C.

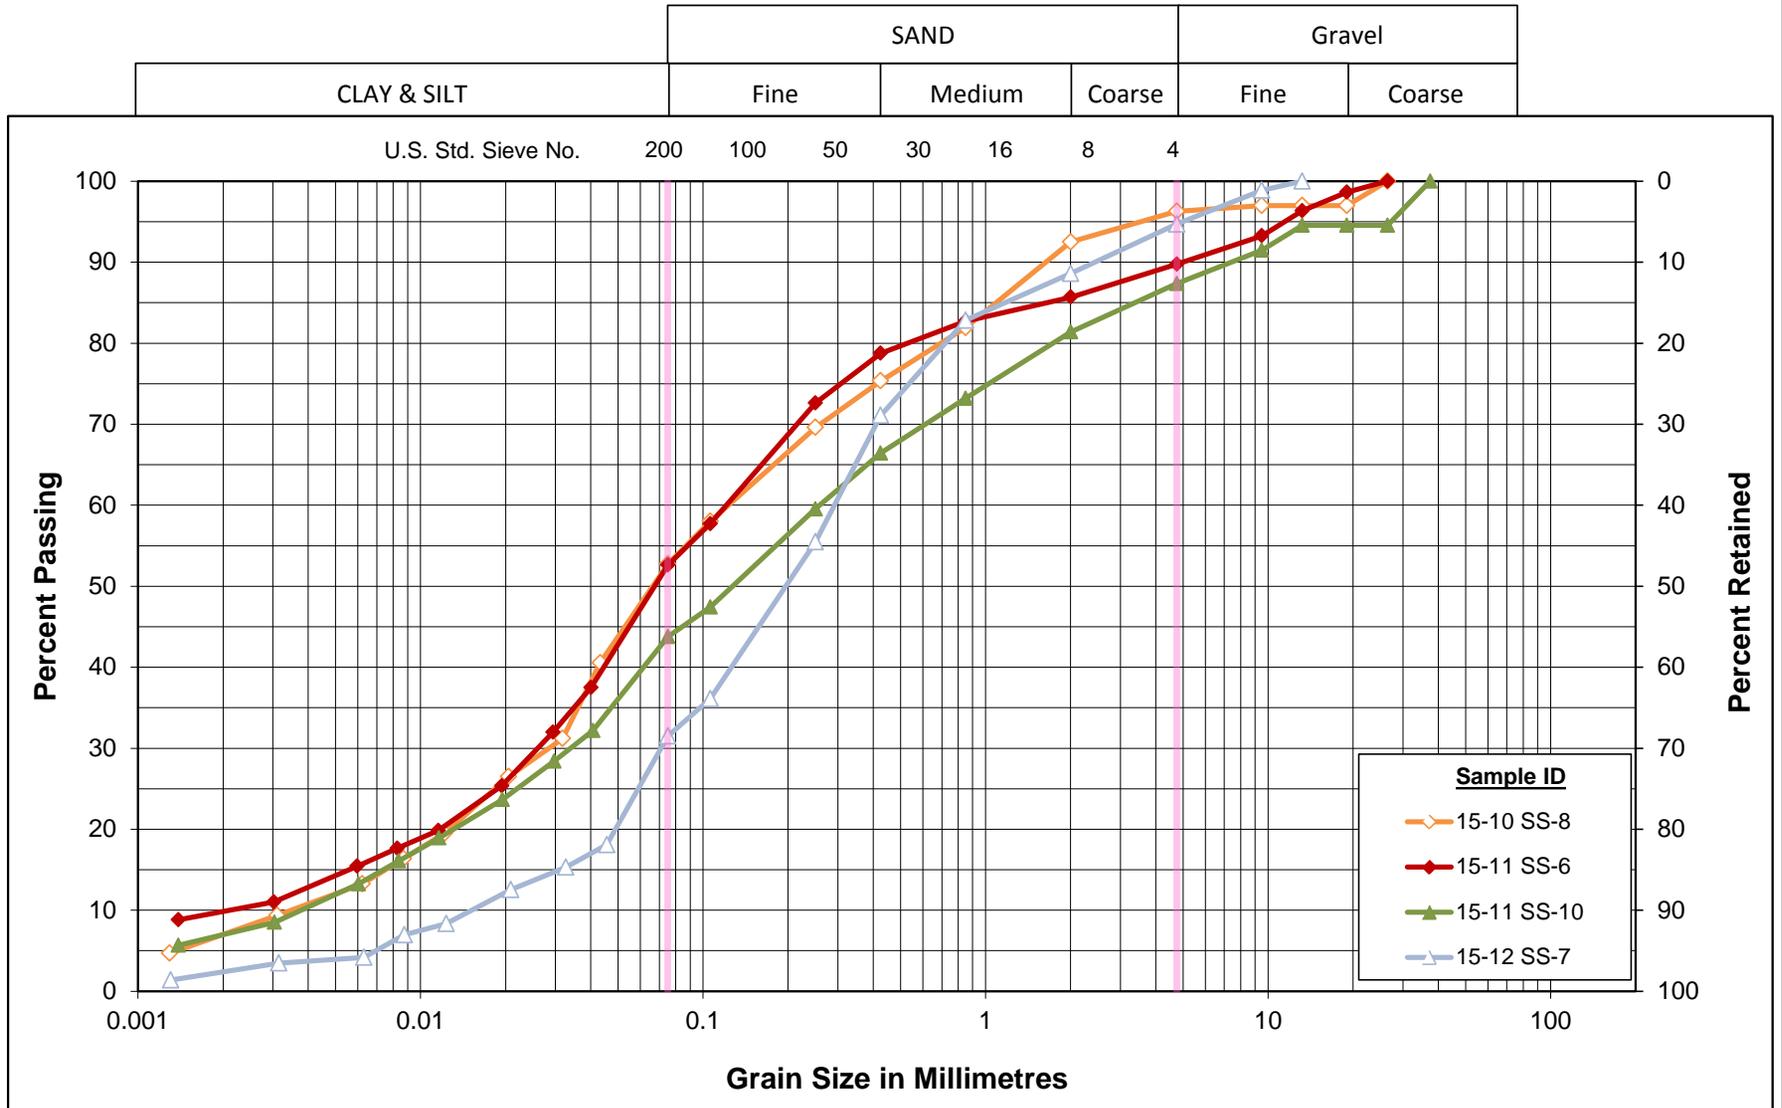
GRAIN SIZE DISTRIBUTION
Sandy SILT (ML) to Silty SAND (SM)

Gravel:	4 to 13%
Sand:	37 to 63%
Silt:	29 to 79%
Clay:	2 to 17%
Moisture Content:	9 to 37%

The grain size distribution curves for the sandy silt to silty sand material are provided in Figure No. 3 of Appendix C.

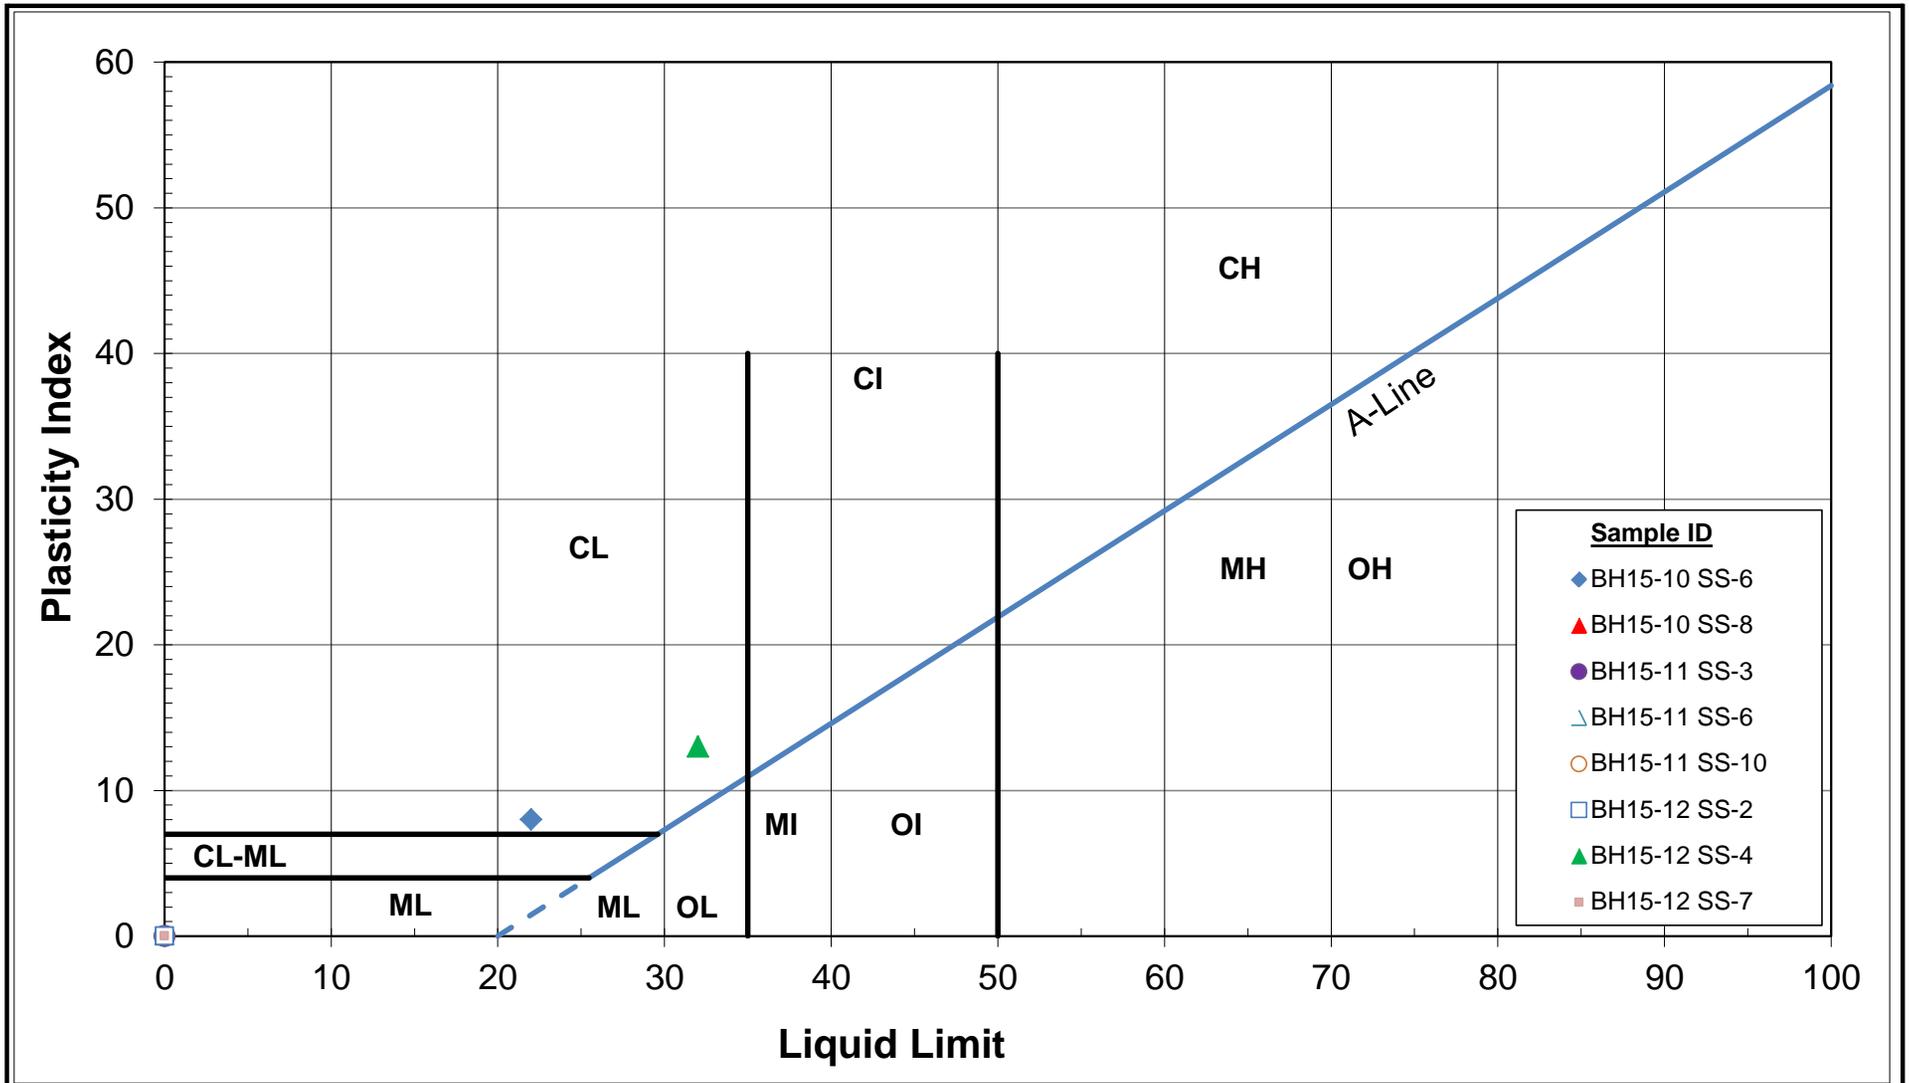
PLASTICITY CHART

Two Atterberg Limit tests were also performed on the fill samples. The Atterberg Limit tests yielded that the samples are non-plastic. The results are shown in Figure No. 4 of Appendix C.

Two Atterberg Limit tests were also performed on the clayey silt samples. The Atterberg Limit test yielded plasticity index of 8 and 13 and liquid limit of 22 and 32. The results suggest a low to medium plasticity. The results are shown in Figure No. 4 of Appendix C.

Four Atterberg Limit tests were also performed on the sandy silt to silty sand samples. The Atterberg Limit tests yielded that three samples were non-plastic and one sample from BH15-10 indicated a plasticity index of 8 and a liquid limit of 22. The results are shown in Figure No. 4 of Appendix C.
