Final Foundation Investigation Report

Highway 24 Resurfacing and
Replacement of Culvert at
Station 17+845 (Site No. 29)
Township of South Dumfries, ON

G.W.P. 3065-11-00

Project No. 165000903

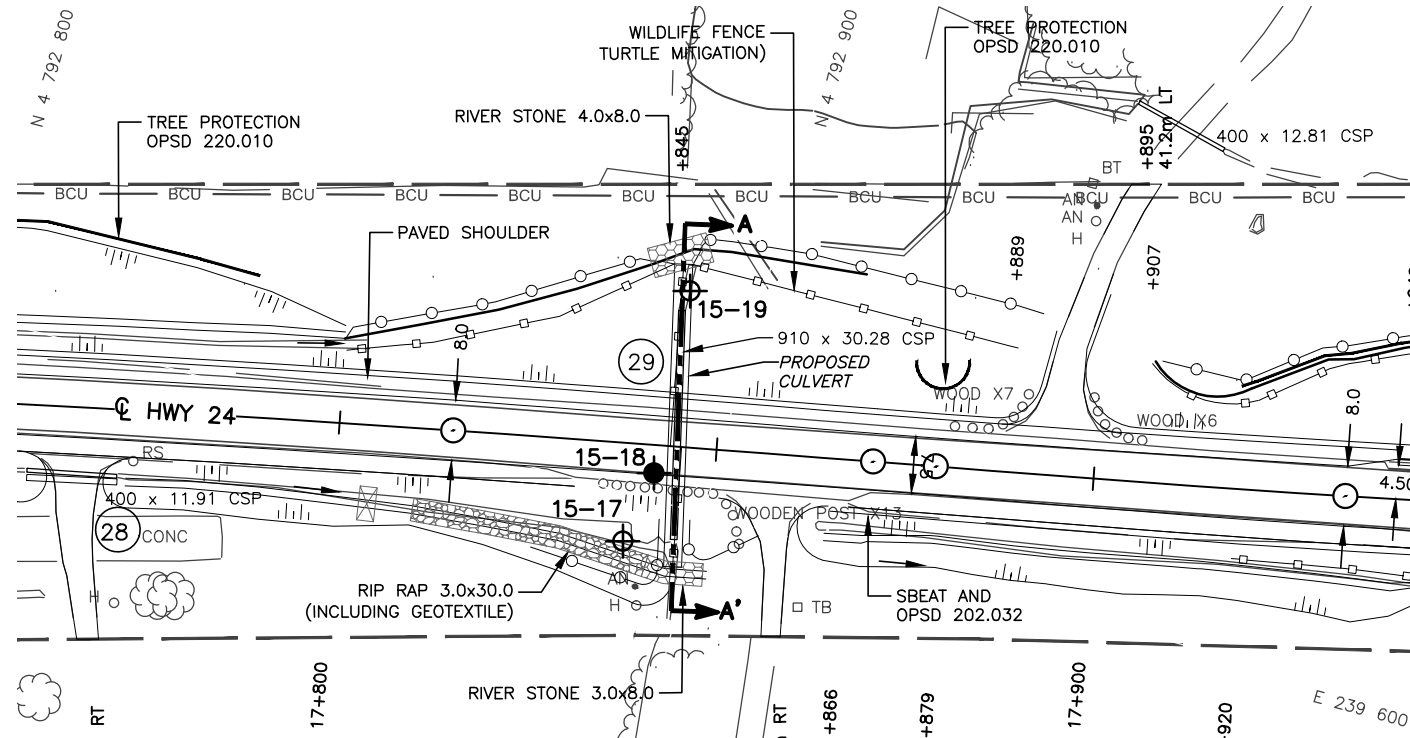
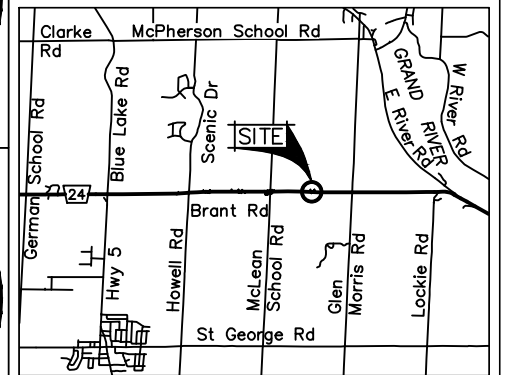
Drawing No. 1 – Borehole Location Plan and Soil Strata Plot

A field investigation consisting of three boreholes was carried out for this assignment. The boreholes were designated BH15-17, BH15-18, and BH15-19 and their locations are shown on the Borehole Location Plan, Drawing No.1 in Appendix A.

Borehole location plans and stratigraphic section of the soils encountered within the boreholes are provided on Drawing No. 1 in Appendix A.

HWY 24, TWP OF S DUMFRIES, ON
CULVERT AT STA 17+845 (SITE 29)
BOREHOLE LOCATIONS & SOIL STRATA

The site location is shown on the Key Plan inset to Drawing No. 1, provided in Appendix A. The existing Culvert crosses beneath Highway 24 near Station 17+845, approximately 0.8 km north of the intersection of Highway 24 and McLean School Road.

The terms of reference indicate that the existing culvert type is a Corrugated Steel Pipe (CSP). The culvert has a diameter of 900 mm and a length of 30.28 m. The culvert is covered with approximately 2.5 m to 4.0 m of fill. The approximate alignment of the existing culvert is shown on Drawing No. 1 in Appendix A.

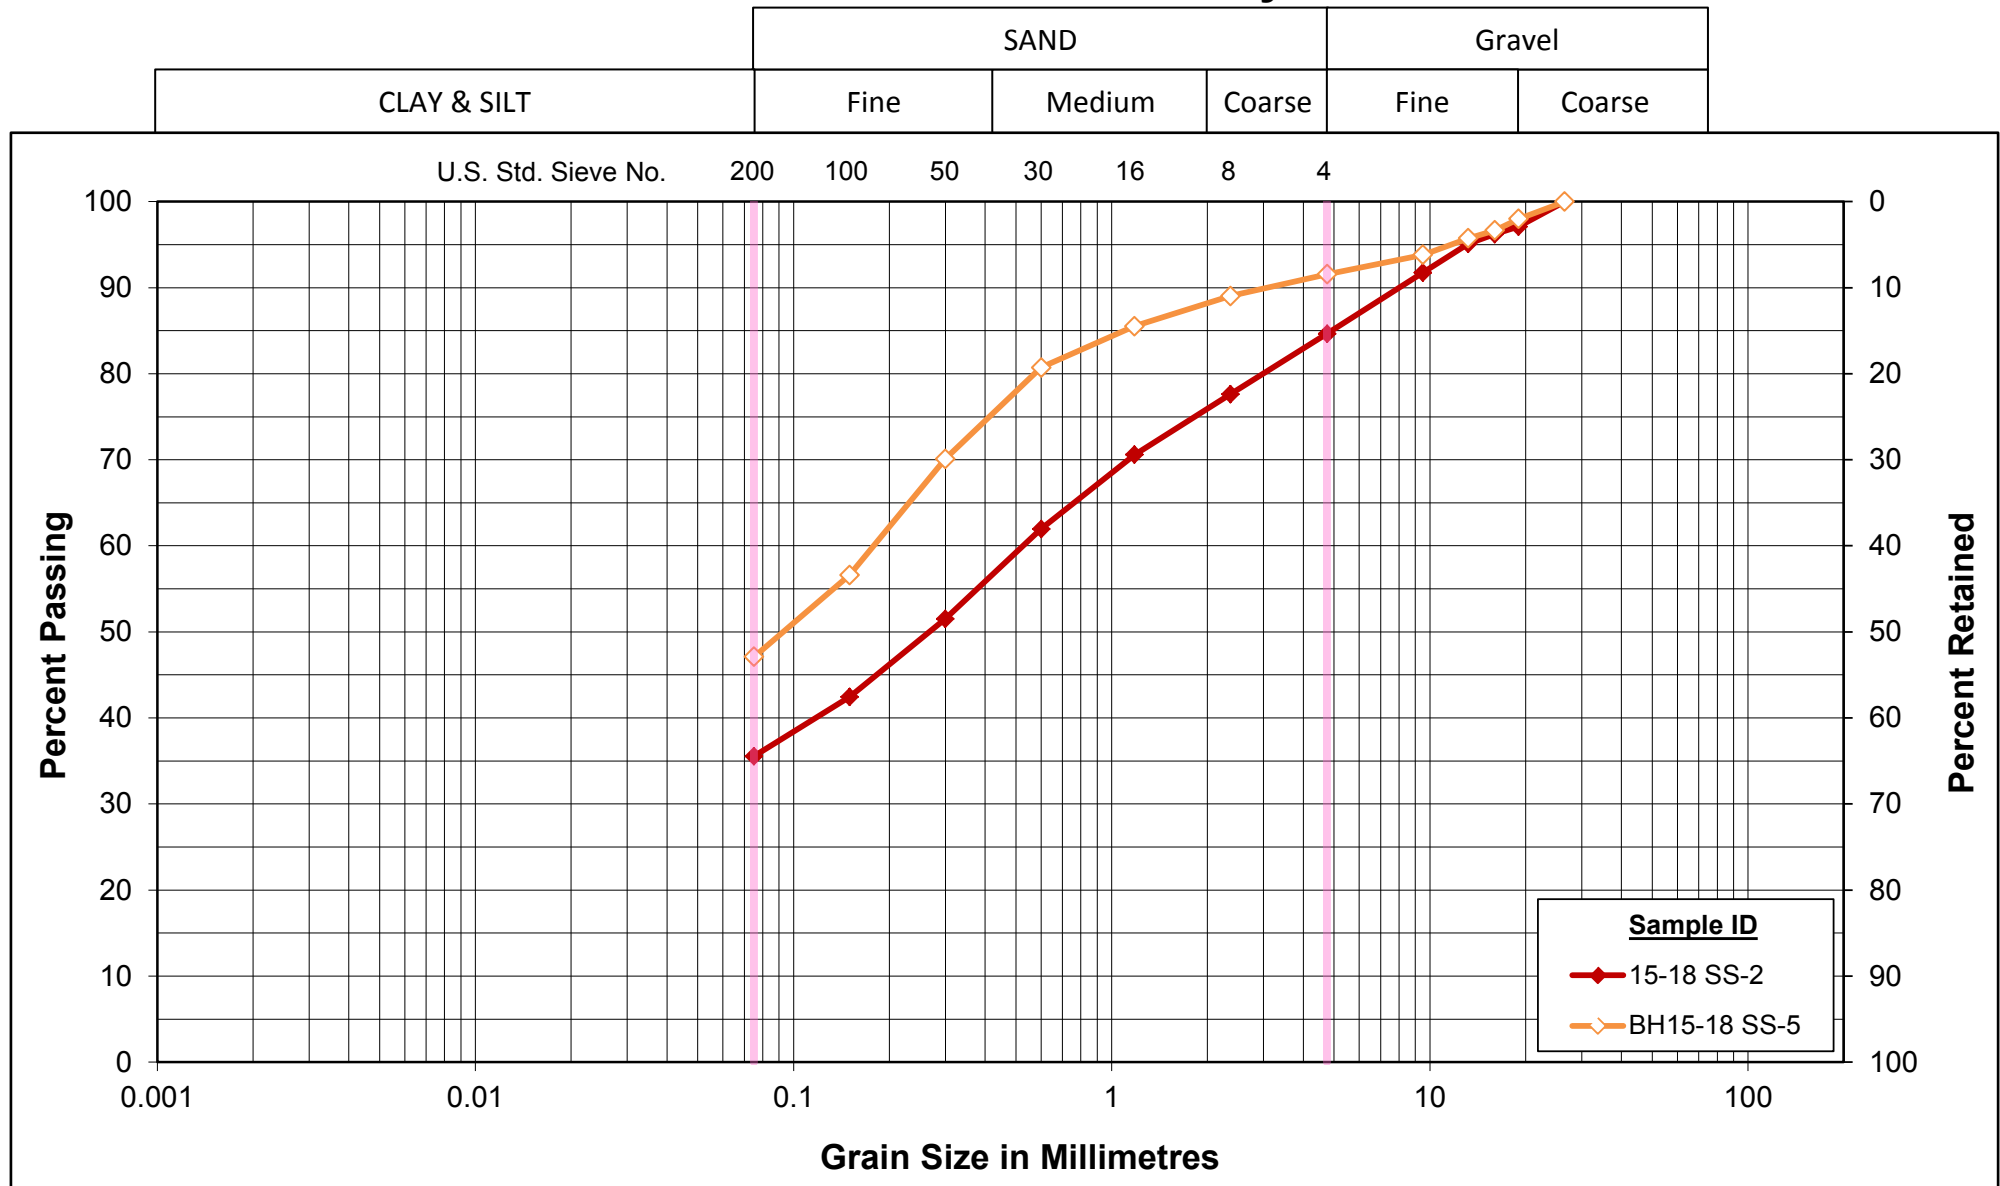
GRAIN SIZE DISTRIBUTION
 FILL: silty SAND (SM) with gravel

Gravel:	69 and 8%
Sand:	21 and 49%
Silt and Clay:	10 and 47%
Moisture Content:	3 to 19%

The grain size distribution curve for the fill material is provided in Figure No. 1 and Figure No. 2 of Appendix C.

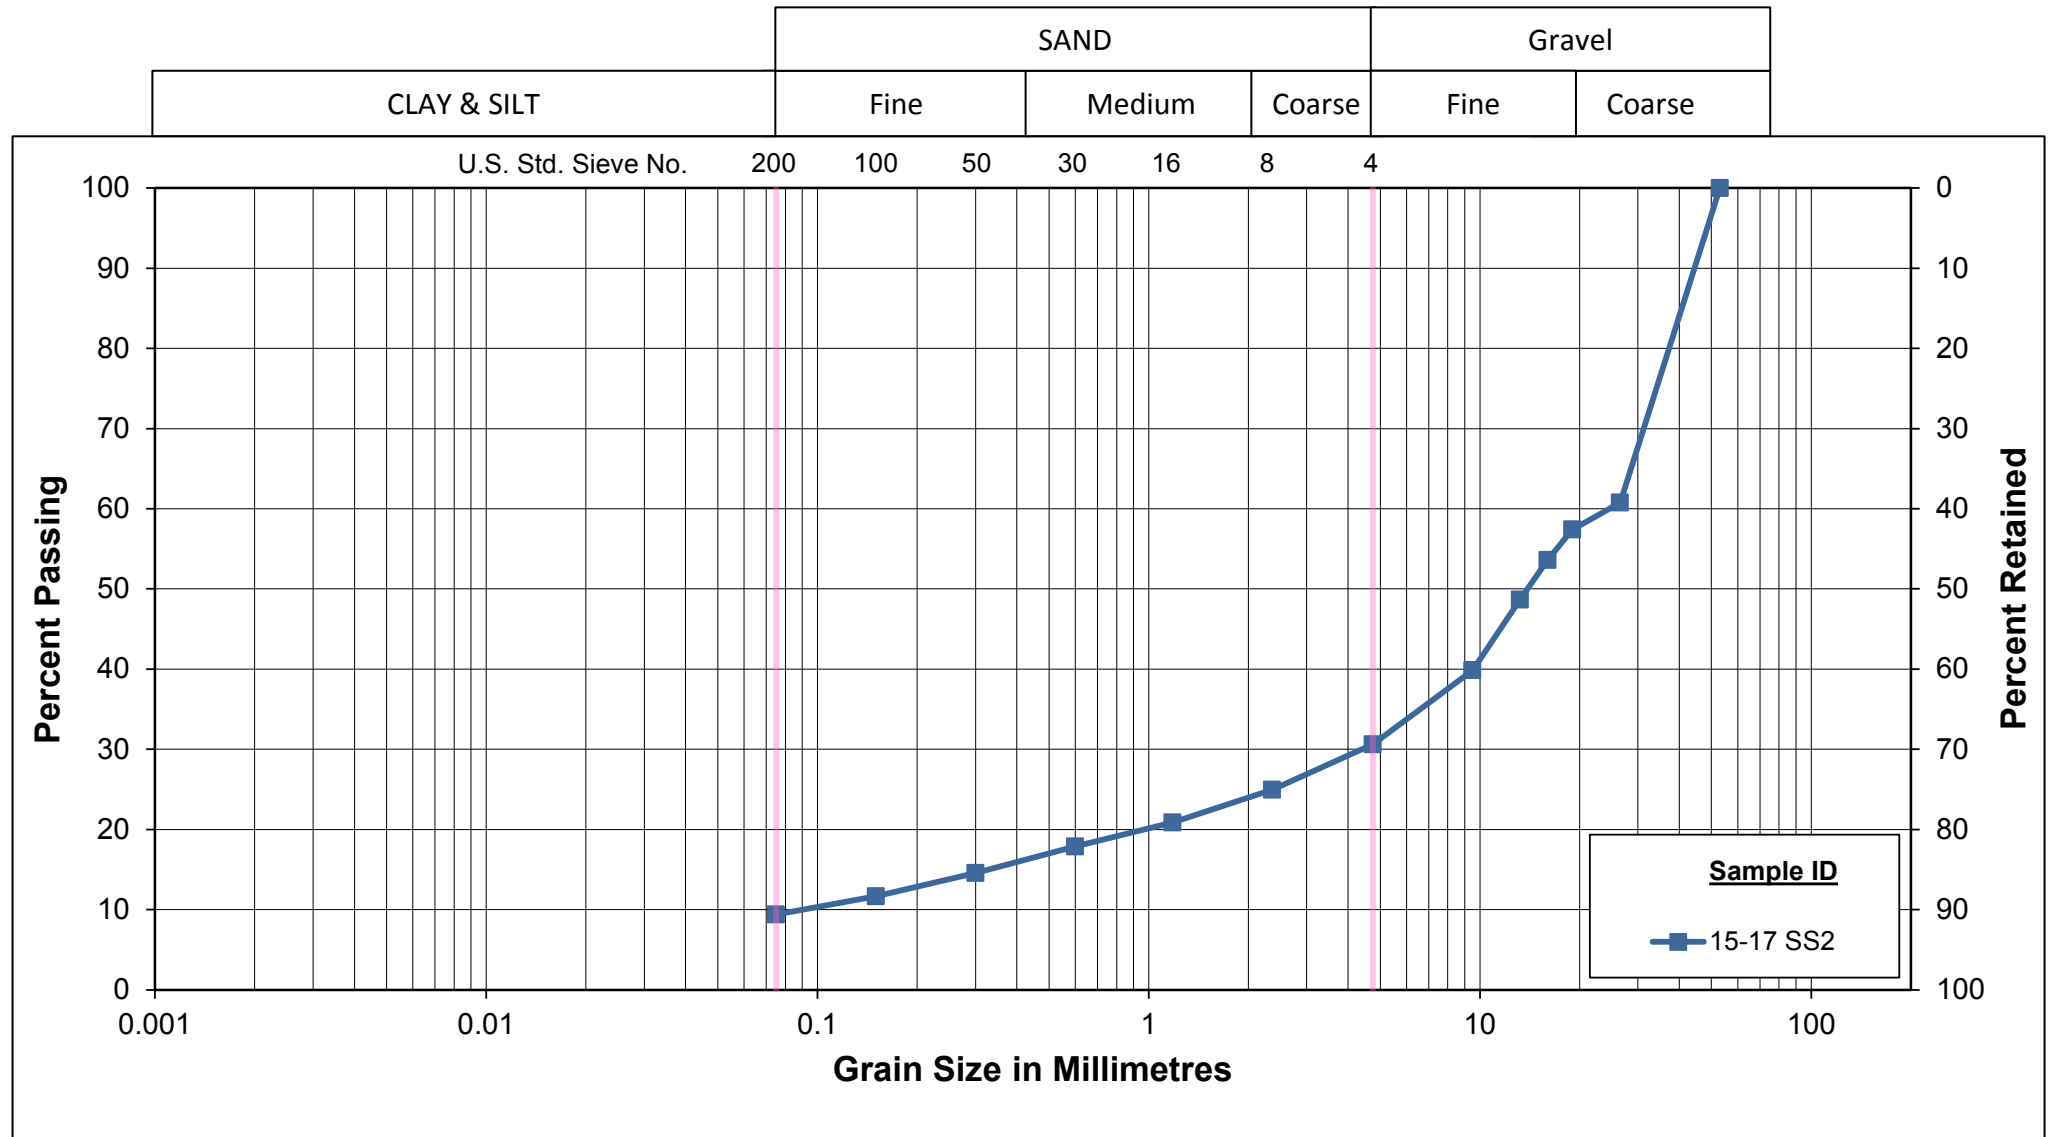
Figure No. 2

GRAIN SIZE DISTRIBUTION
FILL: poorly graded GRAVEL (GP-GM)
with silt and sand

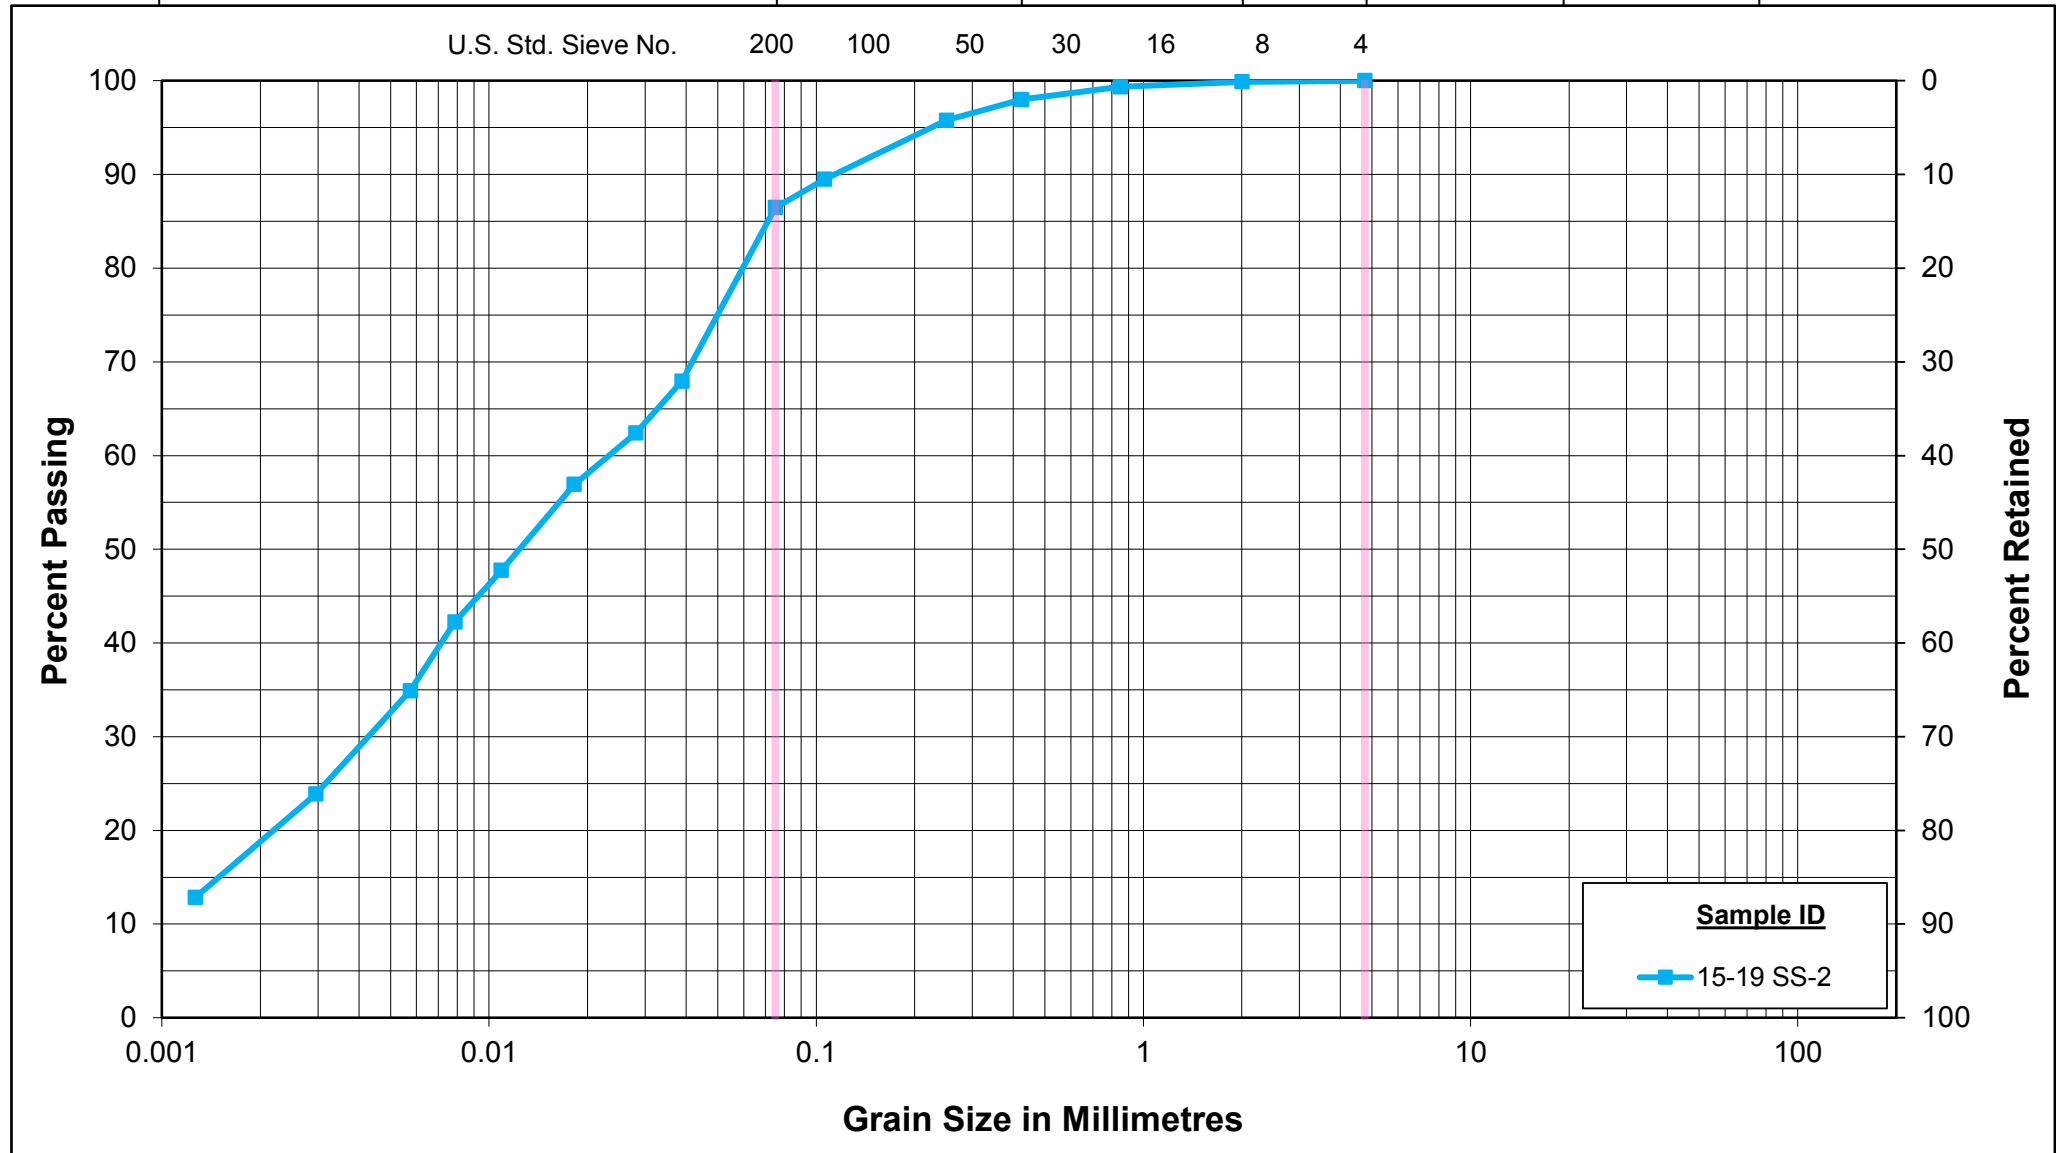
GRAIN SIZE DISTRIBUTION
Sandy SILT (MI) with clay

Gravel:	0%
Sand:	14%
Silt:	69%
Clay:	17%
Moisture Content:	52%

The grain size distribution curve for the silt deposit is provided in Figure No. 3 of Appendix C.

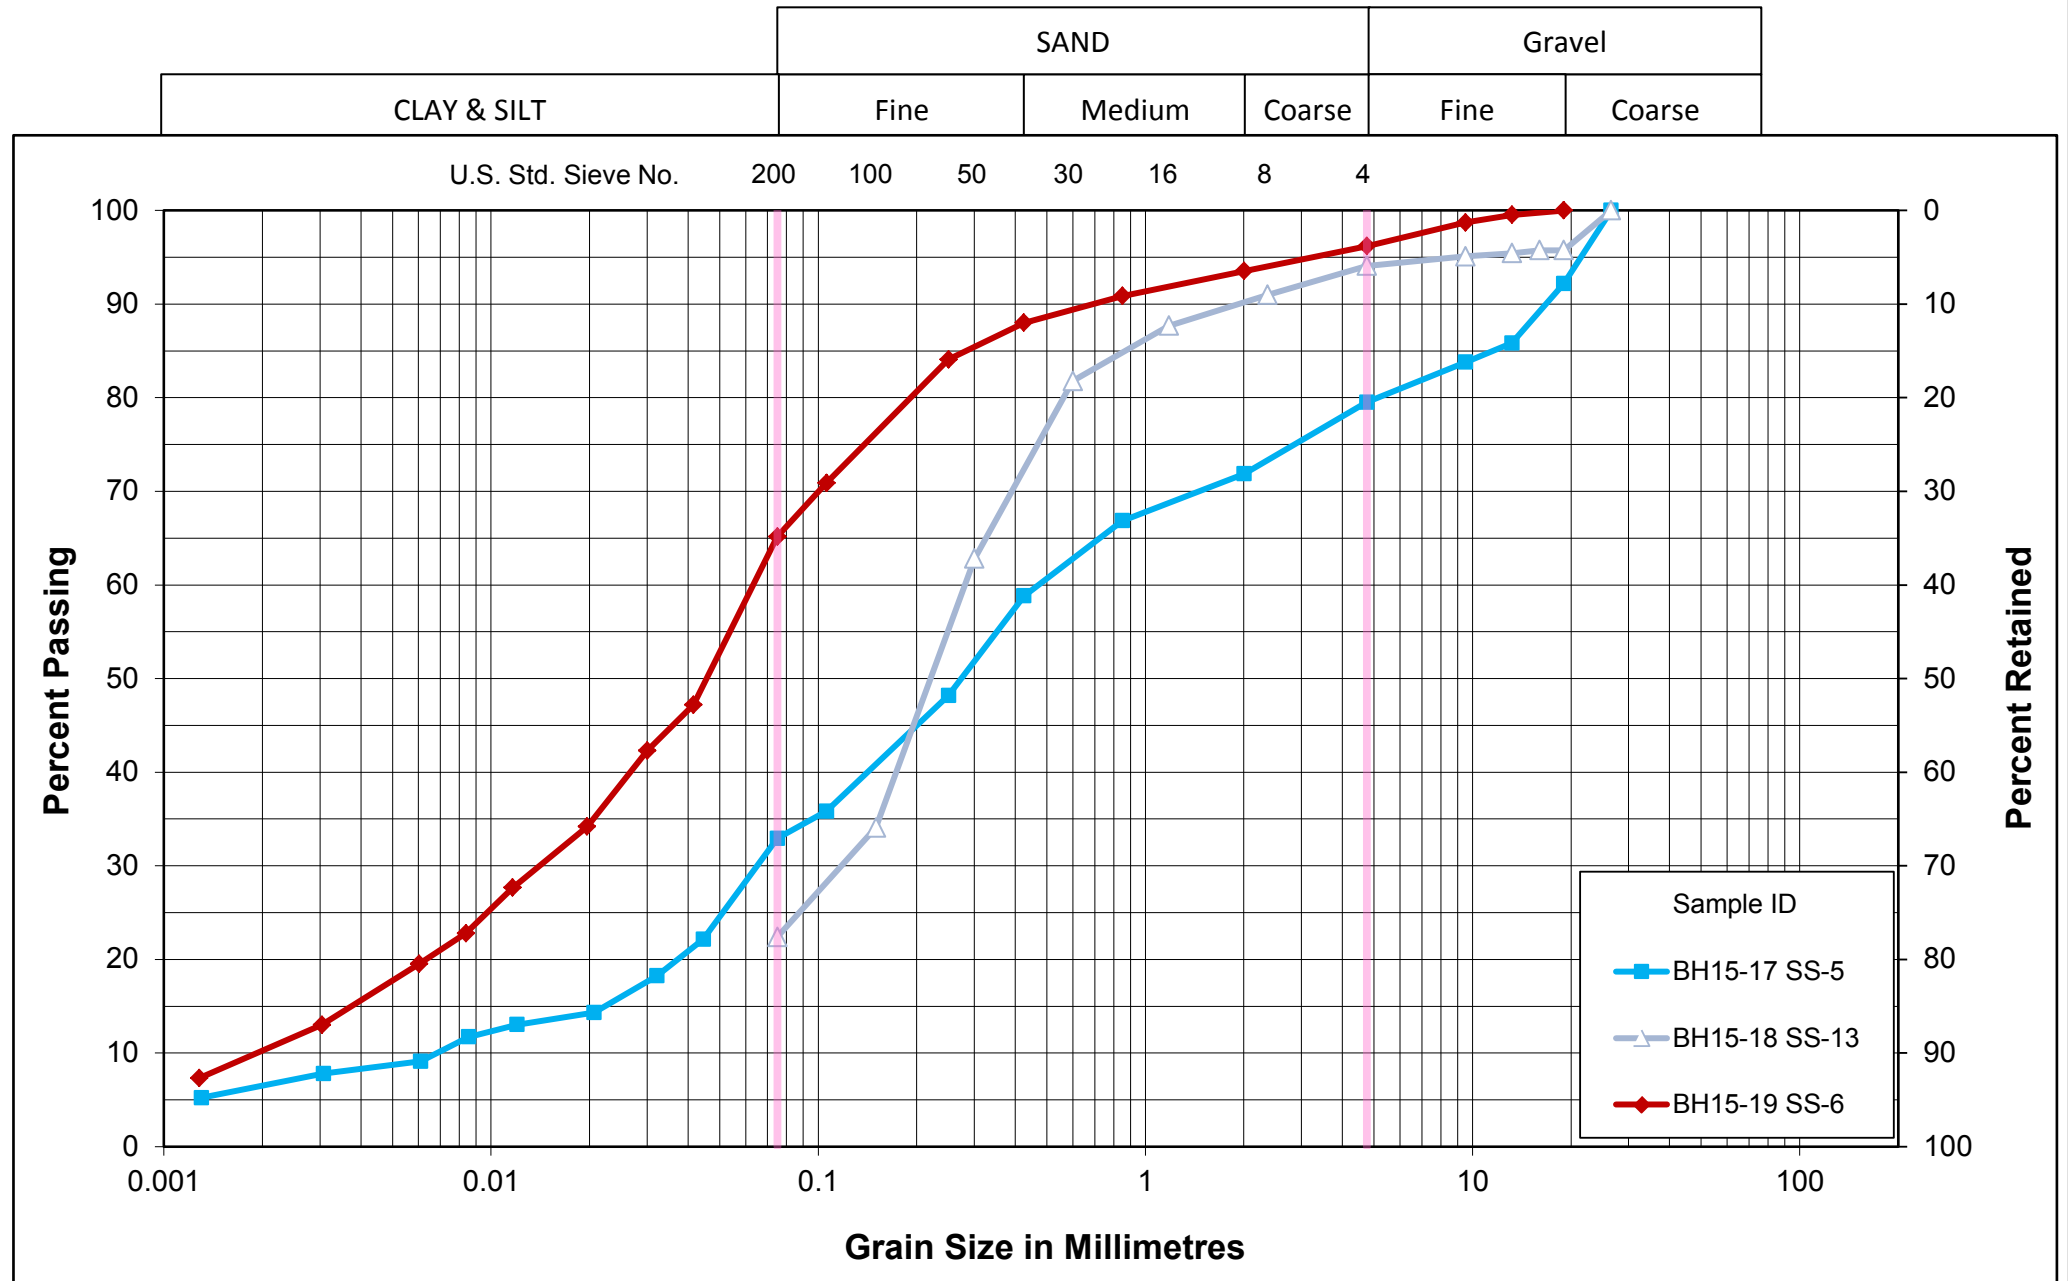
GRAIN SIZE DISTRIBUTION
Silty SAND (SM) with/without gravel to sandy
SILT (ML)

Gravel:	4 to 20%
Sand:	31 to 72%
Silt and Clay:	22 to 65%
Moisture Content:	15 to 25%

The grain size distribution curves for the sand to silt material are provided in Figure No. 4 of Appendix C.

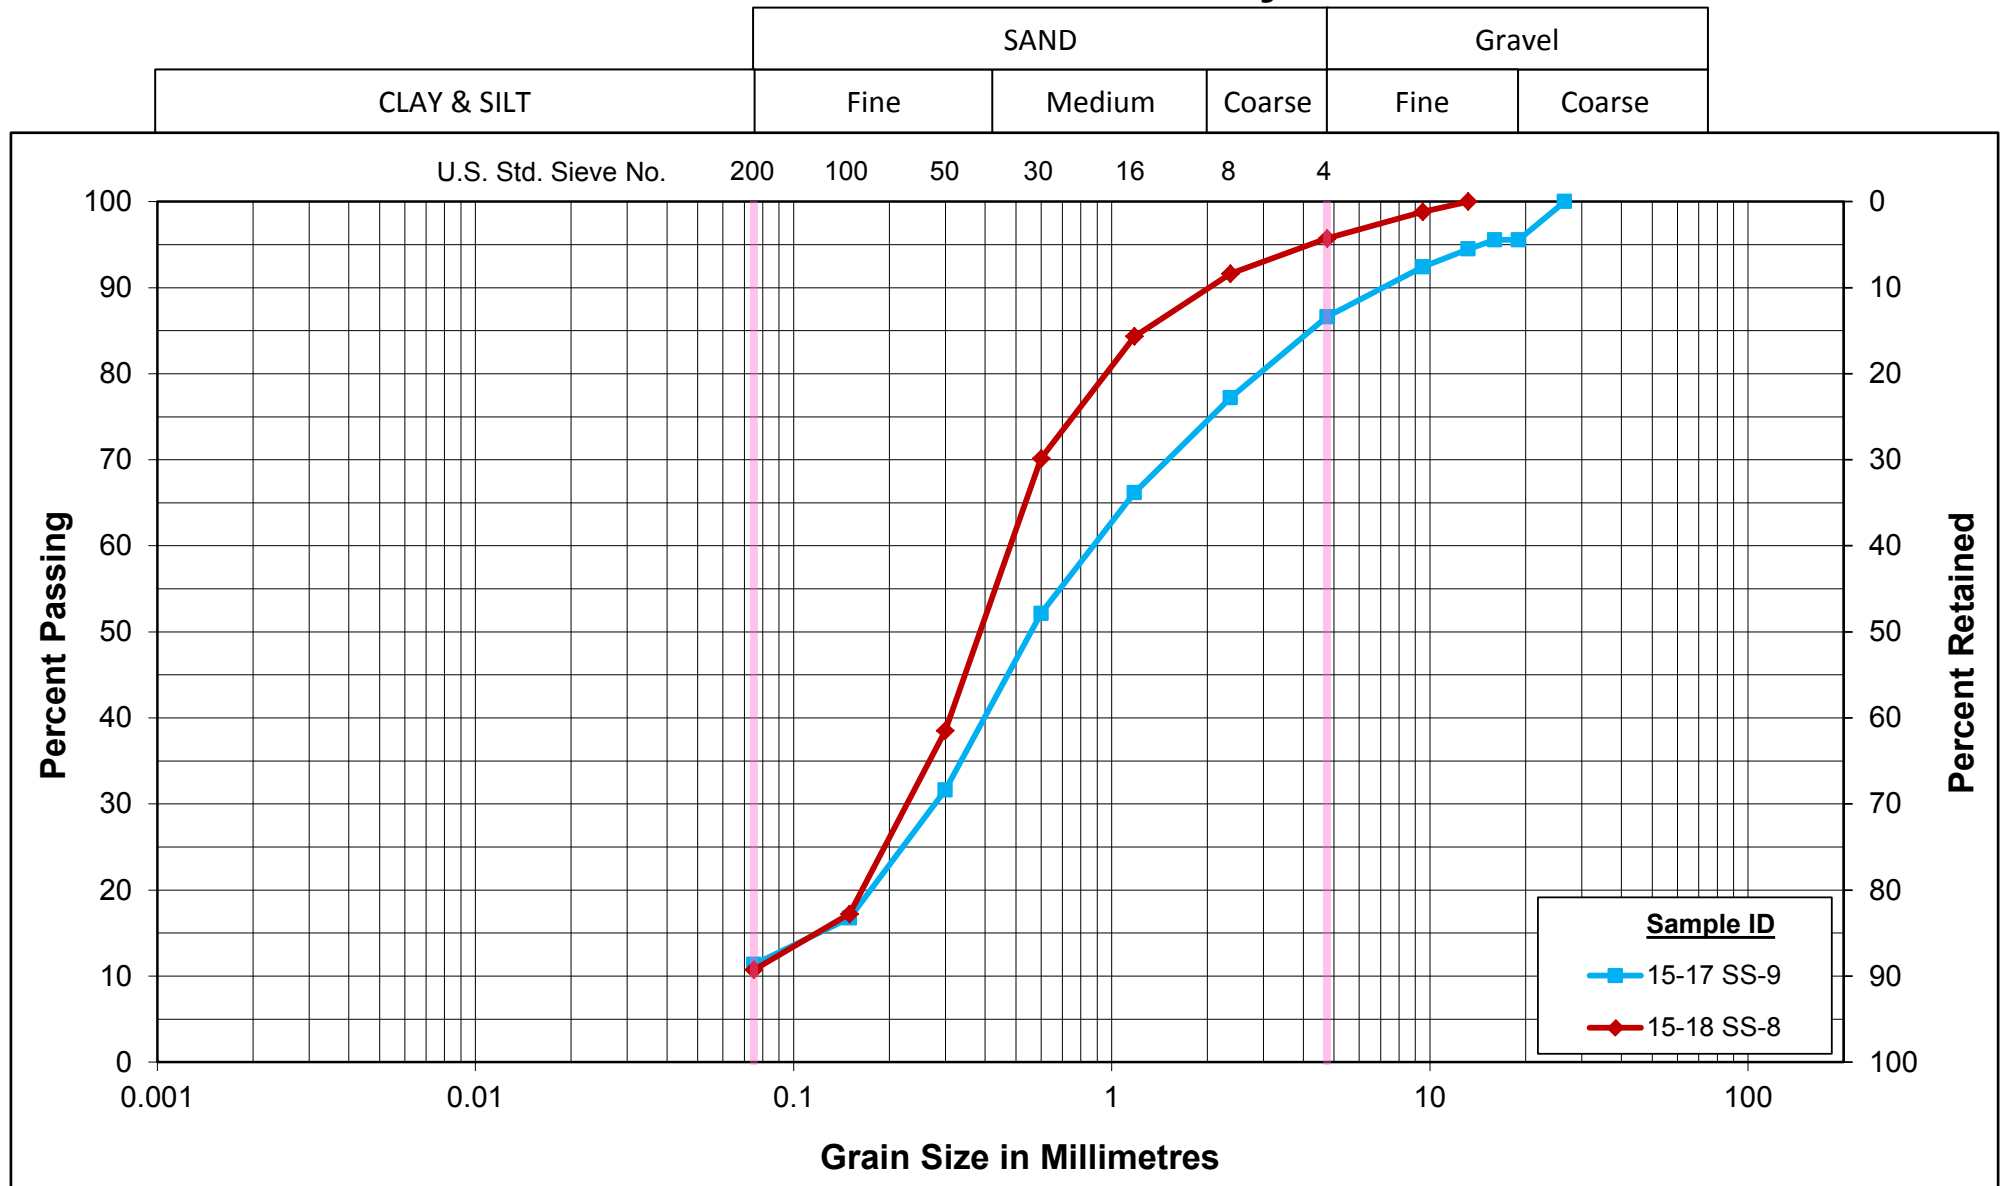
GRAIN SIZE DISTRIBUTION
Well graded SAND (SW-SM) with silt

Gravel:	4 to 13%
Sand:	75 to 85%
Silt and Clay:	11 to 12%
Moisture Content:	11 to 17%

The grain size distribution curves for the well graded sand with silt material are provided in Figure No. 5 of Appendix C.

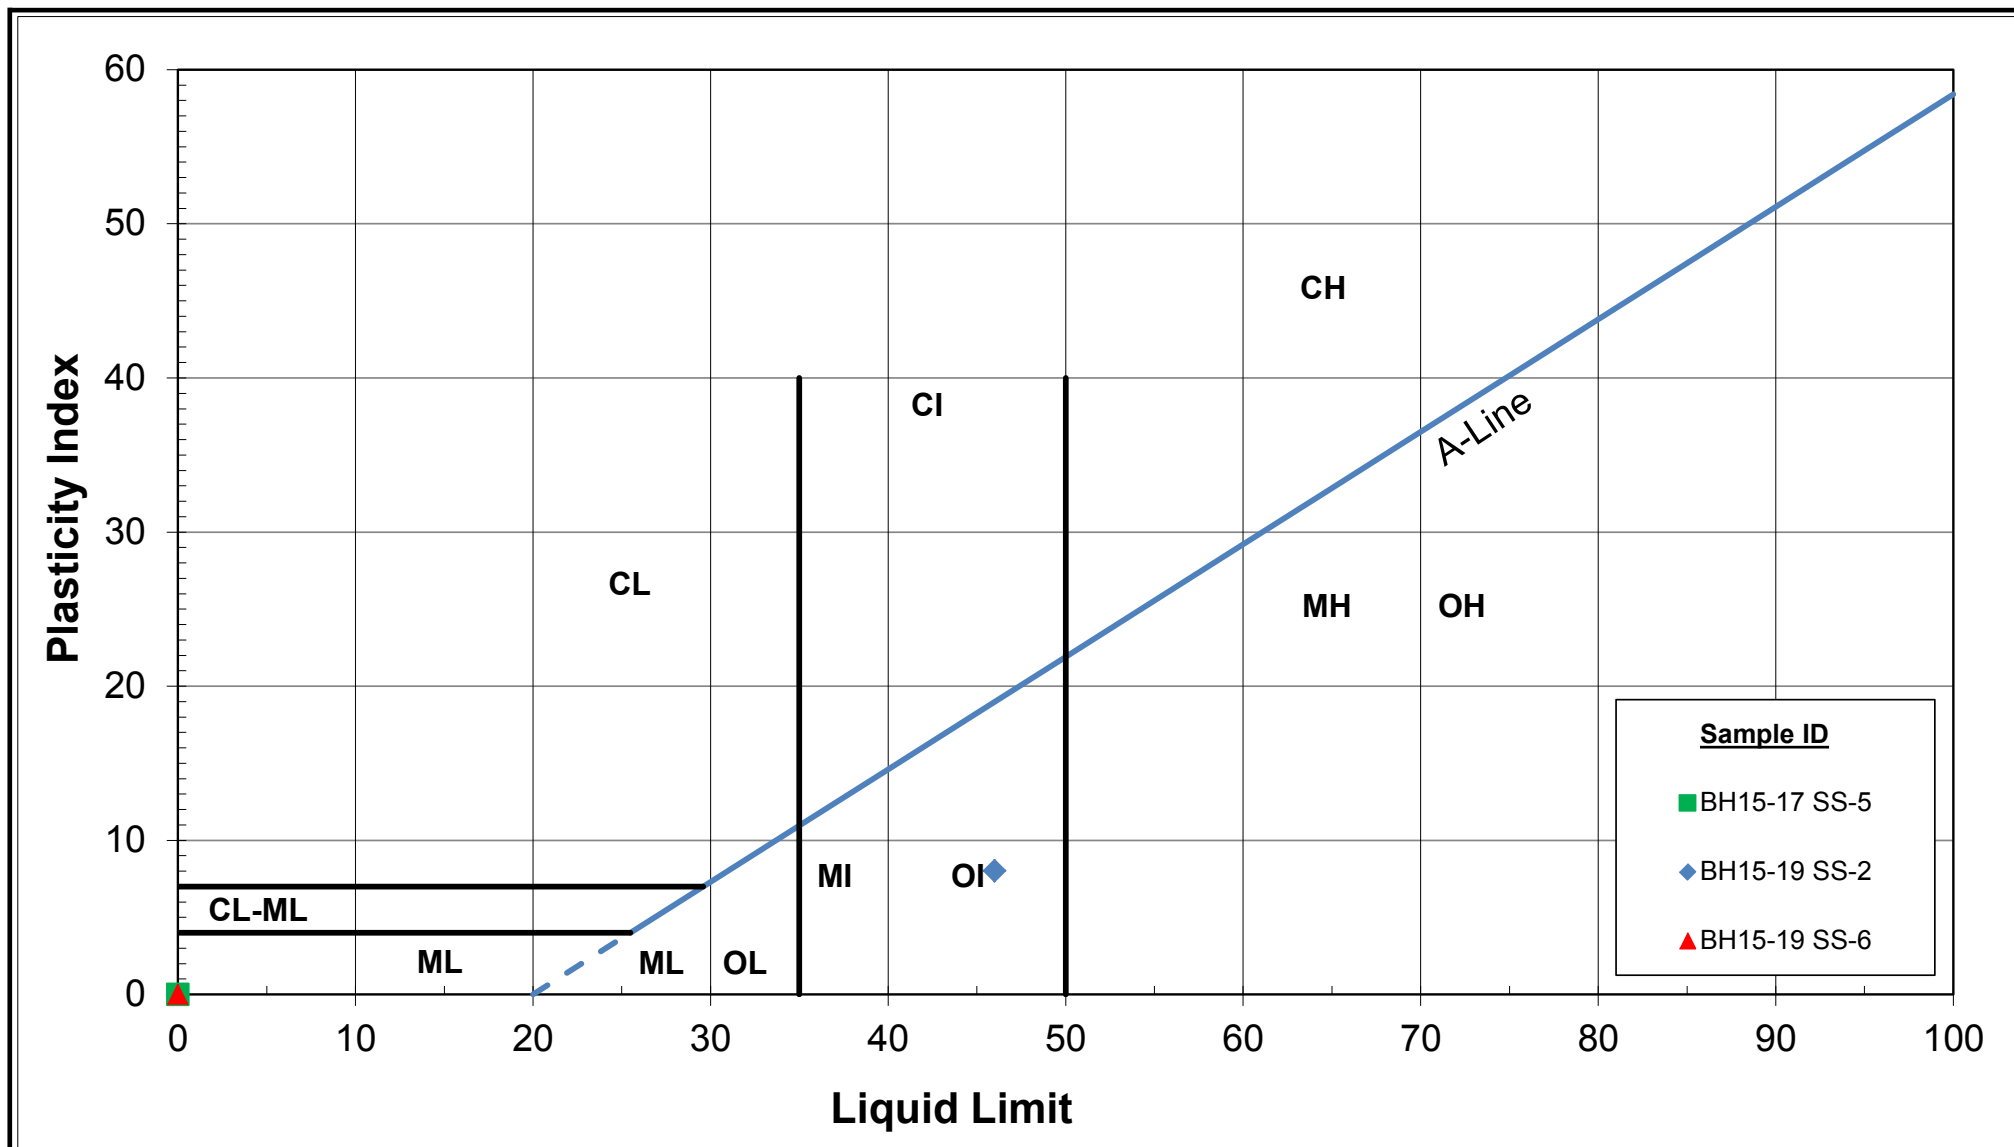
One Atterberg Limit test was also performed on the silt sample. The Atterberg Limit test yielded plasticity index of 8 and liquid limit of 46. The results suggest a medium plasticity. The results are shown in Figure No. 6 of Appendix C.

Two Atterberg Limit tests were also performed on the sand to silt samples. The Atterberg Limit tests yielded that both samples were none plastic. The results are shown in Figure No. 6 of Appendix C.
