FOUNDATION INVESTIGATION AND DESIGN REPORT

**REHABILITATION OF NORTH EMBANKMENT AND APPROACH
HIGHWAY 140 / CNR OVERPASS
PORT COLBORNE, ONTARIO**

MINISTRY OF TRANSPORTATION, ONTARIO

GEOCREs No. 30L14-50

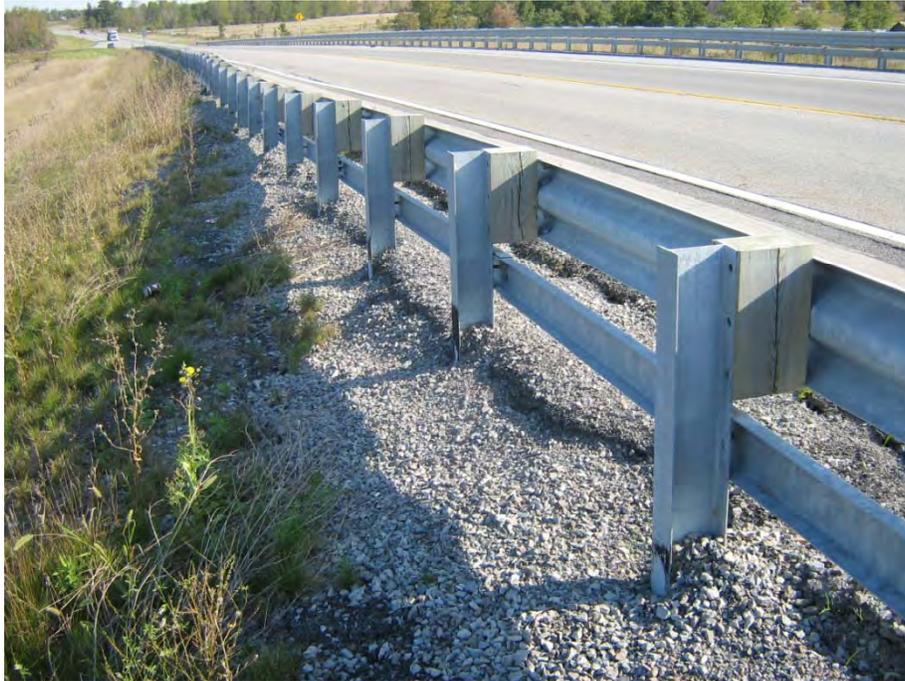
Photo #1: Sloughing of granular at crest of slope, west side of north embankment facing north.

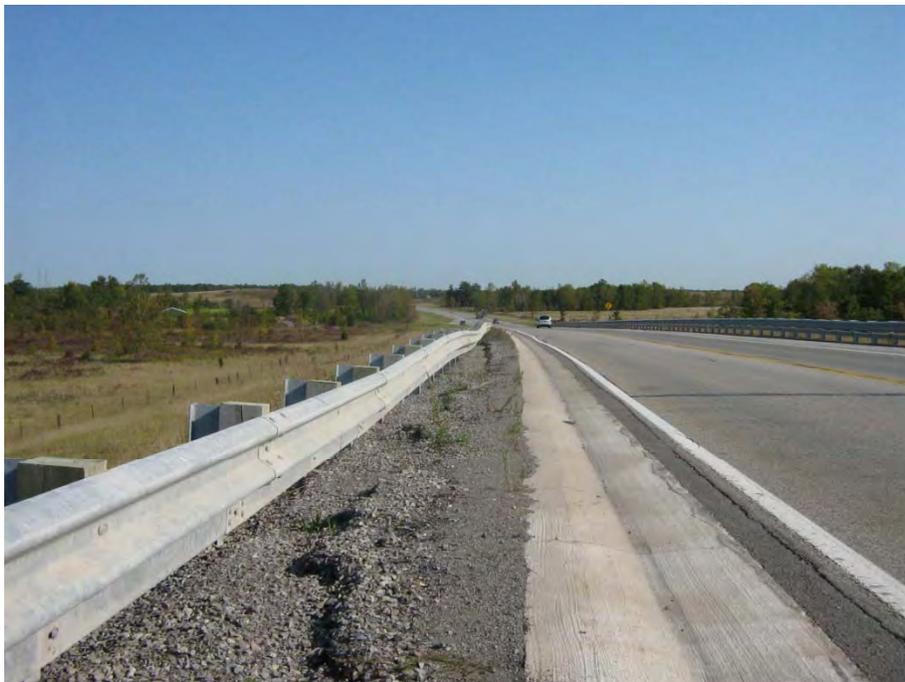
Photo #2: Sloughing of granular inside guide rail, west side of north embankment facing north.

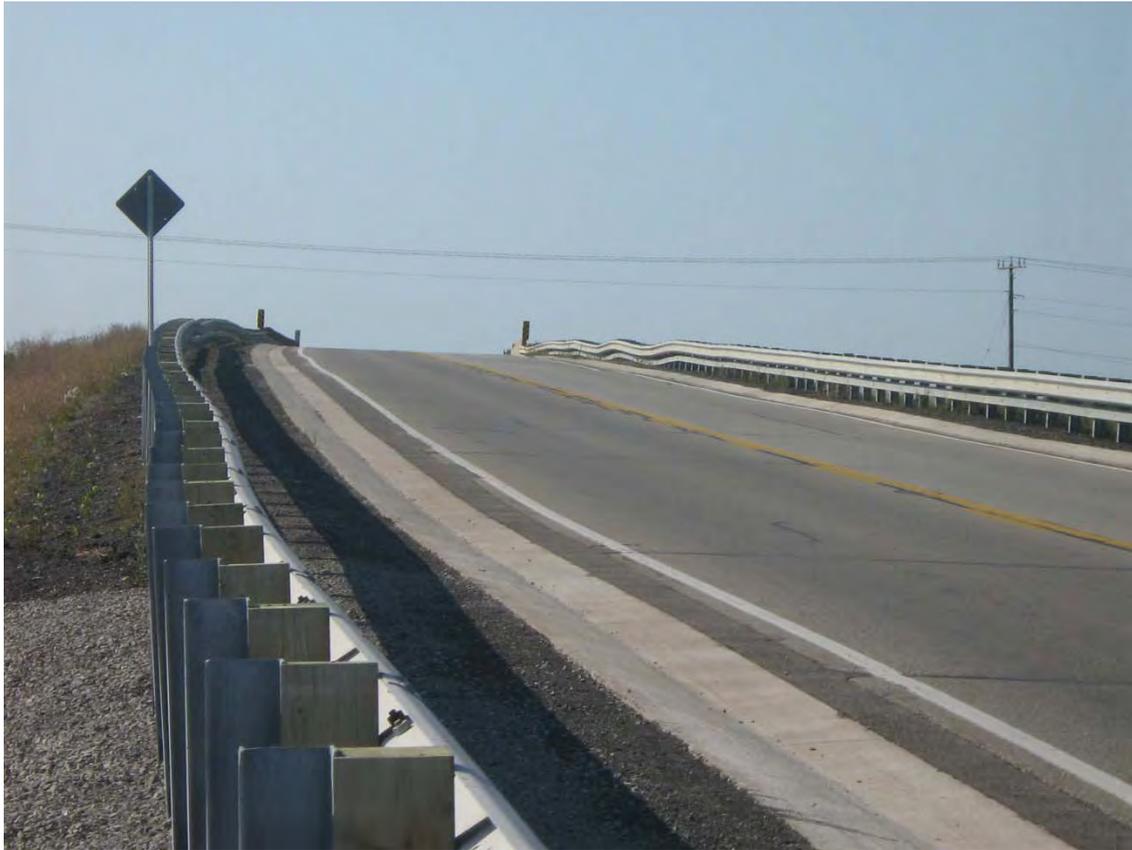
Photo #4: Tilting of guide rail along north embankment, facing south.
