DRAFT
GROUT-IN-PLACE CULVERT LINING INVESTIGATION REPORT

4018-E-0001 ASSIGNMENT #5

Ministry of Transportation Ontario
c/o WSP Canada Group Limited

October 2020
Thurber File No.: 28182

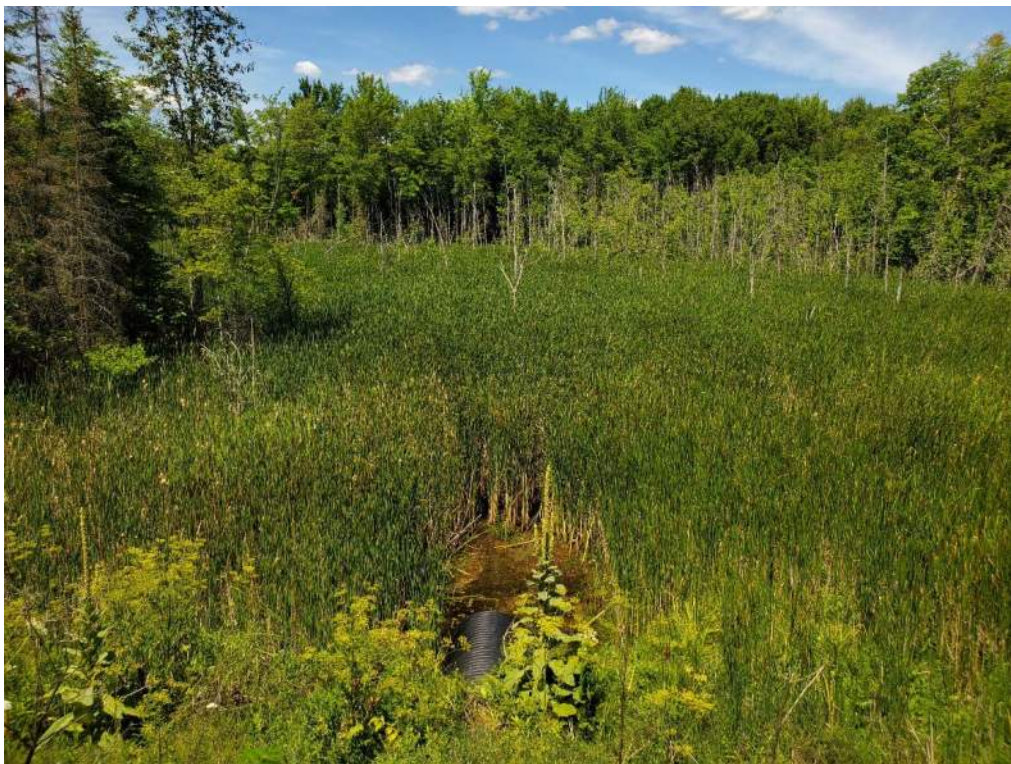
Photo 2: Marshy area with bulrushes located north of culvert – looking north

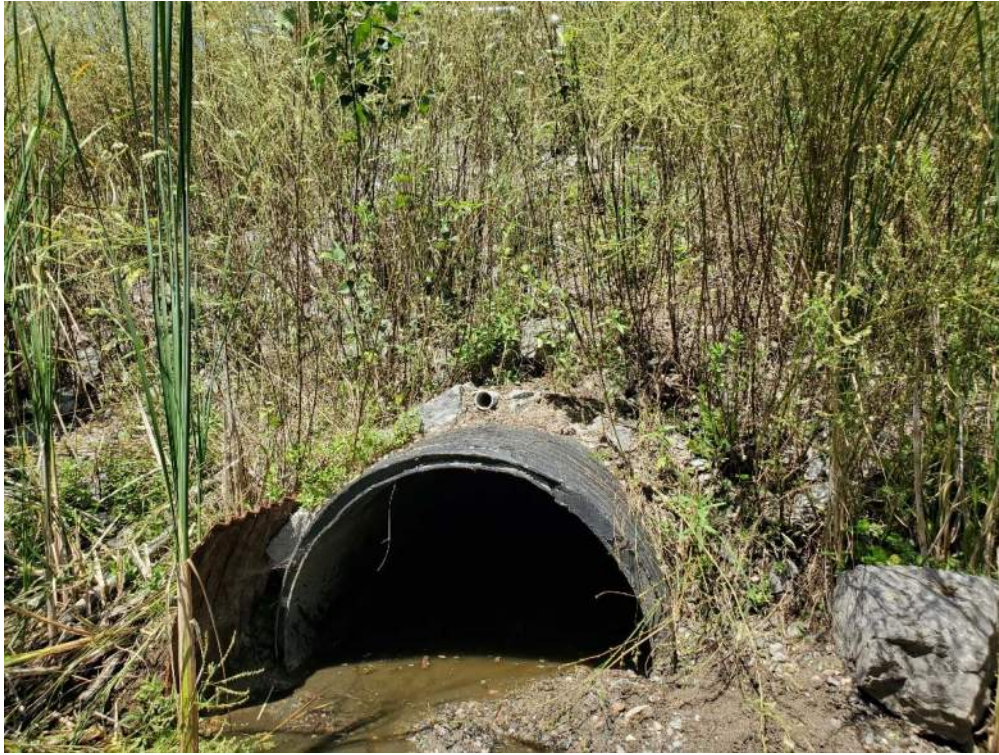
Photo 3: Excessive sediment at south end of culvert – looking north

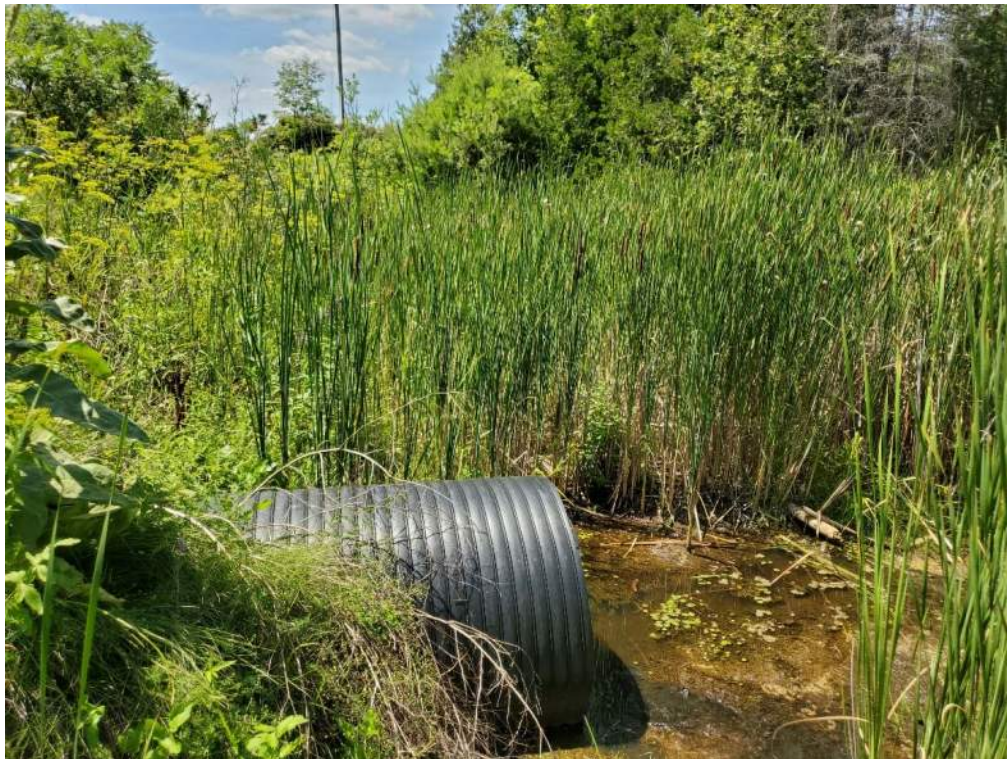
Photo 4: Marshy area with bulrushes and significant basal sediment at south end of culvert. – looking east

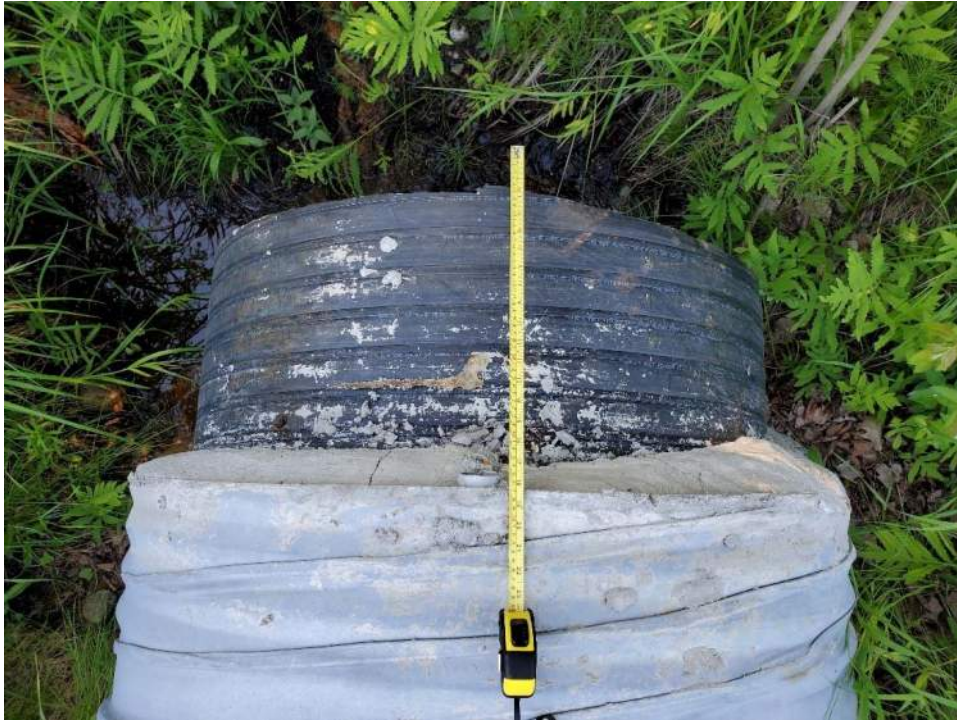
Water Depth (m)	0.02
Grout Condition	Fair. Occasional 1-2mm cracks. Grout protruding 70mm from host pipe on north side and 30mm from host pipe on the south side.
General Comments	Liner is an HDPE pipe ~55mm thick. Grout thickness ranges from 70mm to 165mm.

Photo 3 – Inlet looking down at grout protruding ~30 to 70mm

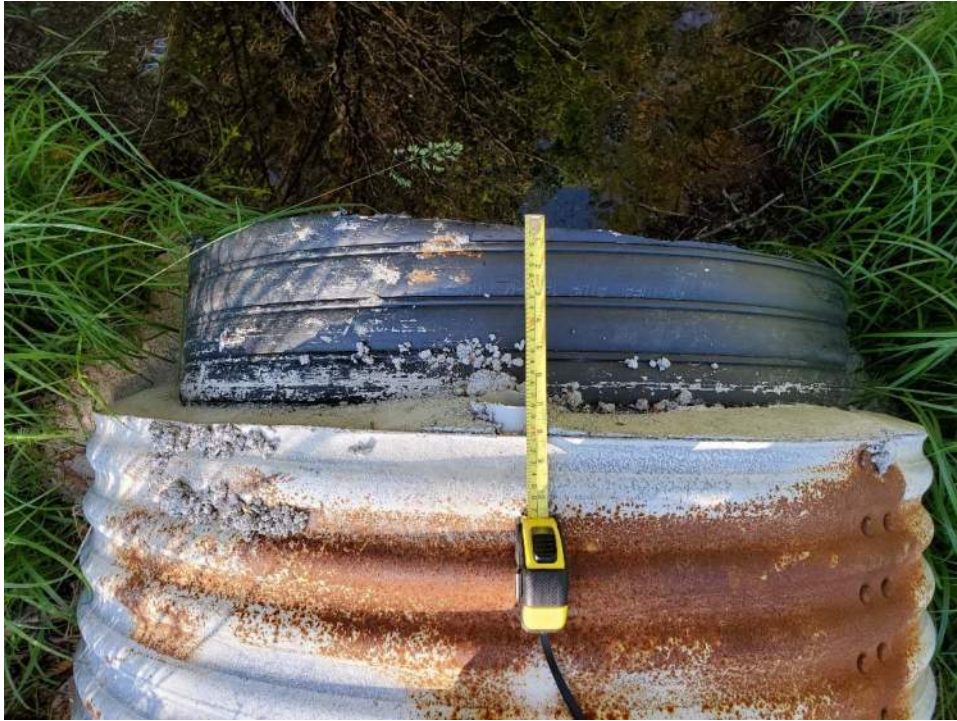
Water Depth (m)	0.04
Grout Condition	Good. One 2mm crack. Grout protruding 30mm from host pipe on north side.
General Comments	Liner is an HDPE pipe ~50mm thick. Grout thickness ranges from 80mm to 110mm.

Photo 3 – Inlet looking down at grout protruding ~30 mm

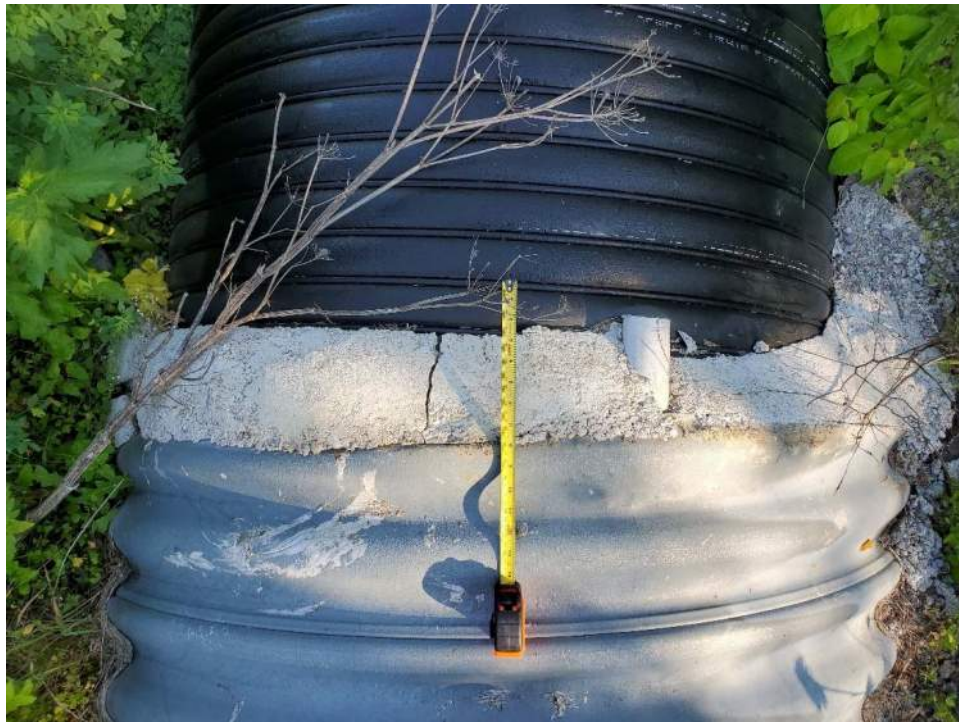
Water Depth (m)	0.09
Grout Condition	Fair. Occasional to frequent 1-4mm cracks. Grout protruding approximately 120mm from host pipe around liner. Slight delamination from liner observed.
General Comments	Liner is an HDPE pipe ~40mm thick. Grout thickness ranges from 100mm to 190mm.

Photo 3 – Inlet looking down at grout protruding ~120mm

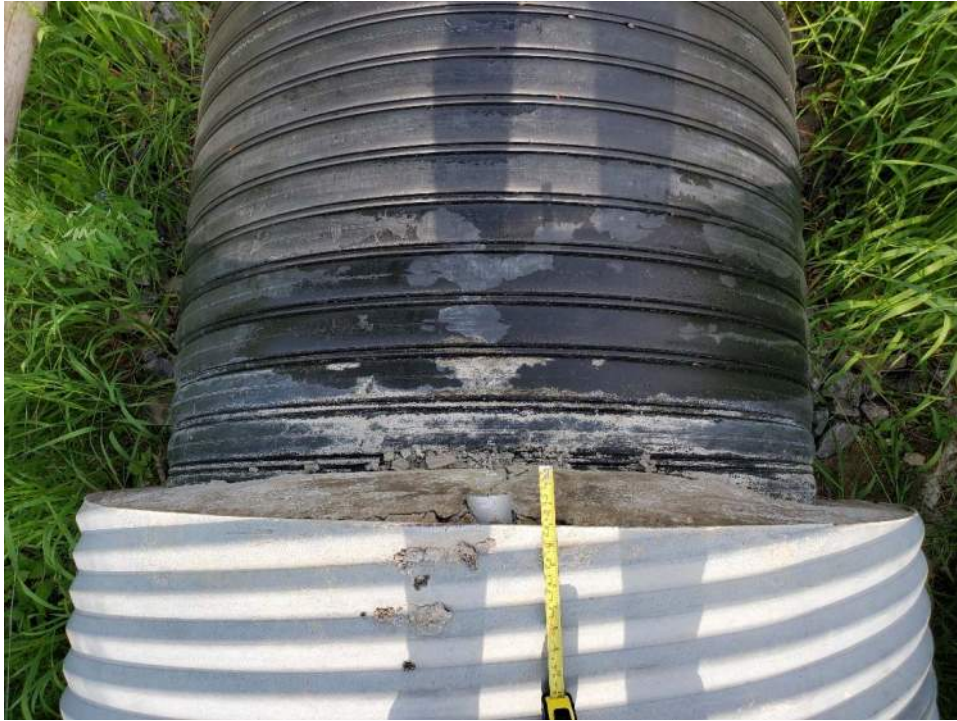
Water Depth (m)	0.02
Grout Condition	Fair. Occasional 1-3mm cracks. Grout at top protruding approximately 70mm from host pipe.
General Comments	Liner is HDPE pipe ~60mm thick. Grout thickness ranges from 160mm to 200mm.

Photo 3 – Outlet looking down at grout protruding ~70mm

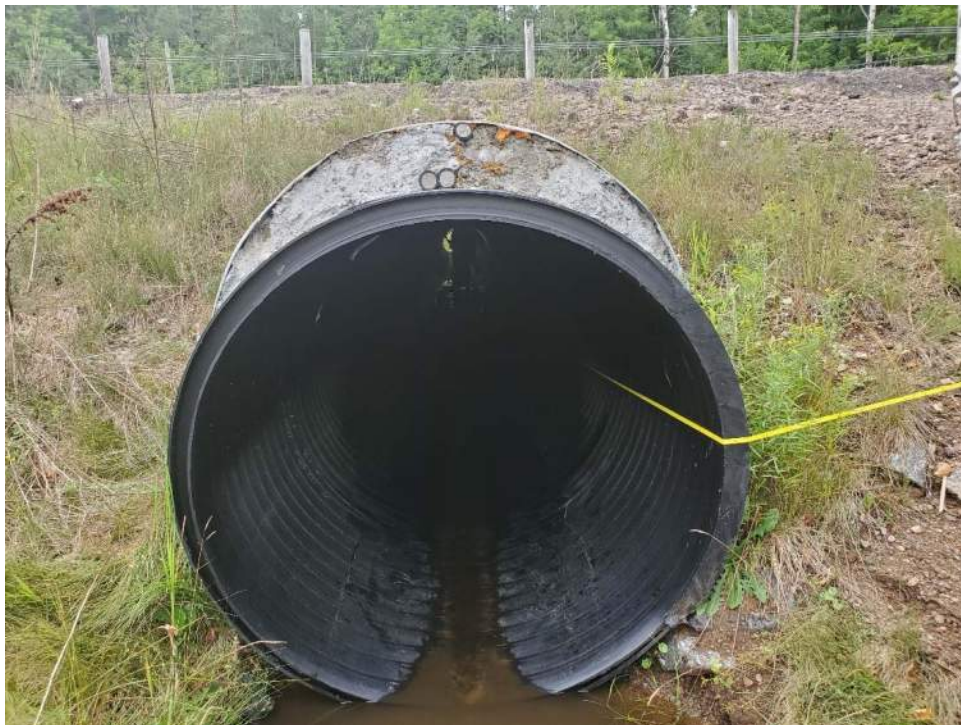
Photo 2: Outlet with minimal flow showing three (3) cut off grout pipes– looking west

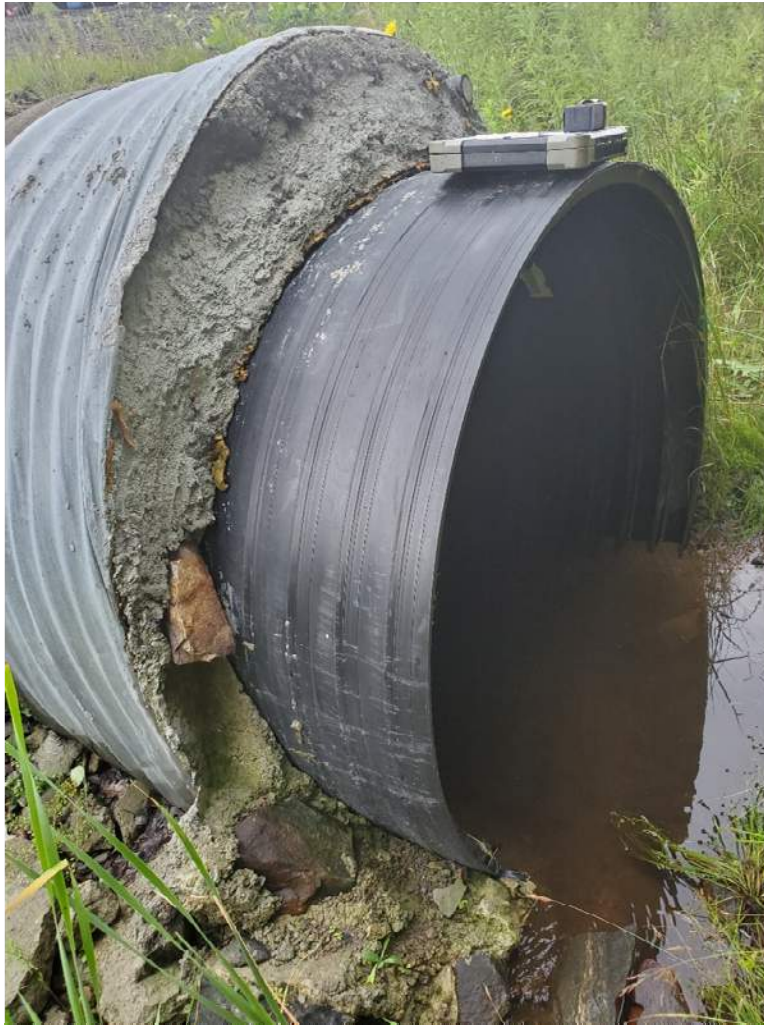
Photo 3: Cobbles paired with spray foam insulation utilized to fill voids at inlet in irregular grout finish

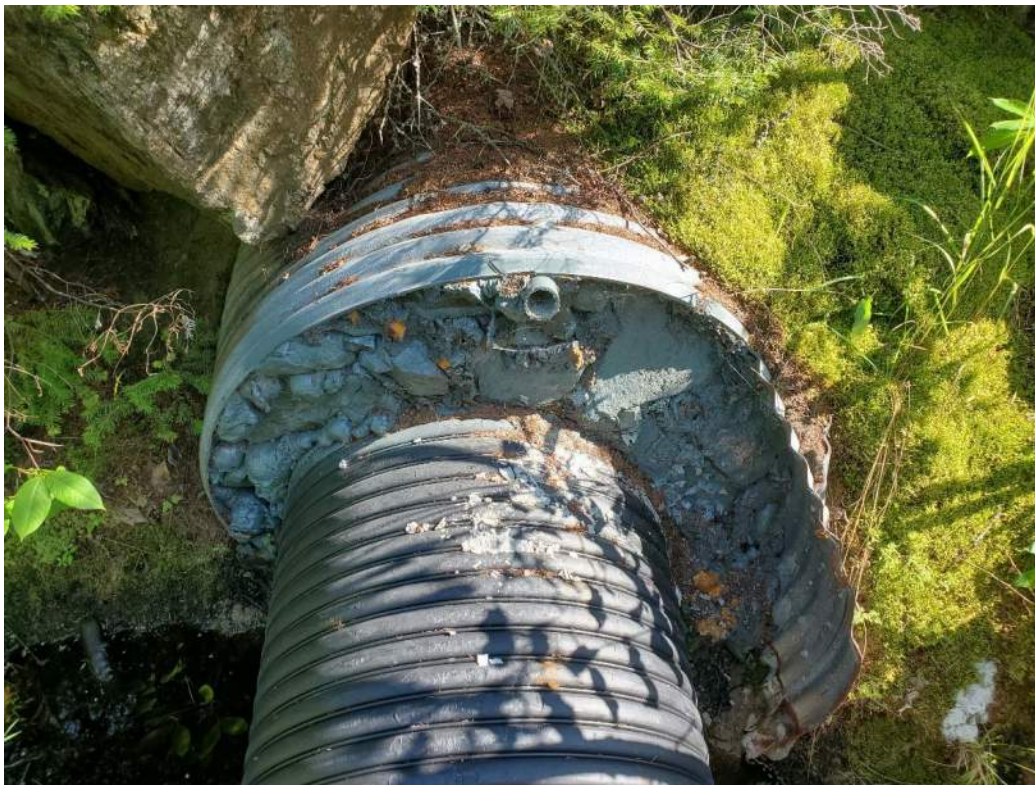
Water Depth (m)	0.18
Grout Condition	poor - spray foam insulation utilized to finalize fill; rocks and cobbles noted within fill mixture; grout pipe cut off and left in place.
General Comments	Grout infill (Spray Foam with cobbles and boulders) at crown approx. 0.30m; HDPE liner extends approx. 2.16m from host pipe.

Photo 2: Voids at north end of culvert filled with cobbles and spray foam insulation – looking south

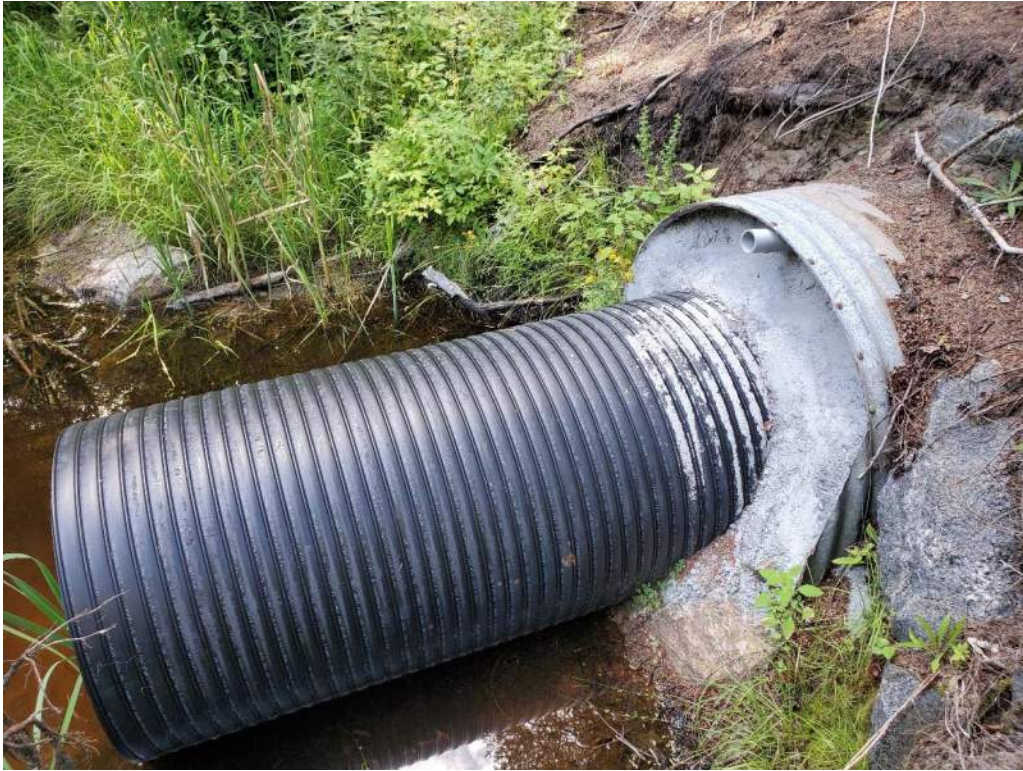
Photo 3: South end of culvert with one cut off grout pipe exposed– looking west

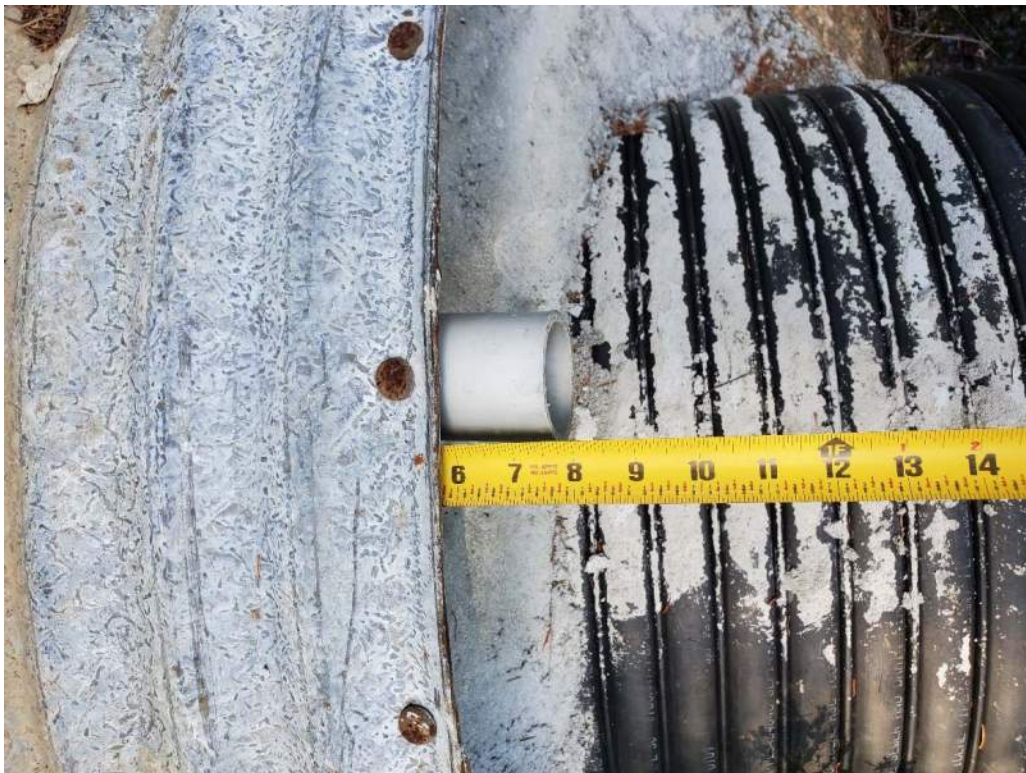
Photo 4: Approximately 150mm host pipe left unfilled with grout at south end of culvert.

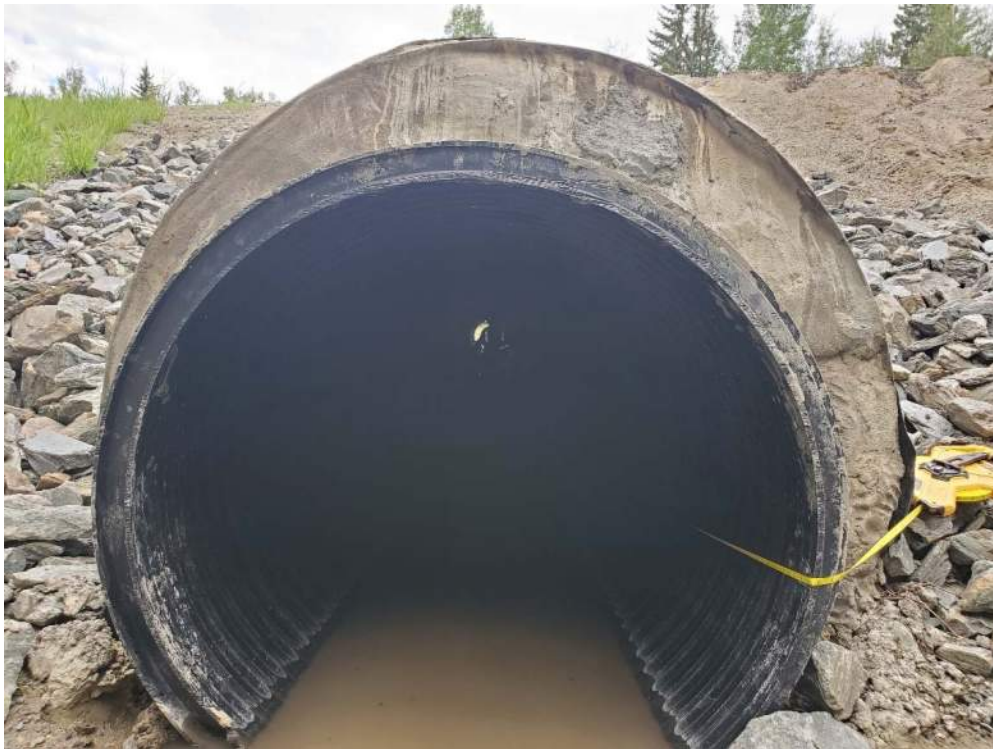
Photo 2: West end of culvert (inlet) not well centred in host pipe, surrounded by rip rap embankment – looking east

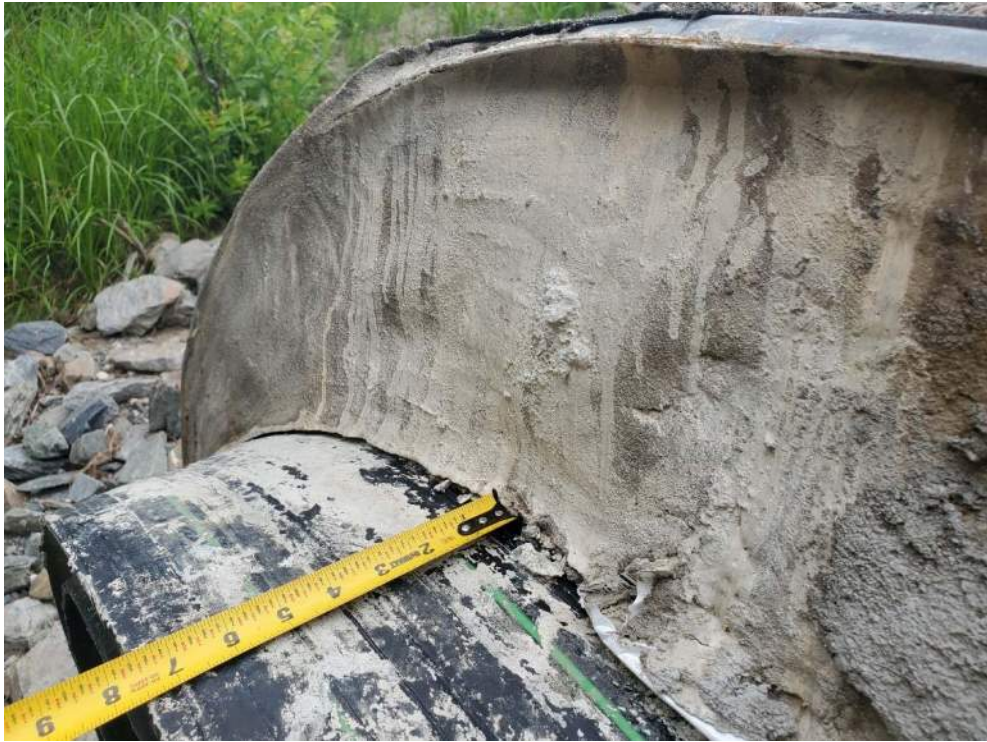
Photo 3: Liner overhang of approx. 0.19m at culvert outlet exhibiting smooth grout finish- looking south

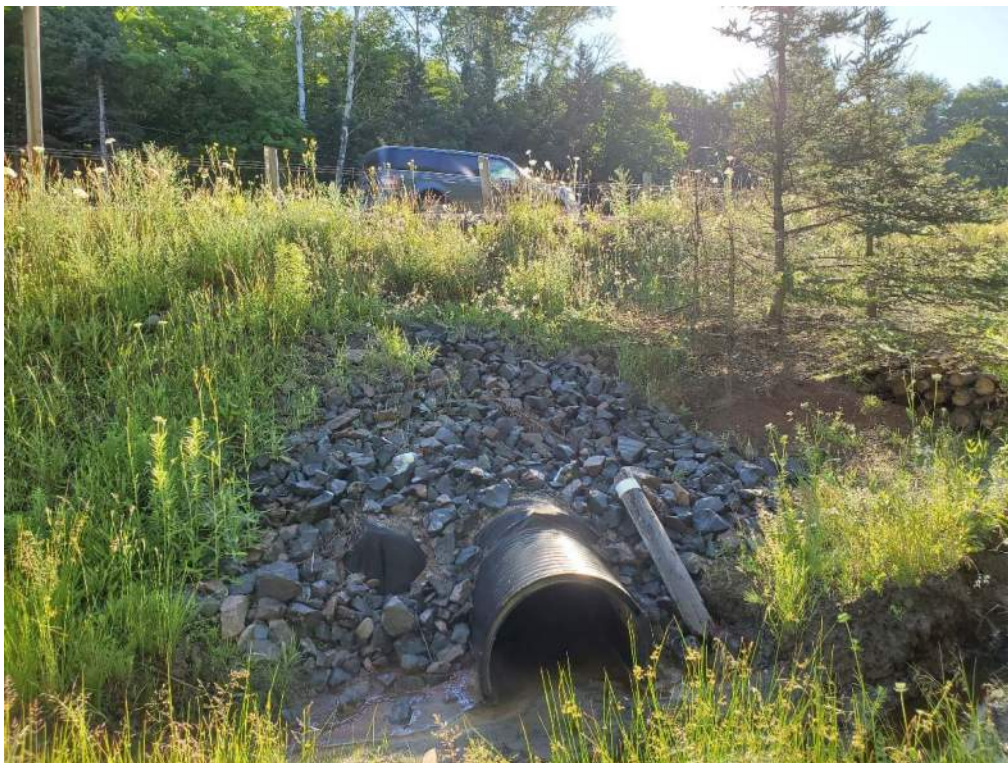
Photo 2: West end of culvert (outlet) liner, surrounded by rip rap embankment. Host pipe is not visible – looking east

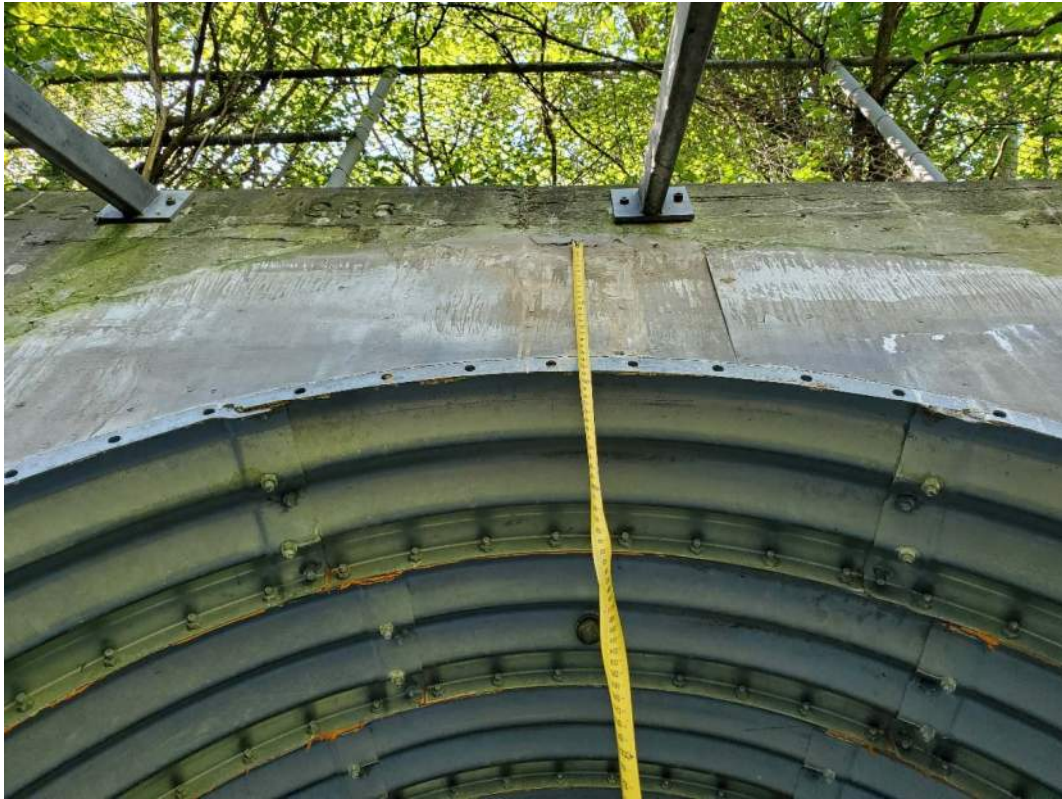
Photo 3: Crown grout infill approx. 0.53m at inlet– looking south

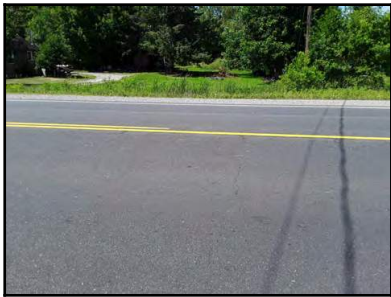
- Progressive edge cracking: **Severity:** Less than 300 mm (12 in) from road shoulder.
- Transverse cracks present: **Frequency:** Frequent (more than 5 cracks); **Severity:** Light (< 5 mm (0.2 in) Width)

Photo 2 - Light transverse cracks.

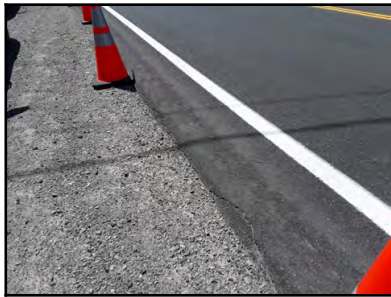
Photo 1 - Light progressive edge cracking on outlet side.

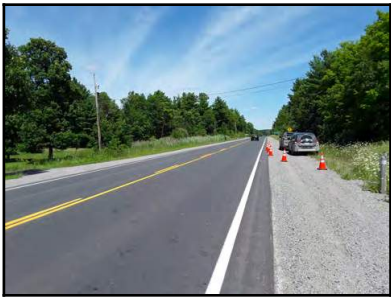
Photo 3 - Highway 7 facing east.

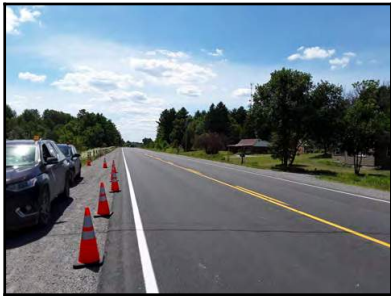
Photo 4 - Highway 7 facing west.

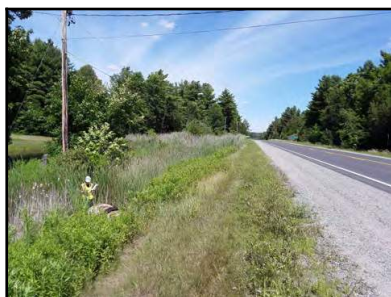
Photo 6 - Inlet embankment.

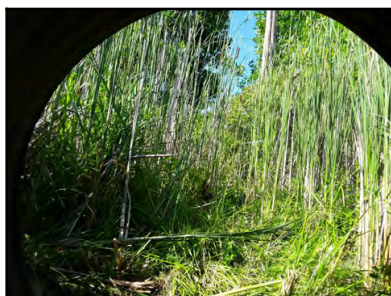
Photo 10 - Upstream channel view.

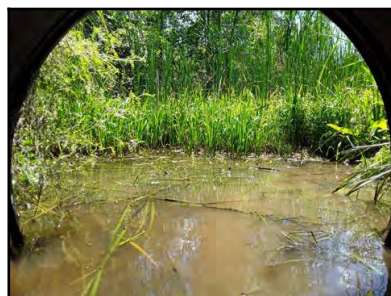
Photo 11 - Downstream channel view.

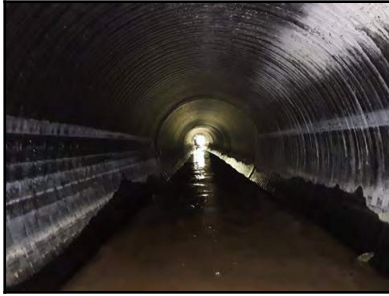
Pipe well aligned.

Photo 12 - Upstream pipe alignment and shape.

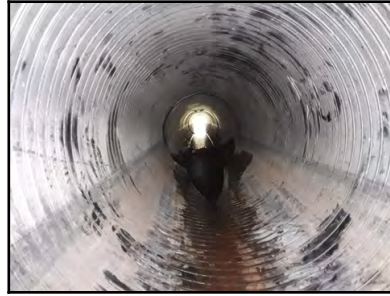
Photo 13 - Downstream pipe alignment and shape.

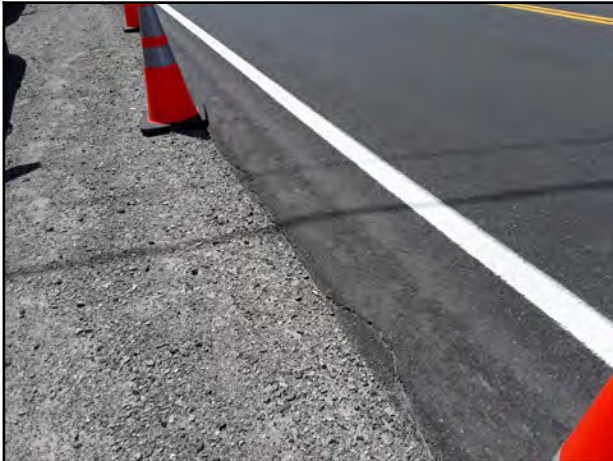
Photo 1 - Light progressive edge cracking on outlet side.

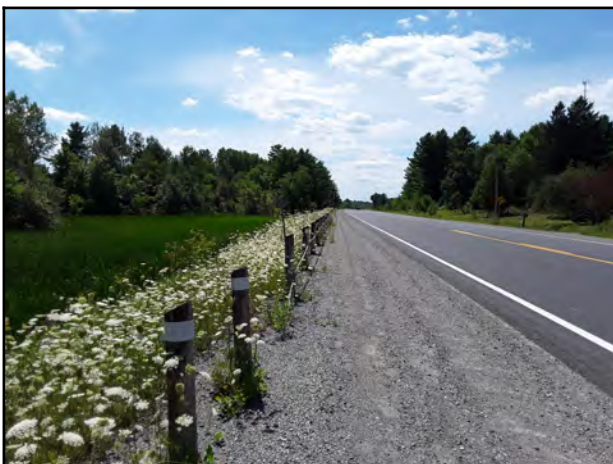
Photo 5 - Outlet guardrail.

The culvert was found to be in fair condition and performing as designed, however, a few deficiencies were noted. The outlet guardrail had significant slack within the steel wires. The visual assessment identified one (1) separated joint of approximately 40 mm with black caulking evident, recorded as V-4.

Based on the findings, it is recommended the steel wire slack in the outlet guardrail be repaired to maintain the structural integrity of the guardrail. Additionally, it is recommended that the areas with confirmed annular voids between the existing culvert and the Sliplined HDPE be injected with grouting material approved by the design engineer. This will ensure the supporting soil structure remains stable when the host culvert fully deteriorates. This can be accomplished by injecting grout directly in the center of the specific area and drilling overflow ports to ensure the product has reached the desired location. Locations of the captured probe holes are indicated by the distance from the inlet, as well as the clock position, and should be referenced during the injections. The SoilSight™ Pipe Map should also be utilized to help estimate the material volumes required to complete the repair. Please refer to the SoilSight™ Pipe Map and segment views for the exact locations of the probe holes.

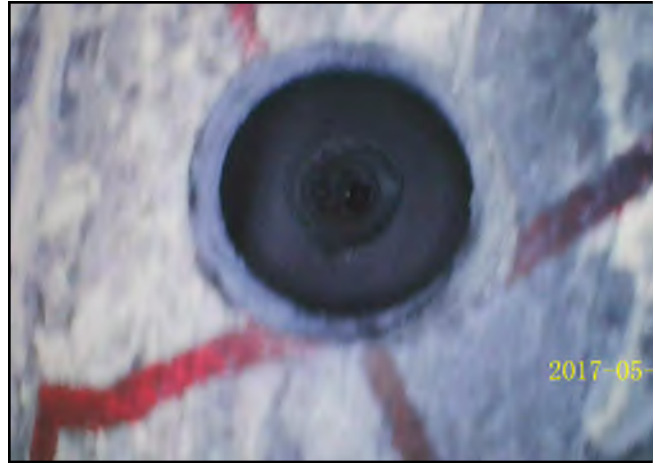
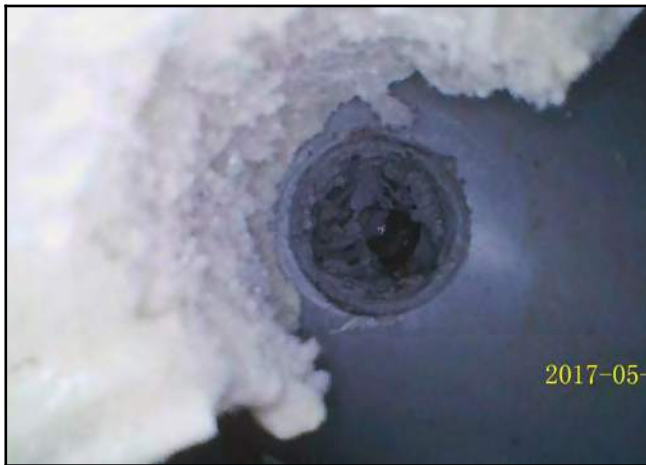
Photo 14 - V-1: Endoscope camera placed in the probe hole showing void.

Photo 15 - V-1: Endoscope camera placed in the probe hole showing void.

As noted in V-1, V-3 and V-6, visible annular voids between the existing culvert and the sliplined HDPE were recorded at each probe hole location, confirming the inSight™ Lite anomalous regions at these locations. V-1, and V-7 were identified as locations of no void. A control point was also taken and recorded as V-5 to ensure the accuracy of the inSight™ Lite assessment. Following the inspection, each hole was sealed with a silicone sealant.

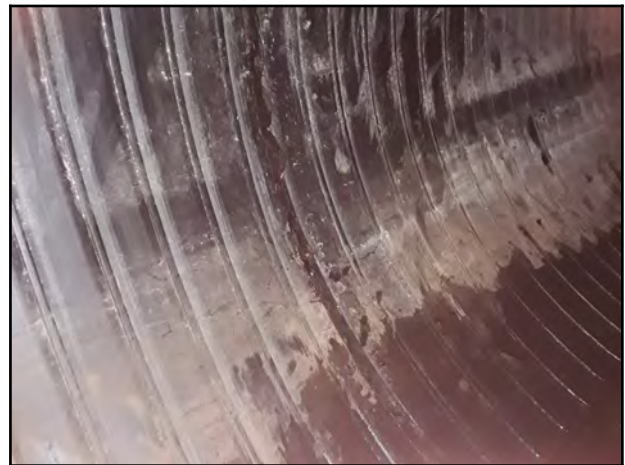
Photo 16 - V-2: Joint with evident black caulking.

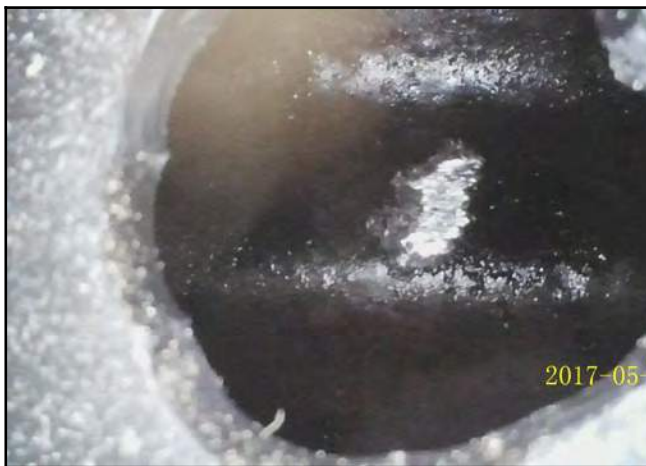
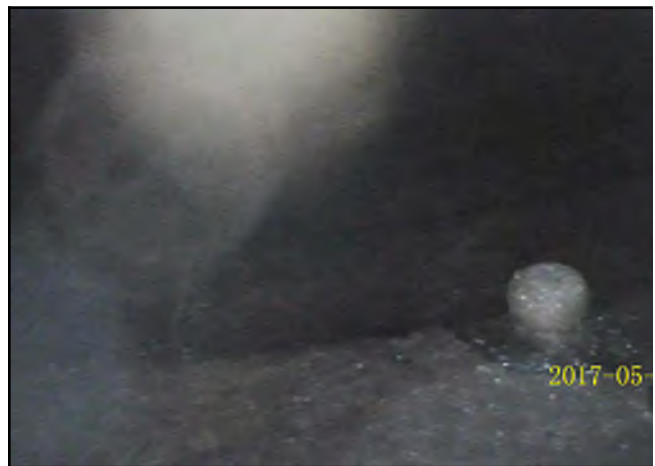
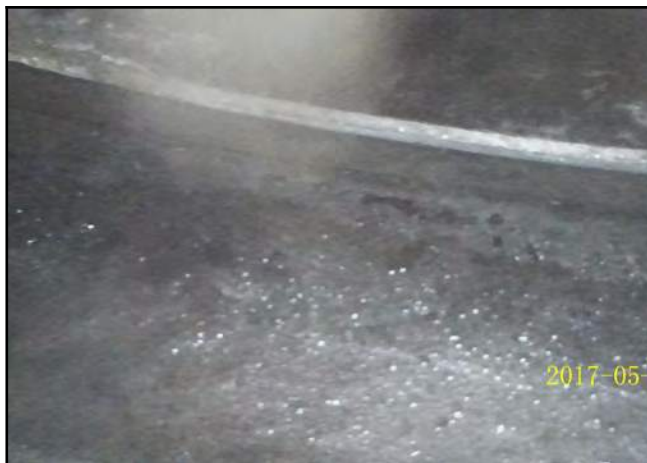
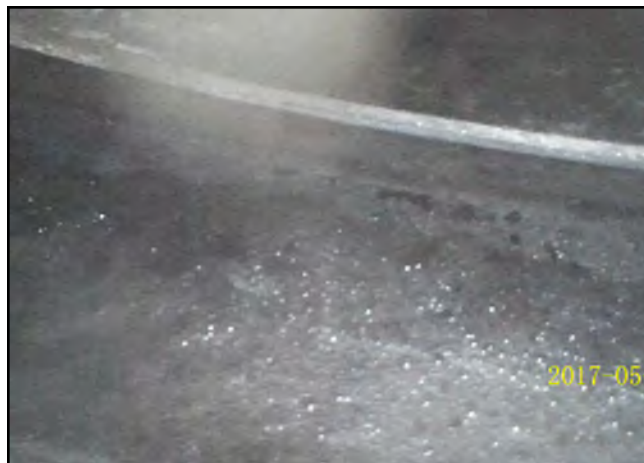
Photo 17 - V-3: Endoscope camera placed in the probe hole showing void.

Photo 18 - V-3: Endoscope camera placed in the probe hole showing void.

Photo 19 - V-3: Endoscope camera placed in the probe hole showing void.

Photo 20 - V-3: Endoscope camera placed in the probe hole showing void.

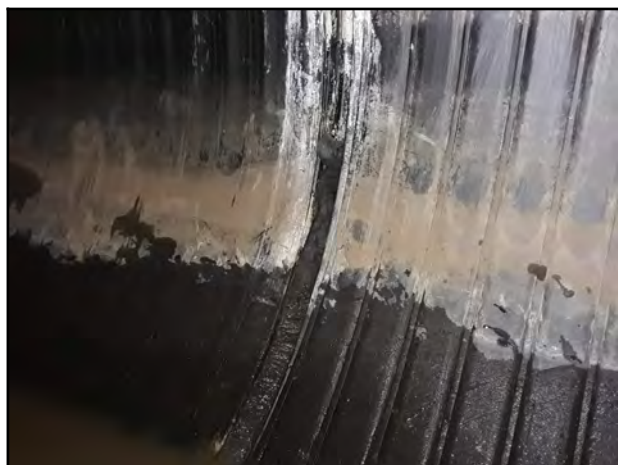
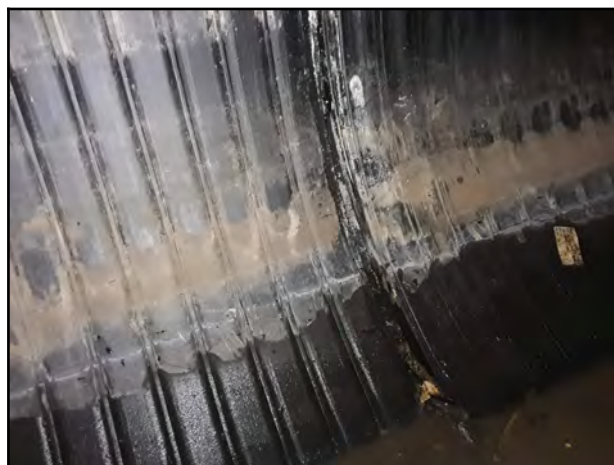
Photo 21 - V-4: Separated joint by approximately 40 mm with black caulking evident.

Photo 22 - V-4: Separated joint by approximately 40 mm with black caulking evident.

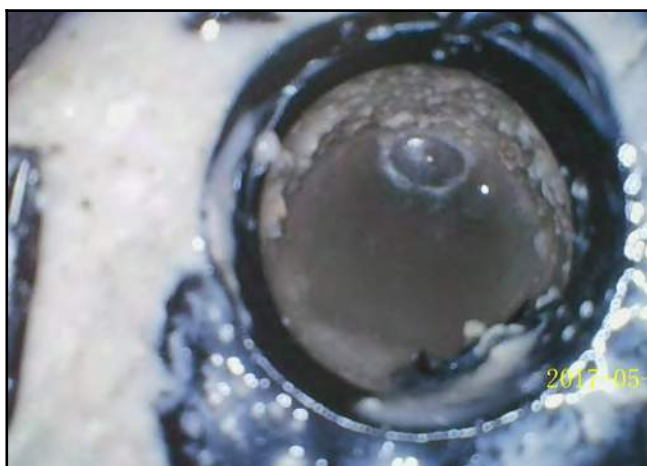
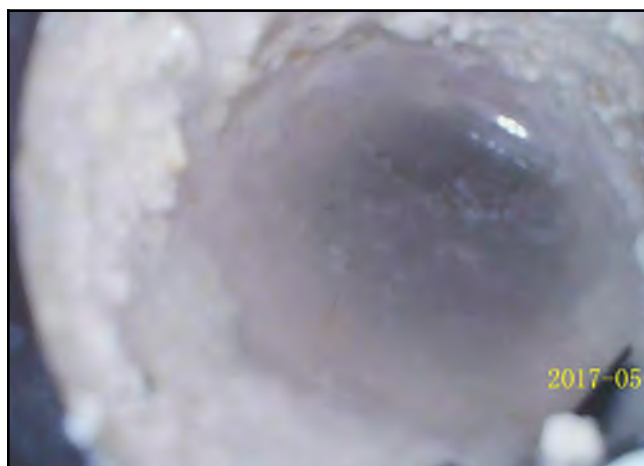
Photo 23 - V-5: Endoscope camera placed in the probe hole showing no void (control point).

Photo 24 - V-5: Endoscope camera placed in the probe hole showing no void (control point).

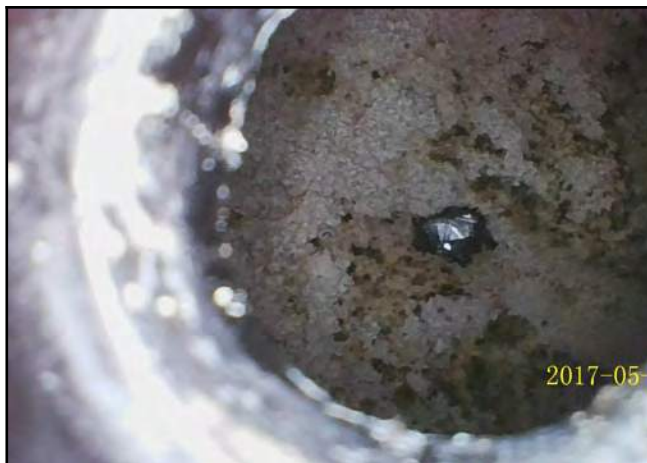
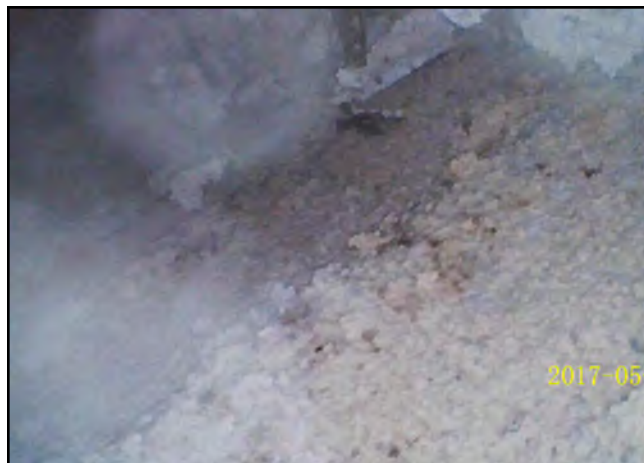
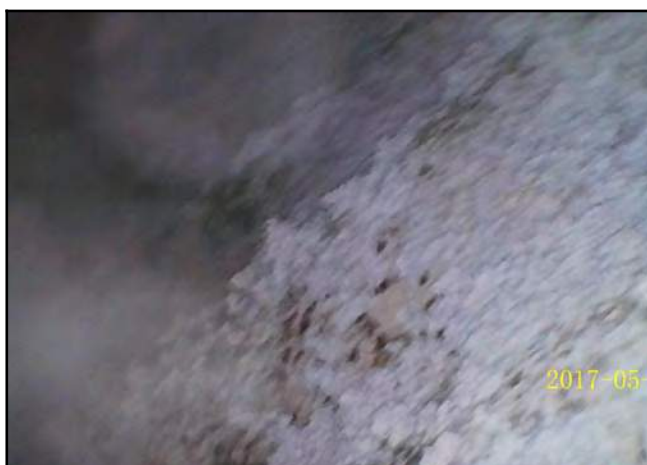
Photo 25 - V-6: Endoscope camera placed in the probe hole showing void.

Photo 26 - V-6: Endoscope camera placed in the probe hole showing void.

Photo 27 - V-6: Endoscope camera placed in the probe hole showing void.

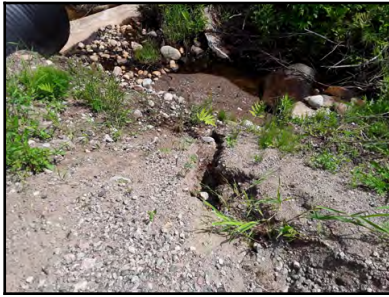
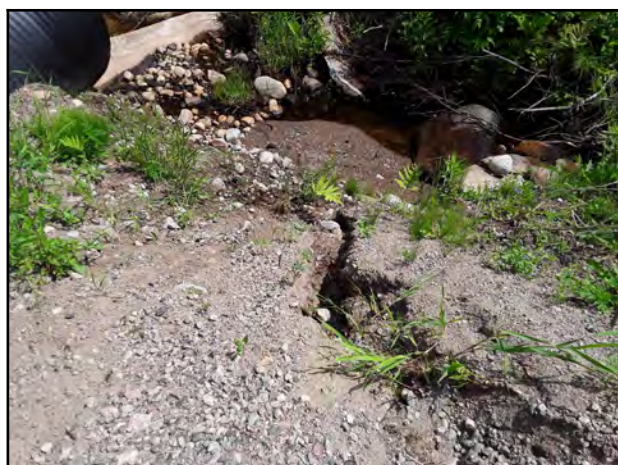
- Erosion channel(s) present: **Frequency:** 2 - 5 channels; **Severity:** Severe (200 - 300 mm (8 - 12 in) Width).
- Vegetation present: **Size:** Small vegetation present (< 3.0 m (10 ft) in height).

Photo 3 - Erosion channel on the outlet embankment measuring approximately 300 mm in width.

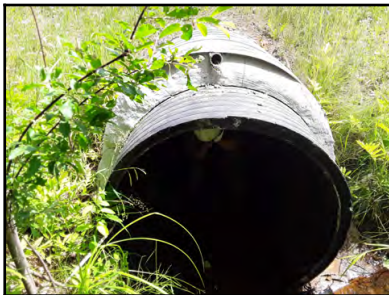
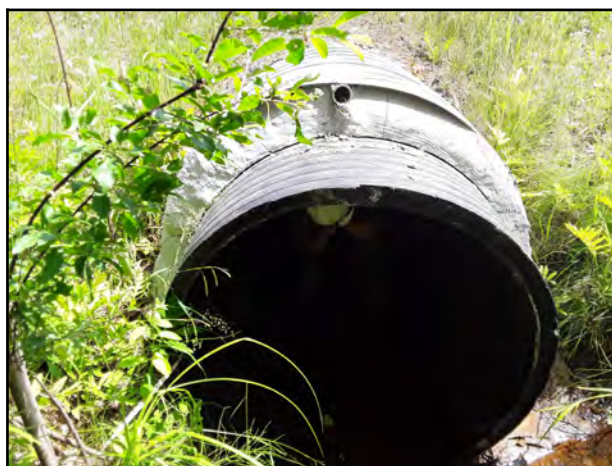
Photo 6 - Inlet overview.:
Annular space of 80 mm
between the existing CMP and
the sliplined HDPE.

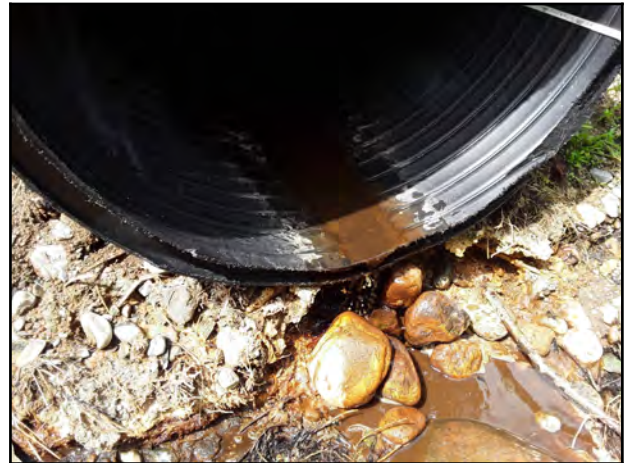
- Outfall is perched/elevated: **Severity:** Severe (< 300 mm (12 in) Height).

Photo 10 - Outlet is perched by approximately 260 mm in height.

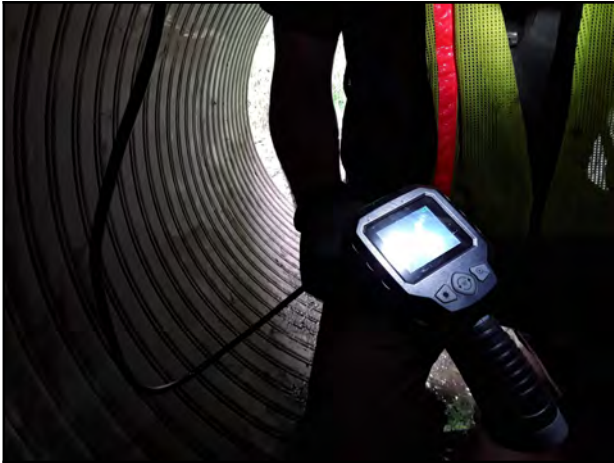
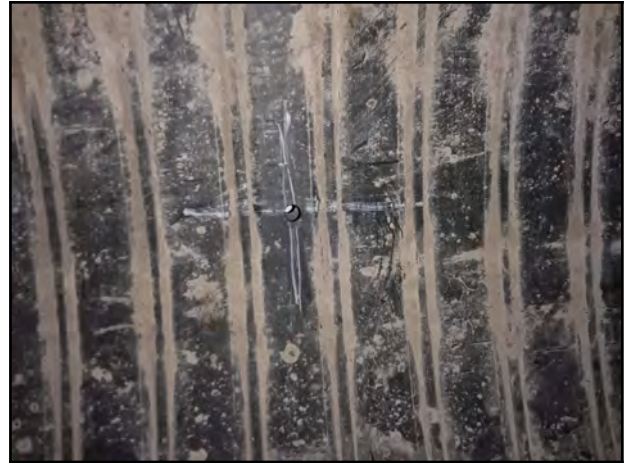
Photo 13 - V-1: Endoscope camera showing visible void.

Based on the findings, it is recommended that the areas with confirmed annular voids between the existing CMP and the Sliplined HDPE be injected with grouting material approved by the design engineer. This will ensure the supporting soil structure remains stable when the host CMP fully deteriorates. This can be accomplished by injecting grout directly in the center of the specific area and drilling overflow ports to ensure the product has reached the desired location. Locations of the captured BCT scan images are indicated by the distance from the inlet, as well as the clock position, and should be referenced during the injections. The BCT images should also be utilized to help estimate the material volumes required to complete the repair. Please refer to the soilsight™ Pipe Map and segment views for the exact locations of the voids.

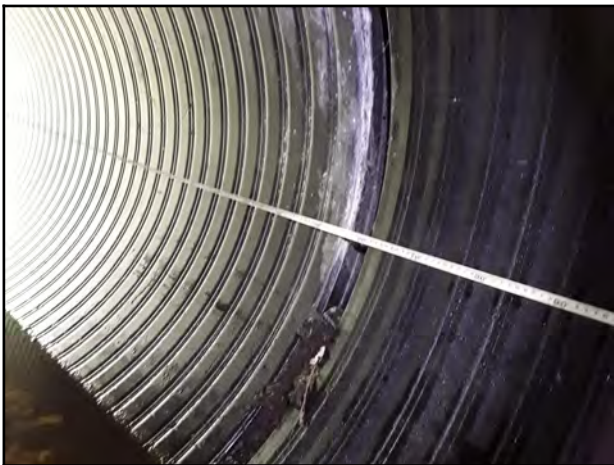
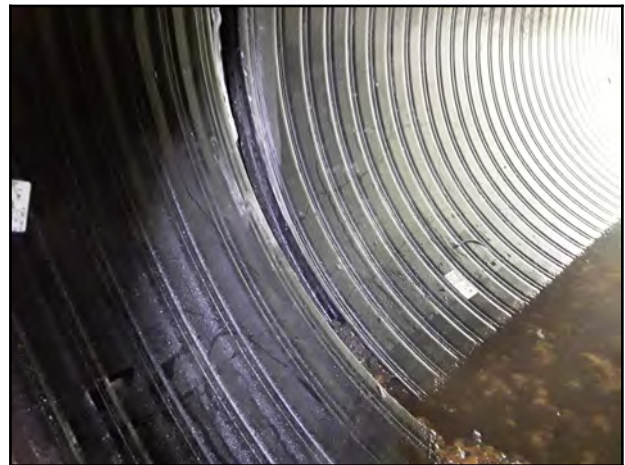
Photo 15 - V-2: Separated joint of approximately 70 mm with visible supporting grout material.

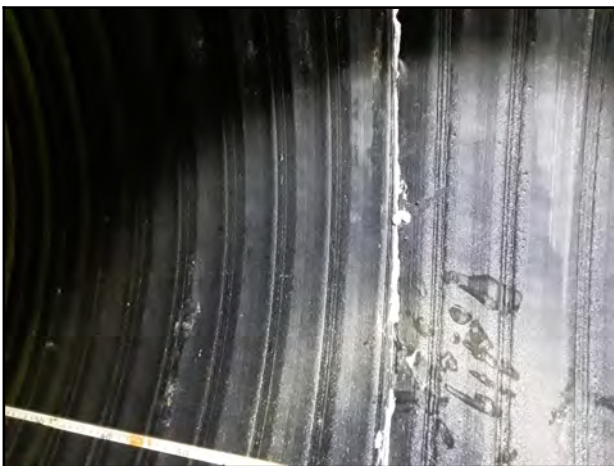
Photo 17 - V-3: Joint with visible silicone sealant.

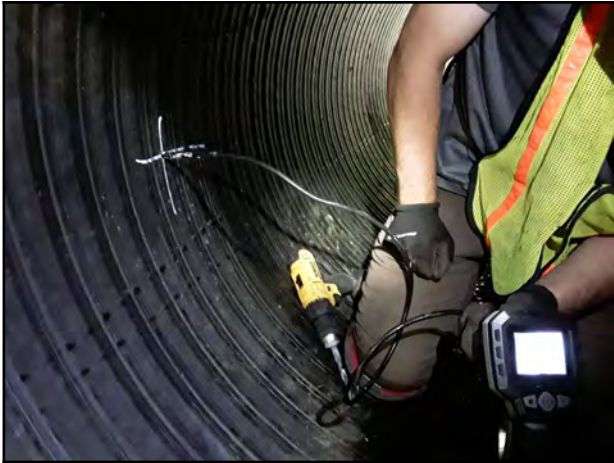
Photo 19 - V-4: Endoscope camera showing visible void.
