DRAFT
GROUT-IN-PLACE CULVERT LINING INVESTIGATION REPORT

4018-E-0001 ASSIGNMENT #5

Ministry of Transportation Ontario
c/o WSP Canada Group Limited

October 2020
Thurber File No.: 28182

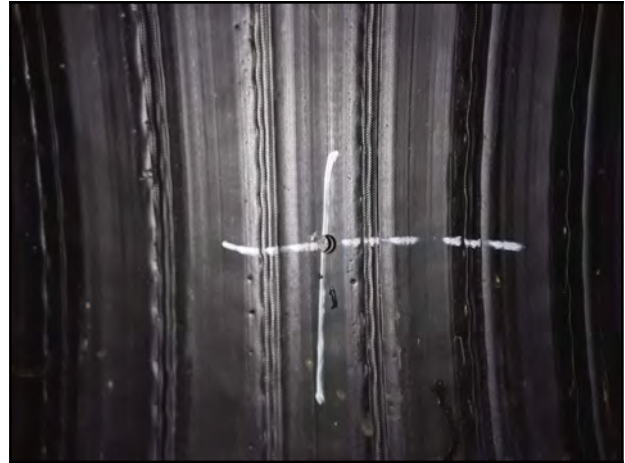
Photo 20 - V-4: Endoscope camera showing visible void.

Based on the findings, it is recommended that the areas with confirmed annular voids between the existing CMP and the Sliplined HDPE be injected with grouting material approved by the design engineer. This will ensure the supporting soil structure remains stable when the host CMP fully deteriorates. This can be accomplished by injecting grout directly in the center of the specific area and drilling overflow ports to ensure the product has reached the desired location. Locations of the captured BCT scan images are indicated by the distance from the inlet, as well as the clock position, and should be referenced during the injections. The BCT images should also be utilized to help estimate the material volumes required to complete the repair. Please refer to the soilsight™ Pipe Map and segment views for the exact locations of the voids.

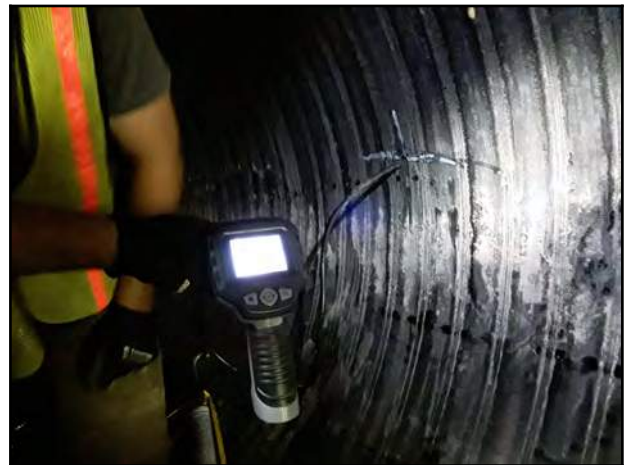
Photo 22 - V-5: Endoscope camera showing visible void.

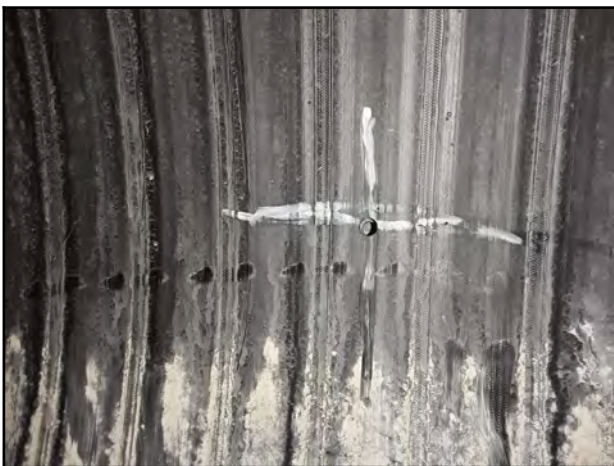
Photo 23 - V-5: Endoscope camera showing visible void.

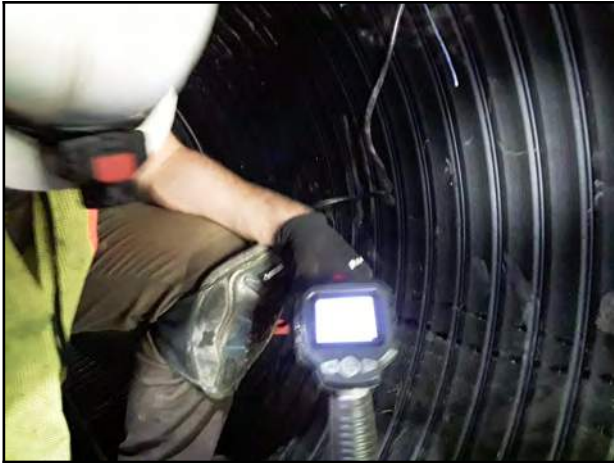
Photo 25 - V-6: Endoscope camera showing visible void.

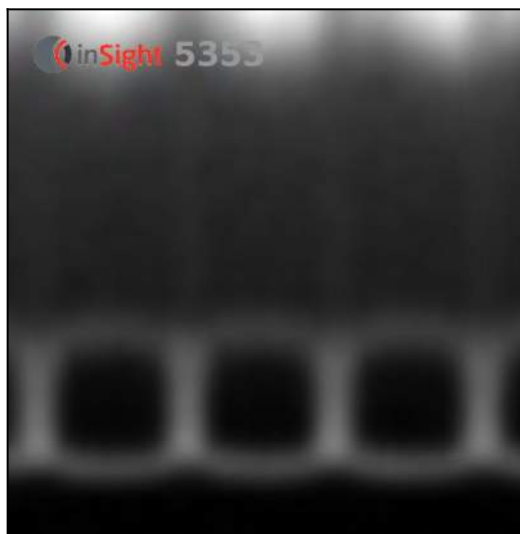
BCT-3 (Scan ID: 5353)

Full annular void between existing CMP and sliplined HDPE.

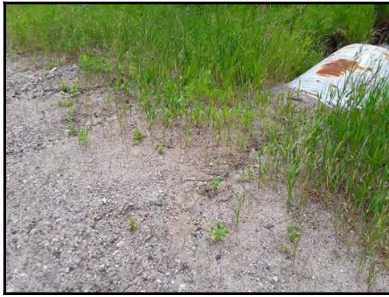
- Erosion channel(s) present: **Frequency:** > 5 channels; **Severity:** Moderate (100 - 200 mm (4 - 8 in) Width).
- Vegetation present: **Size:** Small vegetation present (< 3.0 m (10 ft) in height).

Photo 3 - Minor erosion channels on the outlet embankment with the most severe measuring approximately 190 mm in width.

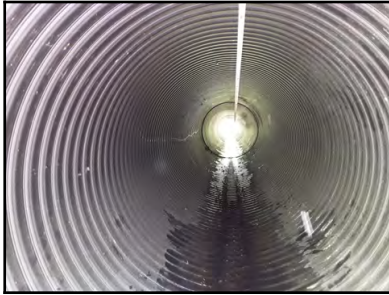
Minor vertical misalignment at the pipe outlet.

Photo 10 - Upstream pipe alignment and shape.

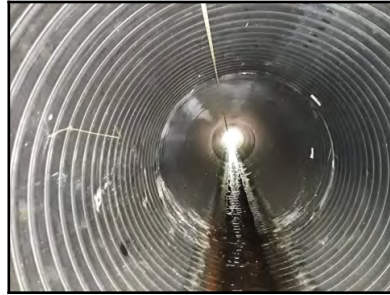
Photo 11 - Downstream pipe alignment and shape.

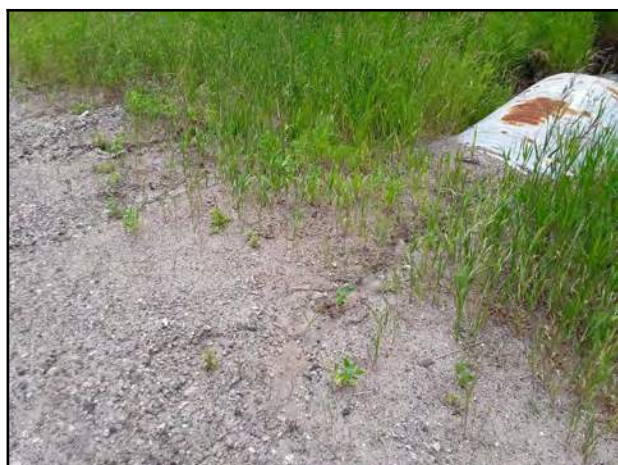
Photo 3 - Minor erosion channels on the outlet embankment with the most severe measuring approximately 190 mm in width.

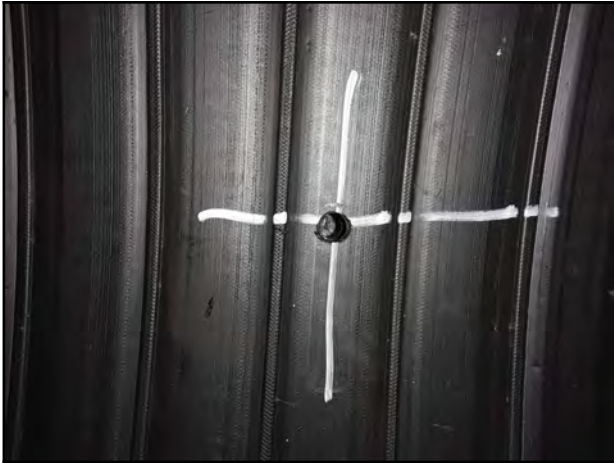
Photo 12 - V-1: Endoscope camera showing visible void.

Based on the findings, it is recommended that the areas with confirmed annular voids between the existing CMP and the Sliplined HDPE be injected with grouting material approved by the design engineer. This will ensure the supporting soil structure remains stable when the host CMP fully deteriorates. This can be accomplished by injecting grout directly in the center of the specific area and drilling overflow ports to ensure the product has reached the desired location. Locations of the captured BCT scan images are indicated by the distance from the inlet, as well as the clock position, and should be referenced during the injections. The BCT images should also be utilized to help estimate the material volumes required to complete the repair. Please refer to the soilsight™ Pipe Map and segment views for the exact locations of the voids.

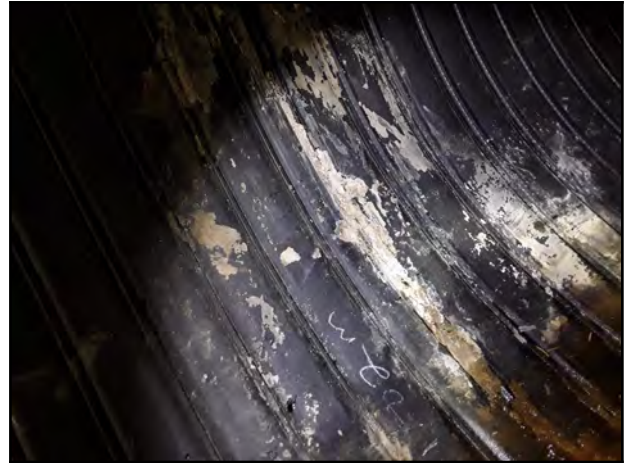
Photo 13 - V-1: Endoscope camera showing visible void.

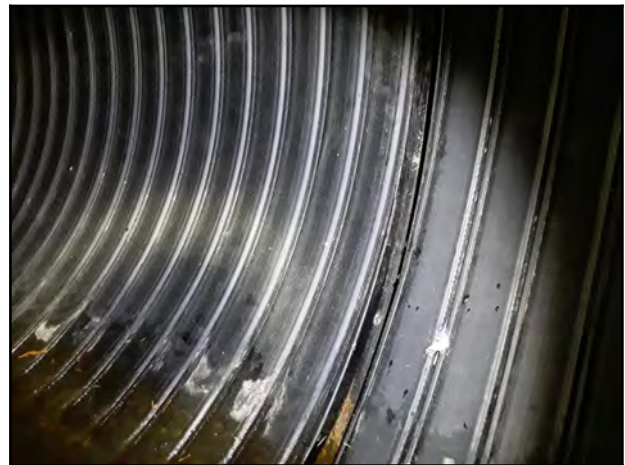
Photo 15 - V-3: Separated joint of approximately 30 mm with a visible coupler.

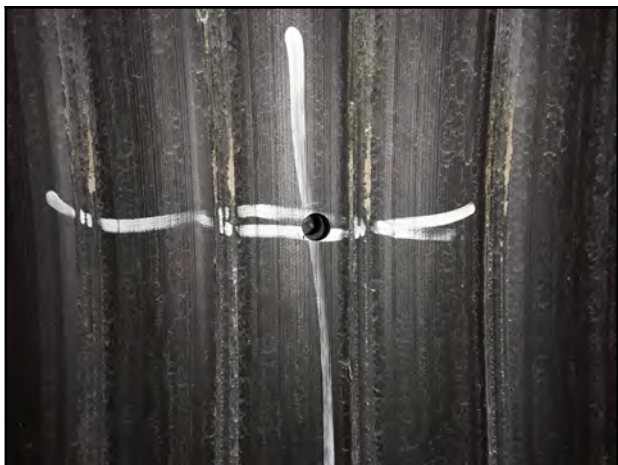
Photo 18 - V-4: Endoscope camera showing visible void.

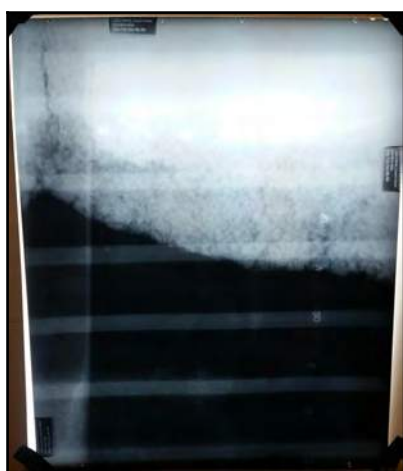
Photo 22 - V-6: Endoscope camera showing visible void.

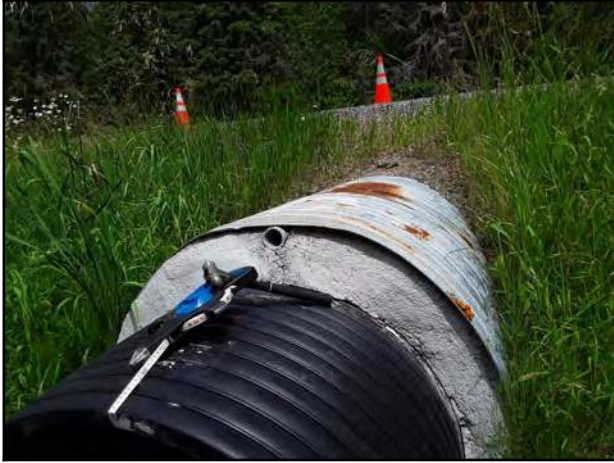
Photo 25 - Annular space of 170 mm between the existing CMP and the sliplined HDPE at outlet.

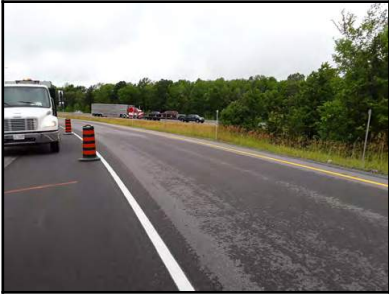
Pavement		Rank 1
Pavement in excellent condition.

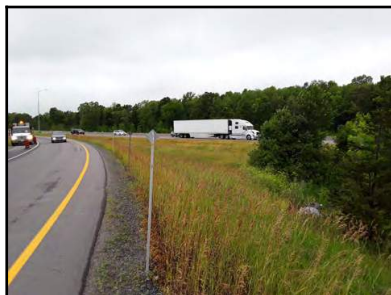
Photo 3 - Inlet embankment.

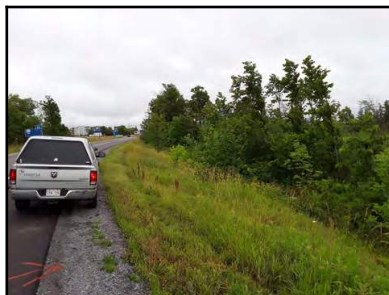
Photo 4 - Outlet embankment.

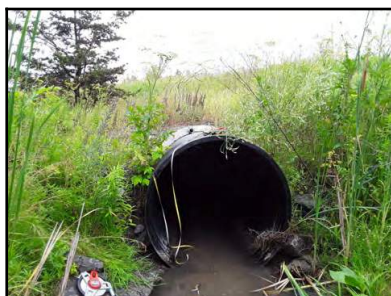
Inlet Headwall: No headwall present.

Photo 5 - Inlet overview.

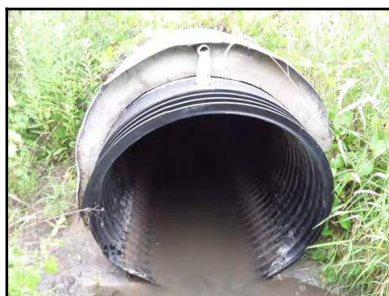
Outlet Headwall: No headwall present.

Photo 6 - Outlet overview.

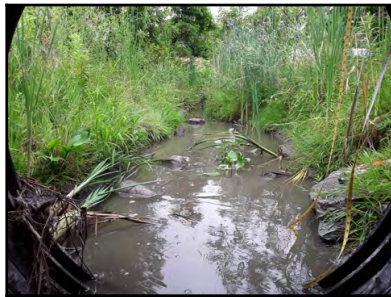
No waterway blockages found.

Photo 7 - Upstream channel view.

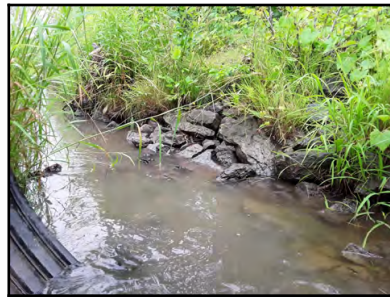
Photo 8 - Downstream channel view.

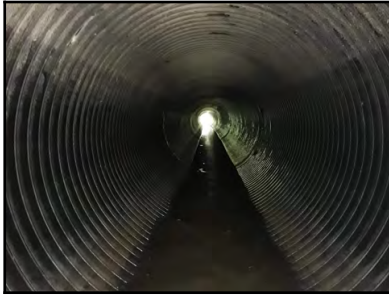
Photo 9 - Upstream pipe alignment and shape.

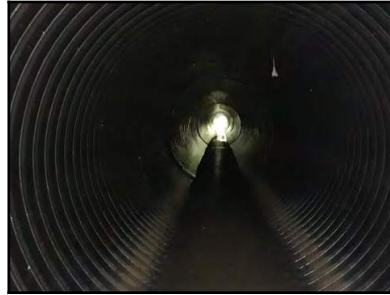
Minor horizontal misalignment at the outlet end.

Photo 10 - Downstream pipe alignment and shape.

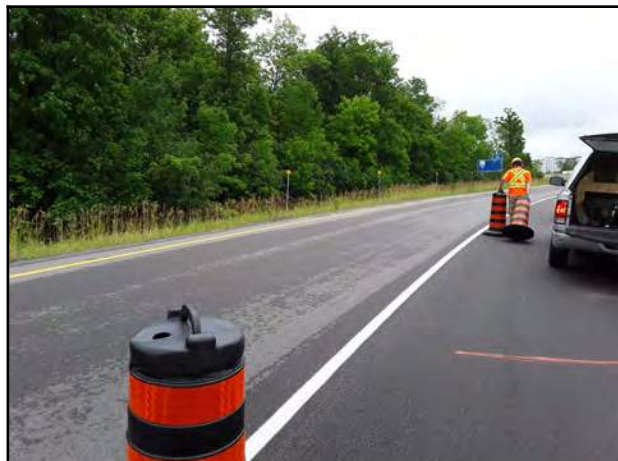
Photo 1 - Highway 401 East Bound Off-Ramp at Wallbridge Loyalist Road facing east.

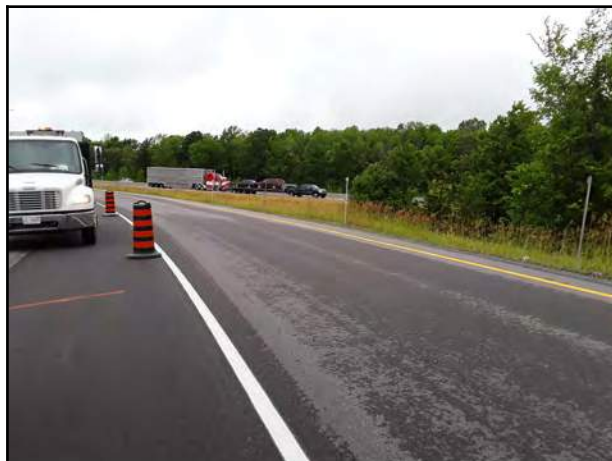
Photo 2 - Highway 401 East Bound Off-Ramp at Wallbridge Loyalist Road facing west.

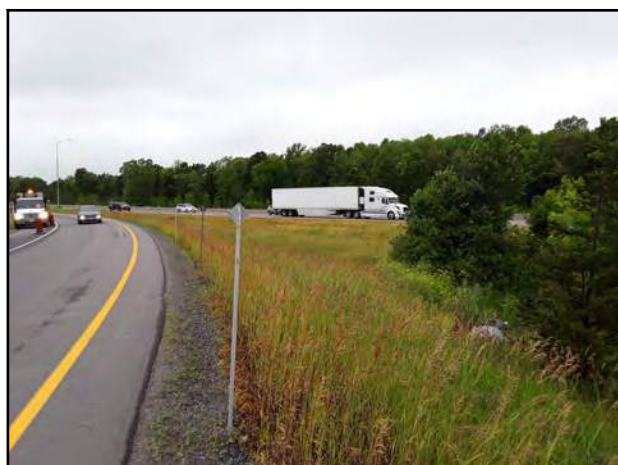
Photo 3 - Inlet embankment.

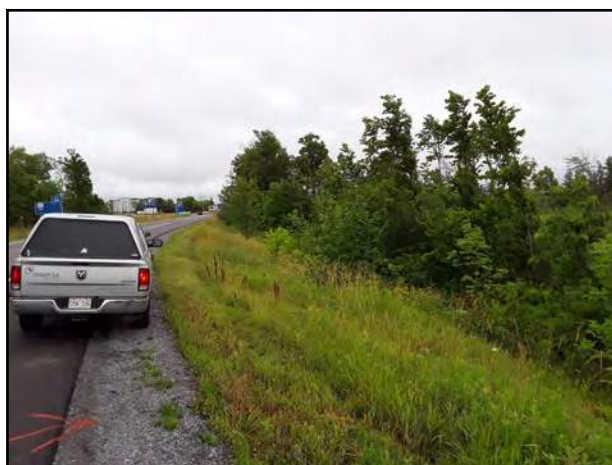
Photo 4 - Outlet embankment.

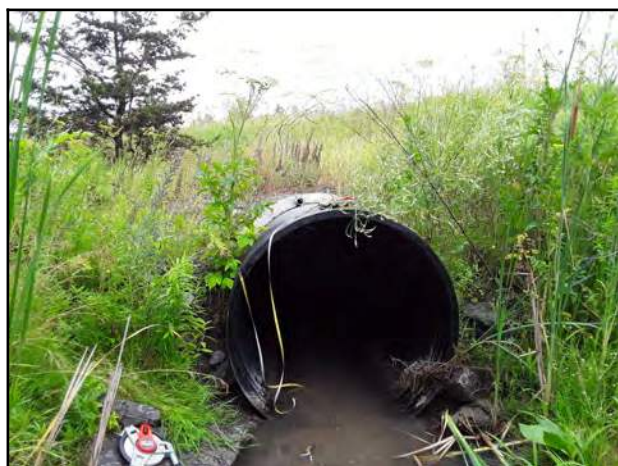
Photo 5 - Inlet overview.

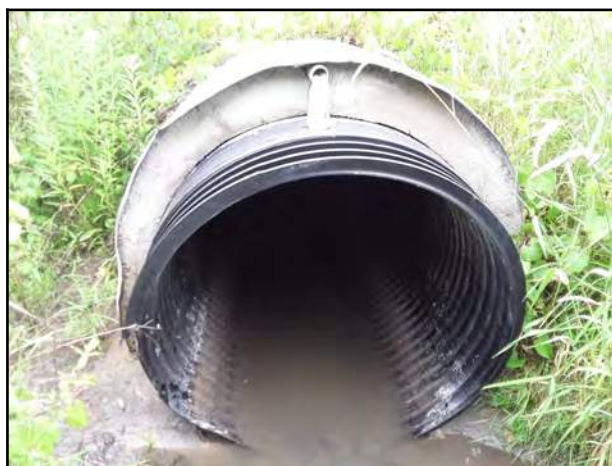
Photo 6 - Outlet overview.

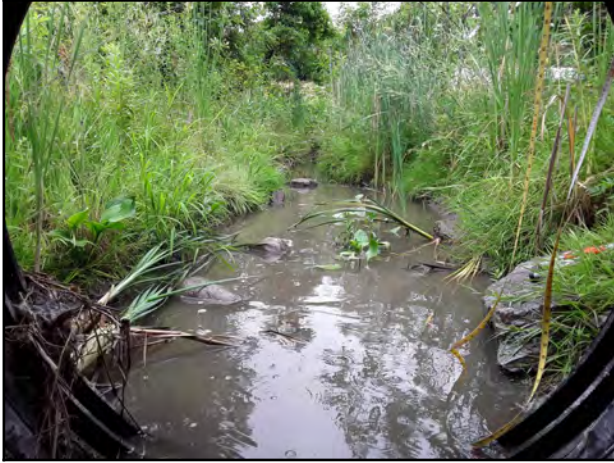
Photo 7 - Upstream channel view.

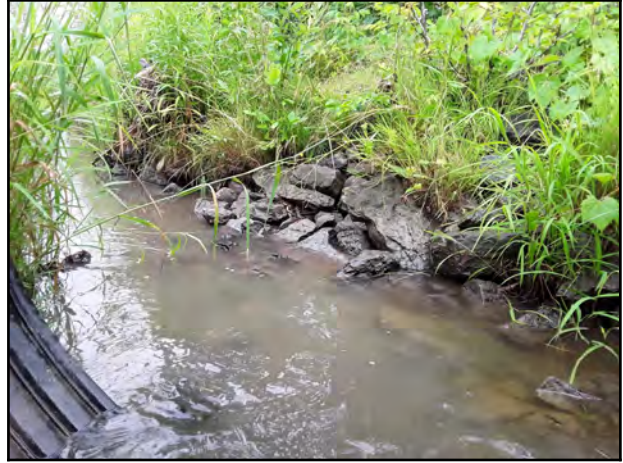
Photo 8 - Downstream channel view.

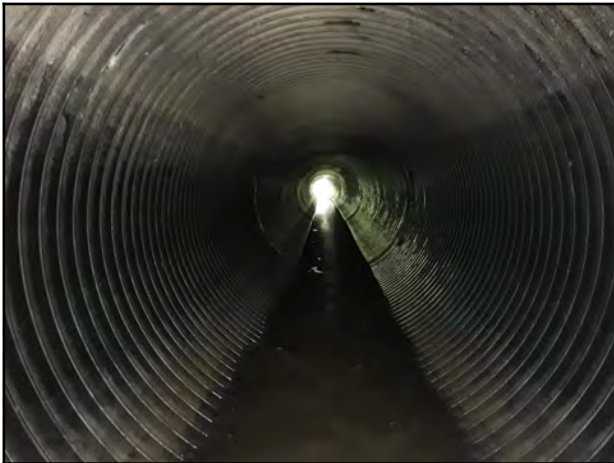
Photo 9 - Upstream pipe alignment and shape.

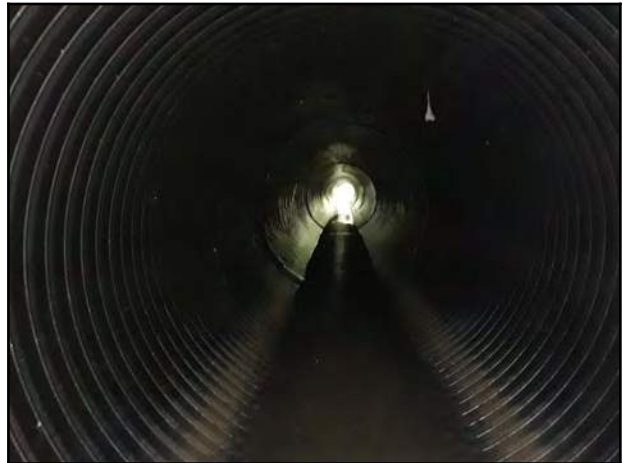
Photo 10 - Downstream pipe alignment and shape.

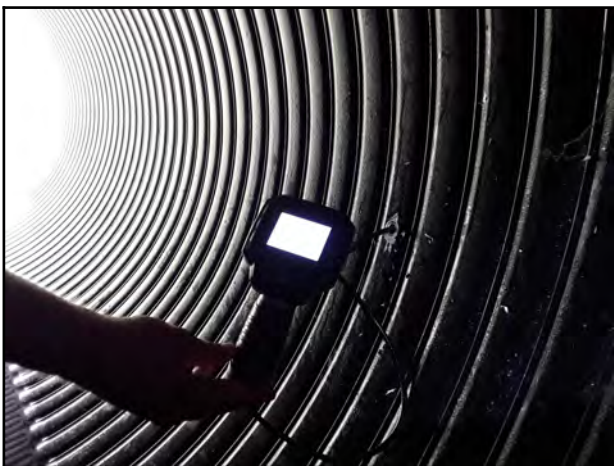
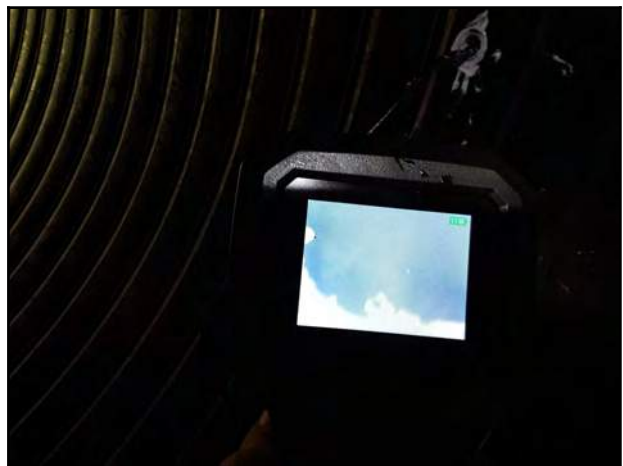
Photo 11 - V-1: Endoscope camera showing visible void.

Photo 12 - V-1: Endoscope camera showing visible void.

Based on the findings, it is recommended that the areas with confirmed annular voids between the existing CMP and the sliplined HDPE be injected with grouting material approved by the design engineer. This will ensure the supporting soil structure remains stable when the host CMP fully deteriorates. This can be accomplished by injecting grout directly in the center of the specific area and drilling overflow ports to ensure the product has reached the desired location. Locations of the captured BCT scan images are indicated by the distance from the inlet, as well as the clock position, and should be referenced during the injections. The BCT images should also be utilized to help estimate the material volumes required to complete the repair. Please refer to the soilsight™ Pipe Map and segment views for the exact locations of the voids.

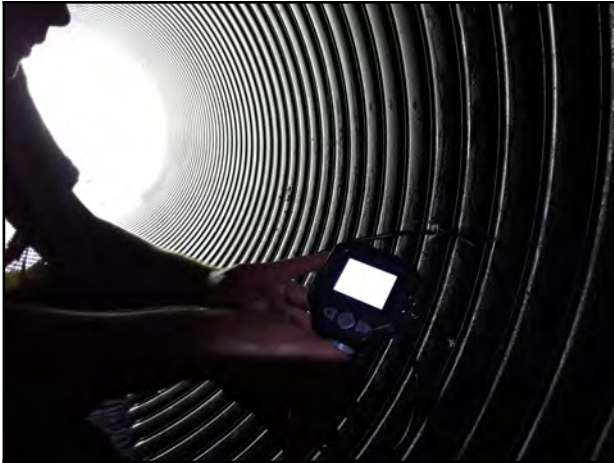
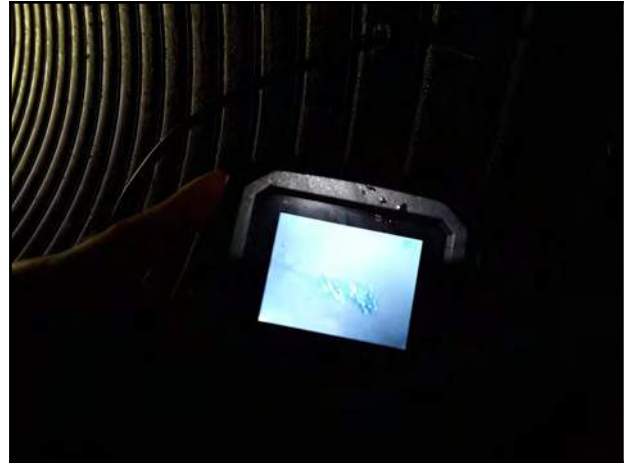
Photo 13 - V-2: Endoscope camera showing visible void.

Photo 14 - V-2: Endoscope camera showing visible void.

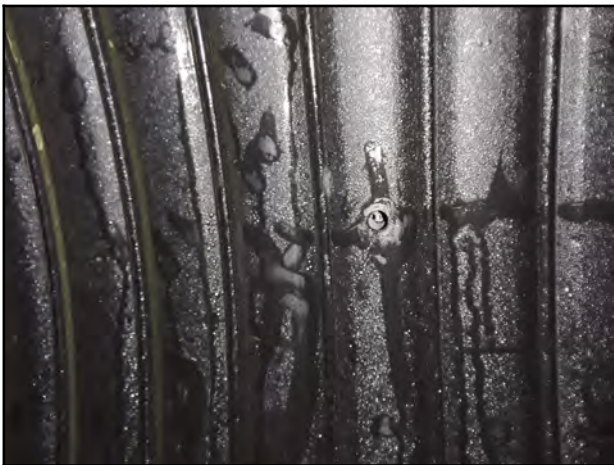
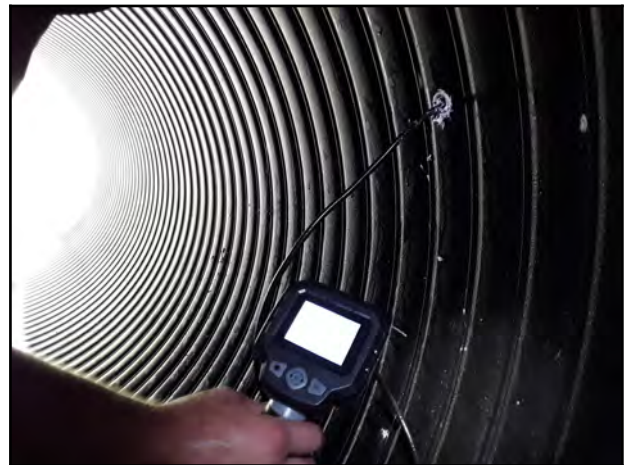
Photo 15 - V-3: Endoscope camera showing visible void.

Photo 16 - V-3: Endoscope camera showing visible void.

Photo 17 - V-3: Endoscope camera showing visible void.

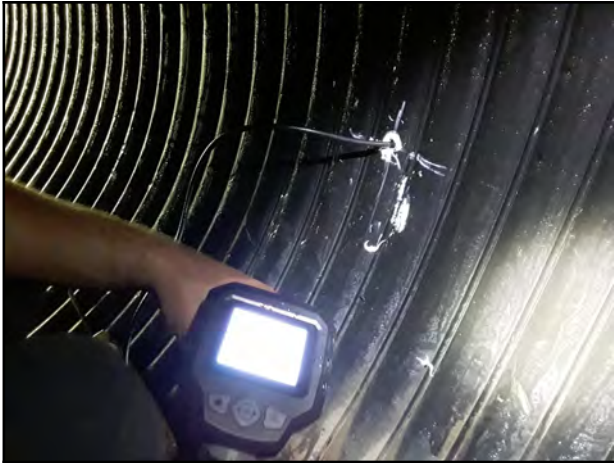
Photo 18 - V-4: Endoscope camera showing visible void. Image is blurry, difficult to see void.

Photo 19 - V-4: Endoscope camera showing visible void. Image is blurry, difficult to see void.

Photo 20 - V-4: Endoscope camera showing visible void. Image is blurry, difficult to see void.

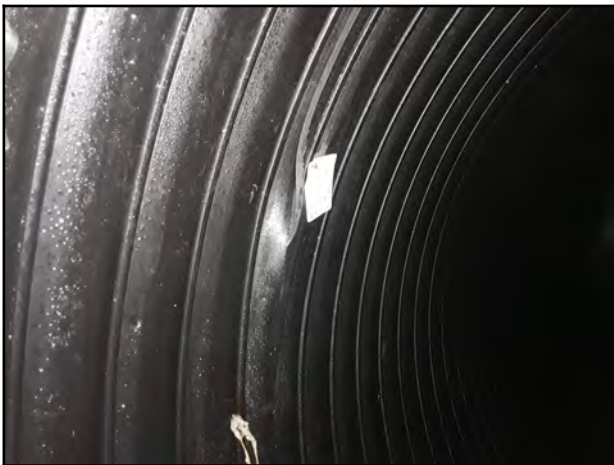
Photo 21 - V-5: Localized damage at joint.

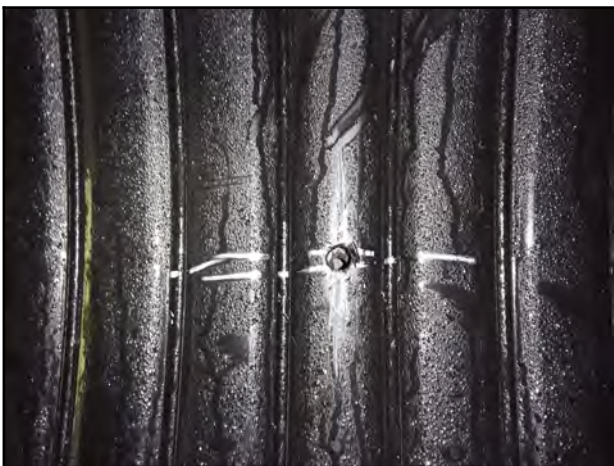
Photo 23 - 4 m at 8:30 with visible void.

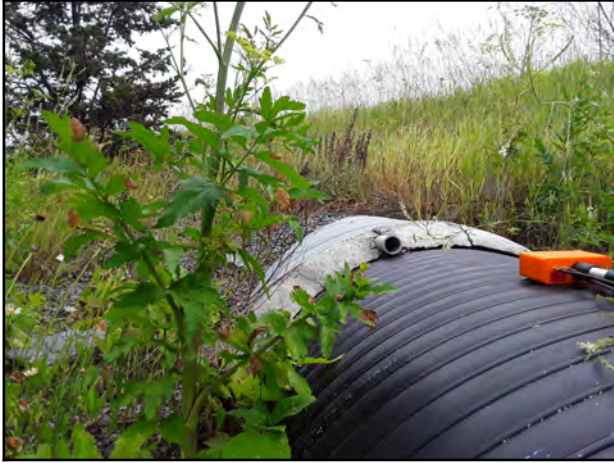
Photo 25 - Annular space of 120 mm between the existing CMP and the sliplined HDPE at inlet.

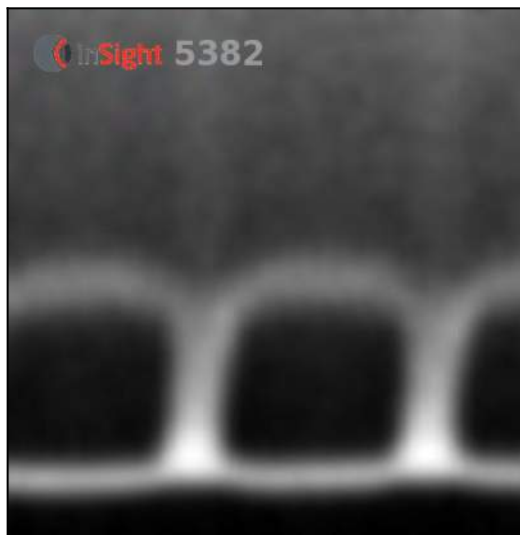
BCT-1 (Scan ID: 5382)

Full annular void between existing CMP and sliplined HDPE.

Based on the findings, it is recommended that the areas with confirmed annular voids between the existing CMP and the sliplined HDPE be injected with grouting material approved by the design engineer. This will ensure the supporting soil structure remains stable when the host CMP fully deteriorates. This can be accomplished by injecting grout directly in the center of the specific area and drilling overflow ports to ensure the product has reached the desired location. Locations of the captured BCT scan images are indicated by the distance from the inlet, as well as the clock position, and should be referenced during the injections. The BCT images should also be utilized to help estimate the material volumes required to complete the repair. Please refer to the soilsight™ Pipe Map and segment views for the exact locations of the voids.

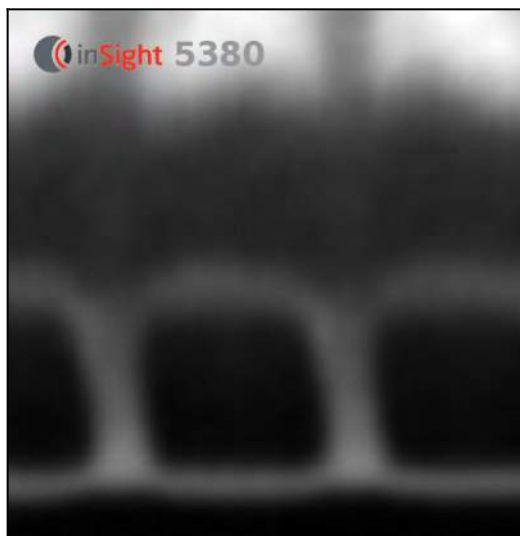
BCT-3 (Scan ID: 5380)

Full annular void between existing CMP and sliplined HDPE.

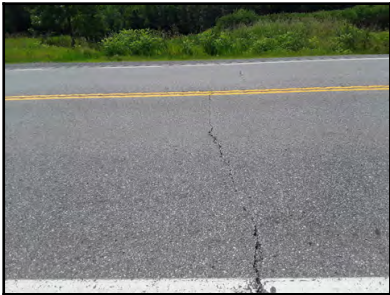
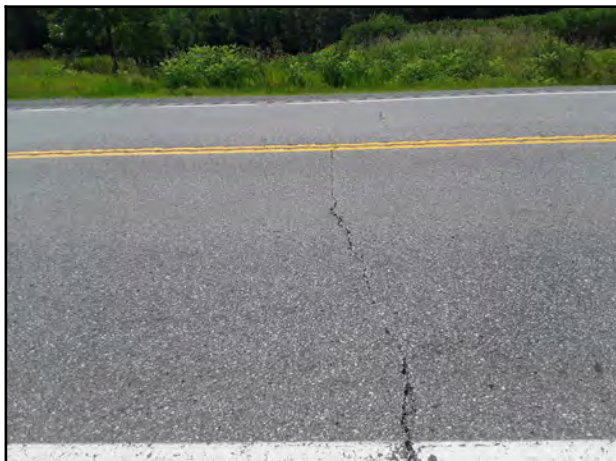
Pavement		Rank 2
Pavement in good condition.		
Cracks		
• Transverse cracks present: Frequency: Medium (2 - 5 cracks); Severity: Light (< 5 mm (0.2 in) Width)

Photo 1 - Minor transverse crack present above the asset.	Photo 2 - Highway 17 facing south.	Photo 3 - Highway 17 facing north.

Photo 1 - Minor transverse crack present above the asset.

The visual assessment identified minor transverse crack documented in Photo 1 along the roadway above the asset. Negligible streambed material was also noted within the culvert located from 1.00 m to 11.00 m. Two (2) visual indicators, V-2 and V-4, were recorded as joints with visible expansion foam and supporting material near the invert. It is unknown why expansion foam was utilized during construction.

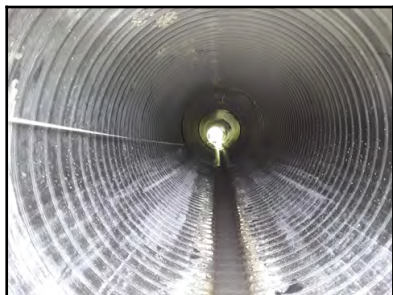
Minor vertical misalignment at the outlet.

Photo 10 - Upstream pipe alignment and shape.

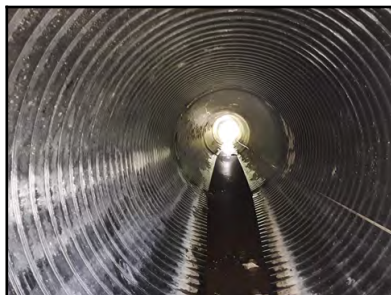
Photo 11 - Downstream pipe alignment and shape.

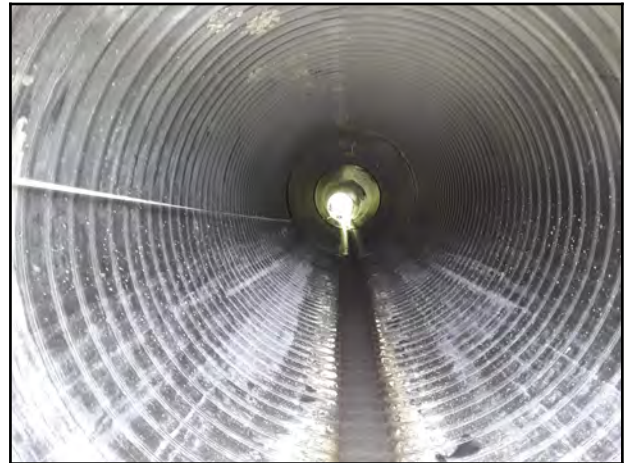
Photo 10 - Upstream pipe alignment and shape.

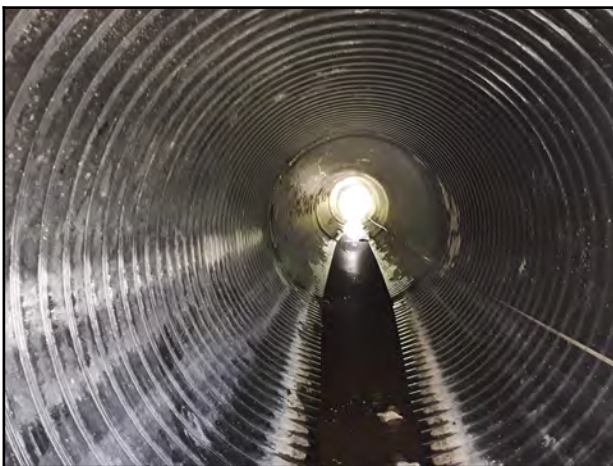
Photo 11 - Downstream pipe alignment and shape.

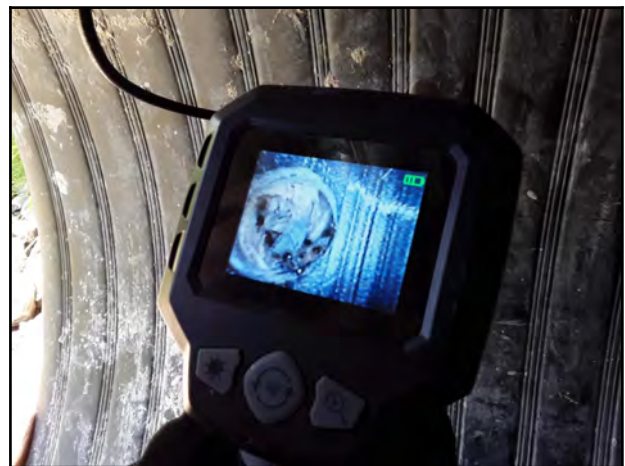
Photo 12 - V-1: Endoscope camera showing visible void.

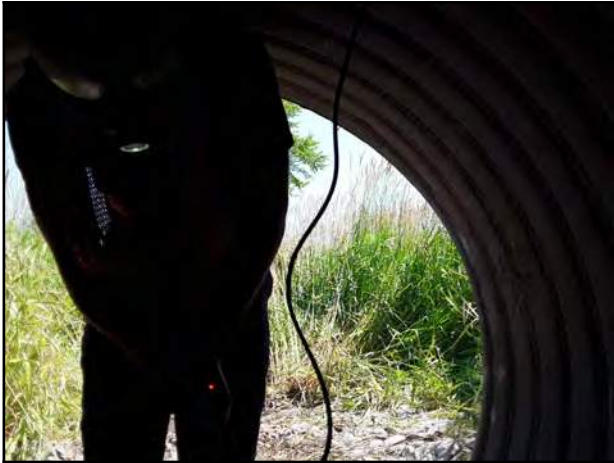
Photo 13 - V-1: Endoscope camera showing visible void.

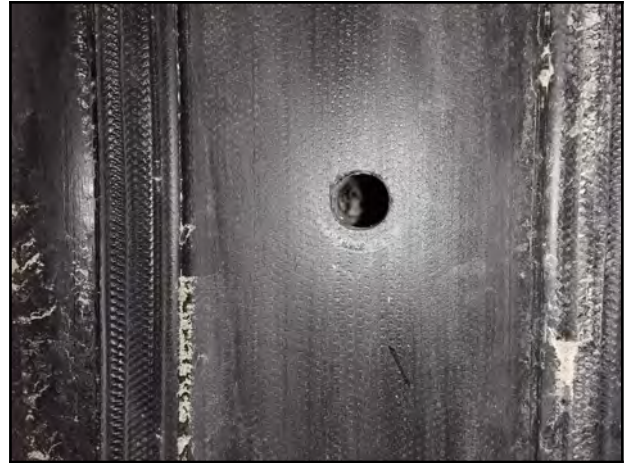
Photo 14 - V-1: Endoscope camera showing visible void.

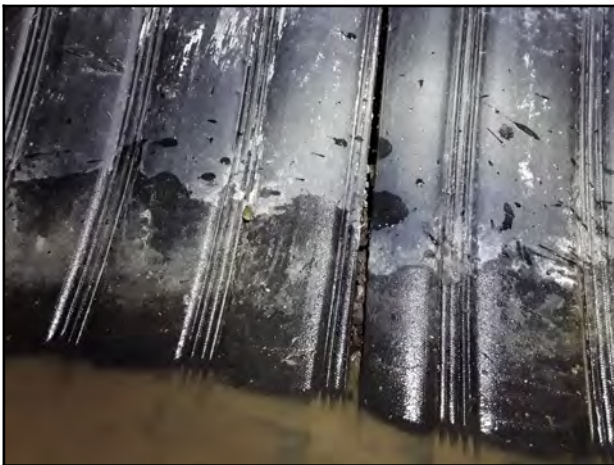
Photo 15 - V-2: Joint with visible expansion foam and visible supporting material.

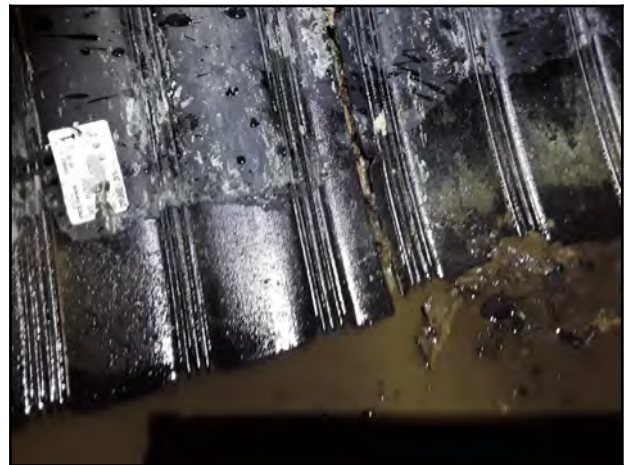
Photo 16 - V-2: Joint with visible expansion foam and visible supporting material.

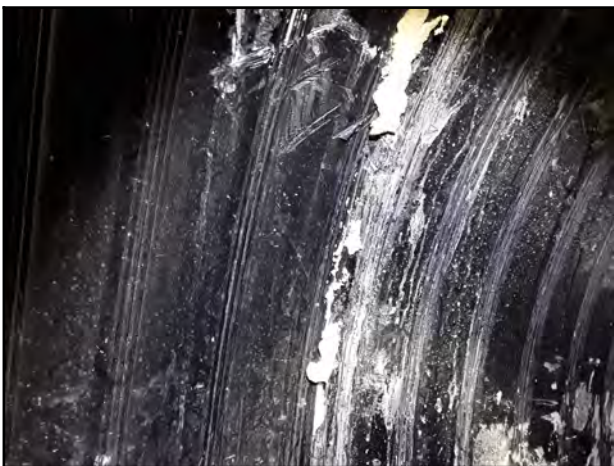
Photo 17 - V-2: Joint with visible expansion foam and visible supporting material.

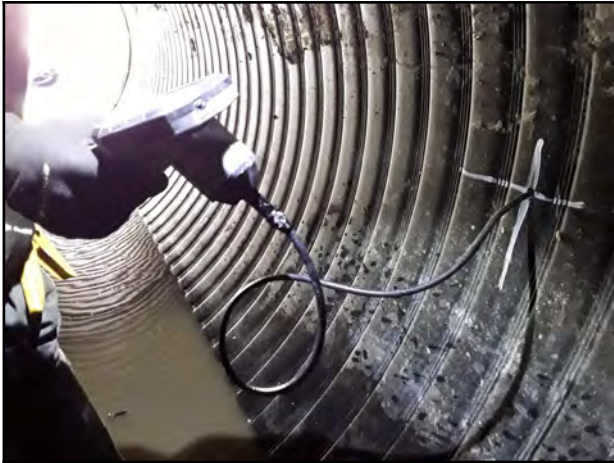
Photo 19 - V-3: Endoscope camera showing visible void.

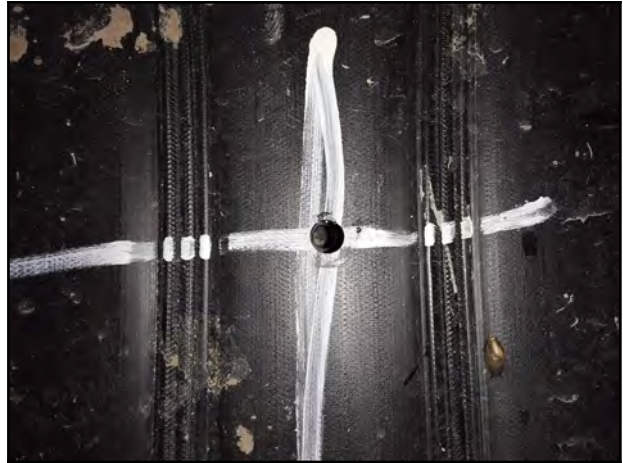
Photo 20 - V-3: Endoscope camera showing visible void.

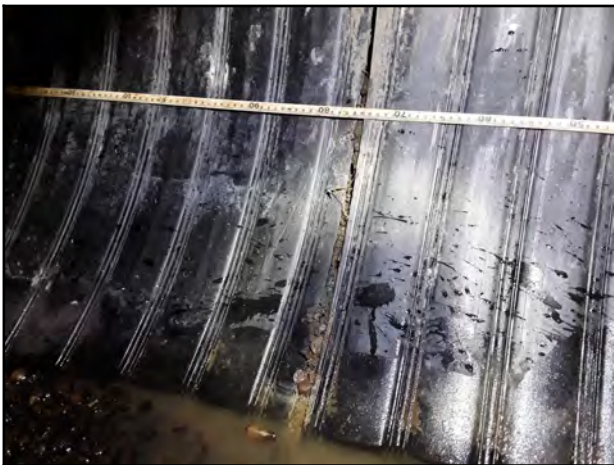
Photo 21 - V-4: Joint with visible expansion foam and visible supporting material.

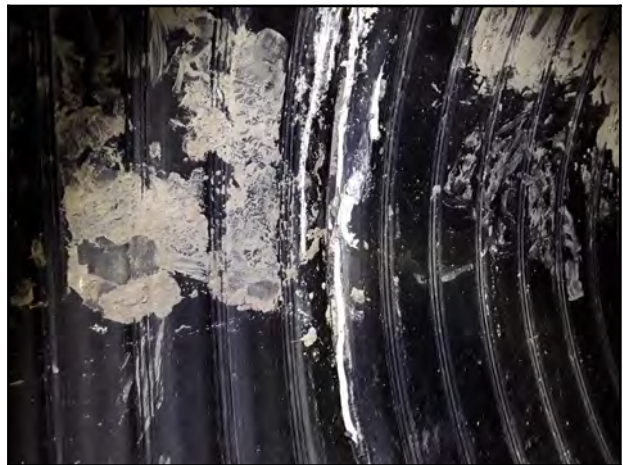
Photo 22 - V-4: Joint with visible expansion foam and visible supporting material.

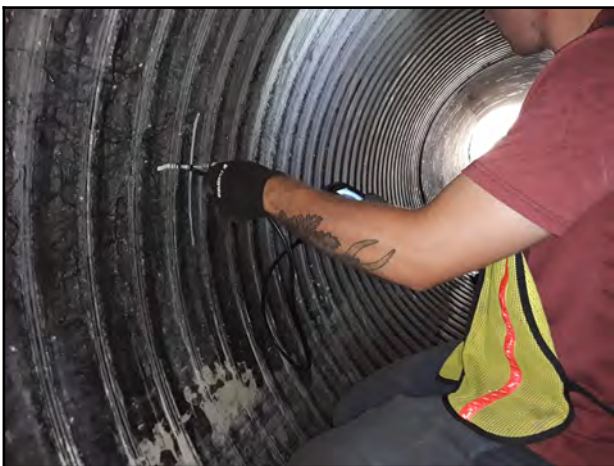
Photo 23 - V-5: Endoscope camera showing visible void.

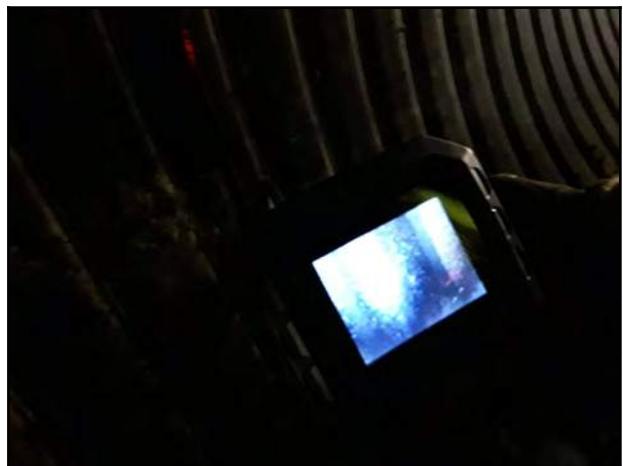
Photo 24 - V-5: Endoscope camera showing visible void.

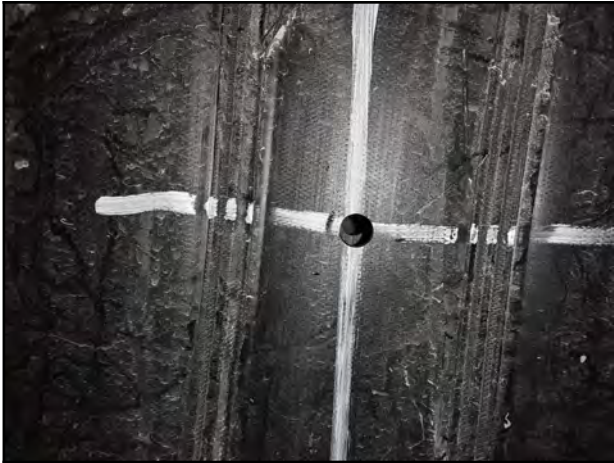
Photo 25 - V-5: Endoscope camera showing visible void.

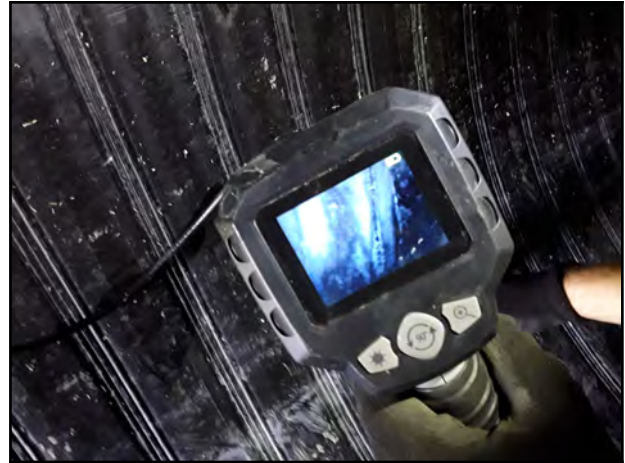
Photo 26 - V-6: Endoscope camera showing visible void.

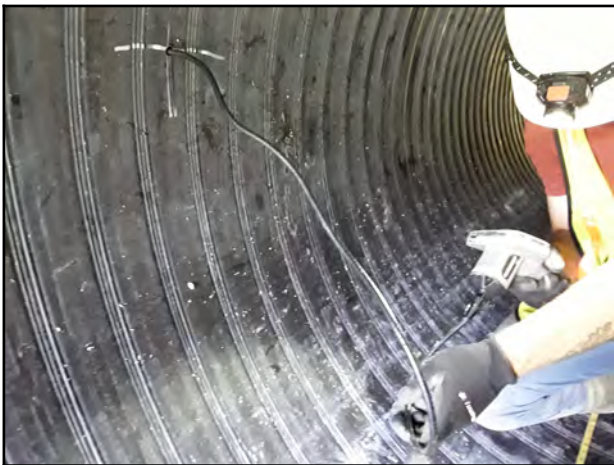
Photo 27 - V-6: Endoscope camera showing visible void.

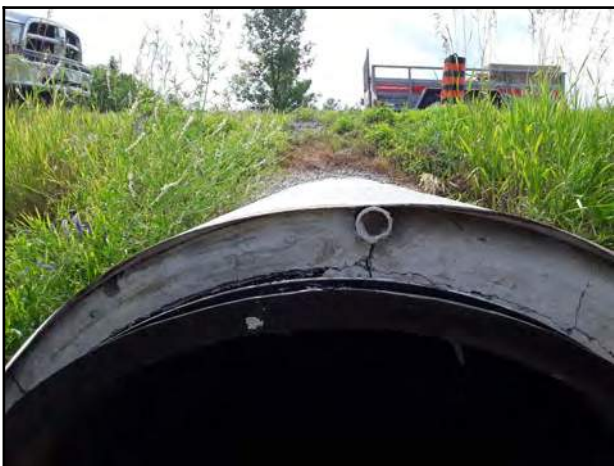
Photo 29 - Annular space of 240 mm between the existing CMP and the sliplined HDPE at inlet.

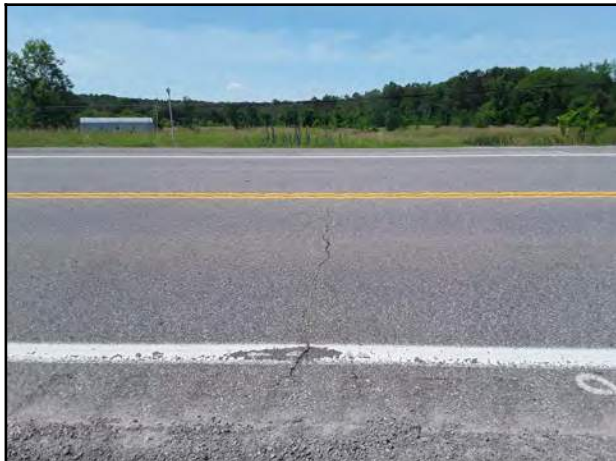
Pavement		Rank 2
Pavement in good condition.		
Cracks		
<ul style="list-style-type: none">Transverse cracks present: Frequency: Low (1 crack); Severity: Medium ((6 - 15 mm)(0.25 - 0.6 in) Width)

Photo 1 - Transverse crack present above the asset.

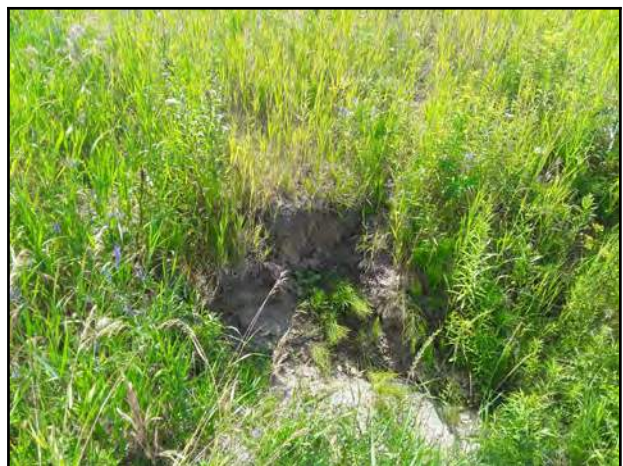
Photo 4 - Minor soil movement at the outlet embankment.

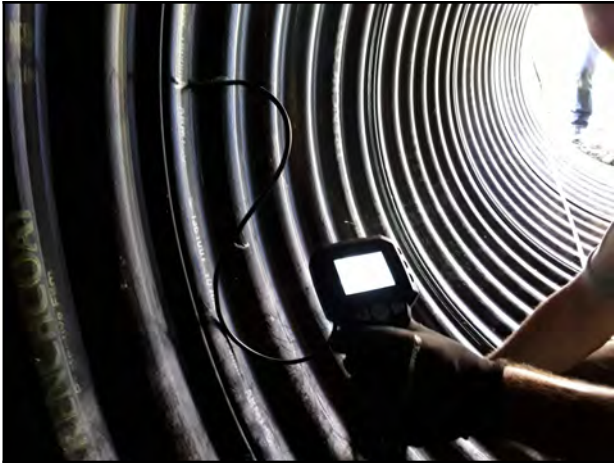
Photo 13 - V-1: Endoscope camera showing visible void.

Based on the findings, it is recommended that the areas with confirmed annular voids between the existing CMP and the sliplined CMP be injected with grouting material approved by the design engineer. This will ensure the supporting soil structure remains stable when the host CMP fully deteriorates. This can be accomplished by injecting grout directly in the center of the specific area and drilling overflow ports to ensure the product has reached the desired location. Locations of the captured BCT scan images are indicated by the distance from the inlet, as well as the clock position, and should be referenced during the injections. The BCT images should also be utilized to help estimate the material volumes required to complete the repair. Please refer to the soilsight™ Pipe Map and segment views for the exact locations of the voids.

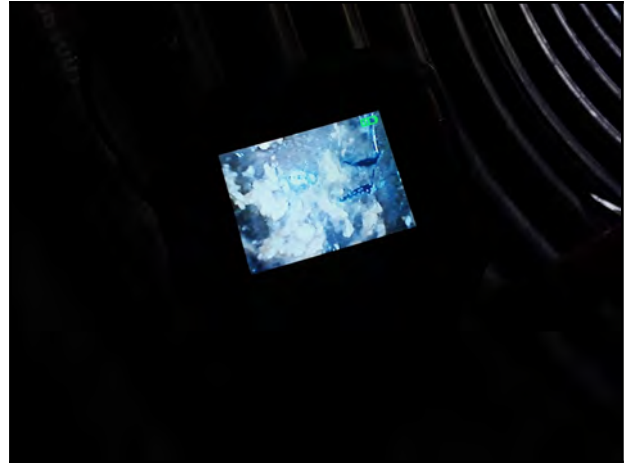
Photo 14 - V-1: Endoscope camera showing visible void.

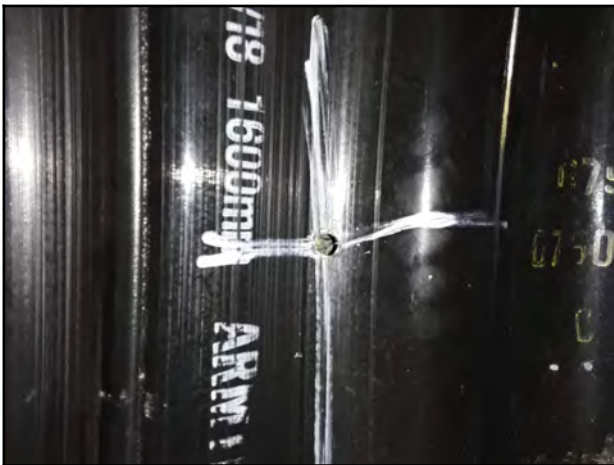
Photo 15 - V-1: Endoscope camera showing visible void.

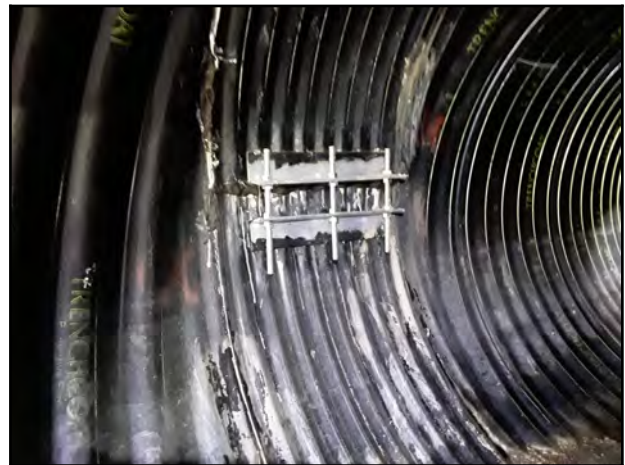
Photo 16 - V-2: Joint with visible expansion foam and grout buildup on the invert.

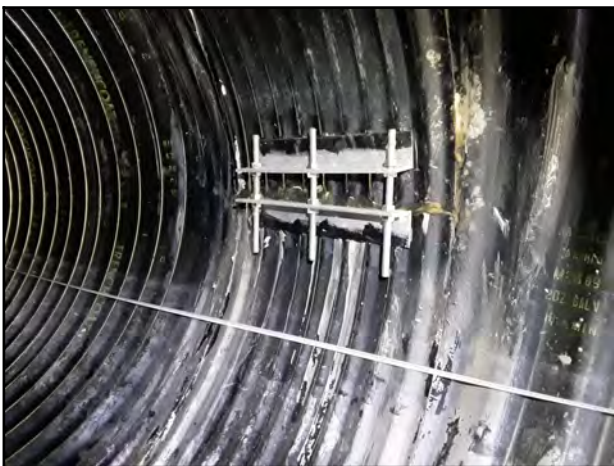
Photo 17 - V-2: Joint with visible expansion foam and grout buildup on the invert.

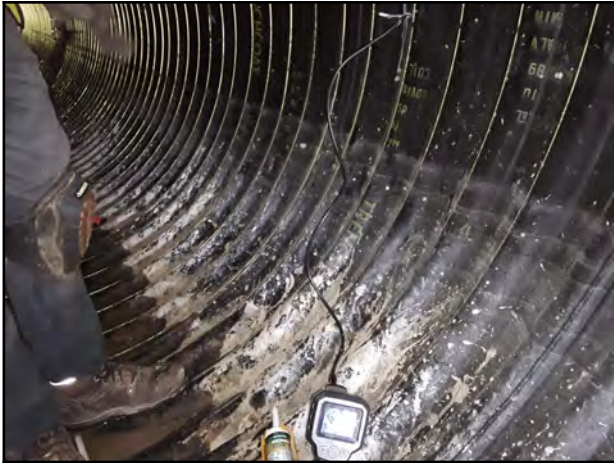
Photo 19 - V-3: Endoscope camera showing visible void.

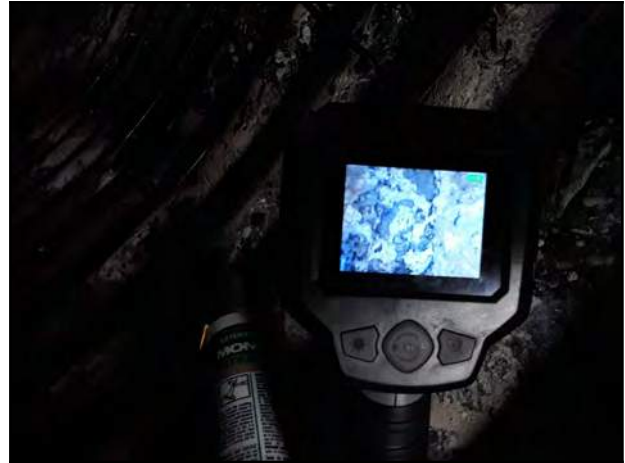
Photo 20 - V-3: Endoscope camera showing visible void.

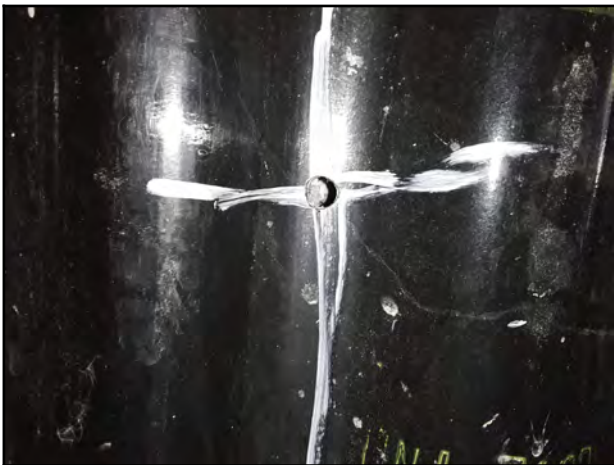
Photo 21 - V-3: Endoscope camera showing visible void.

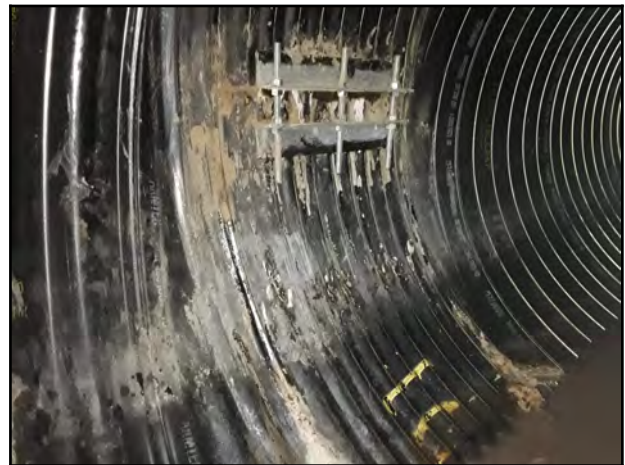
Photo 22 - V-4: Joint with visible expansion foam.
